PRELIMINARY GEOTECHNICAL EVALUATION

Cucharas Basin Collaborative Storage
Huerfano County, Colorado

Project No. 18.117.A
November 7, 2019

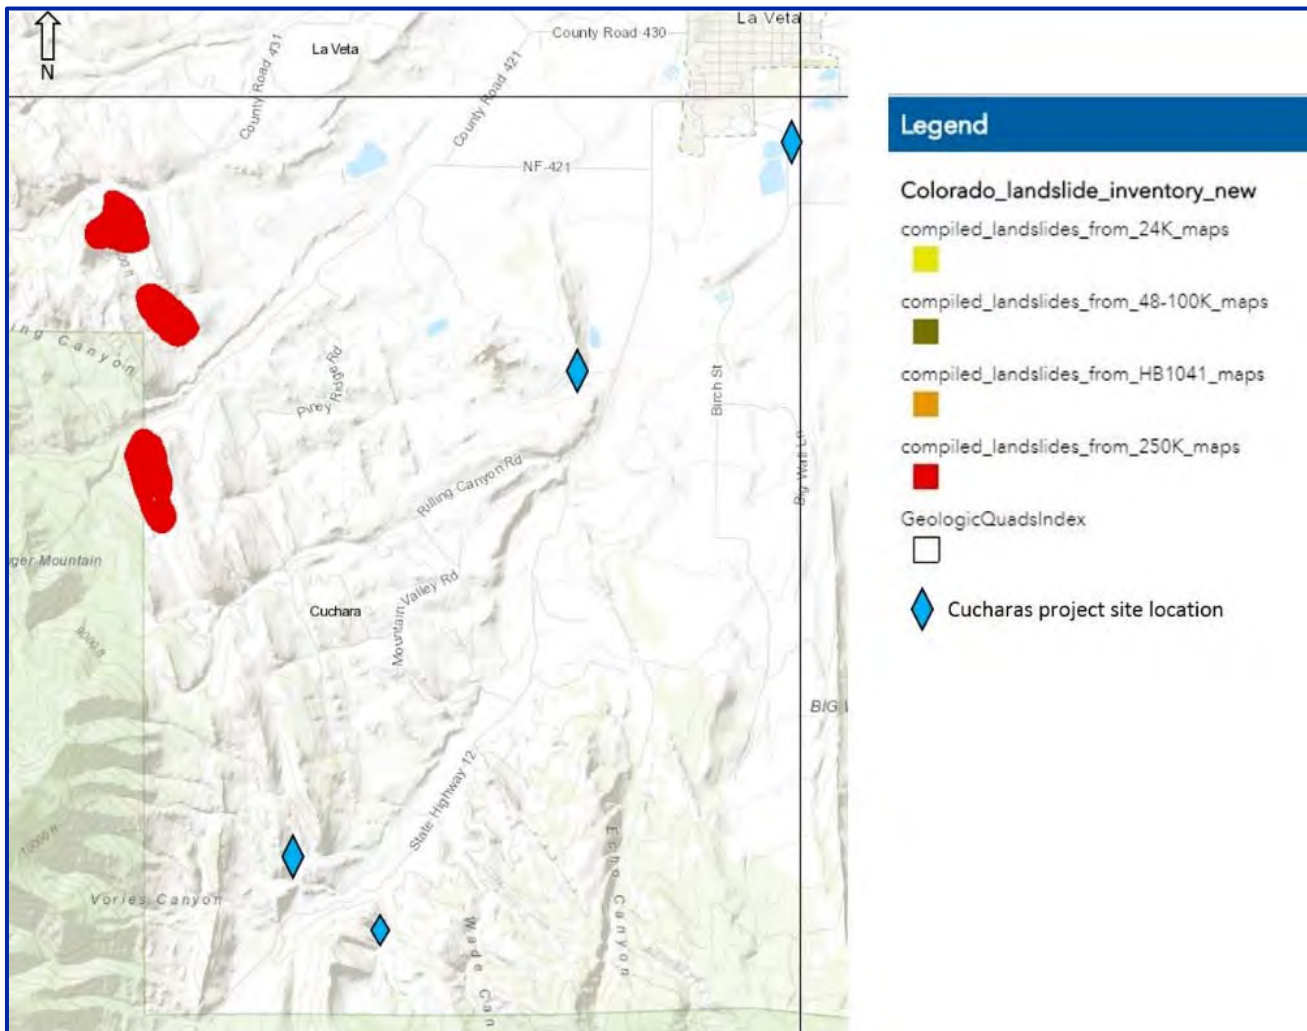
FIGURE 2. Mapped landslides in the Cucharas region from the Colorado landslides inventory. The red polygons are landslide areas digitized from 1:250,000 scale USGS mapping in the mid 1970's by Colton and others on 1 degree by 2 degree quadrangles. This map may not represent all landslides in the area.

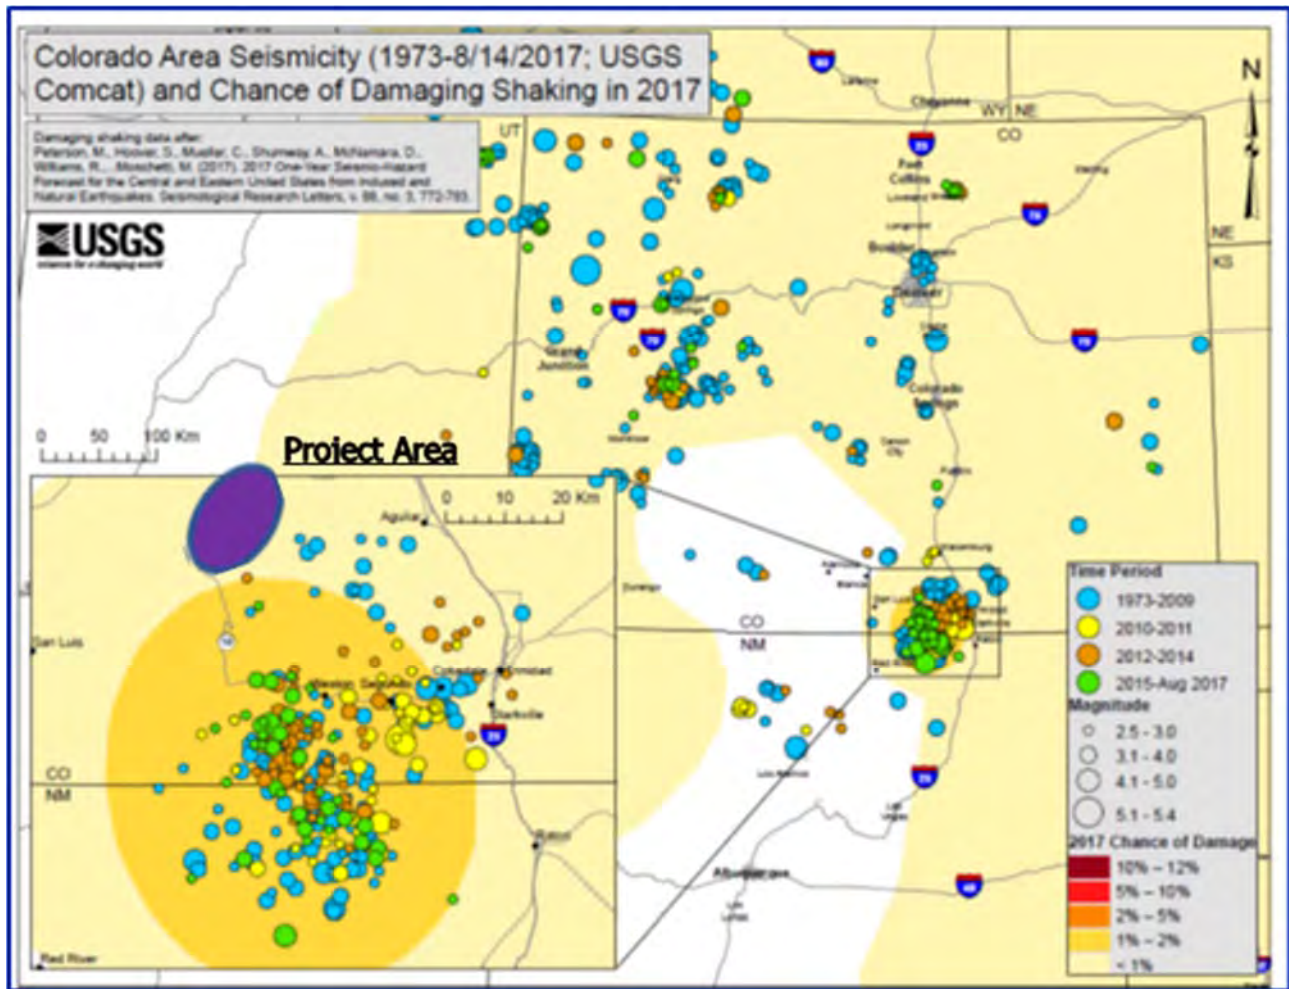
Seismic hazards are low in the project area; however, earthquakes have occurred in the region, mainly south of the project area. Mapped earthquakes and percent chance of damage are shown on the USGS⁵ (Figure 3). The project sites fall into the less than 1% chance of damage area mapped by the USGS. This indicates, should an earthquake occur, there is a very low risk of damage from an event that will affect any of the project sites.

FIGURE 3. Colorado seismicity from the USGS earthquakes hazards program. There is very low seismic risk for the project area.

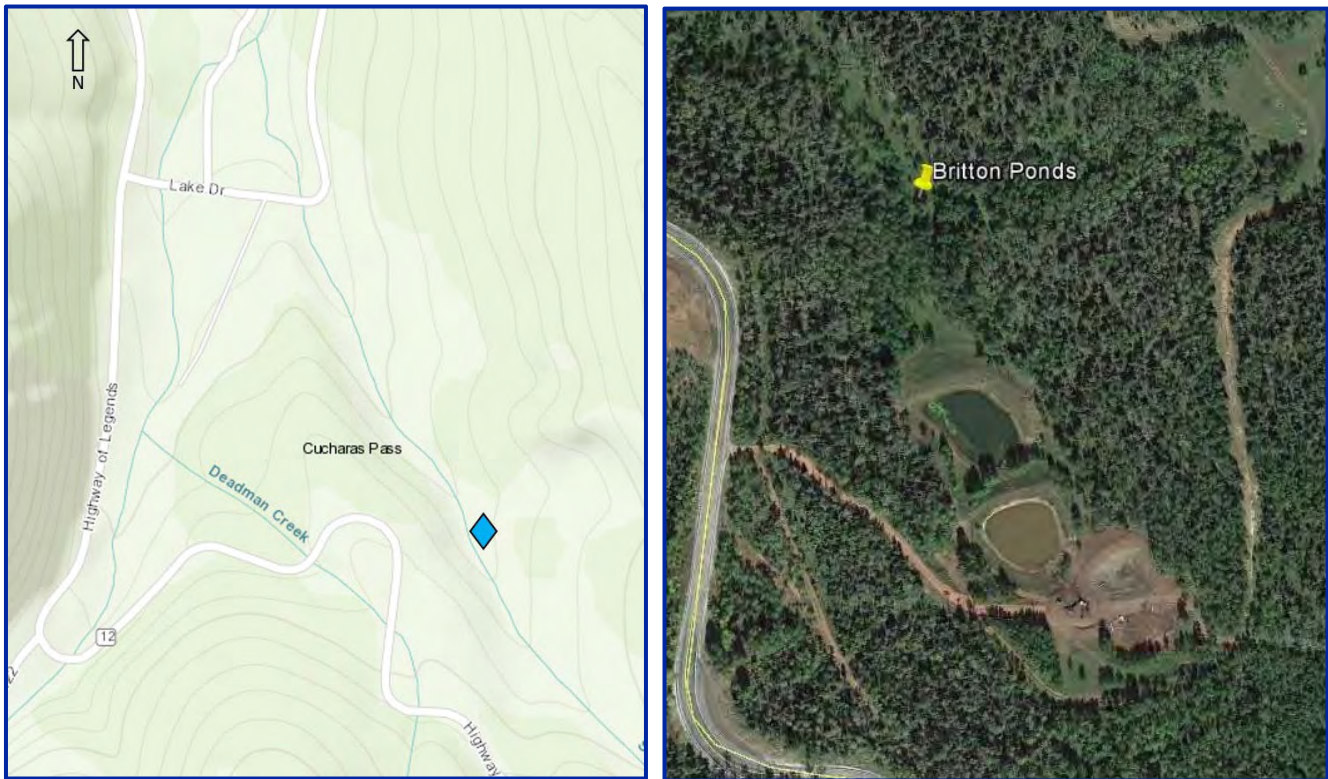
FIGURE 4. Britton Ponds project site (topographic and Google Earth images) is located southeast of the Baker Creek site, east of SH12 and north of Cucharas Pass. Britton Ponds is on the South Fork of the Cucharas River. The drainage occupies a northwest trending valley.

Geologic hazards at this site are minimal. The fracture nature of the sedimentary bedrock may lead to seepage and weathering along the fractures and bedding planes. This could result in a modification of drainage patterns.

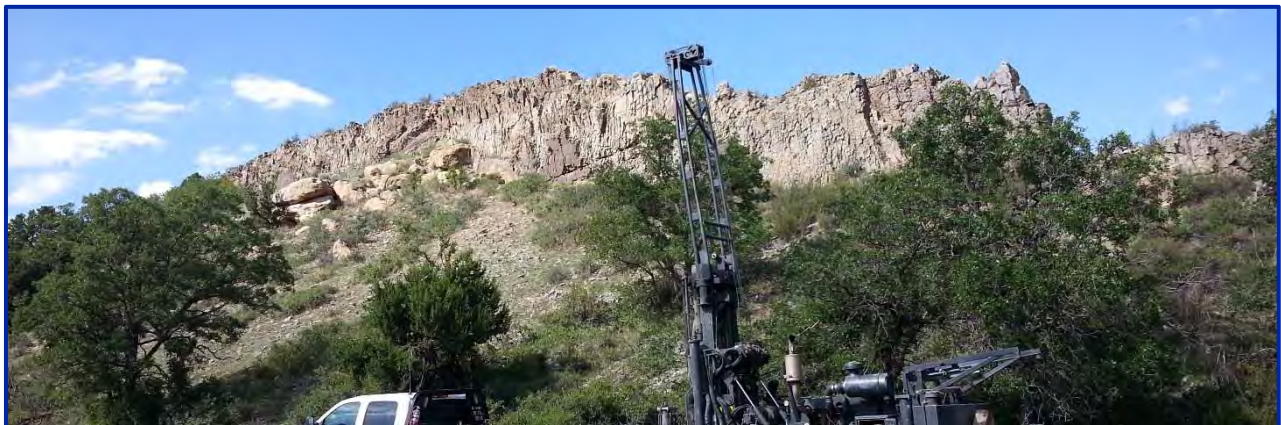
Geologic hazards at Bruce Canyon are rockfall and landslides. The vertical face of the intrusive dike is a source area for rockfall into the project area (Figure 6). Even so, rockfall is not expected to affect the project adversely as there is little evidence of rockfall near the proposed abutment locations, the evidence indicates rocks that have fallen are not large, and rocks would likely fall into the reservoir, as opposed to on the embankment. The slopes on either side of the valley have the potential for downslope movement (Figure 7). Because of the interbedded and fractured nature of the sedimentary rock units in this area, the slope stability could be affected by infiltration and movement of water along fractures and bedding planes, increased weathering, and reduced strength along discontinuities.

FIGURE 6. Intrusive dike on the northeast side of the site. A potential source for rockfall into the project area.

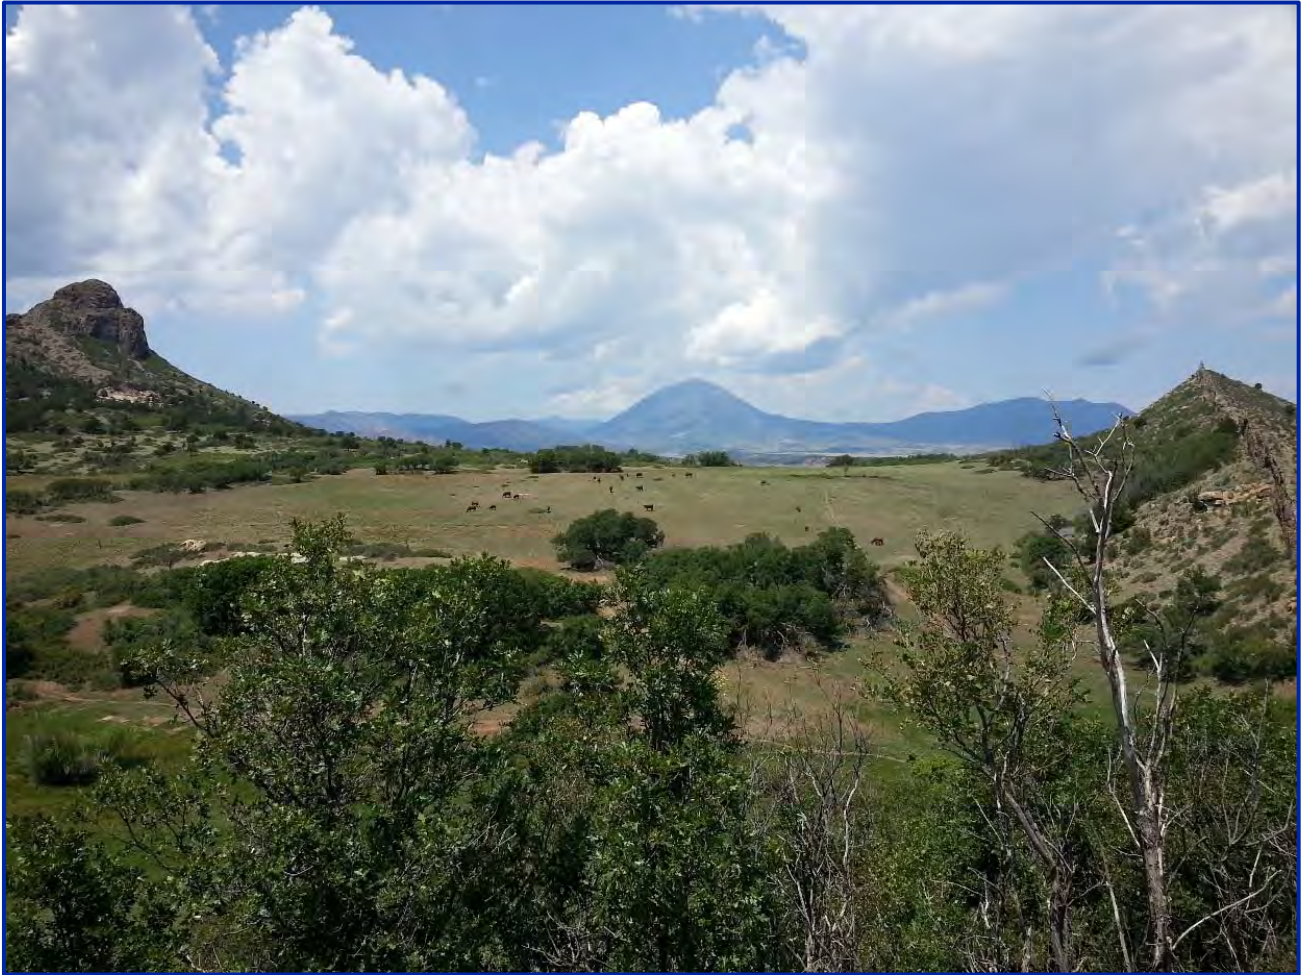
FIGURE 7. Bruce Canyon project site. View looking north from the south side of the project area. Steep hill slopes on either side of the valley have the potential for downslope movement due to the fractured and interbedded nature of the sedimentary rock units.
