LOAN FEASIBILITY AND EVALUATION REPORT

QUEEN DAM

KIOWA COUNTY, COLORADO

March 2020

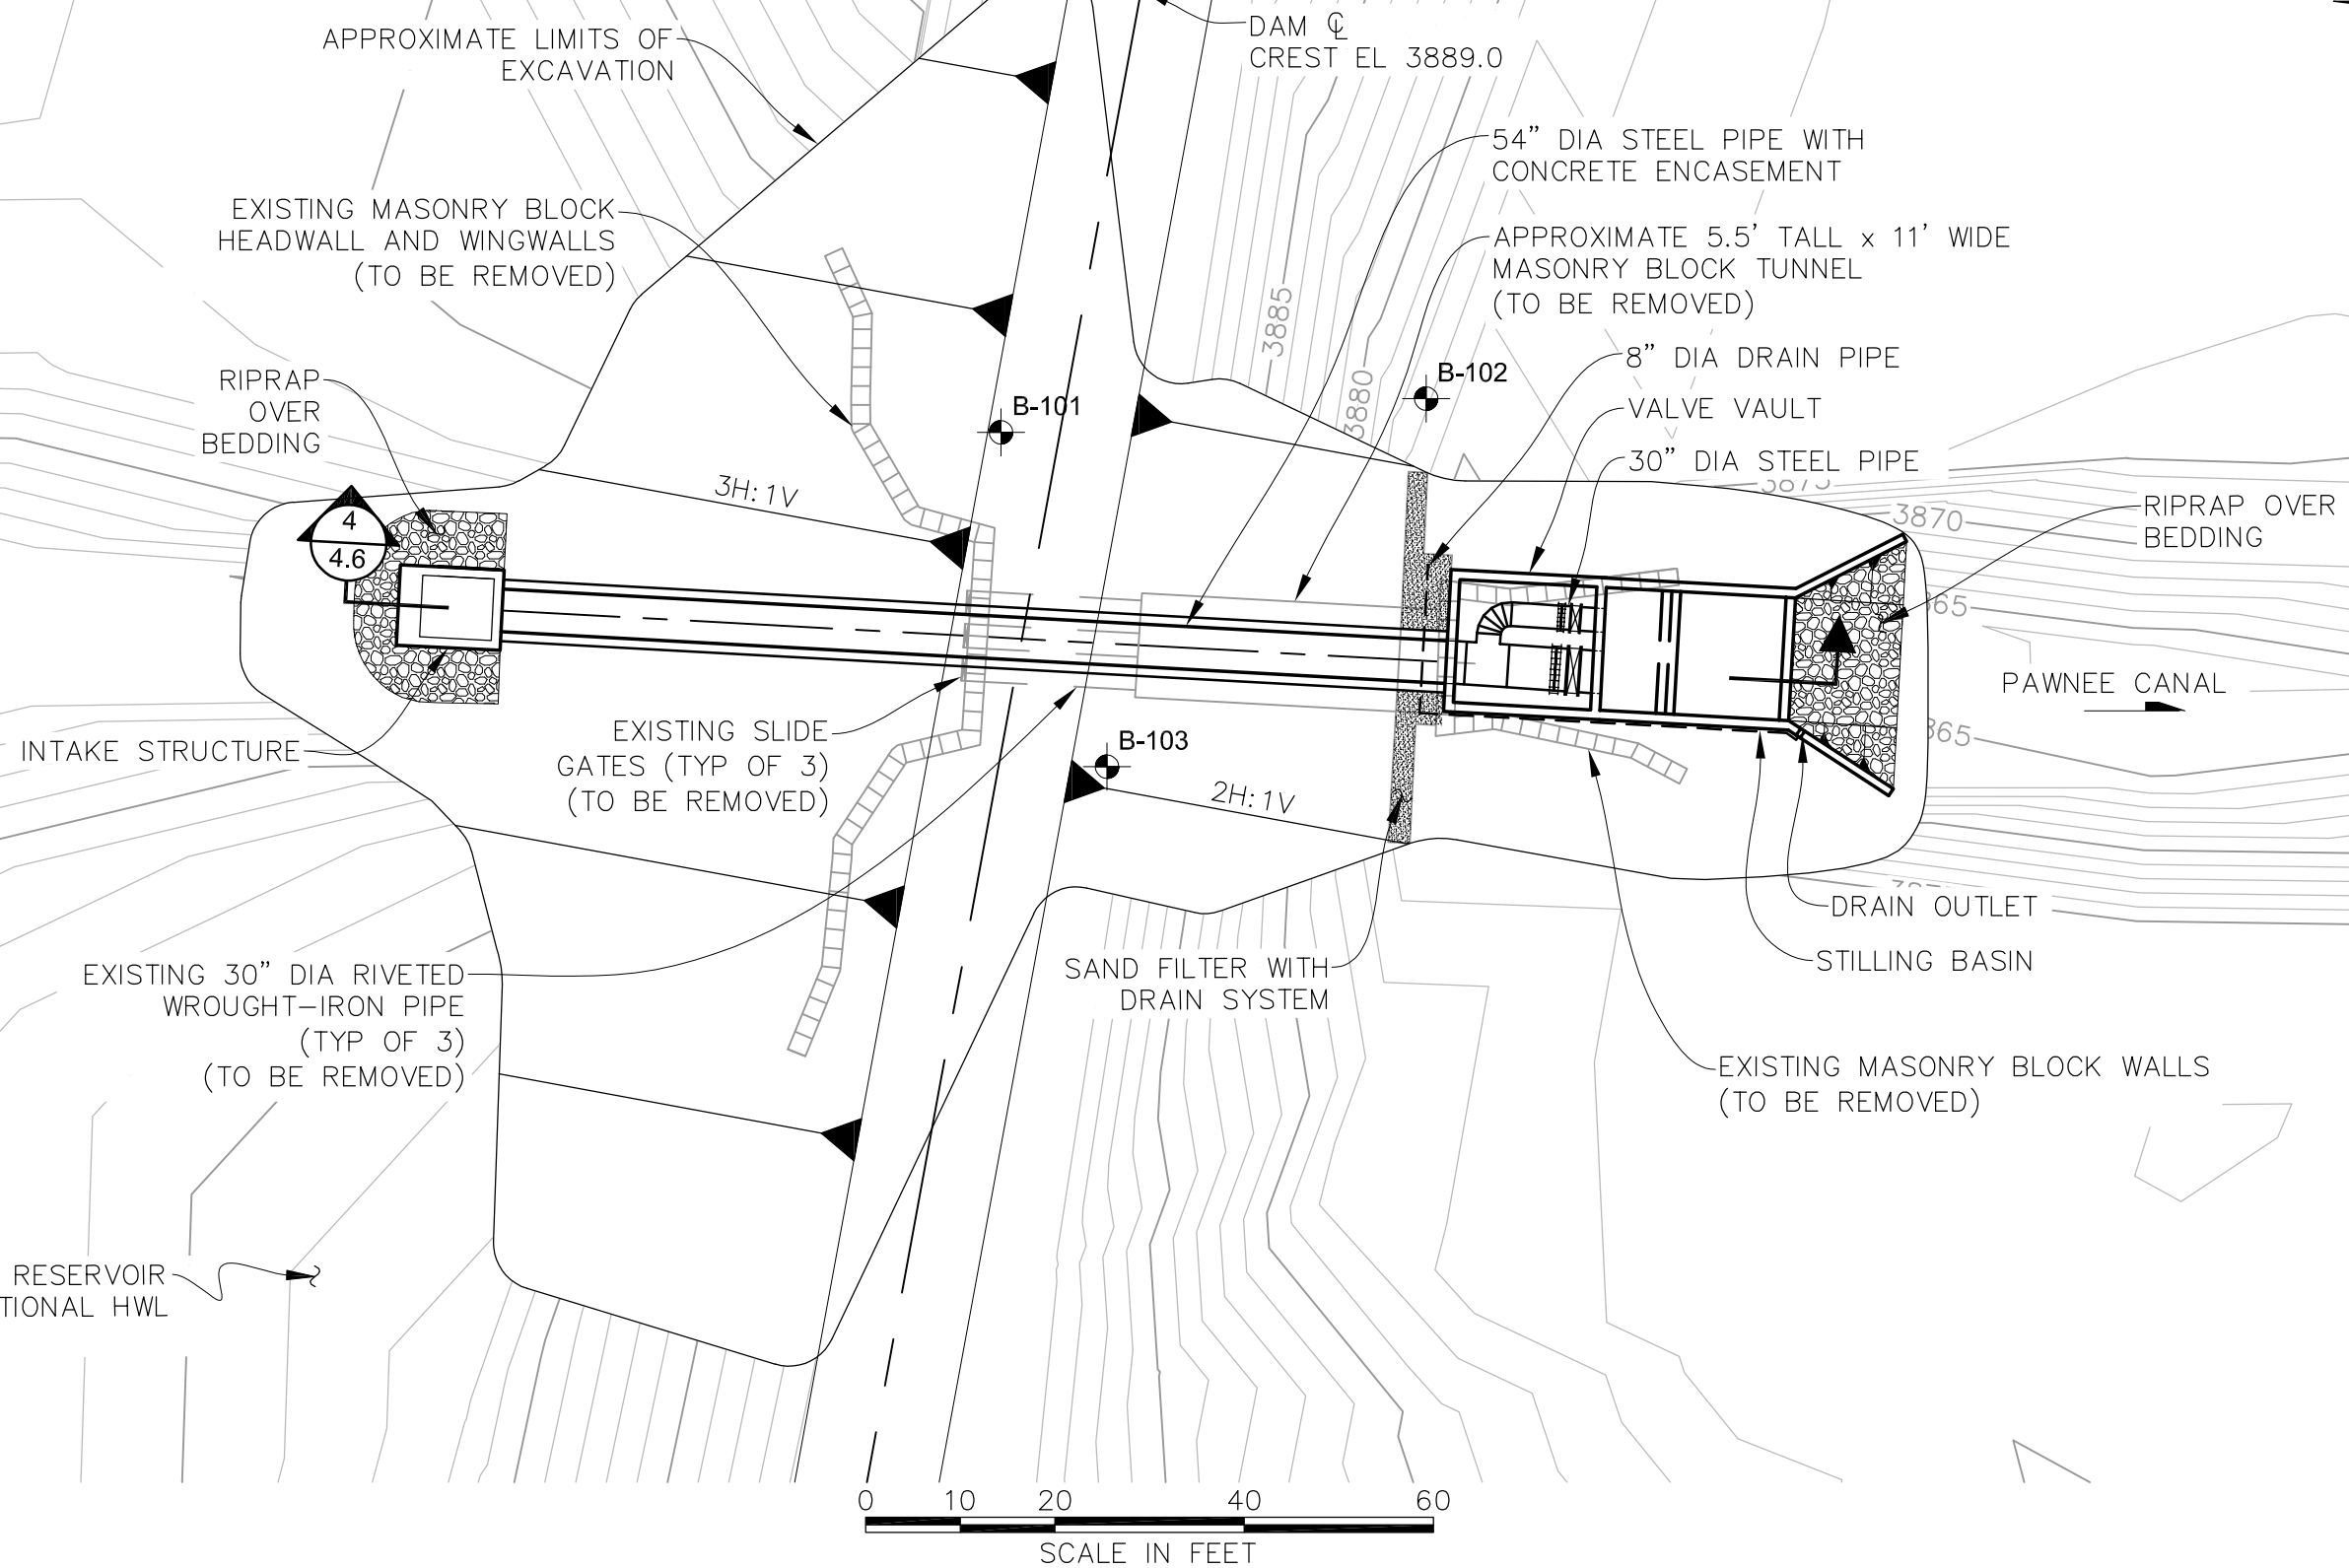
Figure 4.5

Alternative 2 includes the removal of the entire outlet works and replacement of the outlet works components. A general plan, profile, sections, and details are shown on Figures 4.5, 4.6, and 4.7. This alternative includes the following:

In RJH's opinion, the selection of Alternative 2 is the most feasible and cost-effective option for the rehabilitation of the outlet works. The selected alternative removes risks and uncertainties associated with keeping the upstream masonry headwall, wingwalls, and conduits. In addition, the existing outlet works is over 100 years old, which likely exceeds the intended service life. Replacement of the outlet works would reduce the overall frequency of maintenance and associated costs.
