**Re: Loan Feasibility Study Grant for Evergreen Dam Rehab
Grant Contract Number POGG1, PDAA, 201900002360
Letter of Intended Next Steps**

Condition Assessment Report Evergreen Dam Outlet Works

Evergreen, Colorado

June 2019
Project 1804163

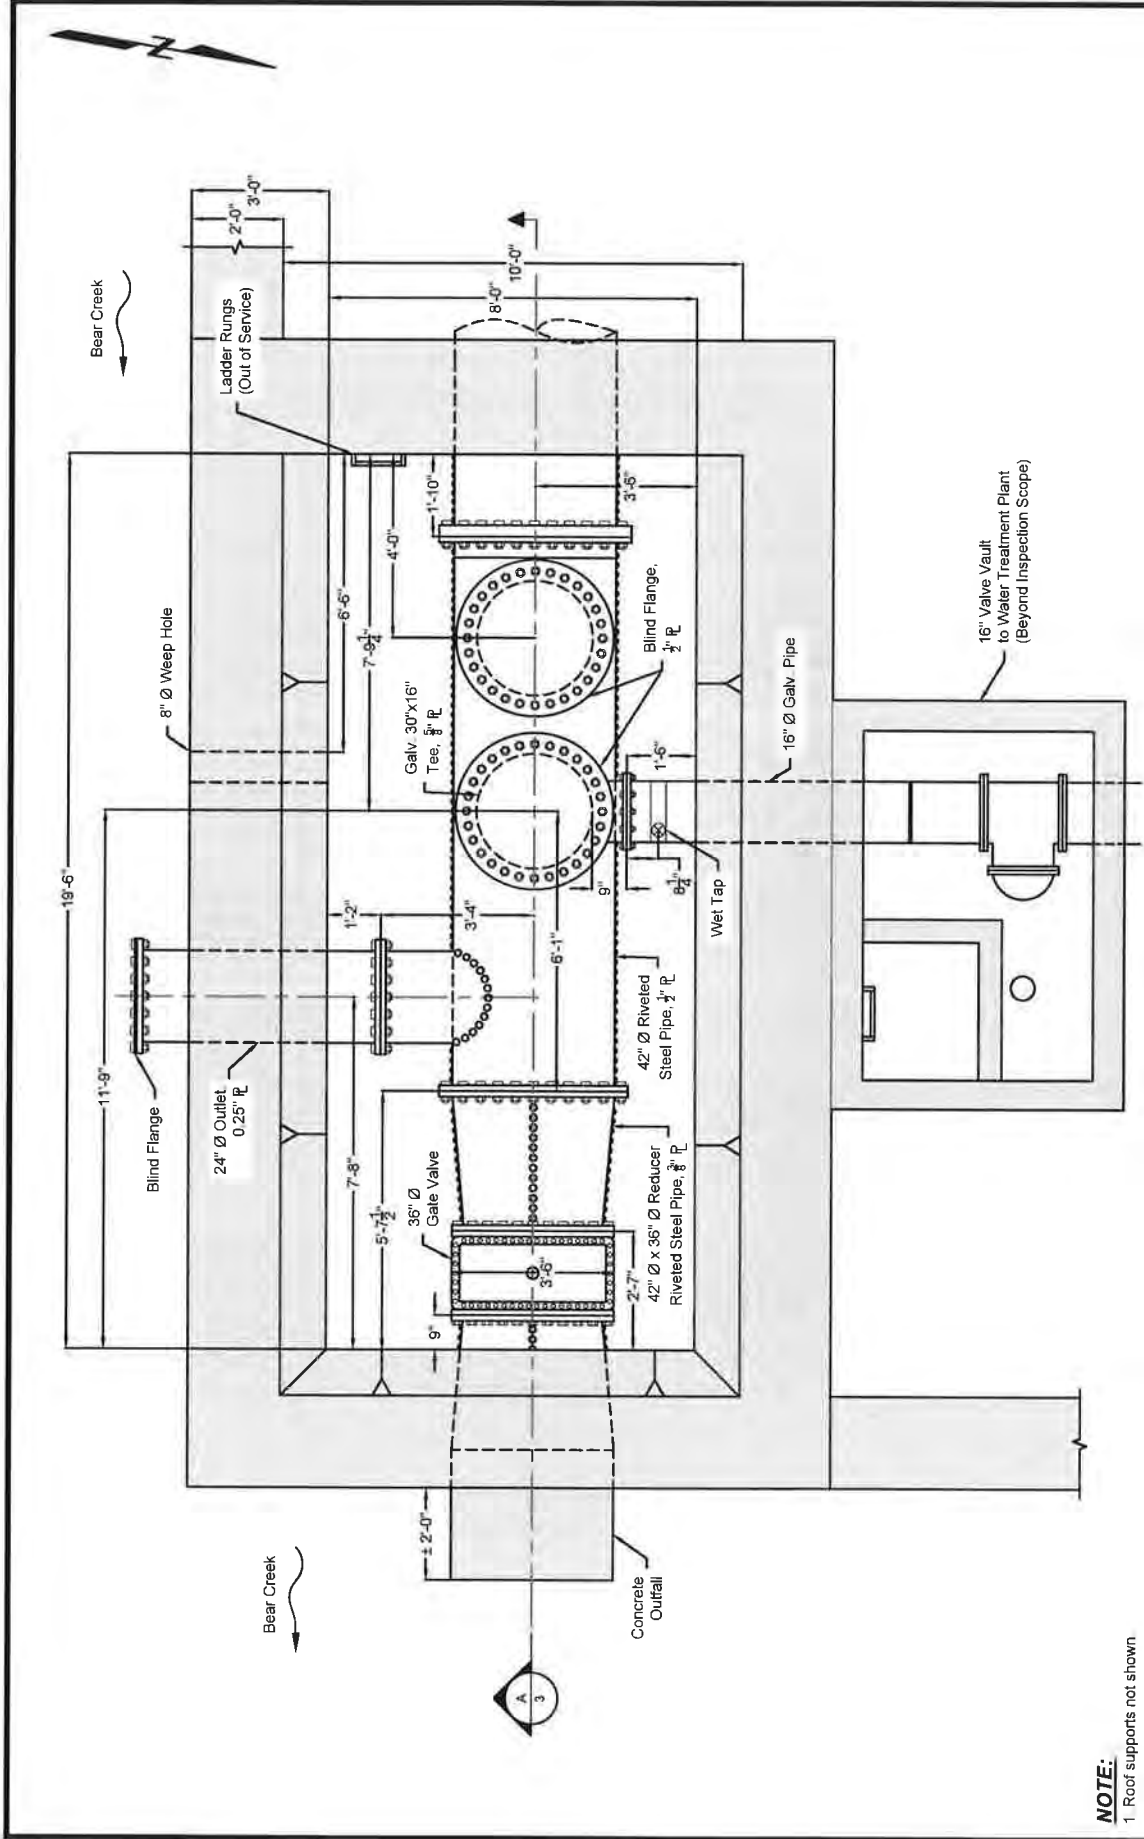
<p>GEI Consultants</p>	<p>Evergreen Dam Outlet Works Assessment Evergreen, CO</p>
<p>Project 1804163</p>	<p>Evergreen Metro District</p>
<p>RESERVOIR OUTLET VAULT</p>	<p>June 2019</p>
<p>Fig. 2</p>	<p></p>

The downstream outlet works vault was originally observed to be in a poorly maintained condition, with sediment and debris covering much of the outlet conduit. After the vault was cleaned by Evergreen Metro, the outlet conduit itself was observed to be in satisfactory condition. Portions of the external coating were missing, but large scale corrosion or pitting was not documented. Because the outlet works conduit was constructed with concrete up to the springline of the conduit, it will be difficult to modify the conduit to accommodate additional valve configurations beyond what currently exists. The interior of the conduit was not able to be assessed due to the fact that the conduit was pressurized. Measurements taken of the outlet vault during the condition assessment are documented in Figures 2 and 3, and inspection photographs are in Appendix B.

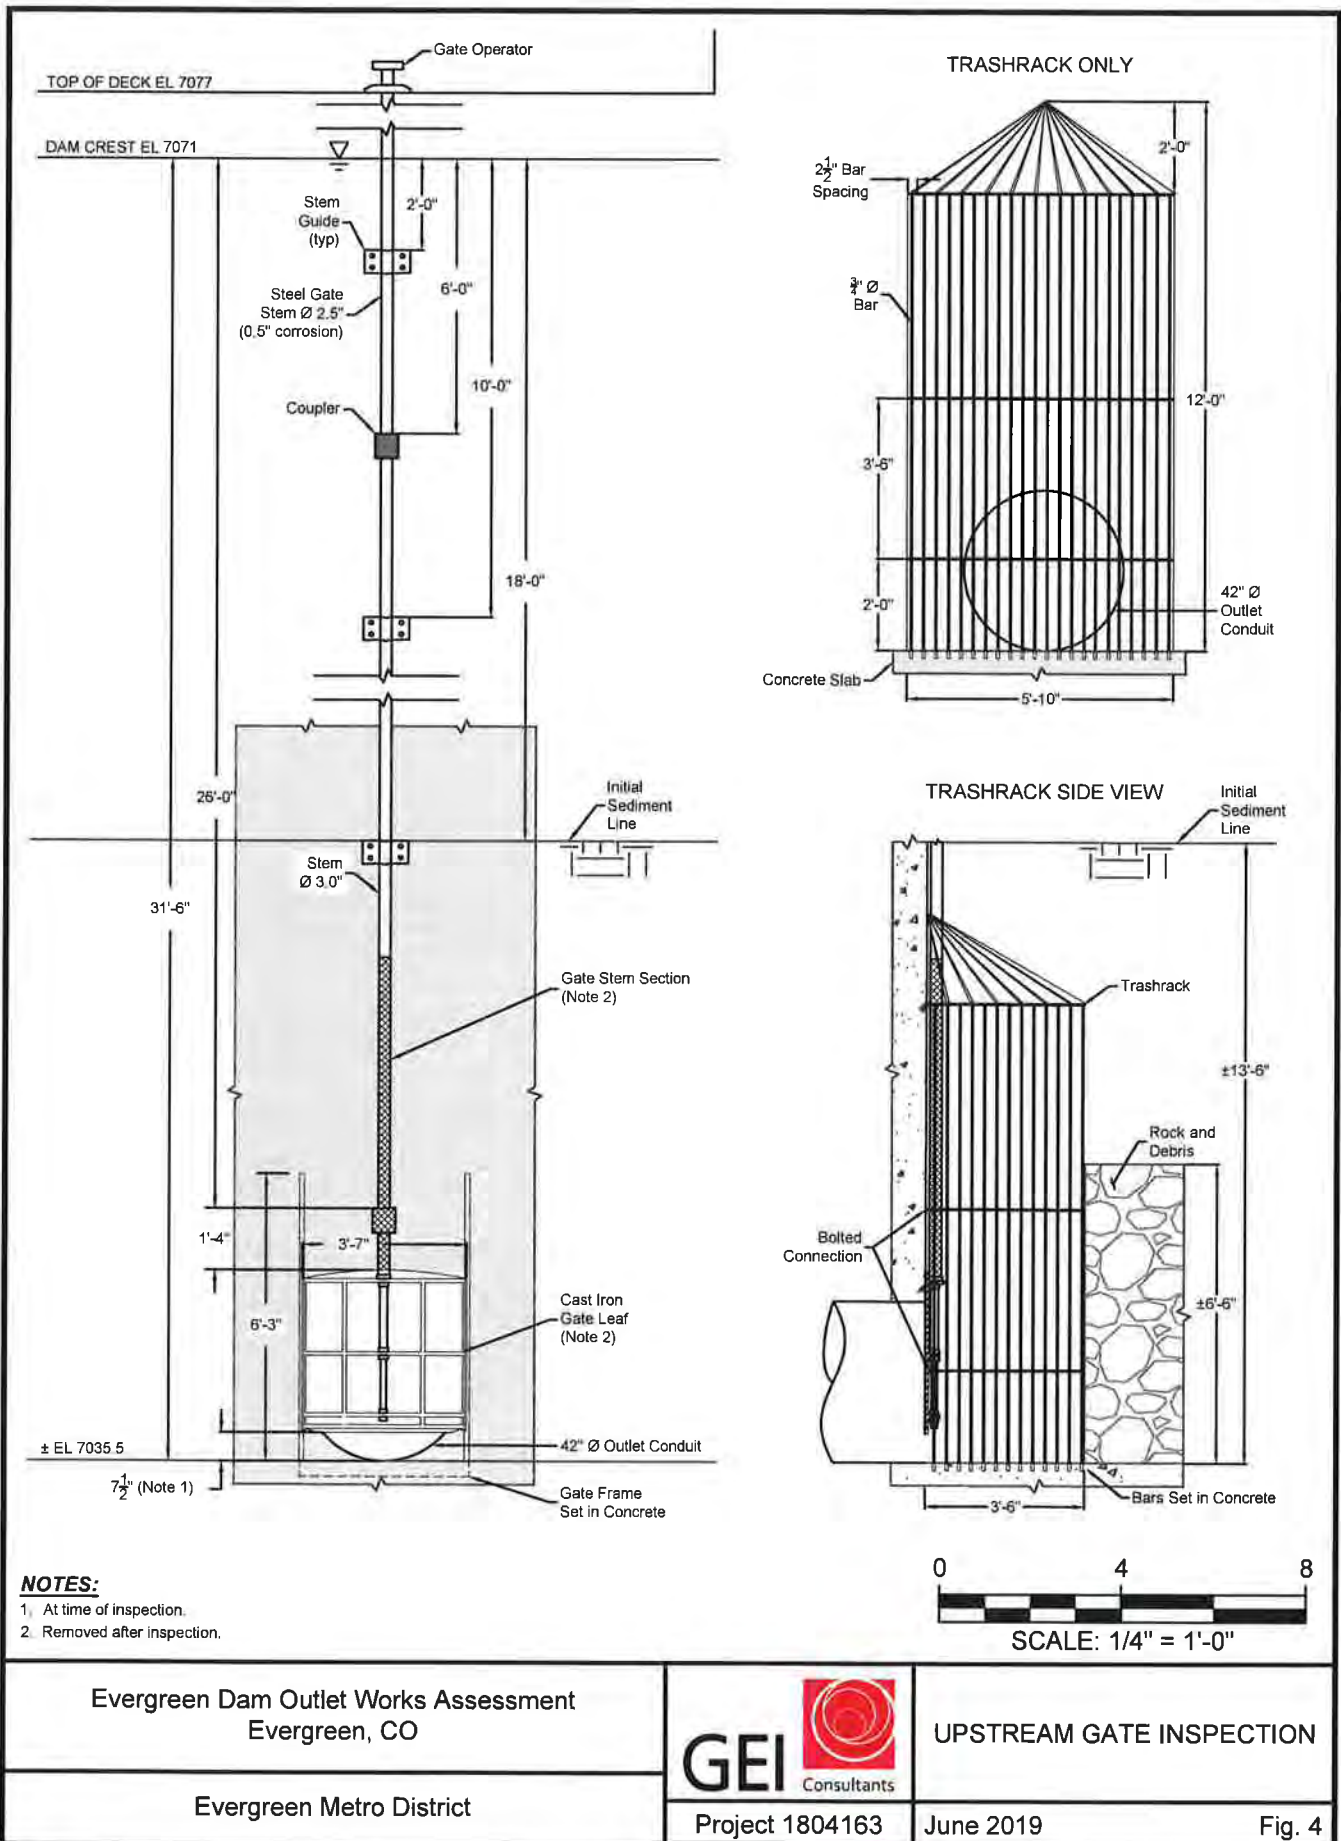
Figure 4: Upstream Gate Inspection

Following the removal of sediment and debris, a gate inspection was conducted in which the divers recorded video and took measurements of the gate assembly. The divers observed that the gate was opened approximately 7.5 inches. The gate frame was observed to be bolted to the dam on the left and right sides of the gate. However, the lower sill of the gate frame appears to have been cast into the concrete slab at the bottom of the trashrack enclosure. The outlet pipe was observed to contain loose silt, and the outlet conduit invert was approximately flush with the concrete sill. The dive team confirmed that there were no additional items of debris or sediment preventing the gate from being moved to the closed position. Observations established that the gate stem has three stem guides securing it to the left abutment at depths of 2-, 10- and 18- feet below the water surface (El 7071). There were also two stem couplings present at depths of 6 and 26 feet, respectively. The stem circumference was measured to be 7.9 inches (2.5-inch diameter) at a depth of approximately 3 feet, and 9.5 inches (3.0-inch diameter) at a depth of 18 feet, just below the level of the silt prior to the sediment displacement operations. The corrosion above the silt line was noted to be greater than below the silt. Based on these observations, it is likely that the upper gate stem lost at least 0.5-inches of steel thickness due to corrosion.

The upstream outlet works assembly was found to be in poor condition. The gate operator was not functional, and the gate stem above the initial sediment line had a thick coating of rust and scale. After removal of a portion of the corrosion, the gate stem above the sediment line and trashrack below the silt line show signs of approximately 0.5-inch of section loss due to corrosion. Although the amount of rock and debris present on the upstream side of the trashrack can attest to the current strength of the steel, future performance cannot be estimated. A material assessment of the cast iron gate leaf was not performed. Upon visual inspection, the gate leaf does have some pitting, but it has not undergone the same amount of corrosion as the steel members.

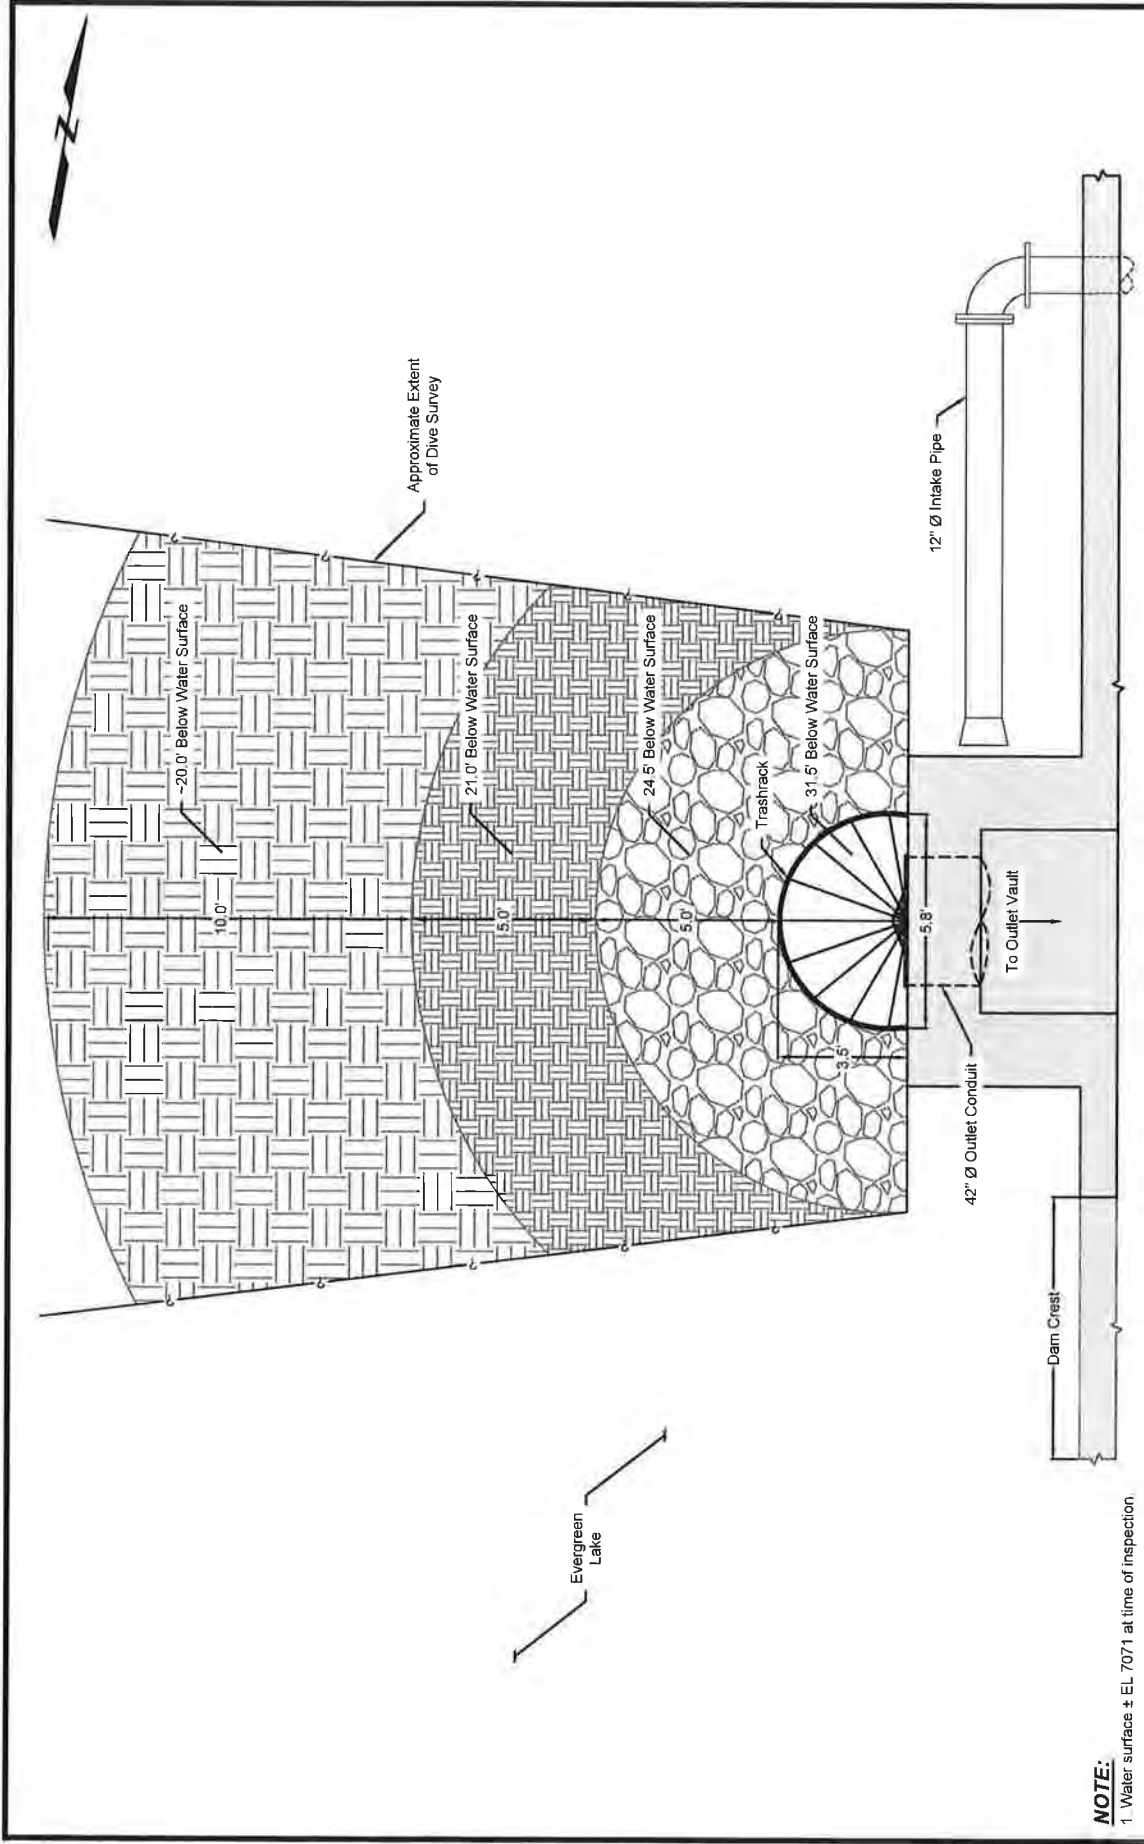
Figure 5: Upstream Debris Removal Summary of Work

The interior condition of the conduit was unable to be evaluated during this investigation, and it is likely to contain sediment due to the gate being maintained in partially opened for a period of time. Documentation of the upstream gate inspection and a summary of sediment removal are found in Figures 4 and 5. Inspection photographs are in Appendix B.

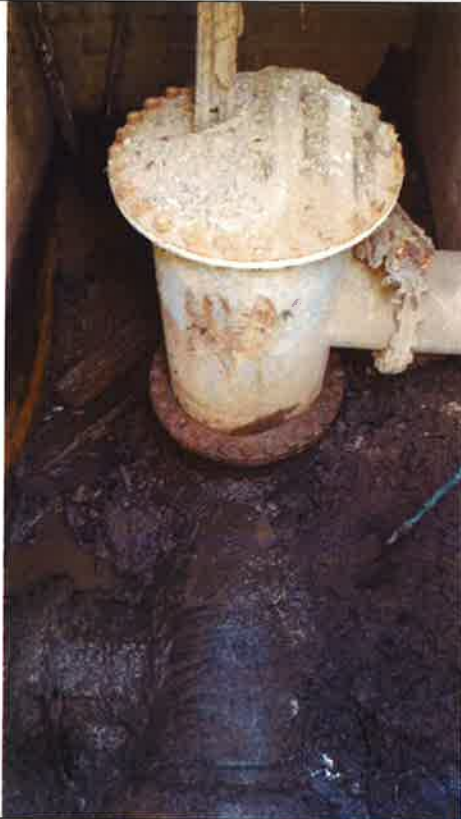
Photo 2: View of 30-inch tee within the outlet vault after most of the rotten wooden timbers have been removed.
Date: 10-29-2018
Source: C. Mattson (GEI)

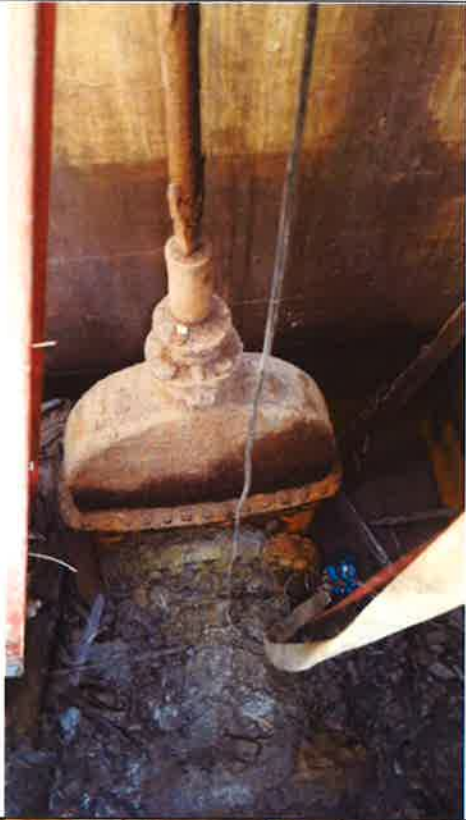
Downstream of the tee connections, the 42-inch diameter outlet pipe reduces down to 36-inches for a 36-inch diameter gate valve. The gate valve was manufactured by Ludlow and was in the closed position. The operating stem of the valve extends through the vault roof. However, the operator at ground surface was non-functional and was only supported by decayed timbers.

Photo 4: View of gate valve in the outlet vault.
Date: 10-29-2018
Source: C. Mattson (GEI)

The existing gate valve would be removed and replaced with a new knife gate valve capable of throttling flow. The 16-inch connection to the WTP intake conduit could still be utilized for delivering water to the WTP through the low level outlet. Energy dissipation at Bear Creek or a flap gate may be required to prevent silt from building up within the conduit.

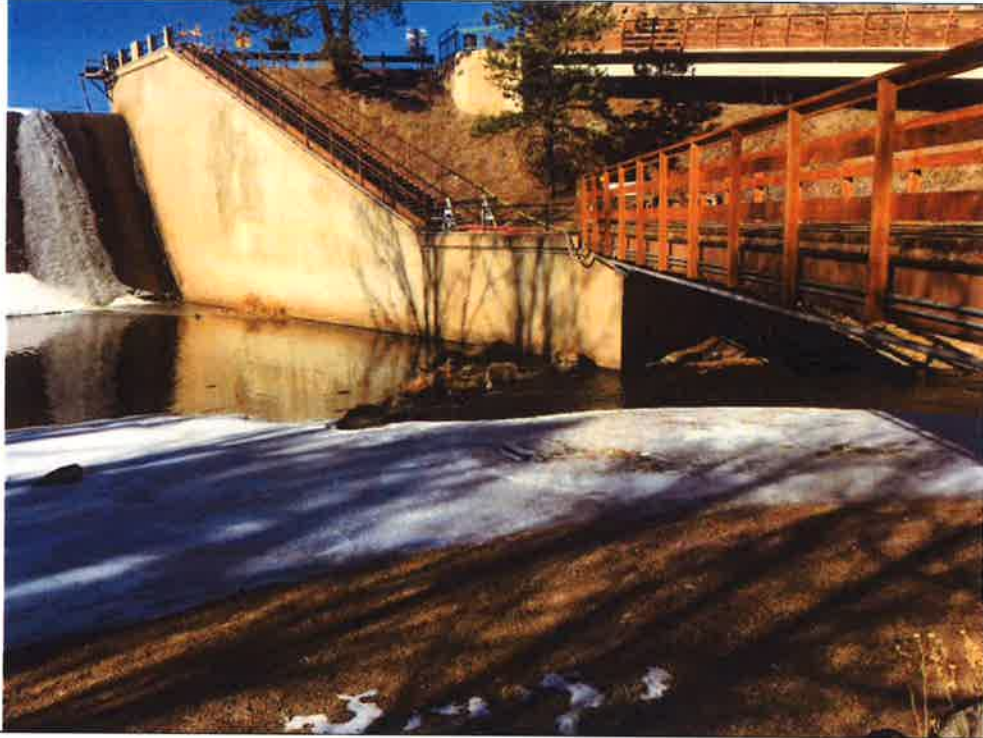
The outfall present on the east side of the vault was observed to be constructed of a reinforced concrete pipe extending approximately 2 feet long into Bear Creek. It is assumed that the conduit transitions from cast-iron to concrete at some point through the outlet vault. The invert of the pipe was within 1 foot of the observed creek bottom and could not be inspected.

Photo 14: Left abutment and pedestrian bridge. Notice sediment at crest of outfall pipe.
Date: 12-07-2018 Source: C. Masching (GEI)

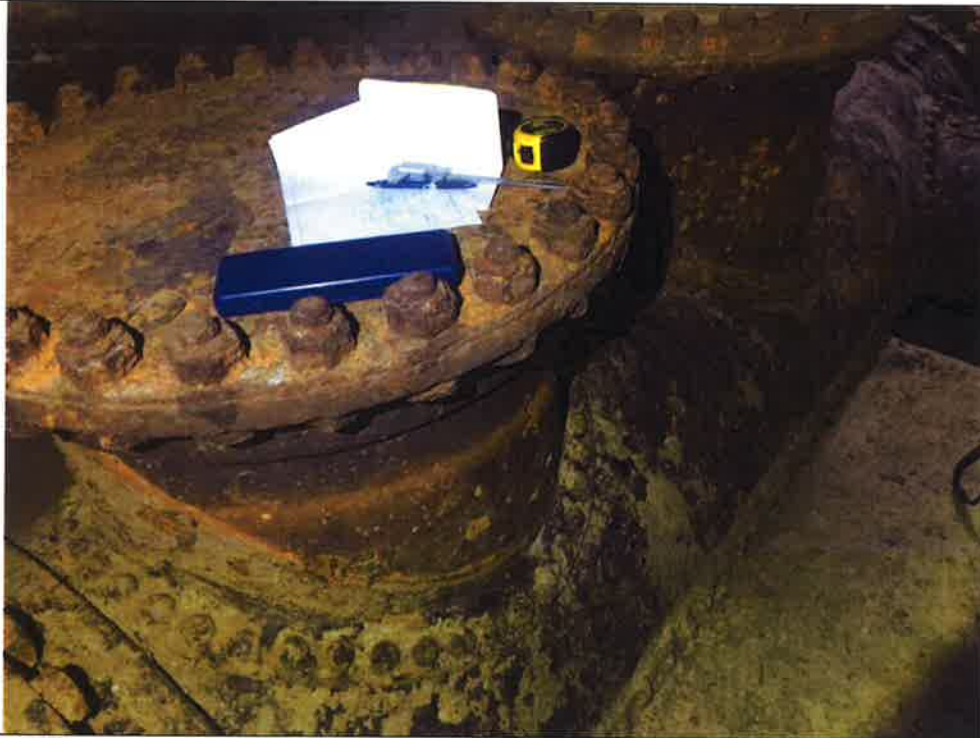
Photo 16: 30-inch blind flange with concrete fill to spring line of 42-inch conduit.
Date: 12-07-2018 Source: C. Masching (GEI)

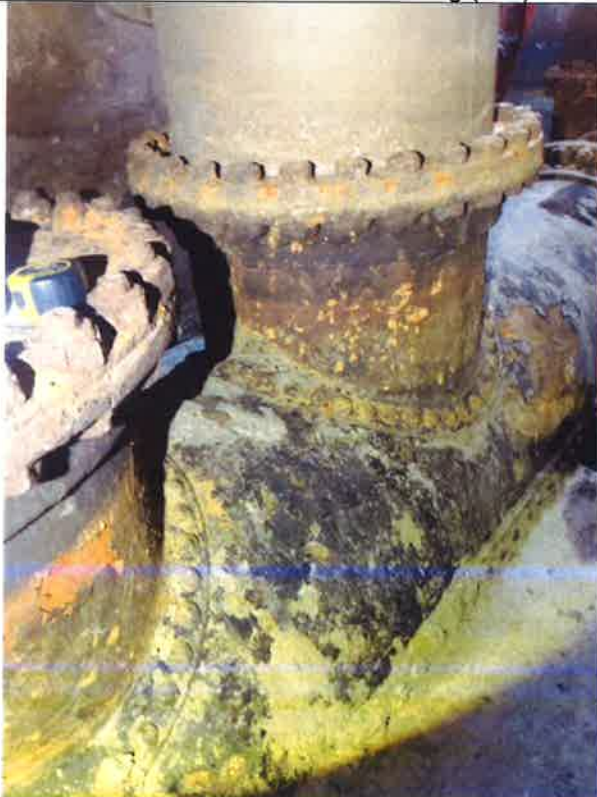
Photo 17: Bottom of fabricated 30-inch x 16-inch tee with concrete fill to spring line.
Date: 12-07-2018
Source: C. Masching (GEI)

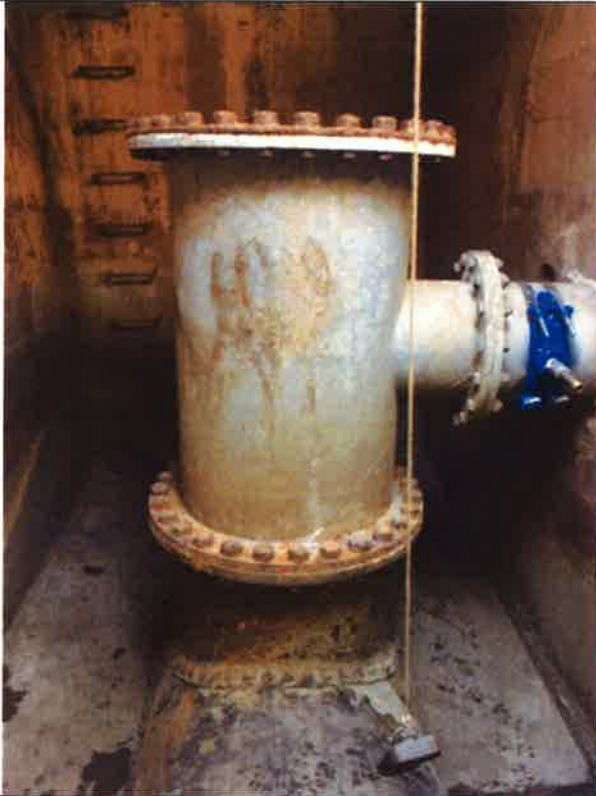
Photo 18: 30-inch by 16-inch tee installed in 1966 for water treatment plant modifications (looking west). Tee is tilted 1.5-inches north.

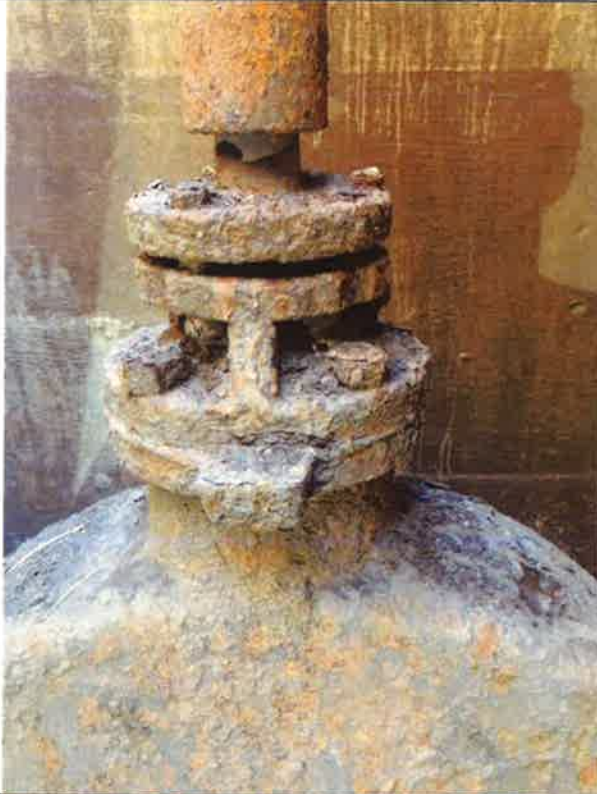
Photo 20: Gate valve mechanism above cover.
Date: 12-07-2018
Source: C. Masching (GEI)

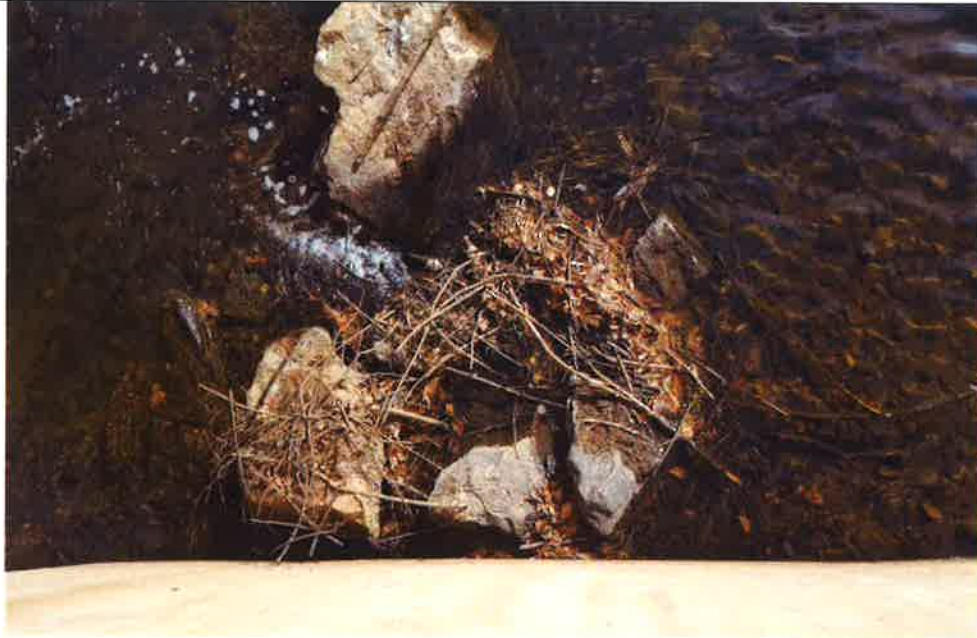
Photo 29: Location of 24-inch line blind flange outside of vault before removal of debris.
Date: 10-29-2018 Source: C. Mattson (GEI)

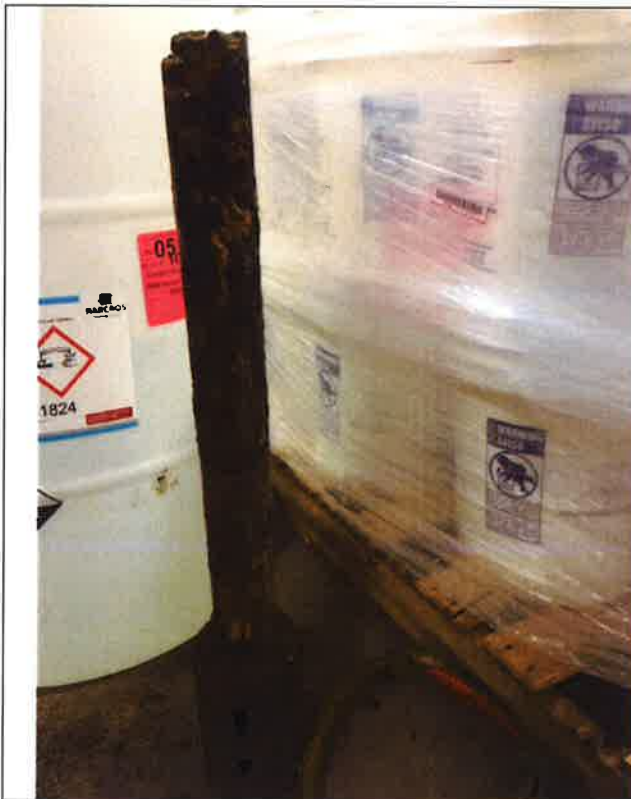
Photo 33: Piece of gate stem and coupler removed from upstream gate assembly.
Date: 03-21-2019
Source: G. Jeffrey (Evergreen Metro)

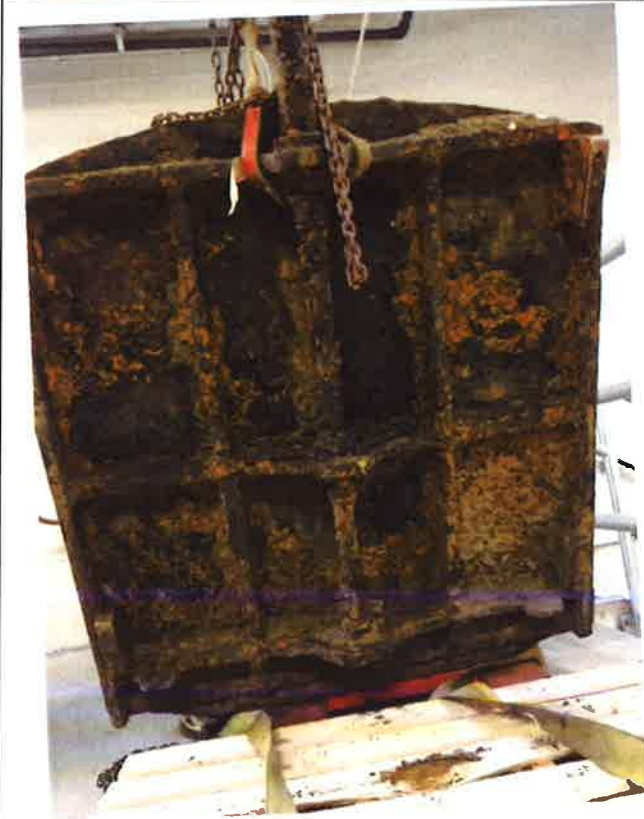
Photo 34: Upstream side of gate leaf.
Date: 03-21-2019
Source: G. Jeffrey (Evergreen Metro)

This option includes procurement and installation of a new fabricated stainless steel gate, gate stem and electric operator with divers. The existing trashrack would be replaced with a new fabricated structure and also installed by divers. Removal of large rocks surrounding the existing trashrack would be required.

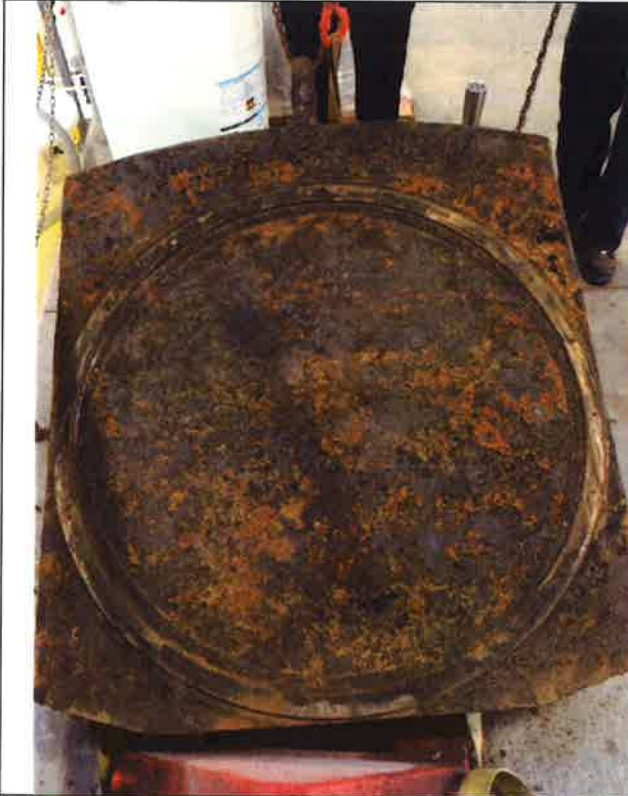
Photo 35: Downstream side of gate leaf.
Date: 03-21-2019
Source: G. Jeffrey (Evergreen Metro)
