# Chambers Reservoir Slope Failure on the South-West reservoir slope

Field Inspection 4-25-17

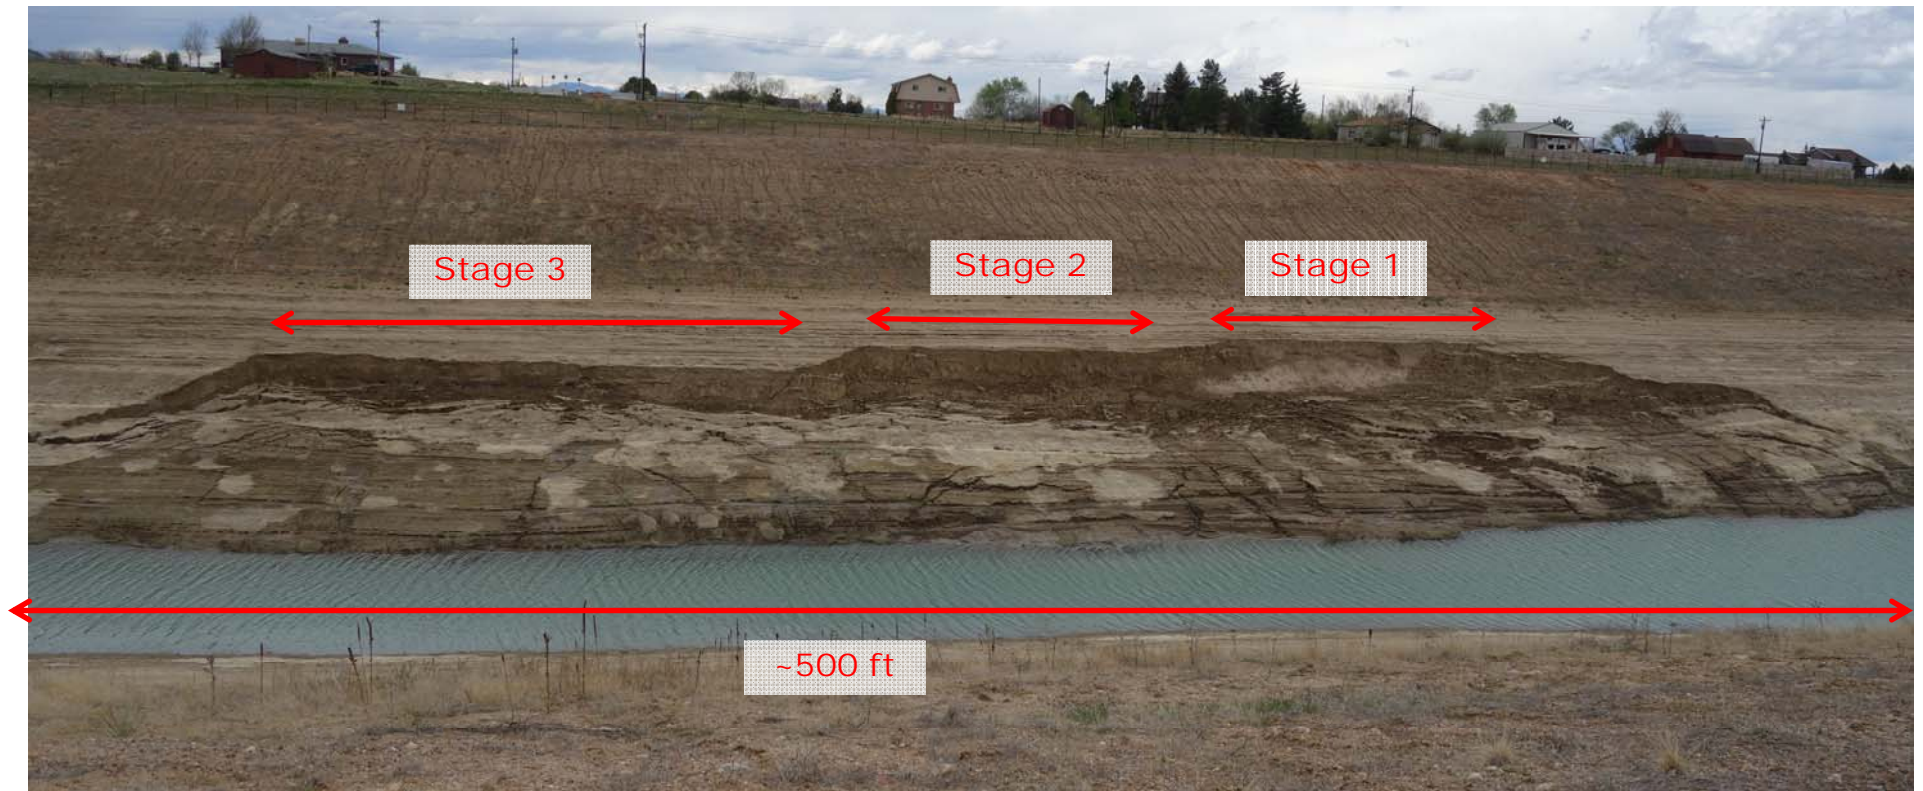
# Progressive Failure

- Occurred ~March 25th or 26th, 2017
- Water observed flowing out from head scarp
  - High groundwater behind CCL
- Reservoir drawdown in March 2017
  - Rate of drawdown = 9 inches per day (El. 5796 – 5774)
  - Most rapid drawdown cycle (history of reservoir)
- March 25<sup>th</sup>, 2017
  - Groundwater El. = 5792 (piezometer S1)
  - Reservoir El. = 5781 (11 feet lower than S1)

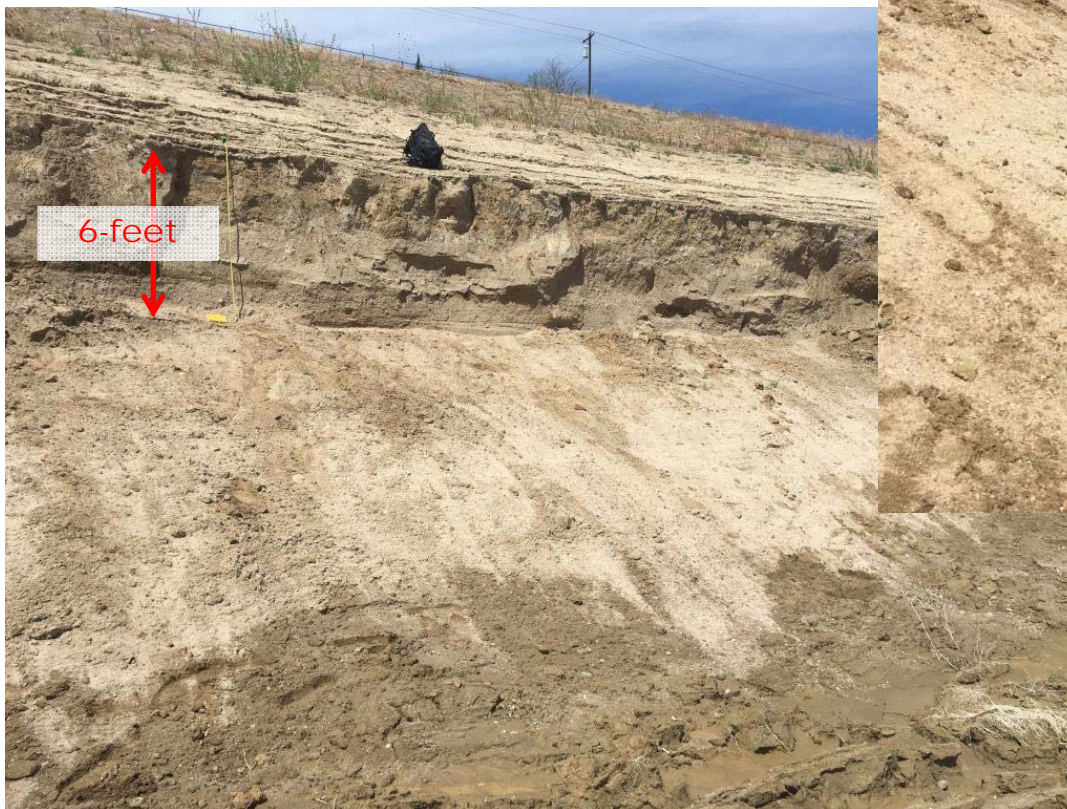
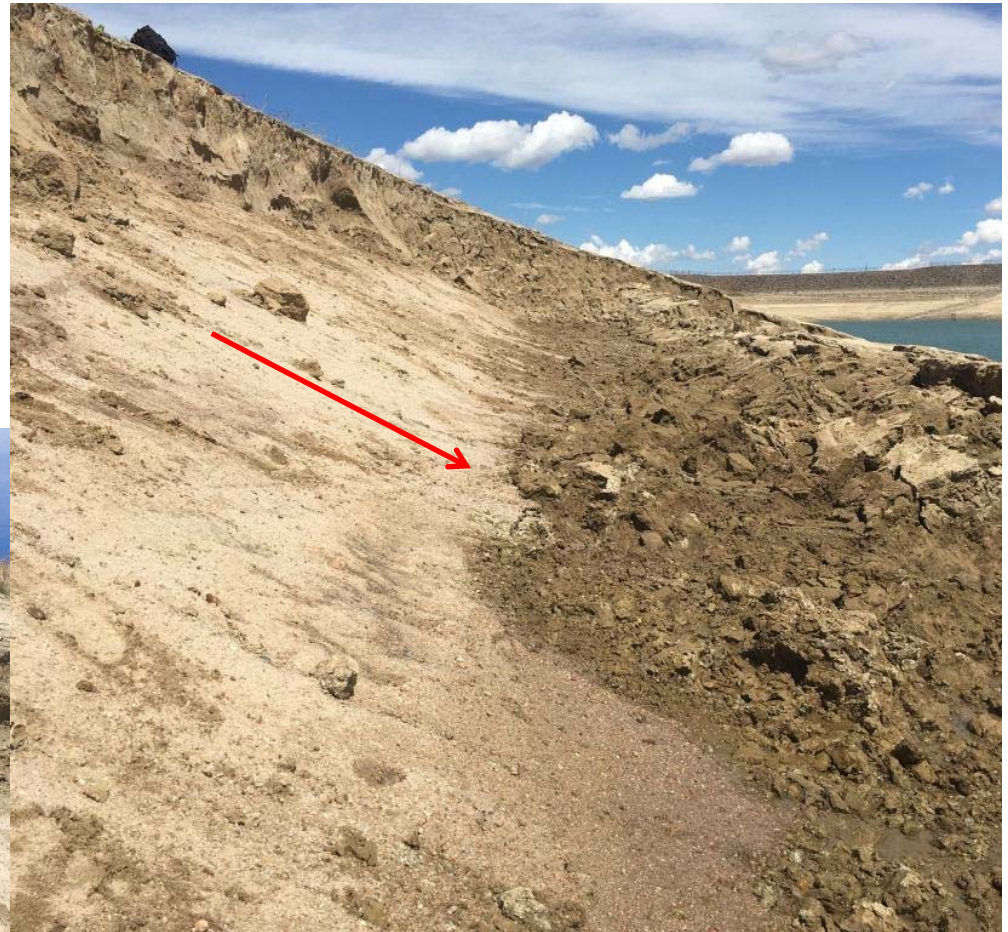
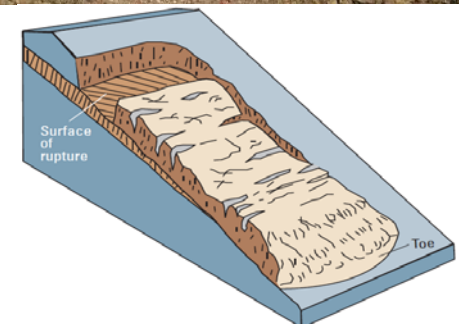
# Main Scarp (stage 1)

- Planar surface
- Sand & fine gravel
- Dry

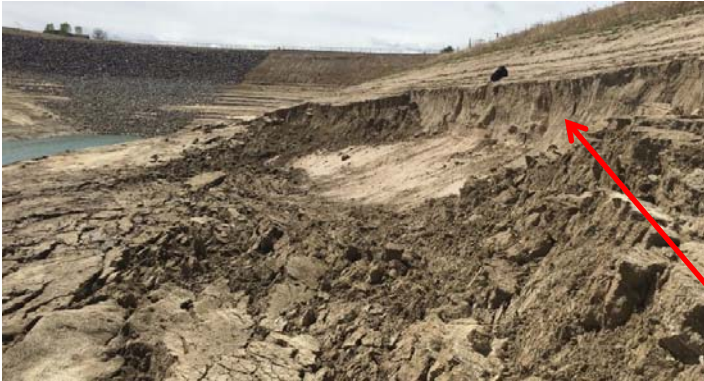
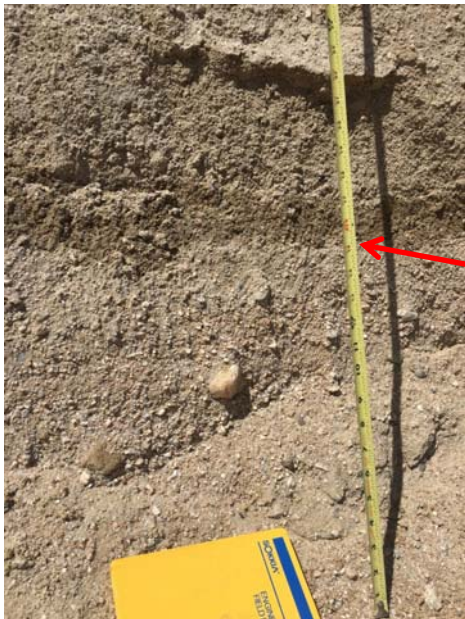
## Main Scarp (stage 1)

Seepage along  
gravelly  
sandy  
layers

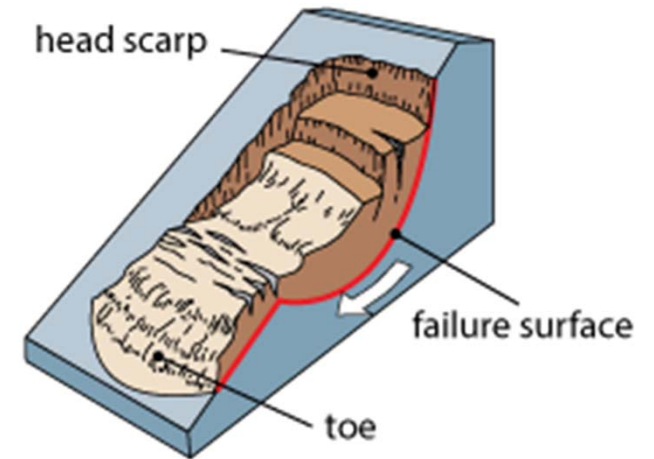
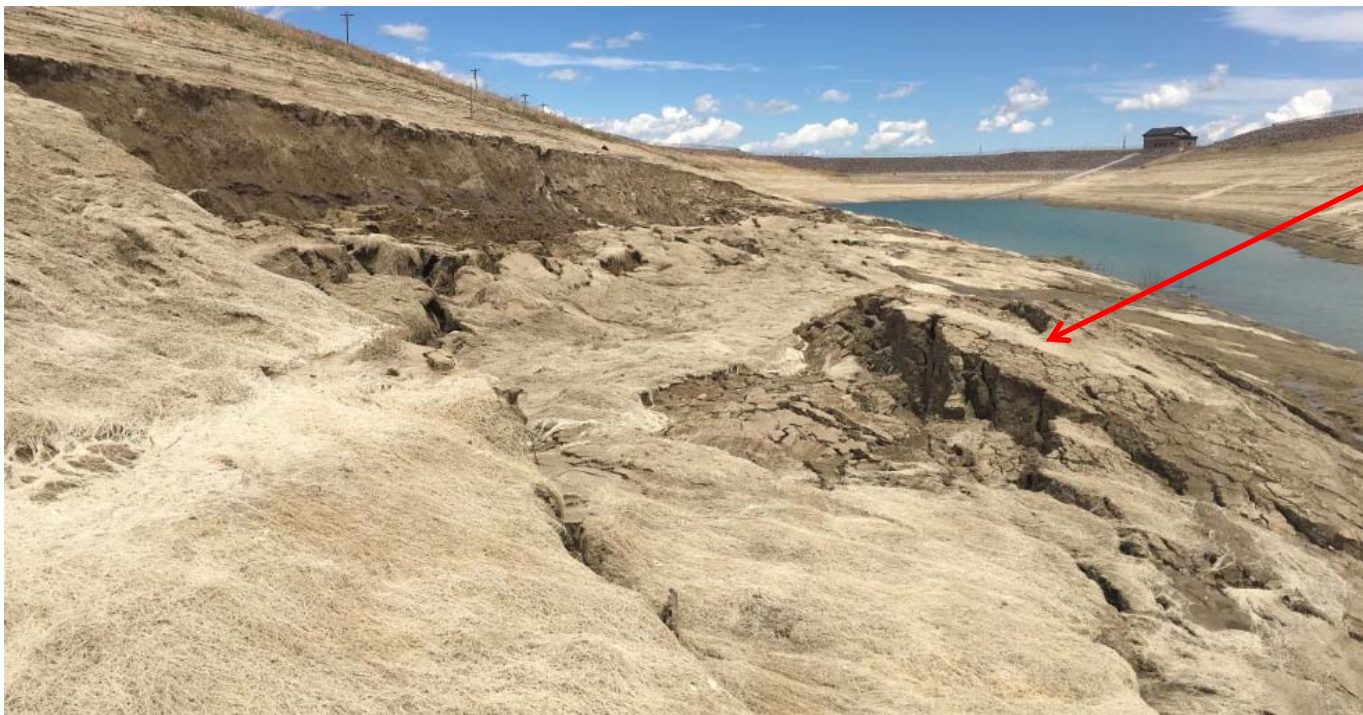
## Lower Slide (stage 3)

- Failure appears to be rotational slide
- Surface of Rupture (failure surface) along wet clay layer

Bulging of  
slide-mass

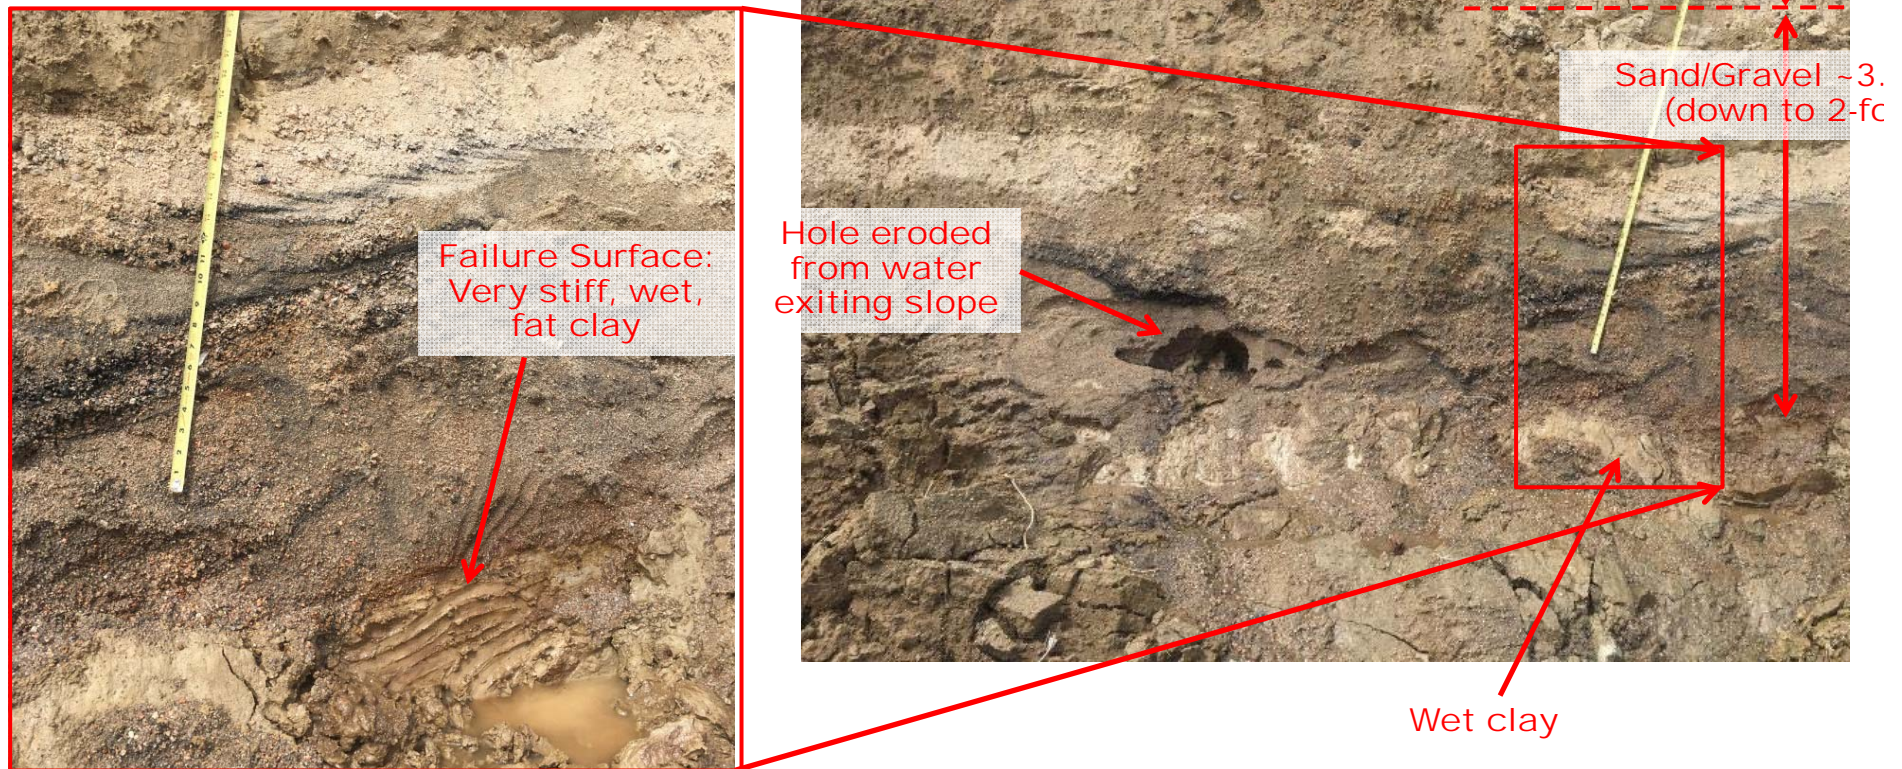
## Lower Scarp (stage 3)

- Scarp is wet
- Water flowing from base of scarp
  - Significant volume of water stored behind CCL

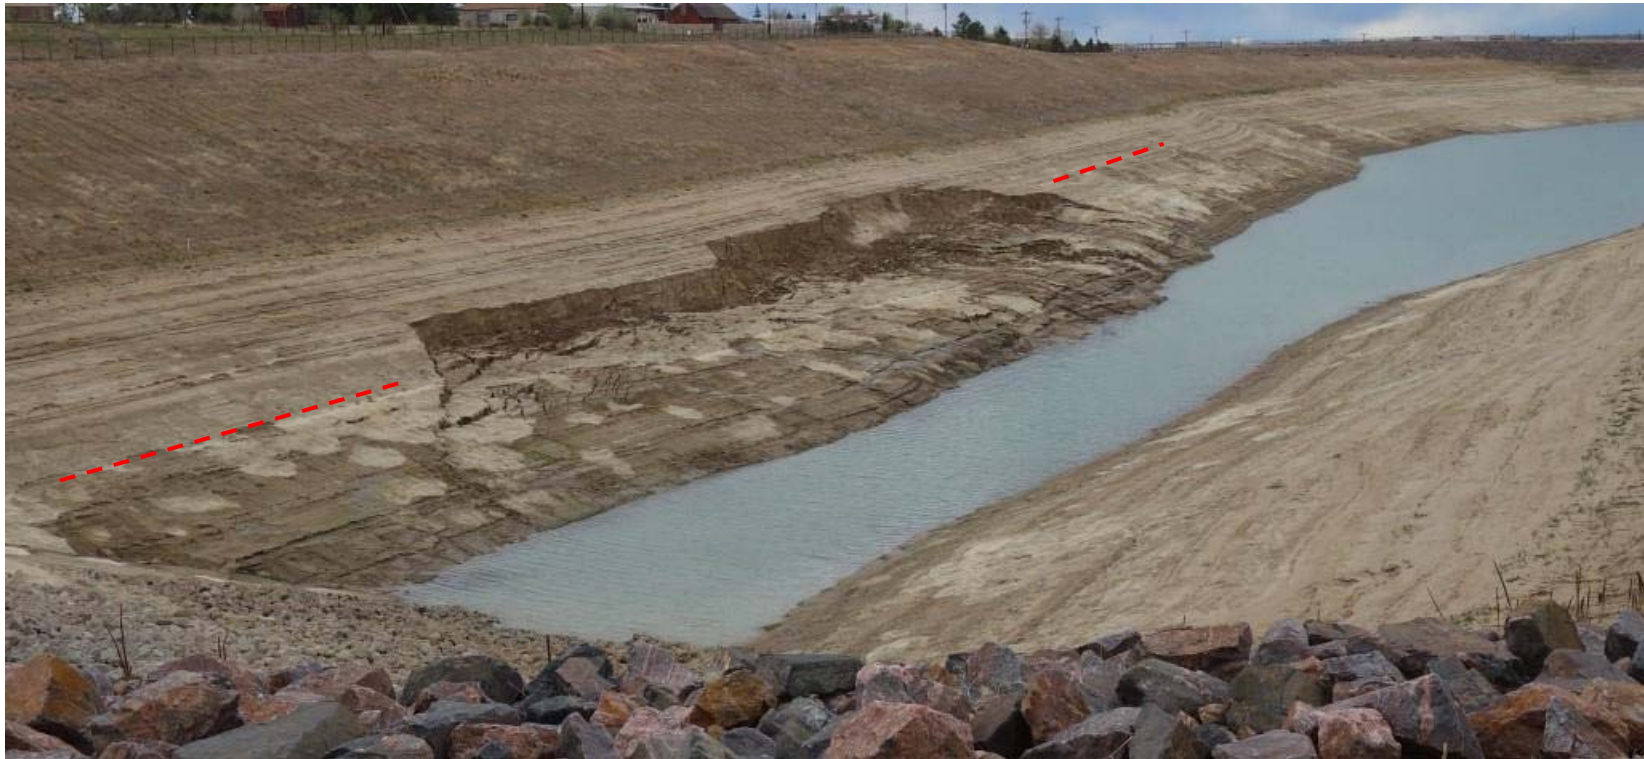
- - - - Tension crack/slope movement observed on both edges of the slope failure

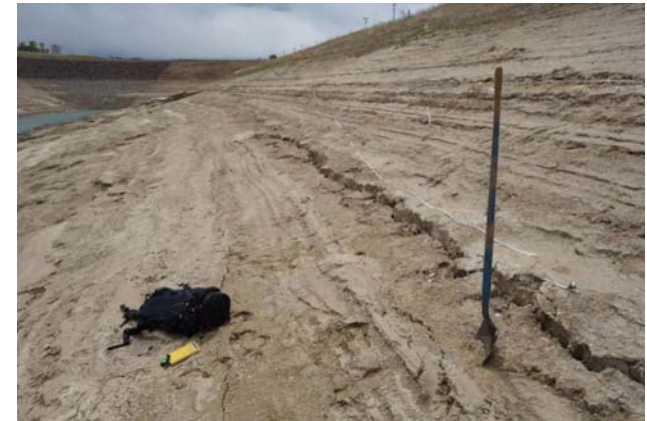
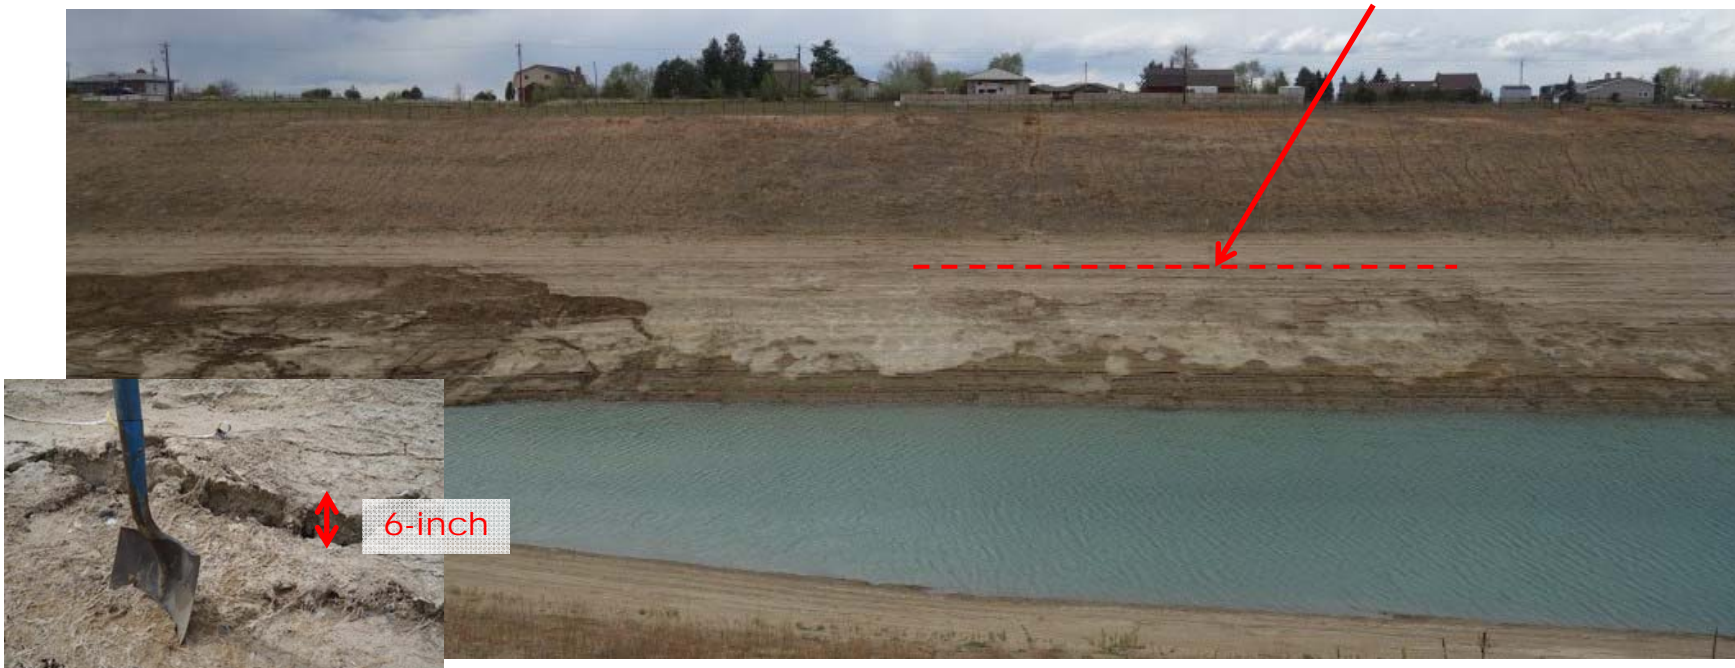
- Tension crack/slope movement (~145' long)
- 200' north of larger instability
- Similar height to other head scarp
- 6-inches vertical movement

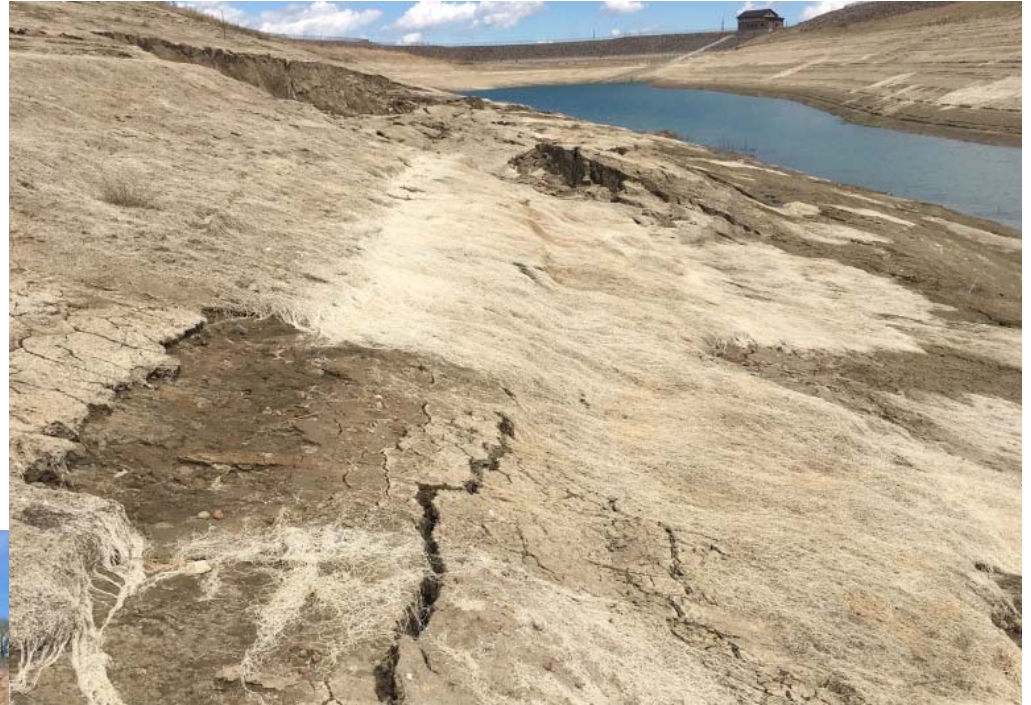
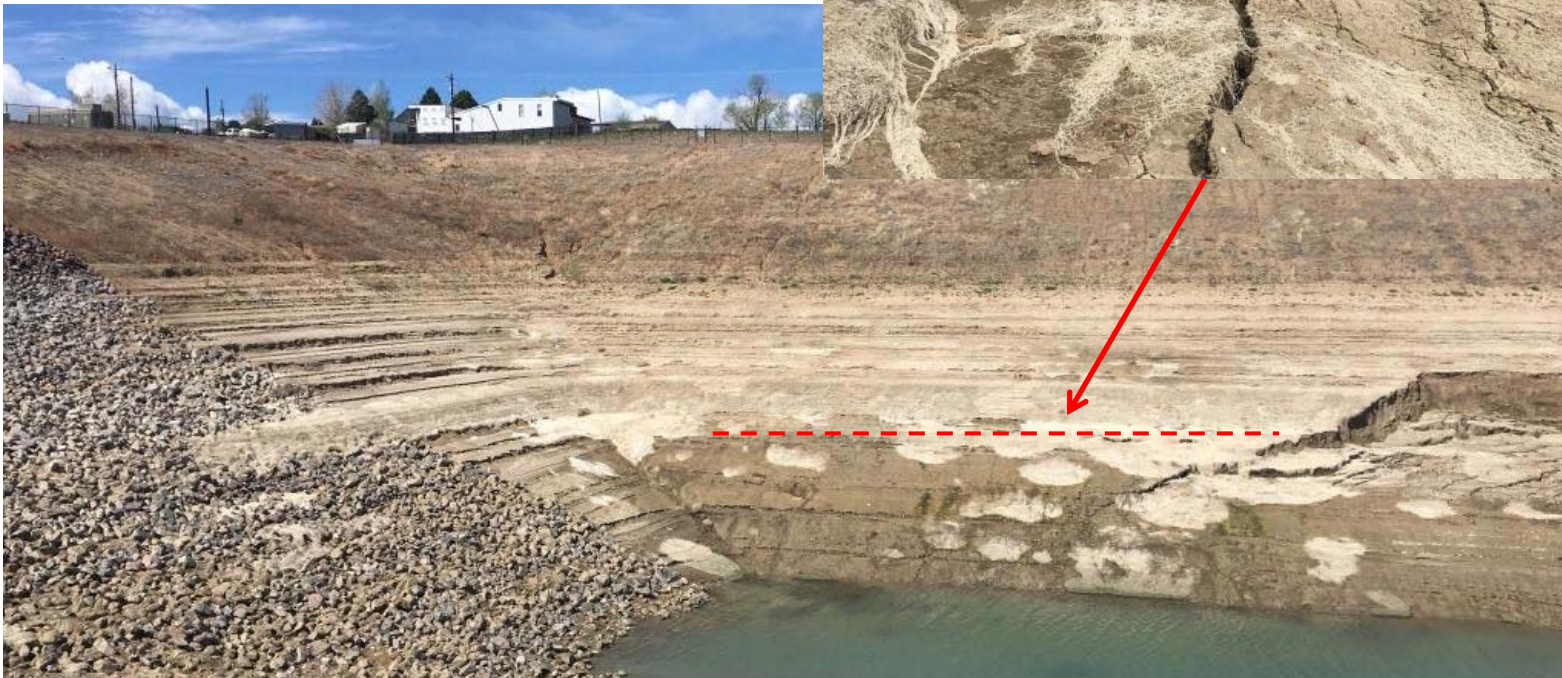
- Tension crack/slope movement
- South edge of larger instability
- 6 to 10-inches vertical movement

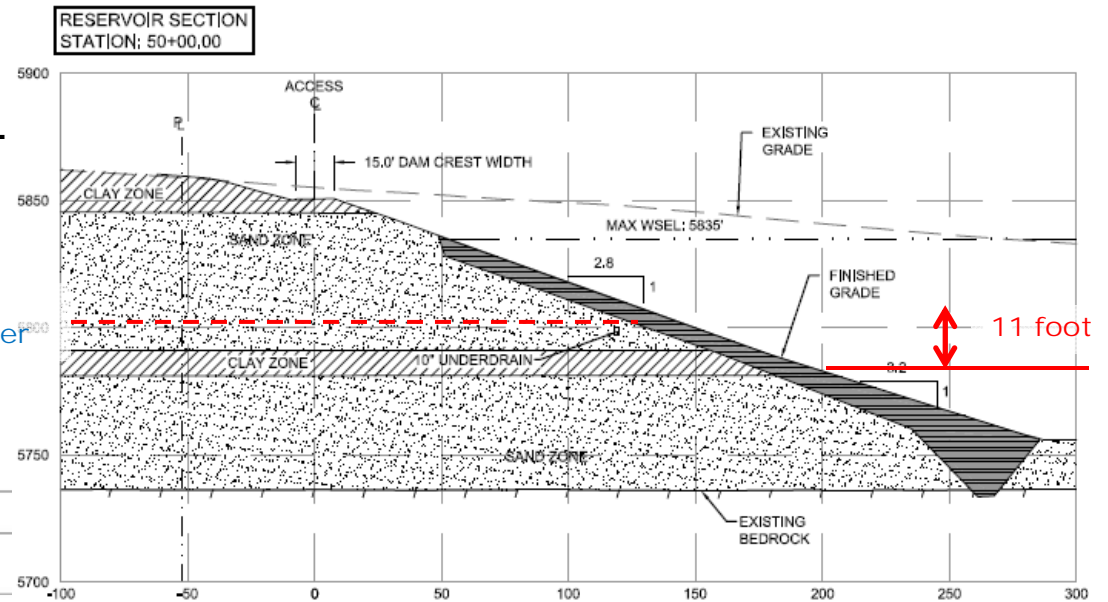
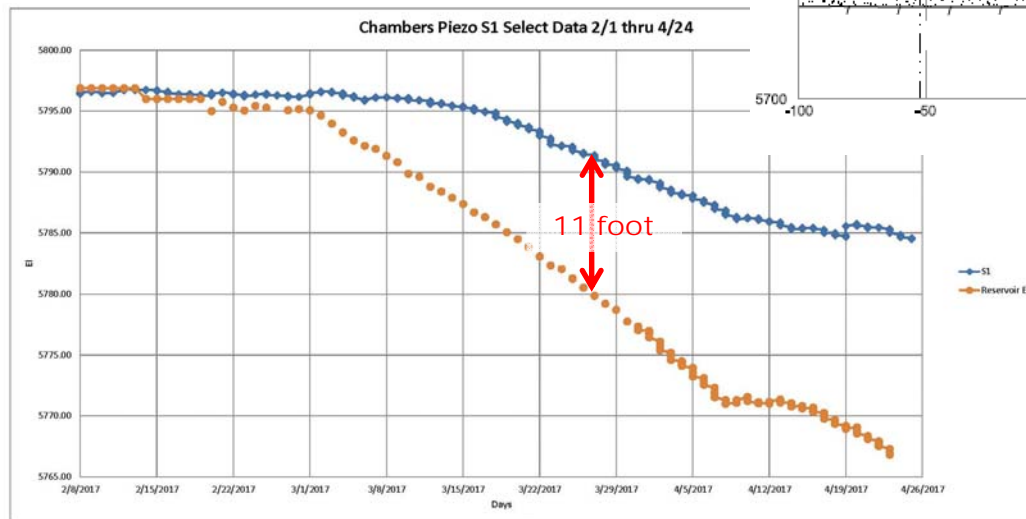
## Elevated groundwater behind CCL with low reservoir pool

- Artesian pressure below CCL
- Uplift destabilized slope

Elevated groundwater

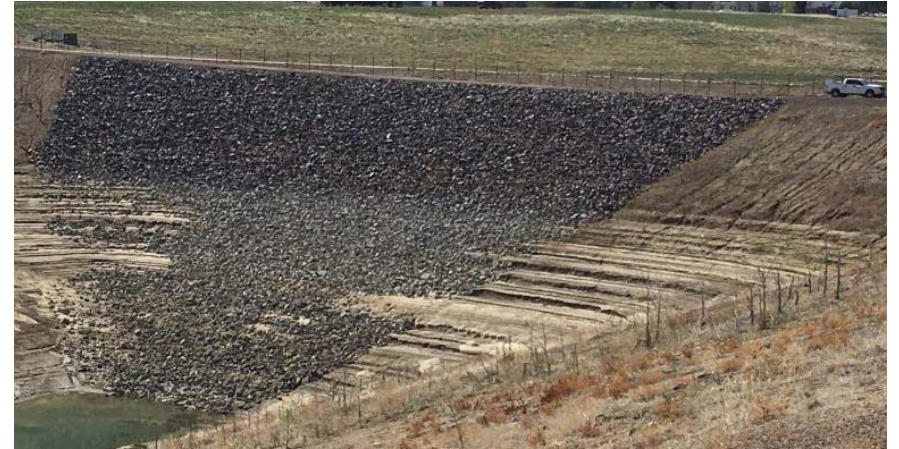
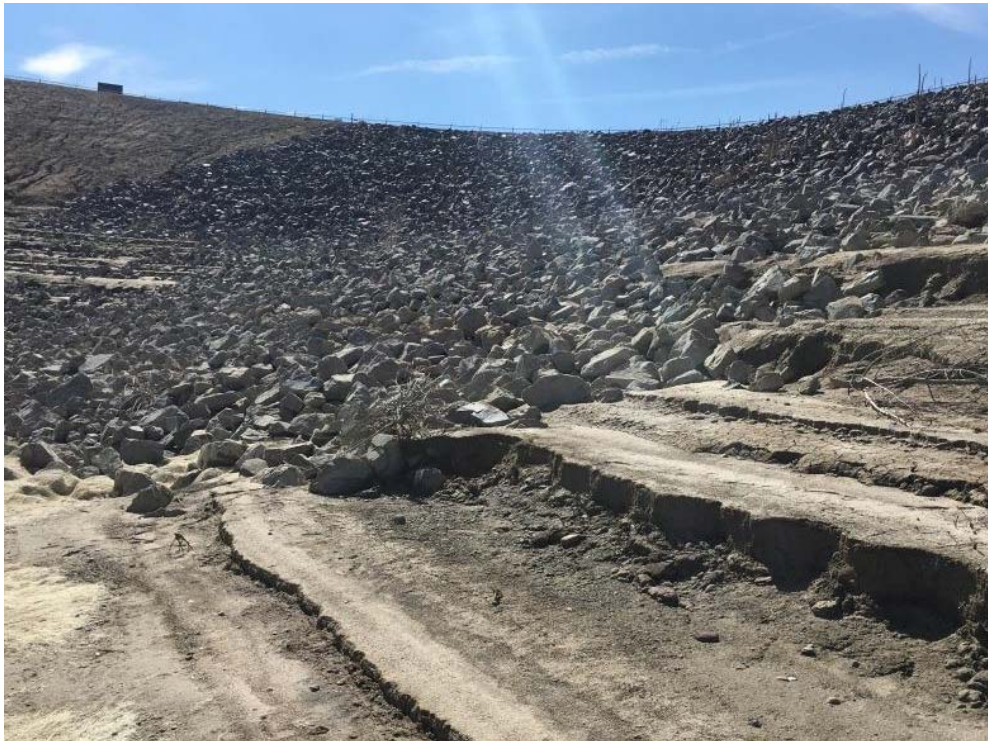
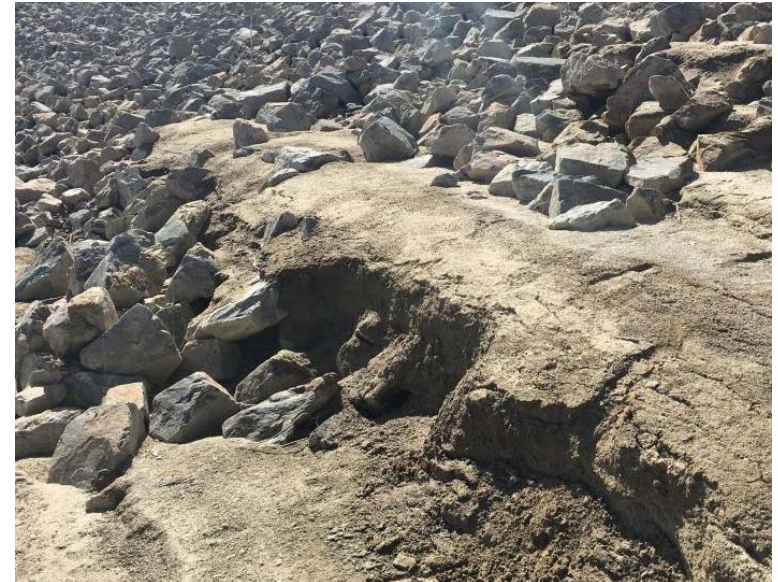
## Observation - Rock Riprap

- Improper bedding material
- Wave erosion undermining riprap
