**Water Supply Reserve Fund – Grant and Loan Program**  
**Water Activity Summary Sheet**  
**July 15, 2020**  
**Agenda Item 16(f)**

**Applicants & Grantee:** Nicholas & Ann Charchalis  
**Water Activity Name:** Drescher Dam Rehabilitation – Engineering Design  
**Water Activity Purpose:** Agriculture/Implementation  
**County:** Moffat  
**Drainage Basin:** Yampa  
**Water Source:** unknown  
**Amount Requested:** \$10,000 Yampa/White/Green Basin Account  
**Matching Funds:** Applicant Match (cash & in-kind) = \$6,000  
• 60% of the Basin Account request (meets 25% min)

# ENGINEER'S INSPECTION REPORT

| DAM NAME: DRESCHER | T: 060N R: 0900W S: 12 | COUNTY: MOFFAT | DATE OF INSPECTION: 6/25/2019 |

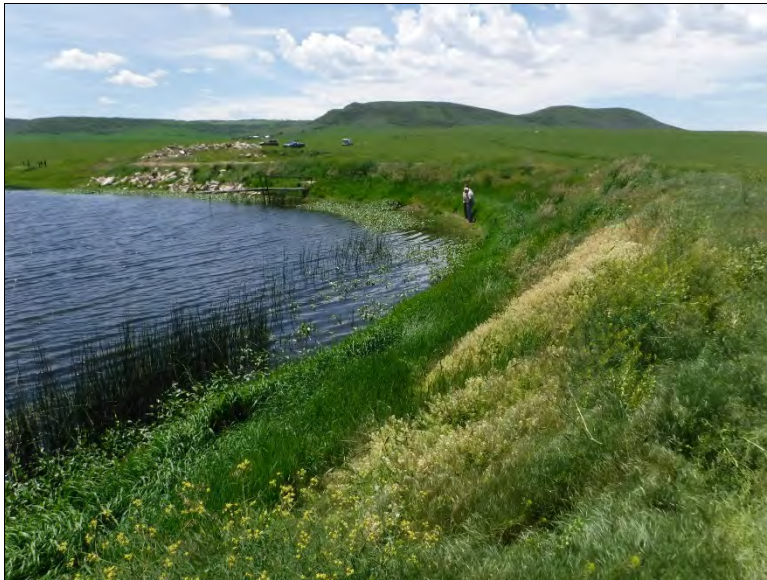
**Historical observations include (1), (2) no riprap on a significant portion of the embankment, with large scarps. Concrete rubble riprap left of the outlet bridge, but with no filter material. (9) Muskrat dens at current water line, approximately 3.5 feet below spill.**

**Current observations similar. Scarping is largely obscured by high grasses and vegetation.**

Photo 1 - Upstream slope

- Upstream slope erosion repair and protection;
- Embankment cross section repair (erosion, rodent damage, remove buried concrete rubble);
- Embankment seepage mitigation (downstream filter & buttress suggested);
- Spillway realignment (entrance) and stabilization;
- Filter collar around the outlet pipe (minimum) and/or replace the pipe.

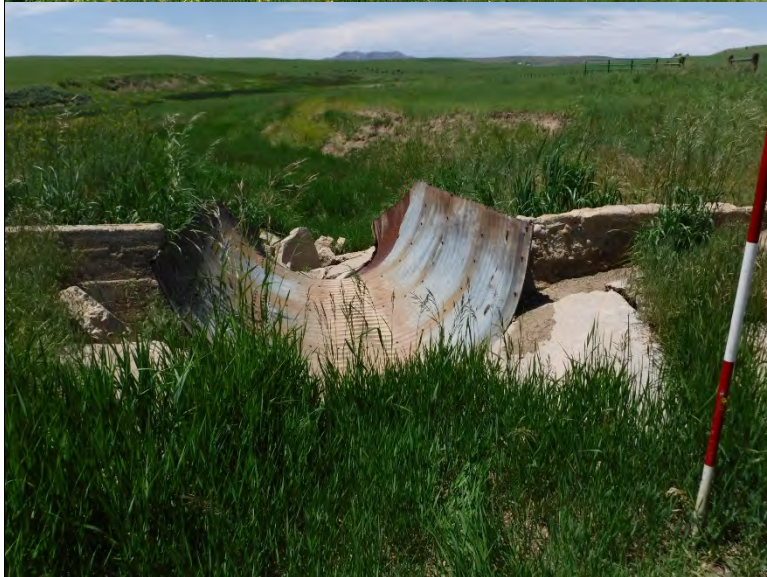
**Historical observations include (52), (54) a half section of CMP placed in an eroded portion of the channel to form a sort of drop structure. Likely structurally inadequate for high spillway flows. Flow currently passes through a fence, but the channel could be regraded to direct flows more directly into the channel instead of following this alignment.**

**Current observations similar. (57) Berm forcing flow through the CMP section constricts the channel.**

Photo 2 - Spillway drop structure

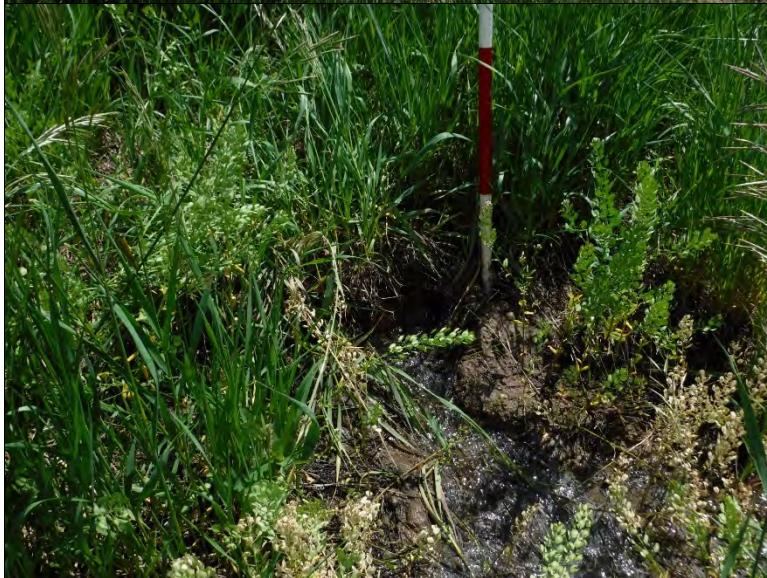
**Current observations similar. (26) Pronounced slump right of the outlet around mid slope in the historical seepage area. Does not appear new. (29) Rodent hole with seepage (20 gpm) 12 feet off the crest right of the outlet. See Seepage.**

**Current observations include: standing water at the toe on both the left and right side of the dam on the upper benches; saturated embankment along the toe of the maximum section extending above the outlet; evidence of historical seepage from the embankment about 1/3 of the way up, right of the toe, but left of the benched area; concentrated leak from a rodent hole towards the left side of this seepage area, approximately 12 feet below the crest, flowing approximately 20 gpm, currently clear.**

Photo 3 - Leaking rodent hole about  
12 feet off the crest, 10 feet right of  
the outlet, 20+/- gpm

**6/25/2019 - Lower the reservoir immediately and repair the leaking rodent hole from the upstream side with a clay plug. MARK this location on the downstream slope and MONITOR it when the reservoir is within 8 feet of spill.**

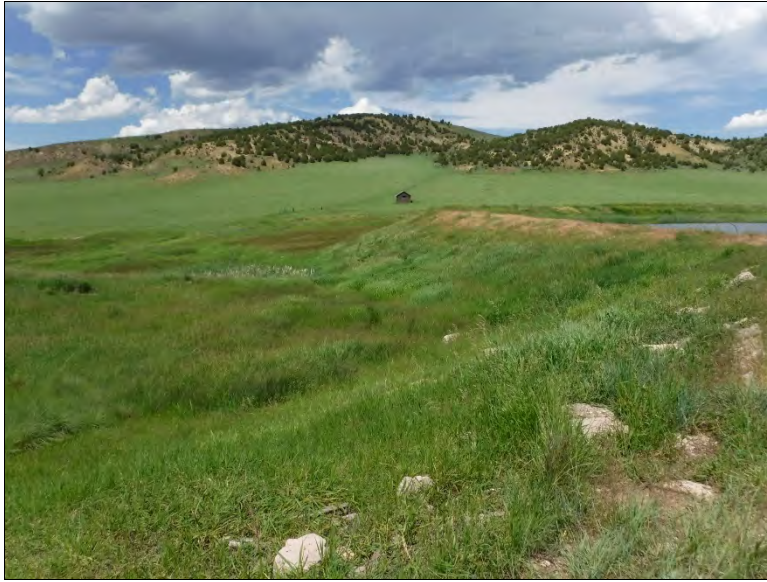
**Historical observations include: (21) possible old livestock trails causing damage; (26) old slumps, especially towards the left side, causing an uneven surface; and (28), (29) seepage in the left groin and on the right side of the embankment causing soft material.**

Photo 4 - Downstream slope
