LOAN FEASIBILITY AND EVALUATION REPORT

QUEEN DAM

KIOWA COUNTY, COLORADO

March 2020

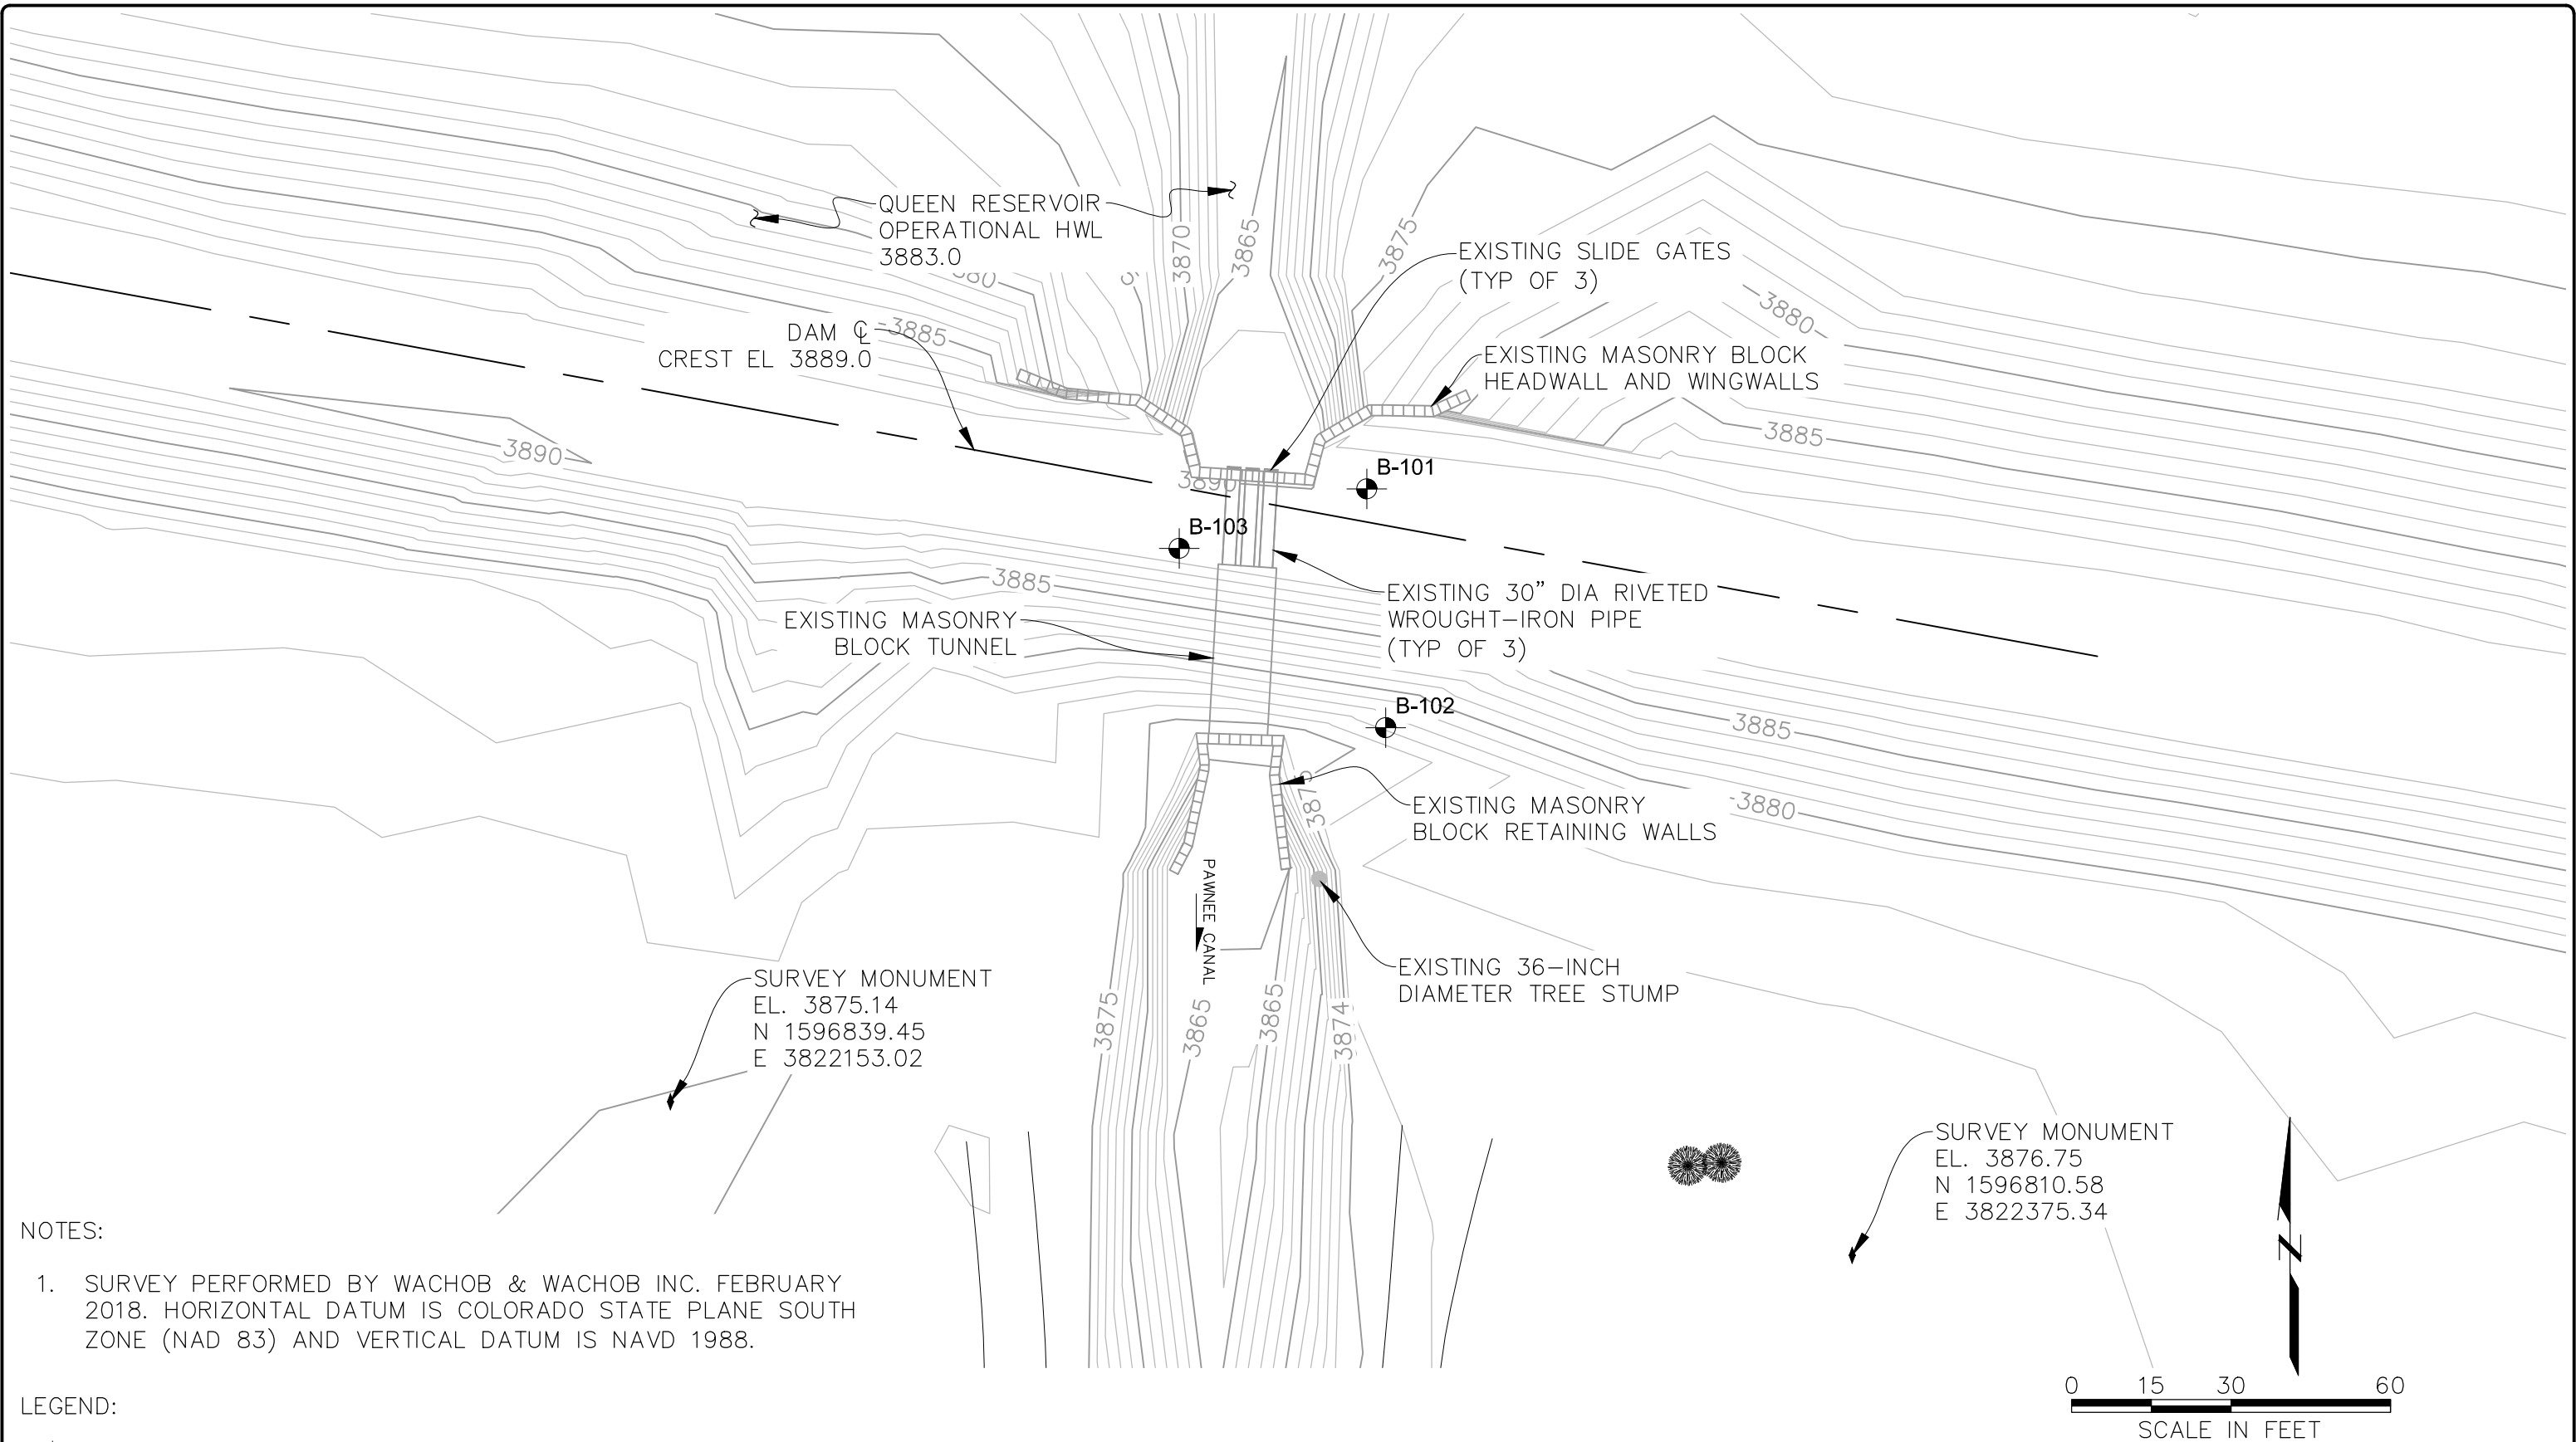
Figure 4.1

- Mortar joints were severely deteriorated or missing between masonry units at several locations.
- Cracks between the masonry blocks were up to 5 inches wide.
- At many locations, a 1/2-inch probe was easily pushed 1.2 to 5 feet through the cracks into the soils behind the masonry blocks of the conduit.
- Lamination and minor corrosion were present along the wrought-iron conduits.

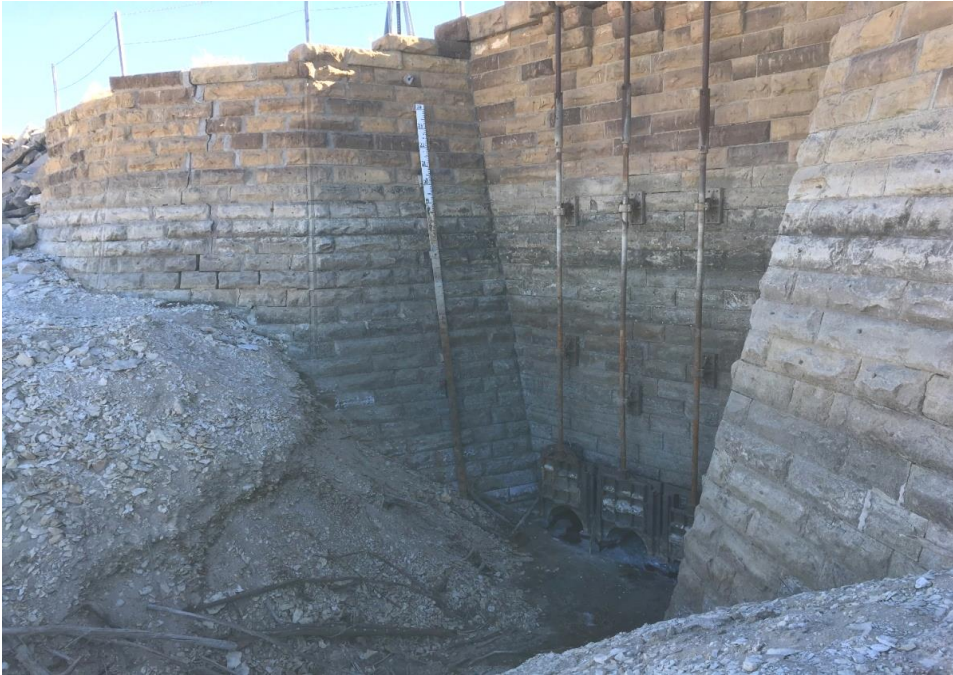
Photograph 1: Stone masonry upstream dam face and slide gates.

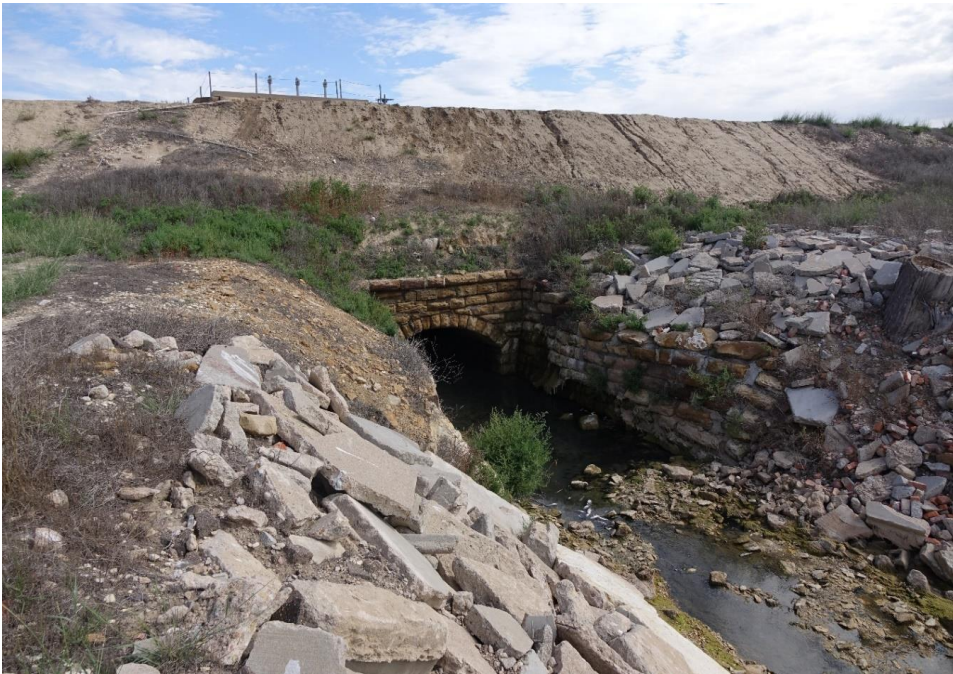
Photograph 2: Stone masonry downstream retaining walls.

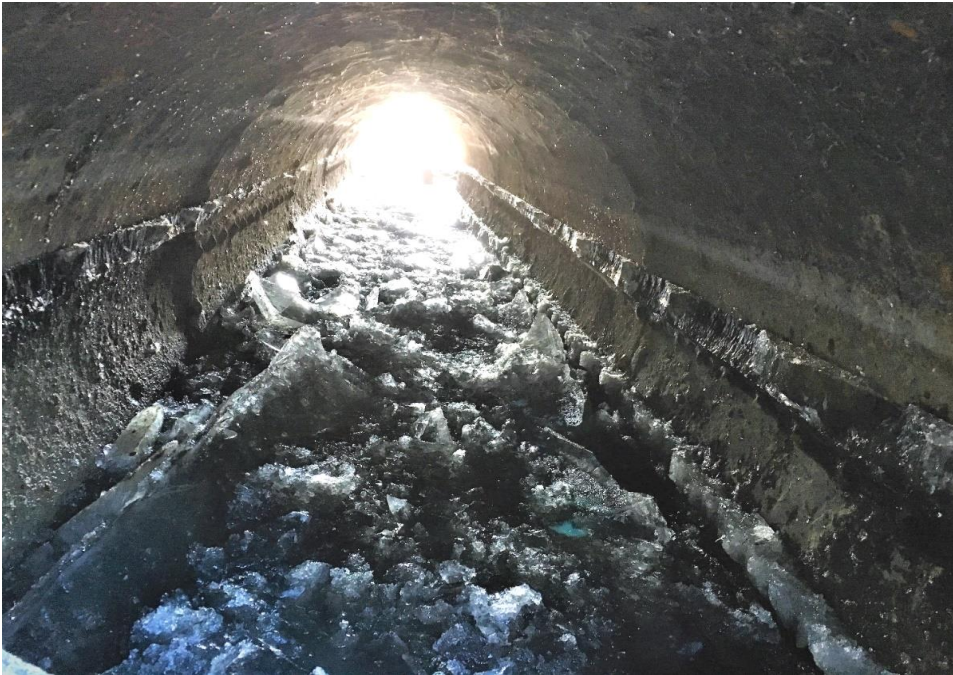
The conduits are about 18 feet long and consist of steel with single-riveted seams and joints. The width and height of the conduit interiors were measured intermittently and based on the measurements the conduits are essentially circular. Lamination and reduced conduit wall thickness was observed within the conduits and appeared to be more significant at the downstream end of the conduits. Soundings were taken in the west (right looking downstream) conduit by occasionally tapping a hammer along the interior surface of the conduit to identify if there may be voids behind the riveted steel. No voids were identified at the locations sounded. Some minor corrosion and deterioration on the pipe interior was identified but no cracks, holes, or joint separations were observed.

Photograph 3: 30-inch diameter riveted steel outlet conduit.

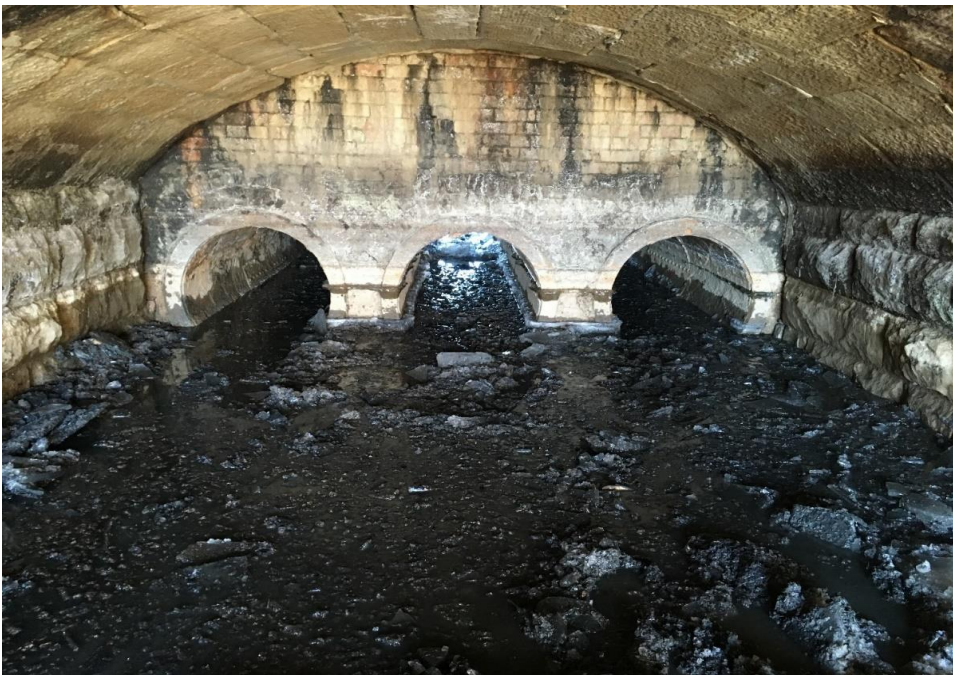
Photograph 4: Conduit headwall/tunnel interface.

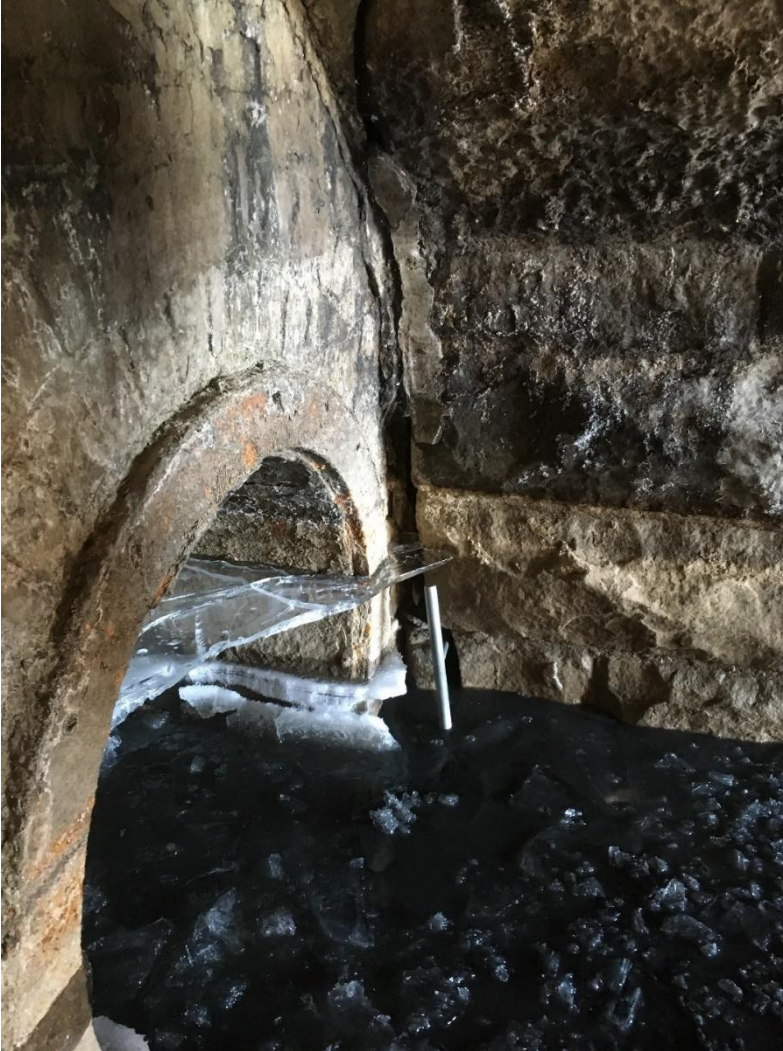
The stone masonry-lined tunnel is 28 feet long and horseshoe shaped, approximately 11-feet-wide by 5.5-feet-tall. The tunnel was inspected from upstream to downstream. At several locations, mortar was missing or severely deteriorated between the stone blocks and cracks and voids were observed. A 1/2-inch diameter, 5-foot-long metal soil probe

Photograph 5: Void between conduit headwall and left tunnel wall interface, showing soil probe in void

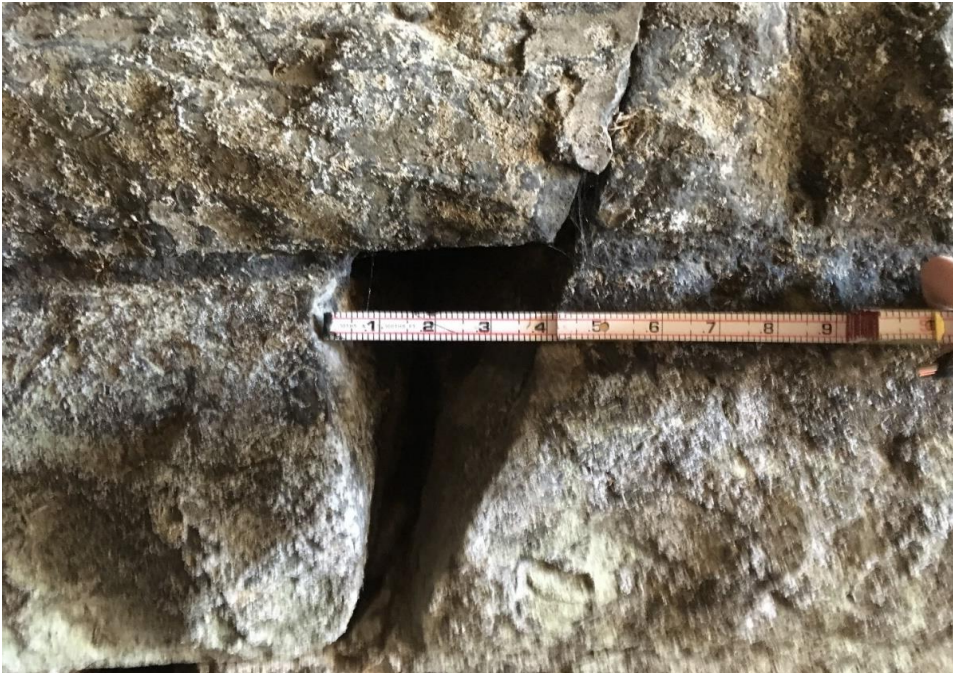
Photograph 6: Left tunnel wall void, 6 feet downstream of headwall.

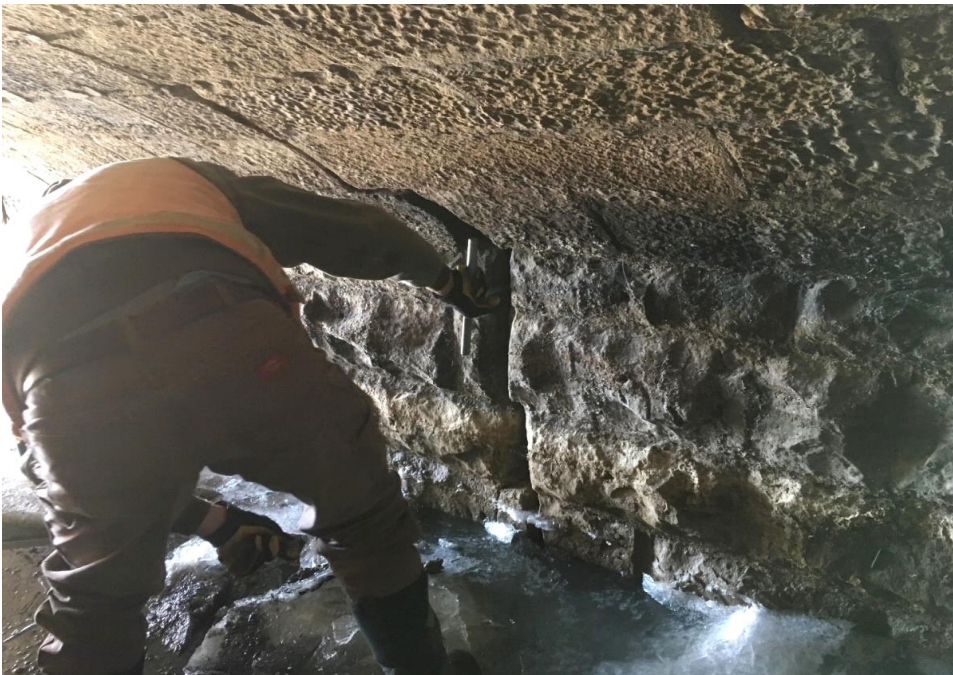
Photograph 7: Right tunnel wall void, 5 feet downstream of headwall.

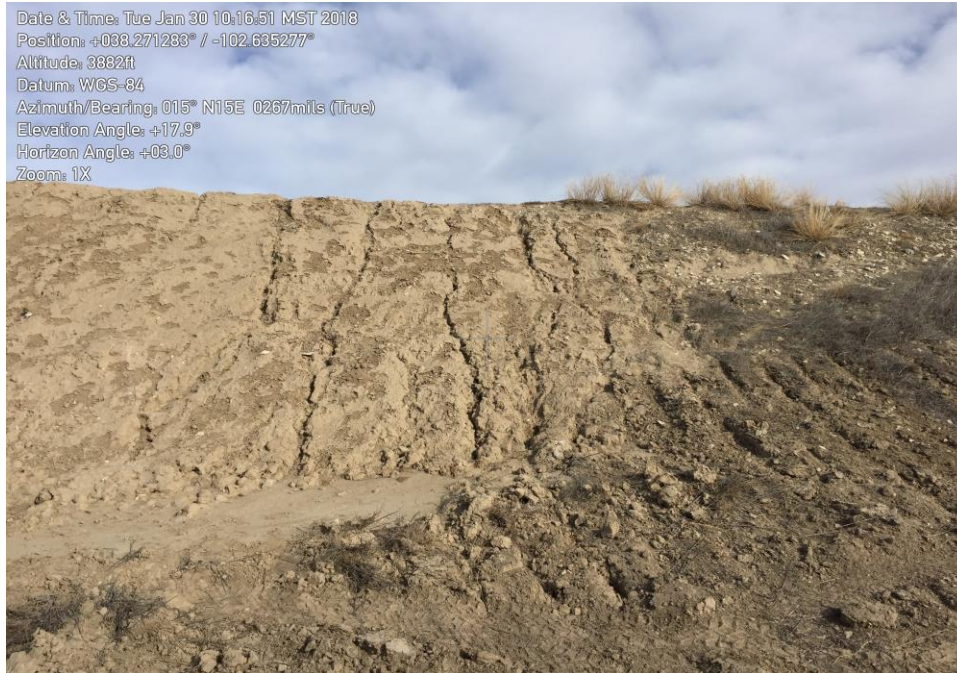
Photograph 1: Erosion Rills on Downstream Embankment Slope (East of Outlet Works).

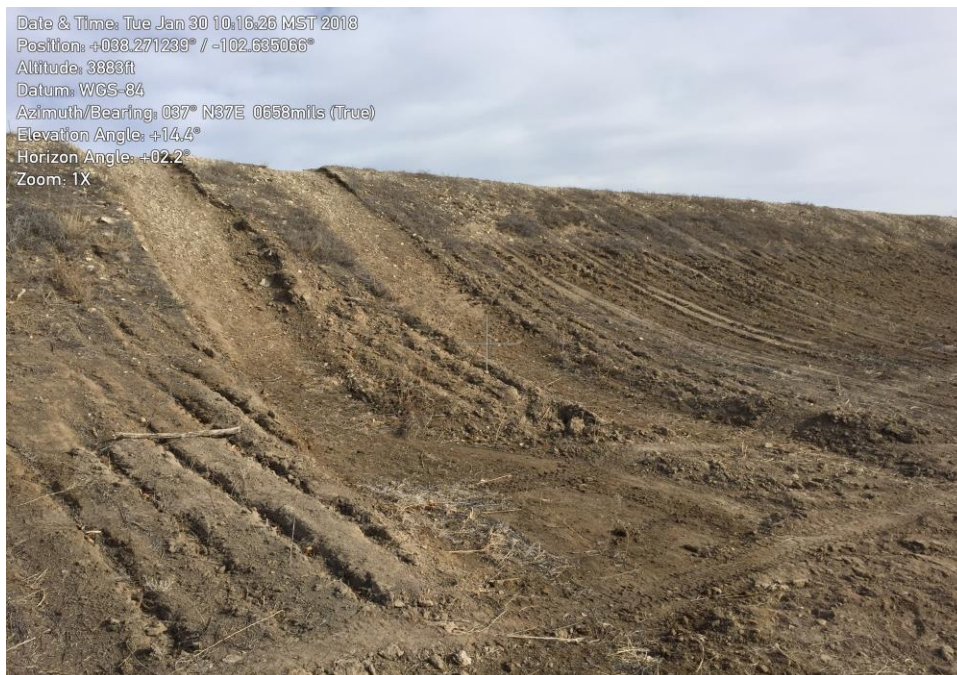
Photograph 2: Rutting on Downstream Embankment Slope (East of Outlet Works).

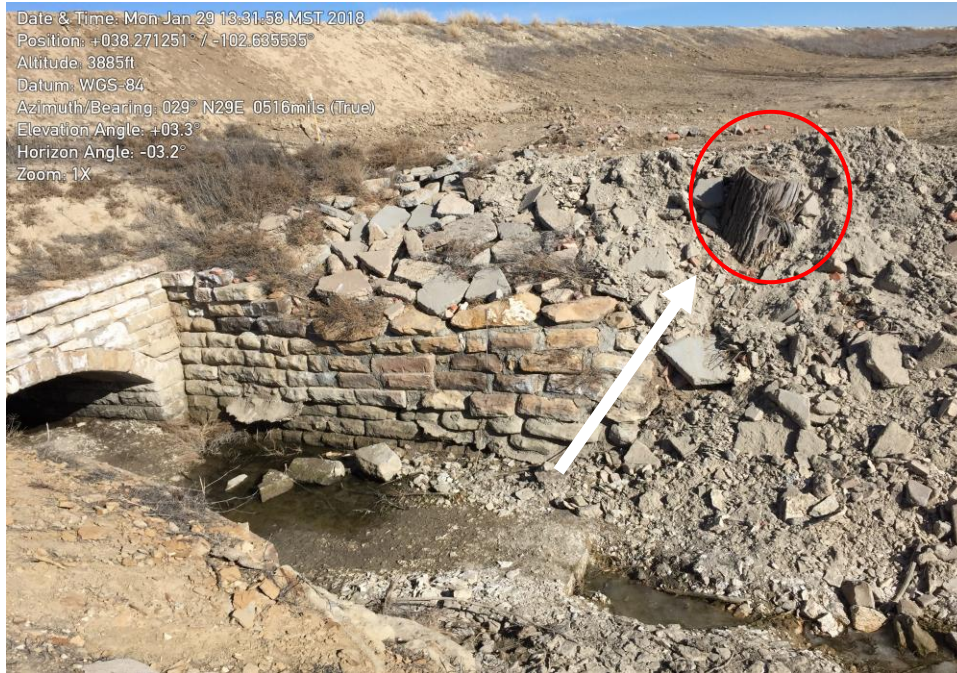
Photograph 3: 36-inch Diameter Tree Stump at Tunnel End Wall (red circle), Left Retaining Wall, and the outlet works.
