WARD LAKE DAM OUTLET REHABILITATION  
Construction File No. C-0888A  
Dam ID No. 400533

Final Construction Report  
December 22, 2020

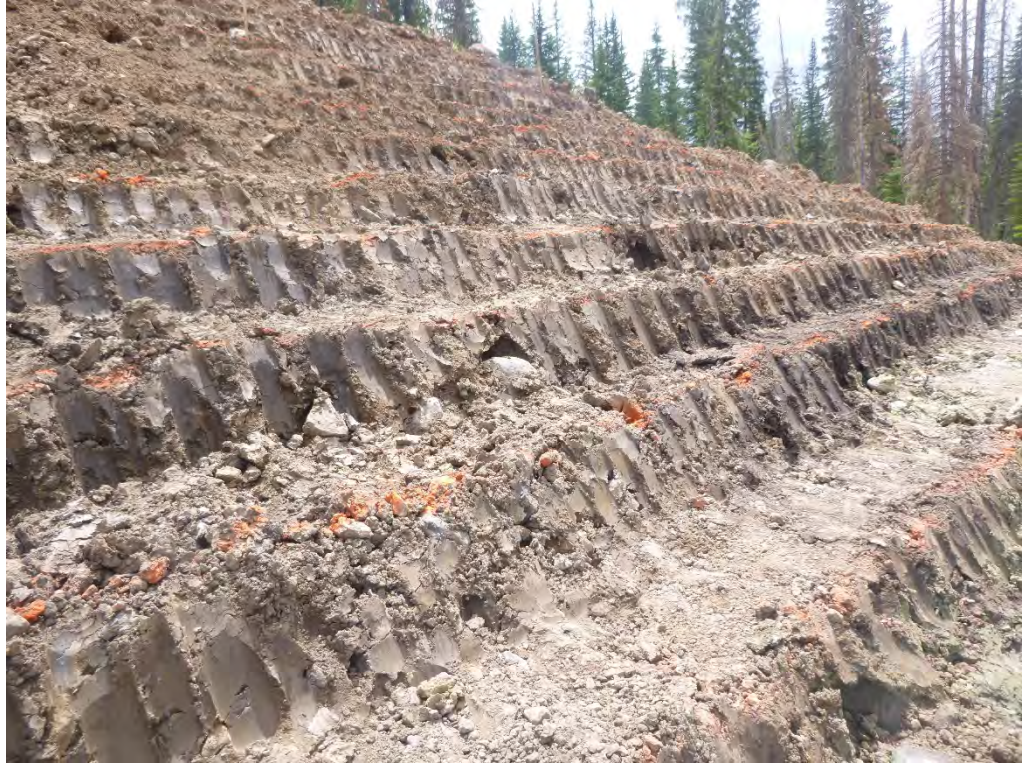
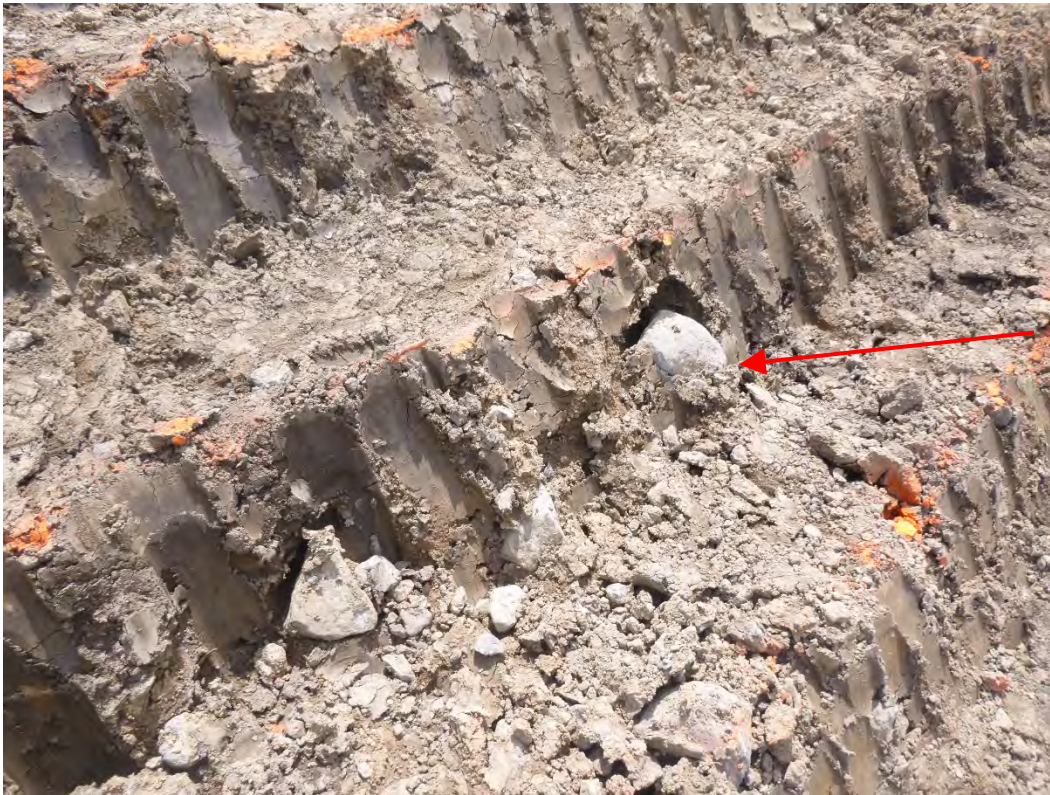
Example of oversized particle in bench that should be removed prior to fill placement. Void needs treatment prior to backfill.

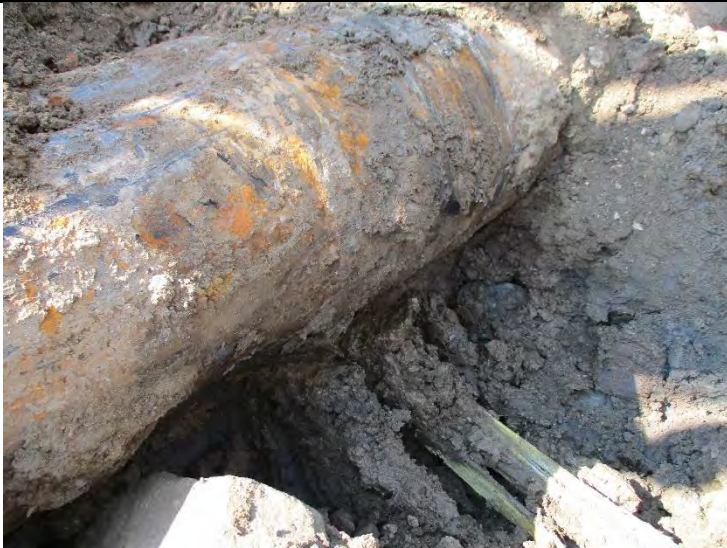
Photo 1. Exposed area beneath old pipe - note woody debris from forms left in place during concrete collar construction

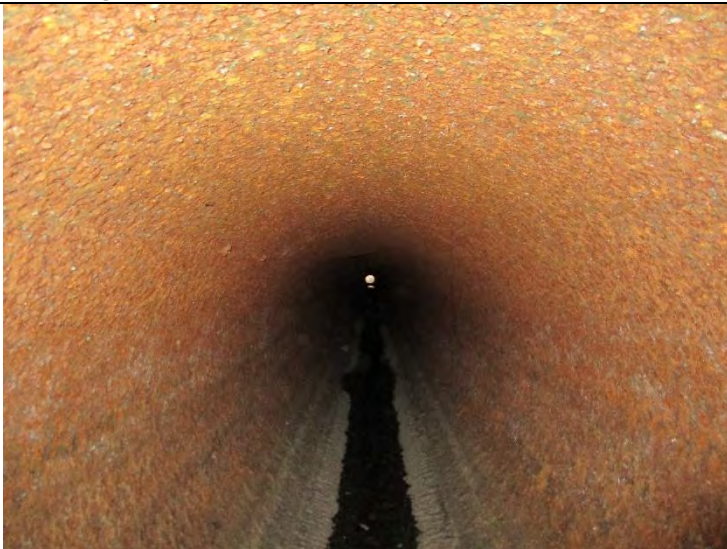
*Photo 5. Interior view of old pipe - surprisingly good condition*

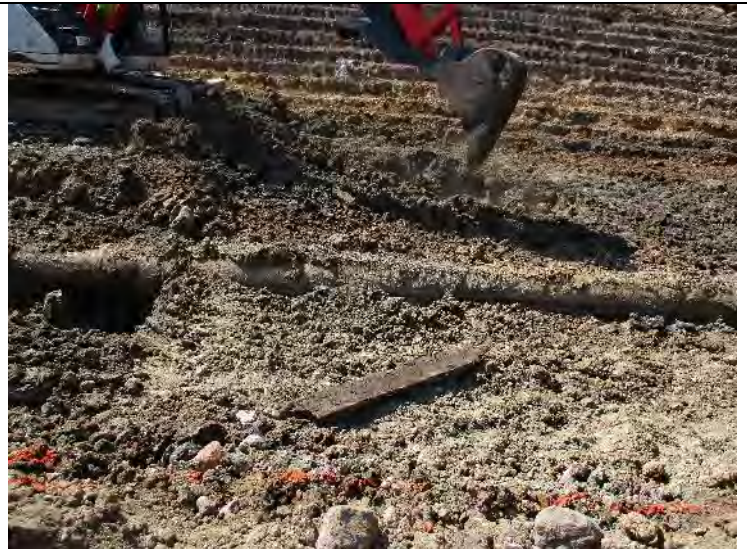
*Photo 6. Formwork left in place from original construction*

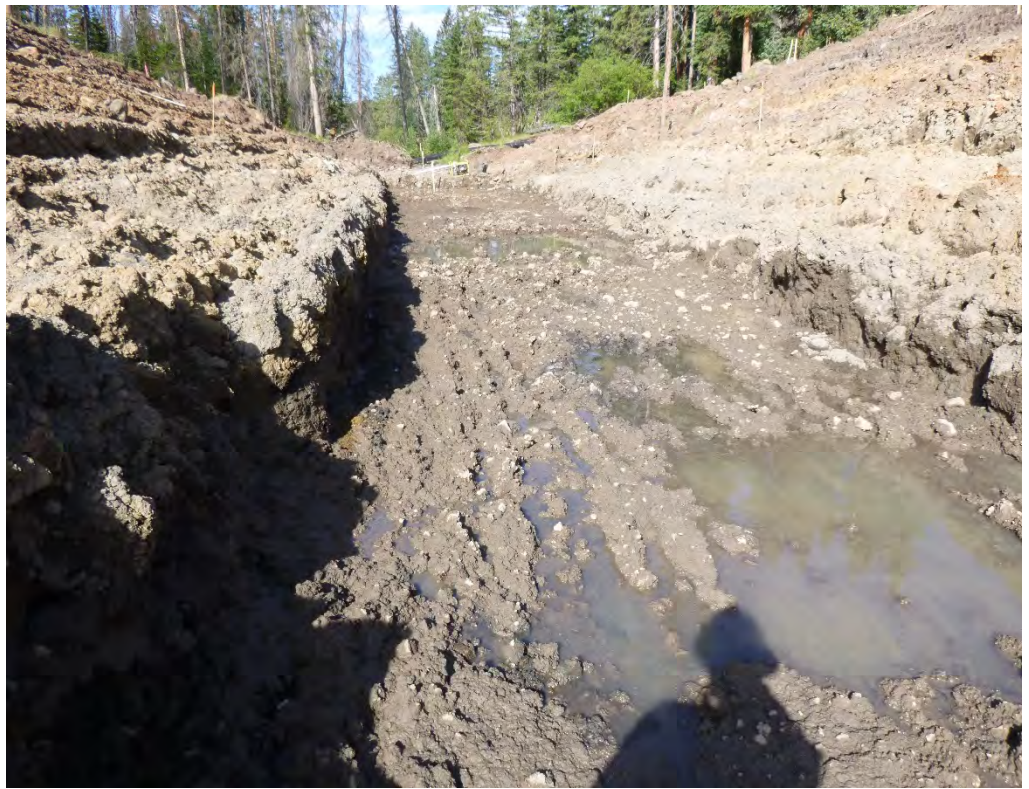
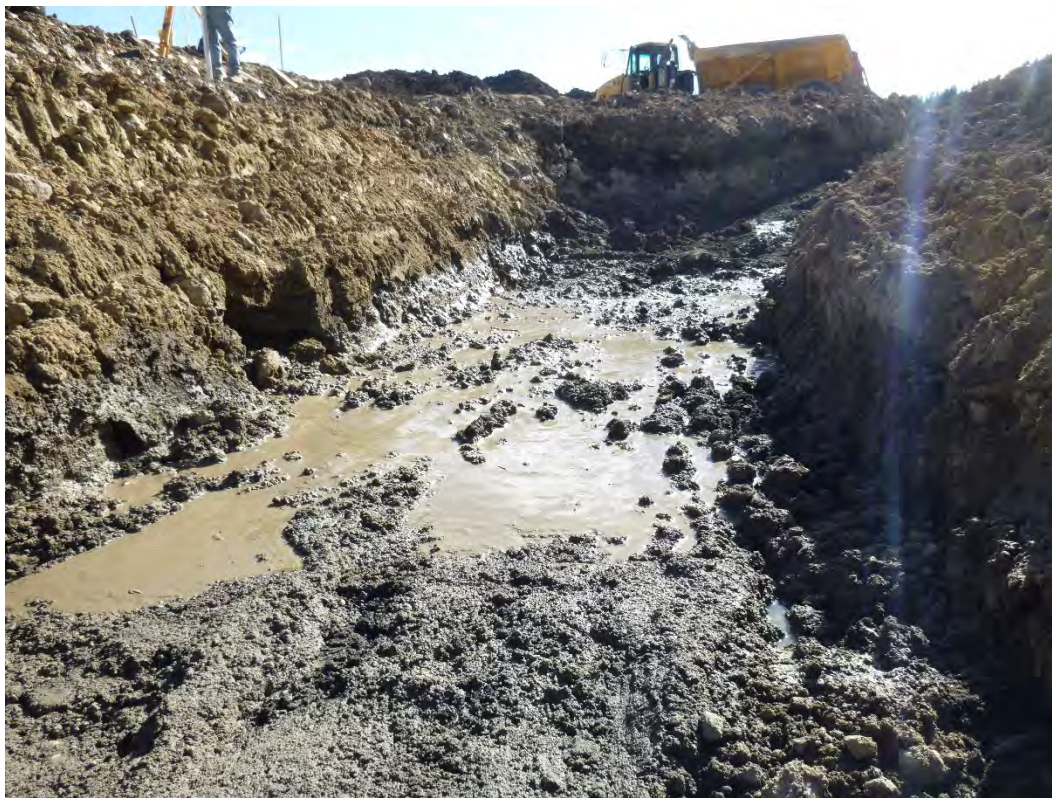
| Problems/Concerns: | <ul style="list-style-type: none"> <li>There is concern that a water source (reservoir, spring, etc) is continually recharging the foundation excavation such that suitable moisture conditions for proof rolling cannot be achieved.</li> <li>The contractor indicated that pumping of accumulated water was successful, but only for a short period of time; less than 24 hours.</li> <li>Flow and amount of water did not seem to be increasing, but no permanent drainage or pumping solution has been implemented.</li> </ul> |

Close-up of typical area of standing water; location is near Sta 1+20 for the outlet sand diaphragm.

| Action Items: | <p>Several potential dewatering solutions were discussed with the engineer and contractor including, but not limited to:</p> <ul style="list-style-type: none"> <li>Installing well points along the edge of the foundation (both sides?) in order to promote drawdown of the water source(s) and prevent pooling at the excavation level. Ideas for well points included: <ul style="list-style-type: none"> <li>Three well points proposed by contractor;</li> <li>8-12 inch diameter slotted pvc pipe buried vertically 2-4 feet at strategic locations;</li> <li>Possible gravel or free-draining material placed in and around the wells;</li> <li>Sump pumps installed into each well;</li> <li>Pumping into the existing dewatering pipe (not preferred) or installing a new dedicated drain line for the well points (preferred).</li> </ul> </li> <li>A trench excavation for gravity draining was discussed, but is not preferred at this time.</li> <li>Moving the reservoir bypass to a more upstream location further away from the excavation to reduce any influence it may have.</li> </ul> <p>The engineer and contractor were advised that any dewatering solution that modifies the outlet works foundation (i.e. wells, trenches, etc) will be required to be properly abandoned by a method acceptable to the Engineer and Dam Safety prior to backfilling.</p> |

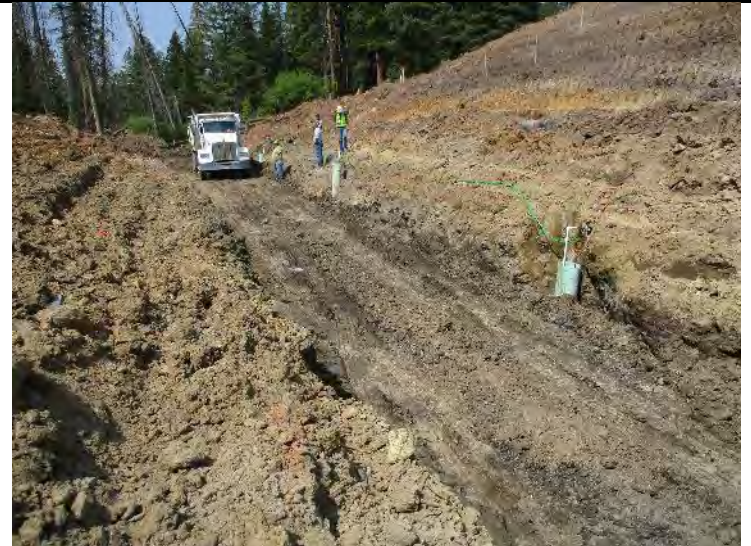
Photo 2. End of third pass. Soft spots were identified in the vicinity of the center and downstream wells.

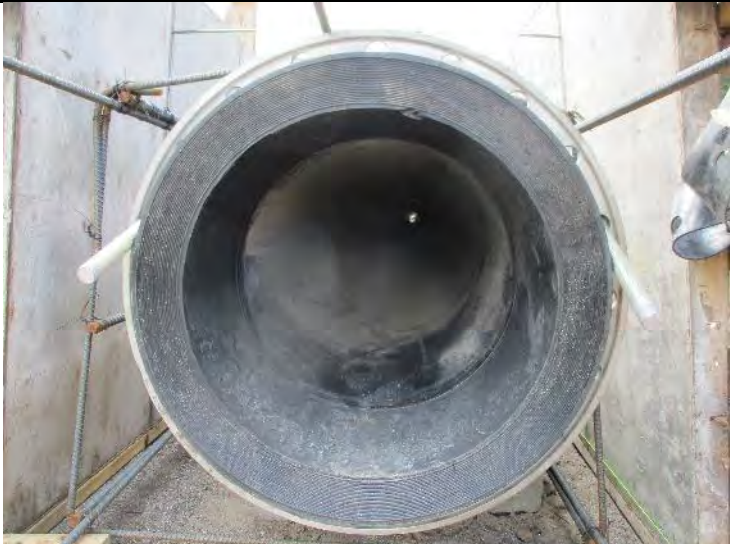
Photo 1. Looking downstream into the HDPE pipe, a slight bend to the right is noted. Temperatures range from mid-to-low 40s in the evening to upper 60s during the day.

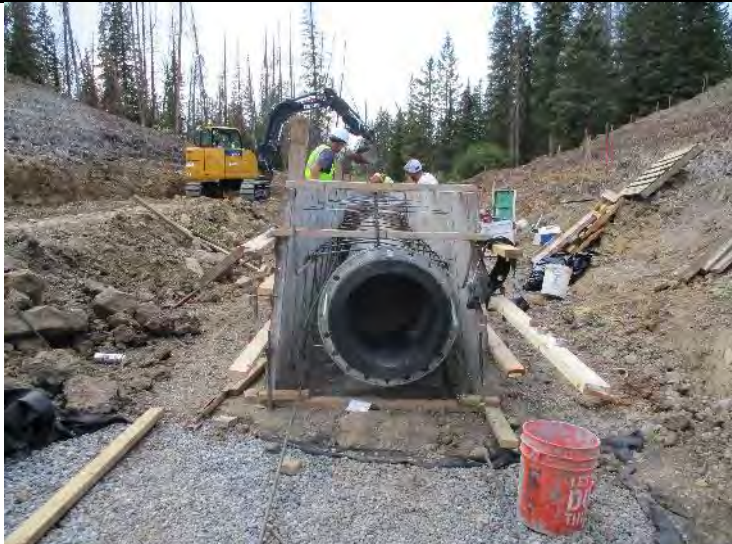
Photo 2. Inlet side. Con-Sy is awaiting an appropriately sized gasket to be delivered to the site.

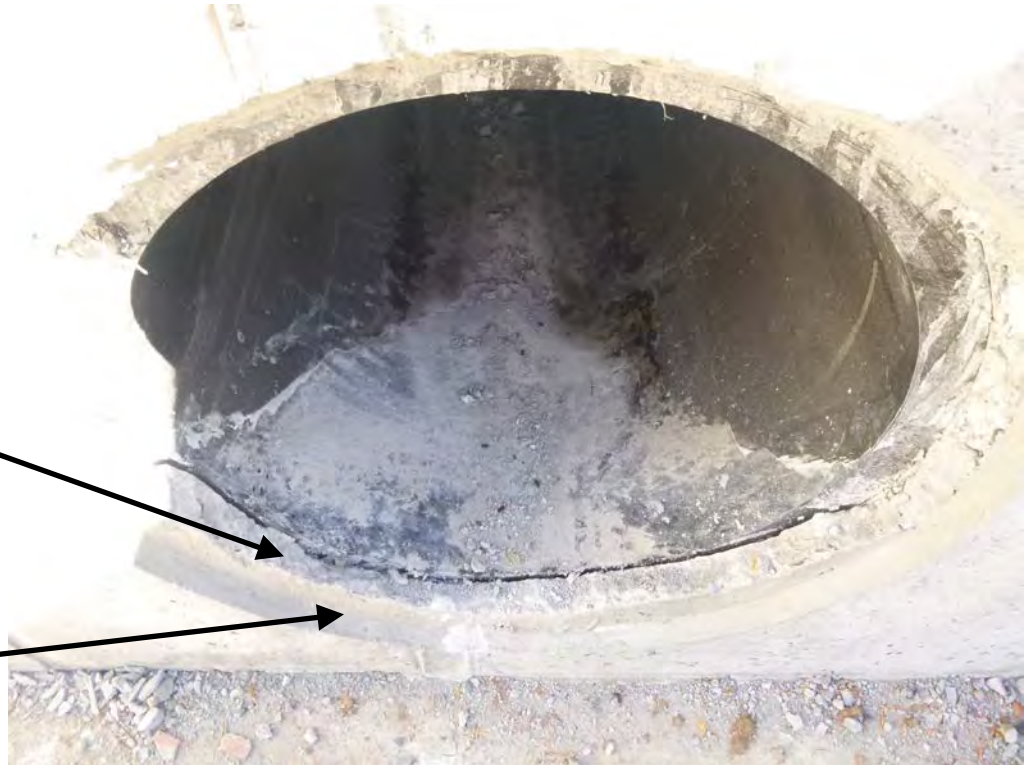
Close-up of downstream end of  
HDPE outlet pipe just inside outlet  
structure opening.

Rough edge created by  
concrete "bleed through"  
and subsequent chipping

Chamfer per Plans Sheet 14

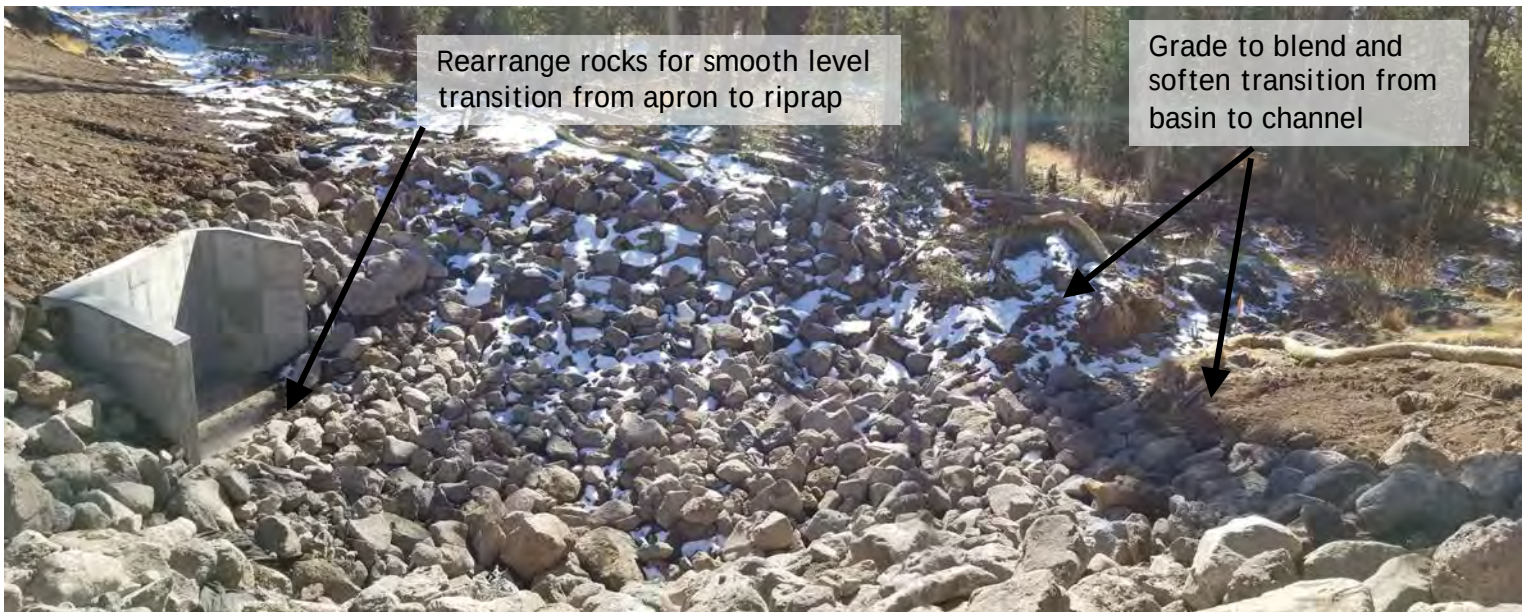
Overall view of outlet structure and stilling basin.  
Notes included for contractor clean-up and finish items.

Rearrange rocks for smooth level  
transition from apron to riprap

Grade to blend and  
soften transition from  
basin to channel

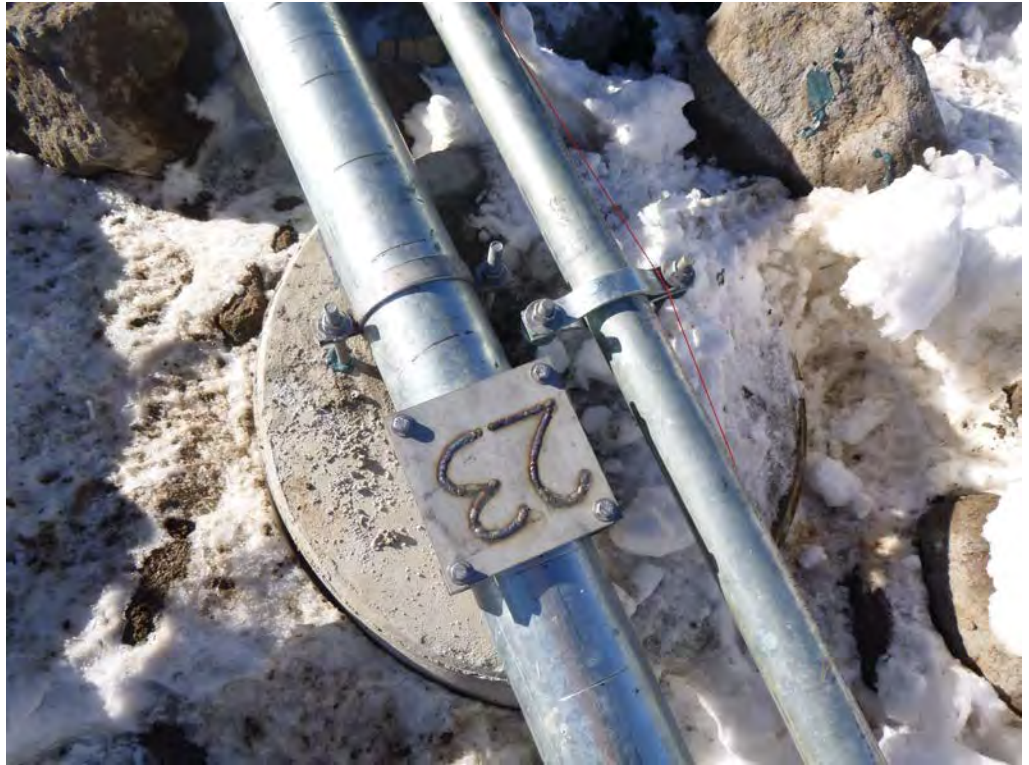
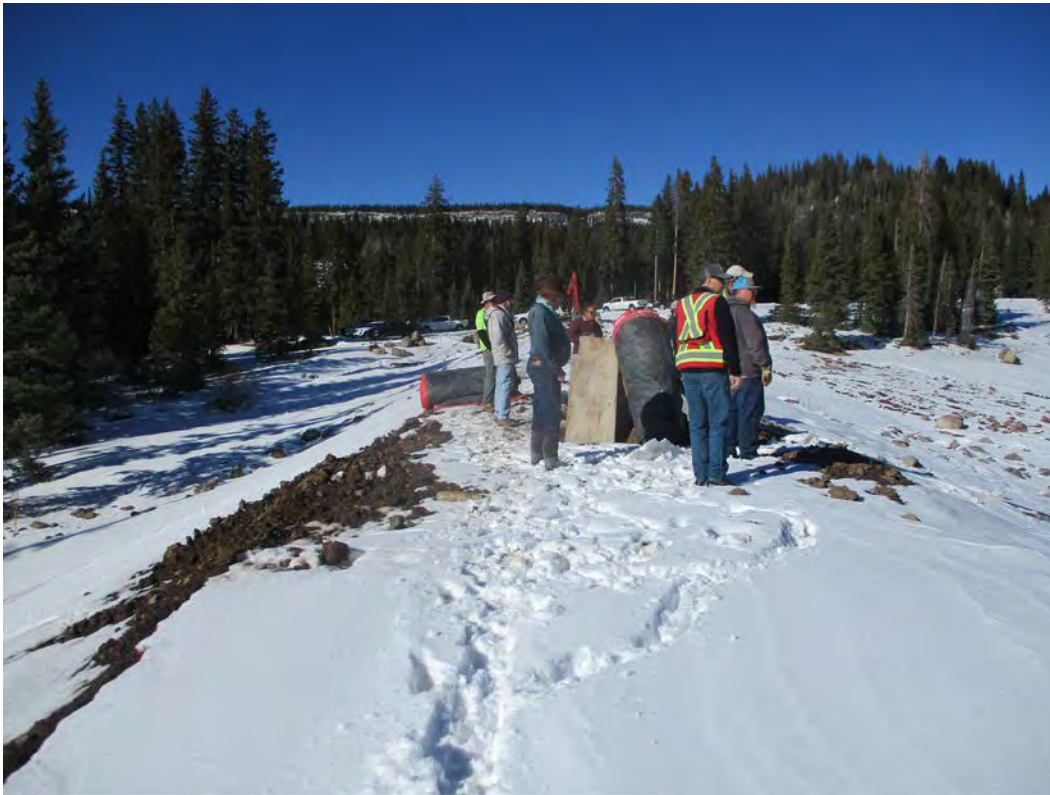
Dam crest area just left gate  
operator support structure in  
need of minor grading to fill in  
low spot and correct drainage.

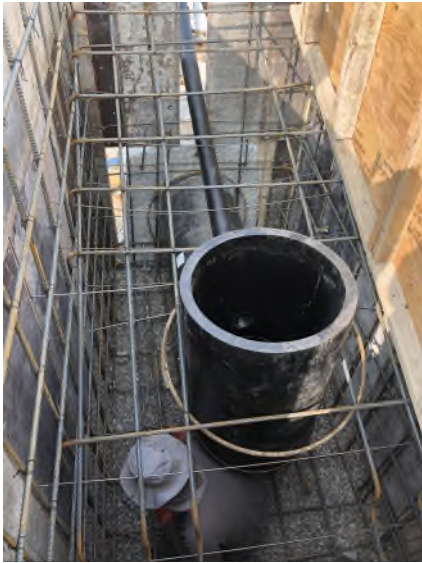
Photo 1. Close-up view of inlet structure reinforcing steel. Note gap in horizontal bars above the ConSy staff member.

| OBSERVATIONS AND DISCUSSION | |
|---|---|
| Action Items: | <ol style="list-style-type: none"><li>1. DOWL to confirm two #5 horizontal bars on the top of the concrete structure, reservoir-side of the HDPE inlet, prior to concrete pour tentatively scheduled for Friday, September 18, at 11am.</li><li>2. (retained, discussion continues) Plan for preparation and pre-forming of exposed benches in breach cut, prior to placement of embankment materials will be resolved by field directive provided by DOWL to Con-Sy. Revisited due to brief winter conditions (week of Sept 7<sup>th</sup>) and weathered appearance pre-formed benches exhibit and the wetting-drying cycle the material has undergone since benching was conducted one month ago (see CIR from 22JUL2020). There is concern that simply moisture conditioning the exposed material may not be sufficient to promote bonding with new embankment fill. At a minimum, the SEO would like to discuss the plan with DOWL's geotechnical engineer (reference).</li></ol> |
