**OVERLAND #1 DAM**

# Overland Reservoir Staff Gauge Beam

## Final Construction Report

Dam ID: 400422

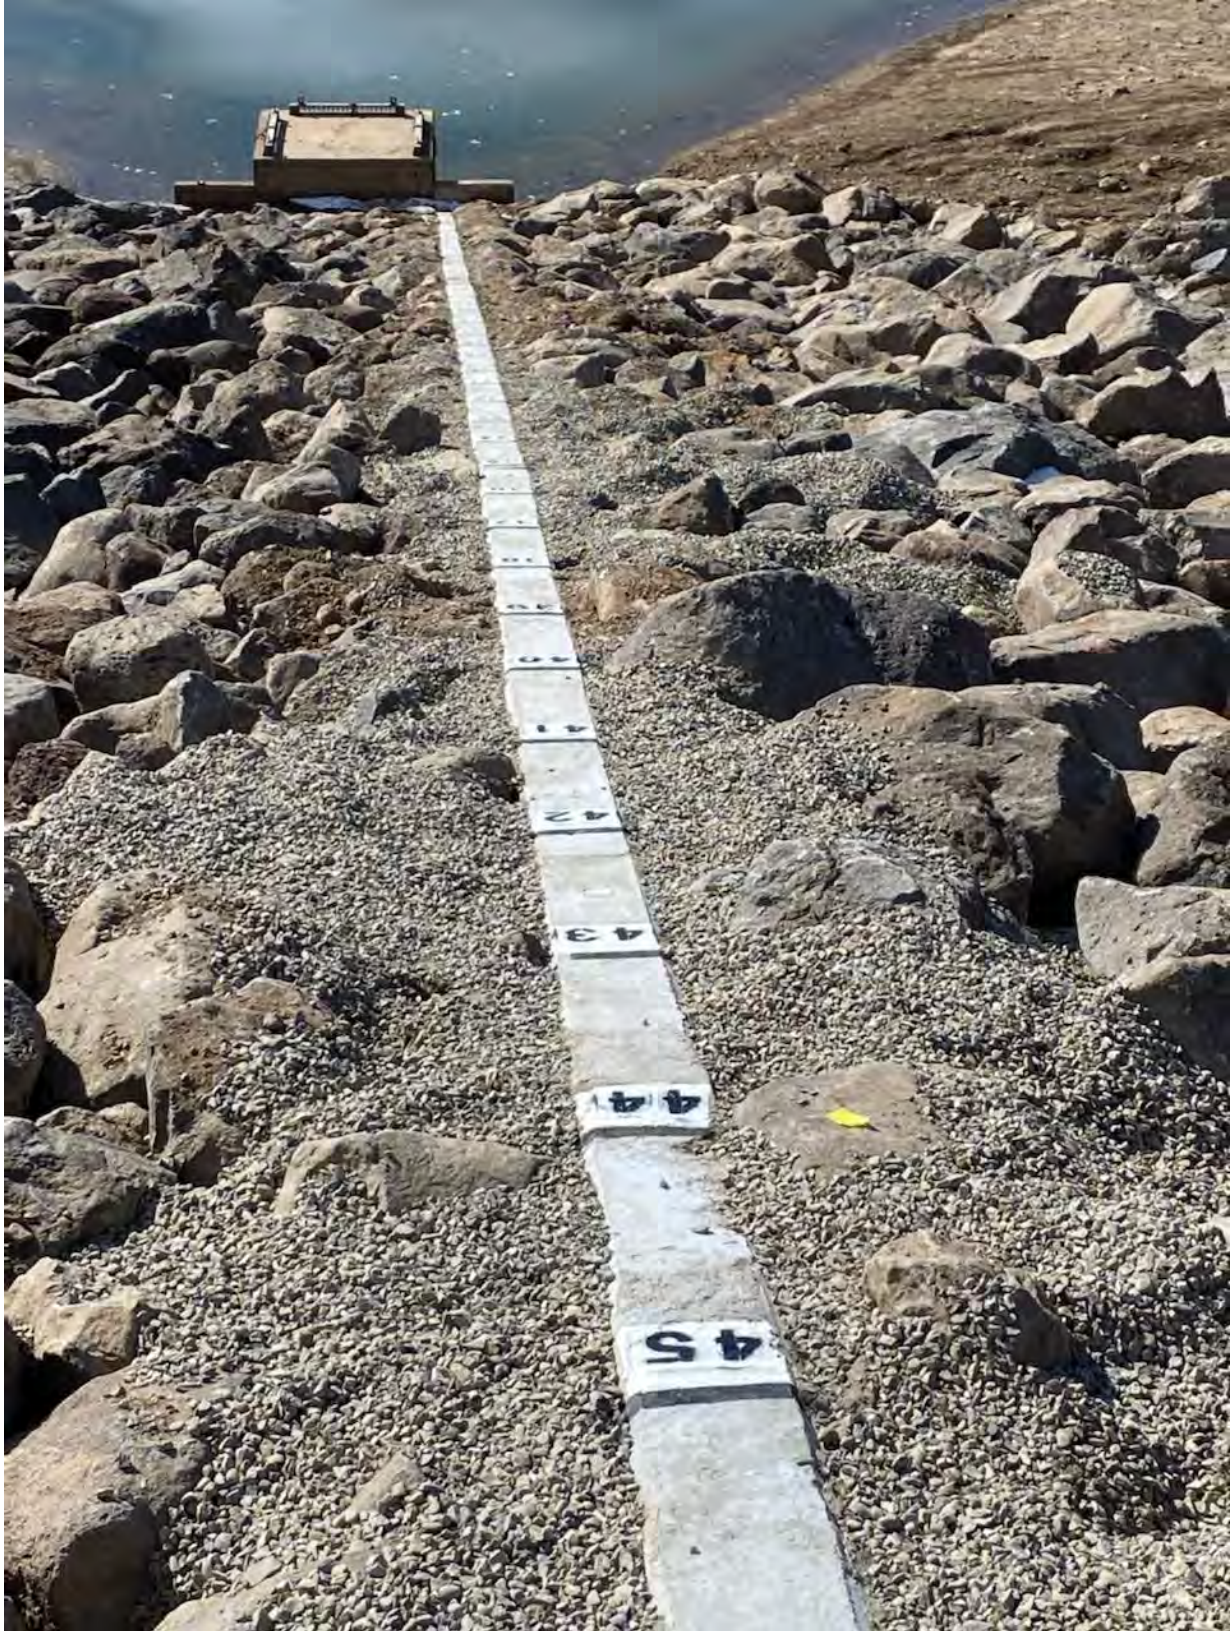
The concrete pour into the 156-foot long grade beam form presented some challenges. Forms were set with a cap in place for 10 feet alternating with 5-foot openings for filling proceeding up the dam. Pumping to the form proceeded well, though concrete did not readily flow to fill the covered sections of the form. Significant vibration was required to complete the fill of capped sections which took longer than anticipated. To speed up the process, holes were cut in the middle of capped sections and all available personnel assisted with tapping the forms to augment vibration encouraging fill. The entire pour took approximately 4 hours to complete. When forms were removed, a few areas of slightly incomplete fill were patched with grout as shown in the Inspection Report. Problems encountered do not appear to impact the functionality of the grade beam.

FIGURE 1 COMPLETED OVERLAND RESERVOIR GRADE BEAM

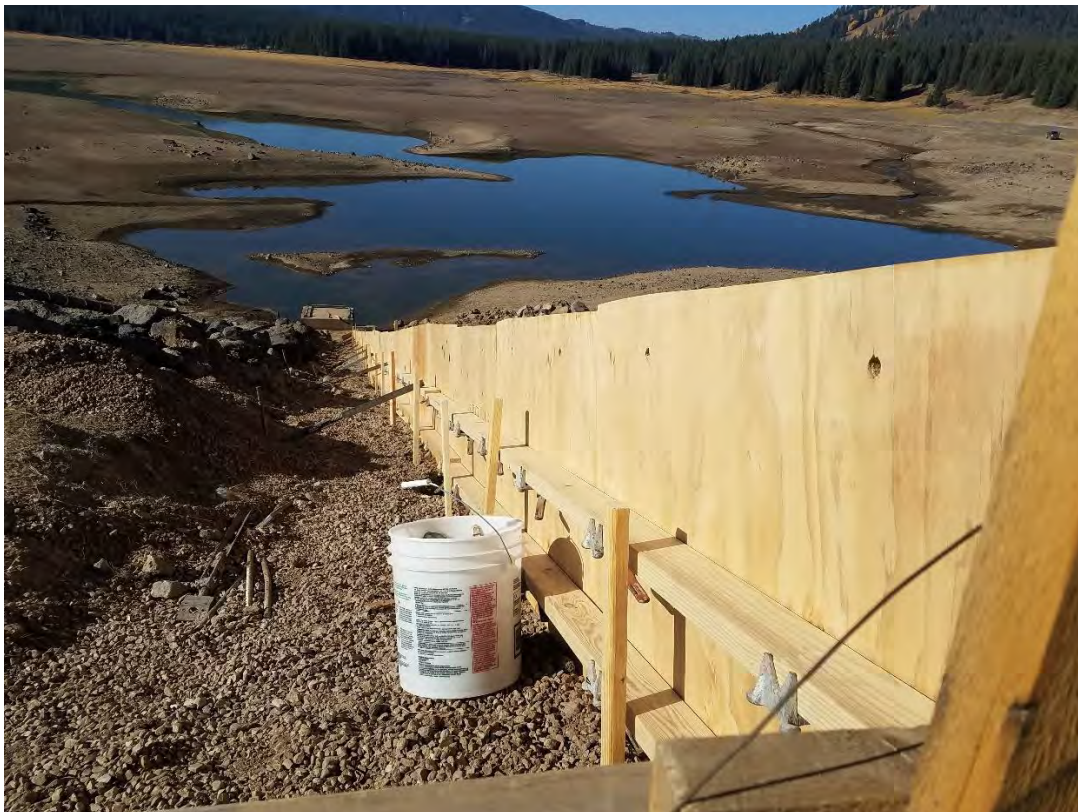
Photo 1 South wall forms loosely set

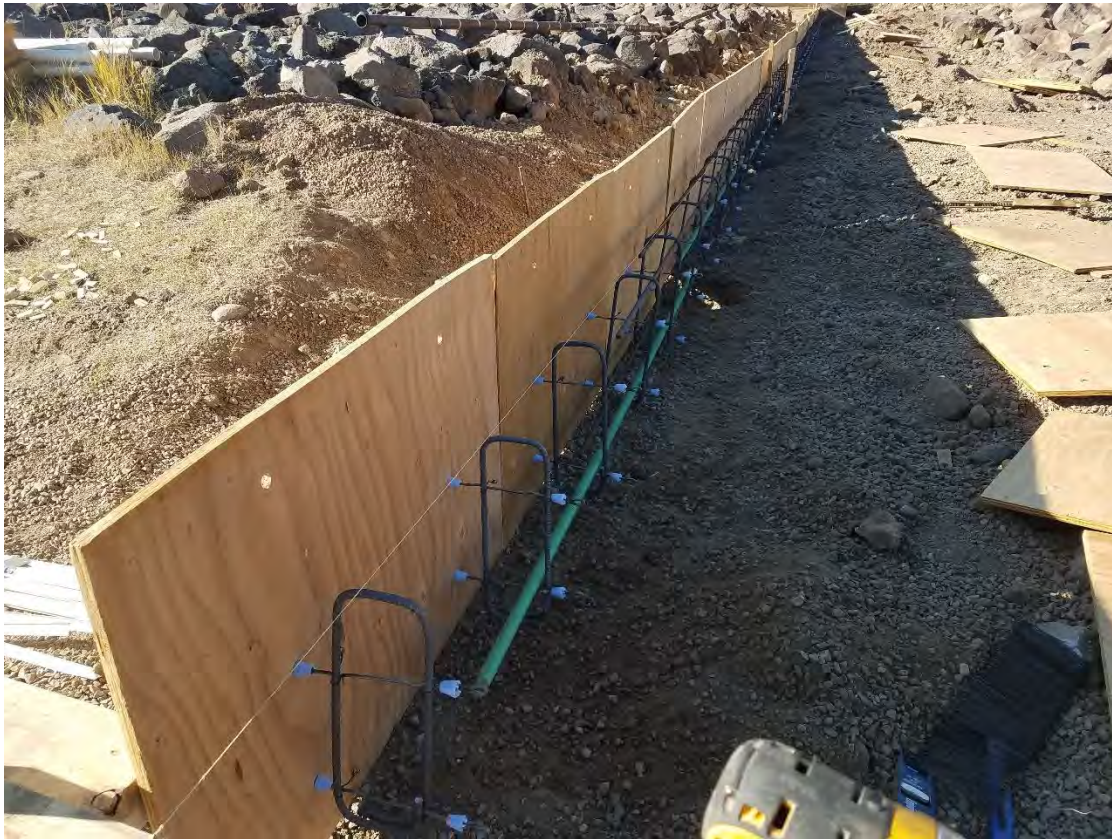
*Photo 2 Rebar stirrups with tension rod loosely placed*

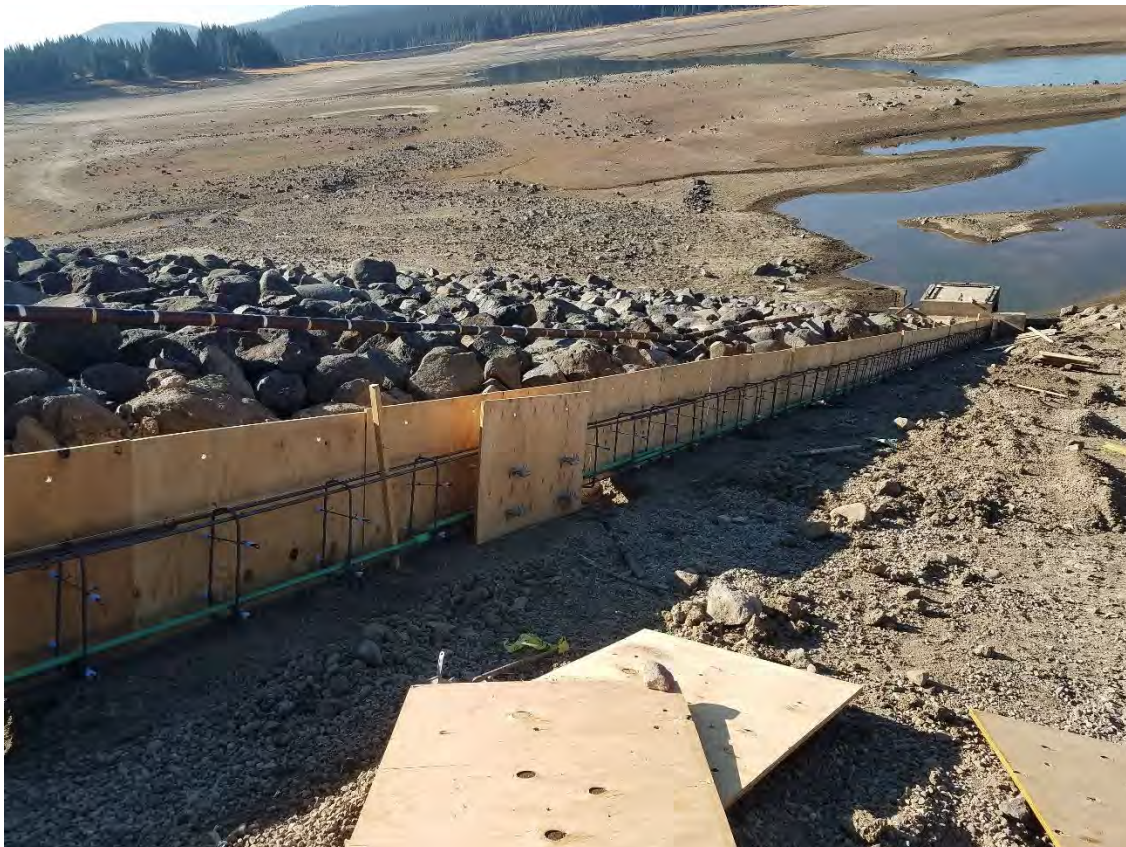
*Photo 3 Longitudinal rebar in place top & bottom*

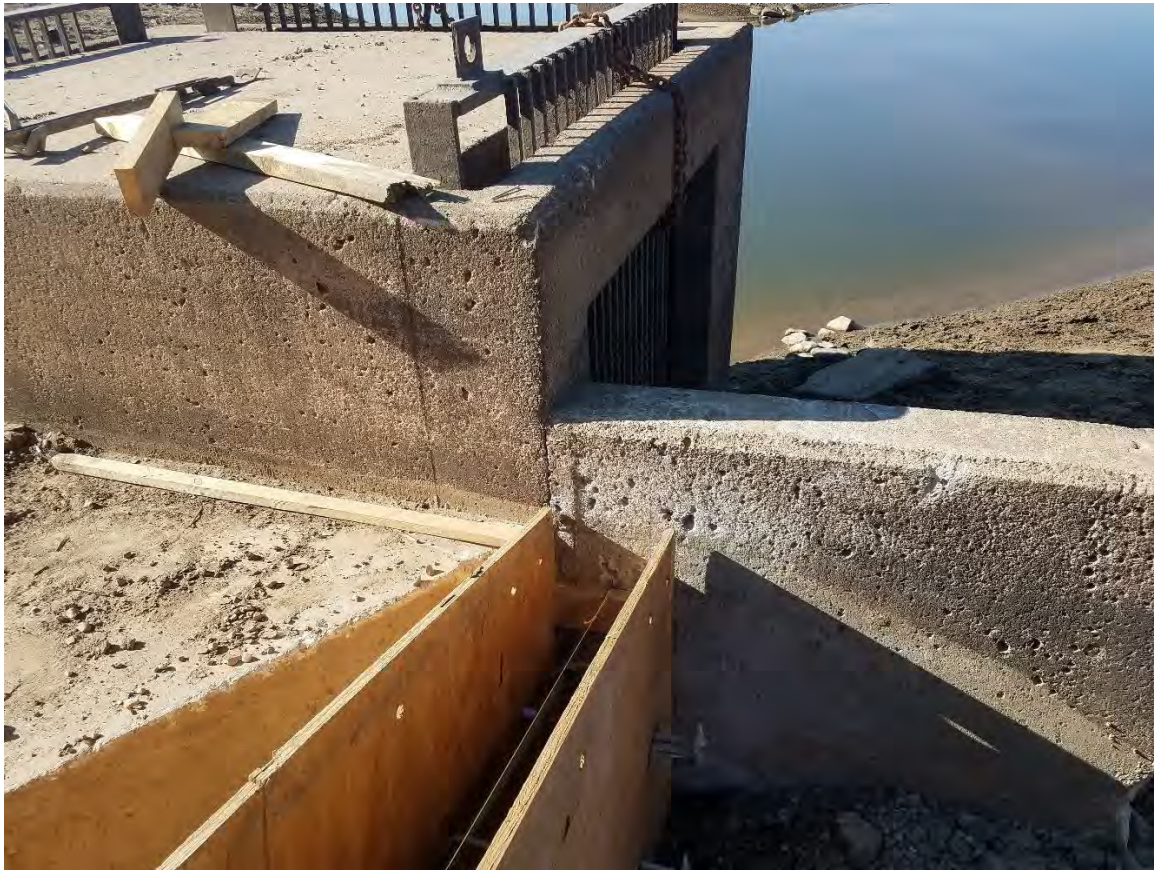
*Photo 4 Beam meets existing inlet structure*

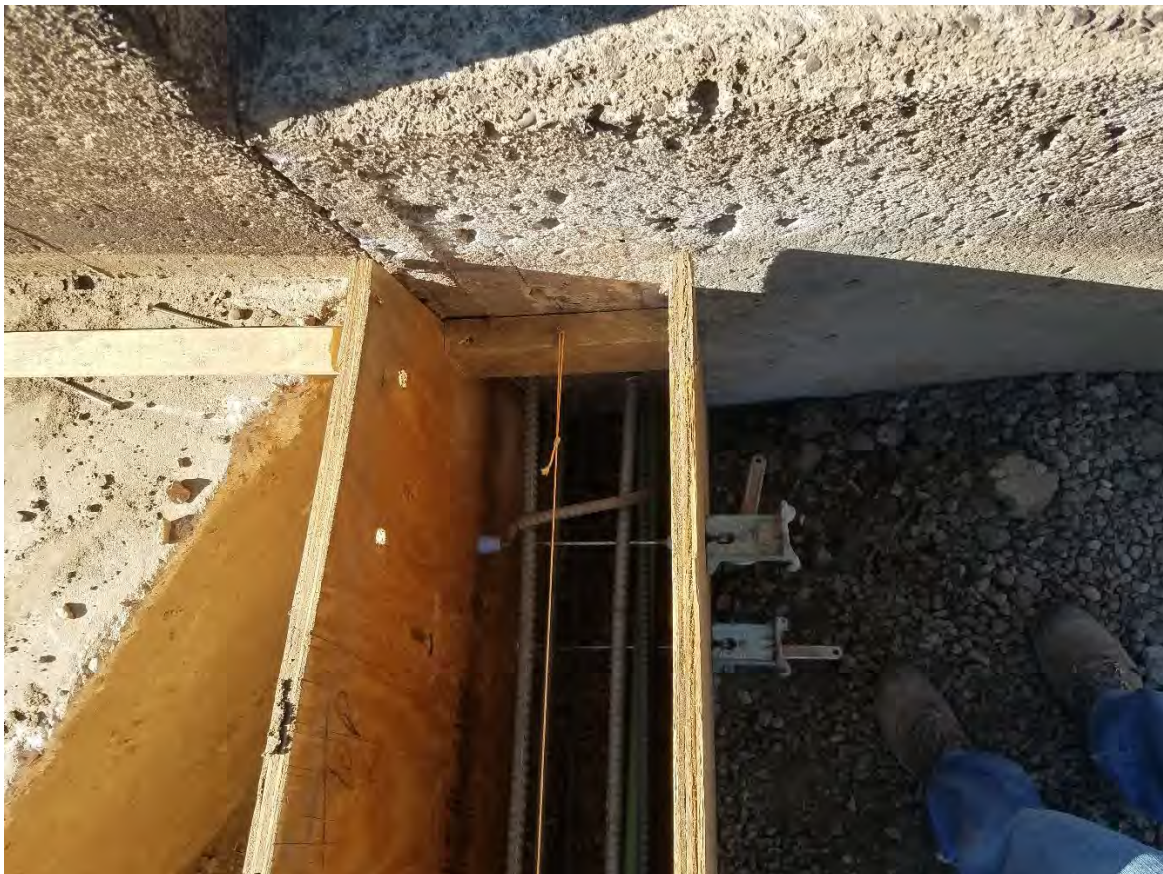
*Photo 5 Six pins grouted into existing concrete for tie in*

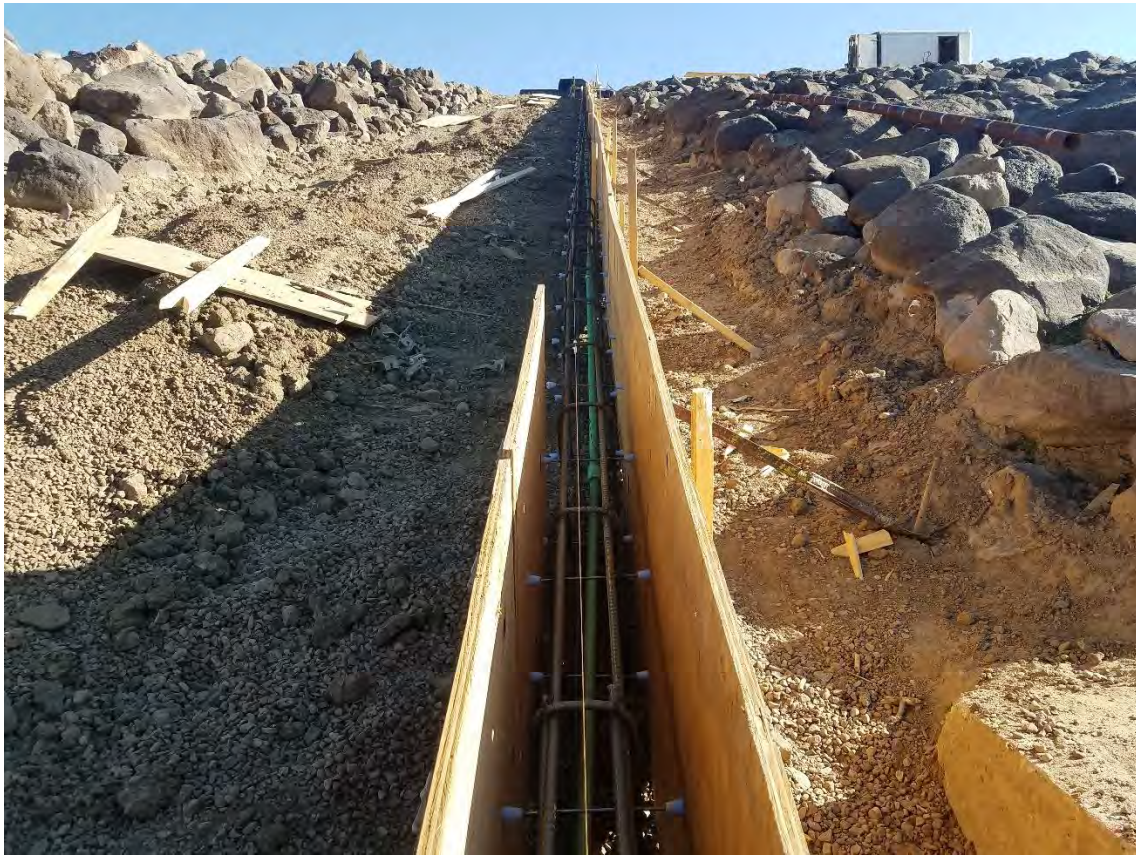
*Photo 6 Beam rising from inlet*

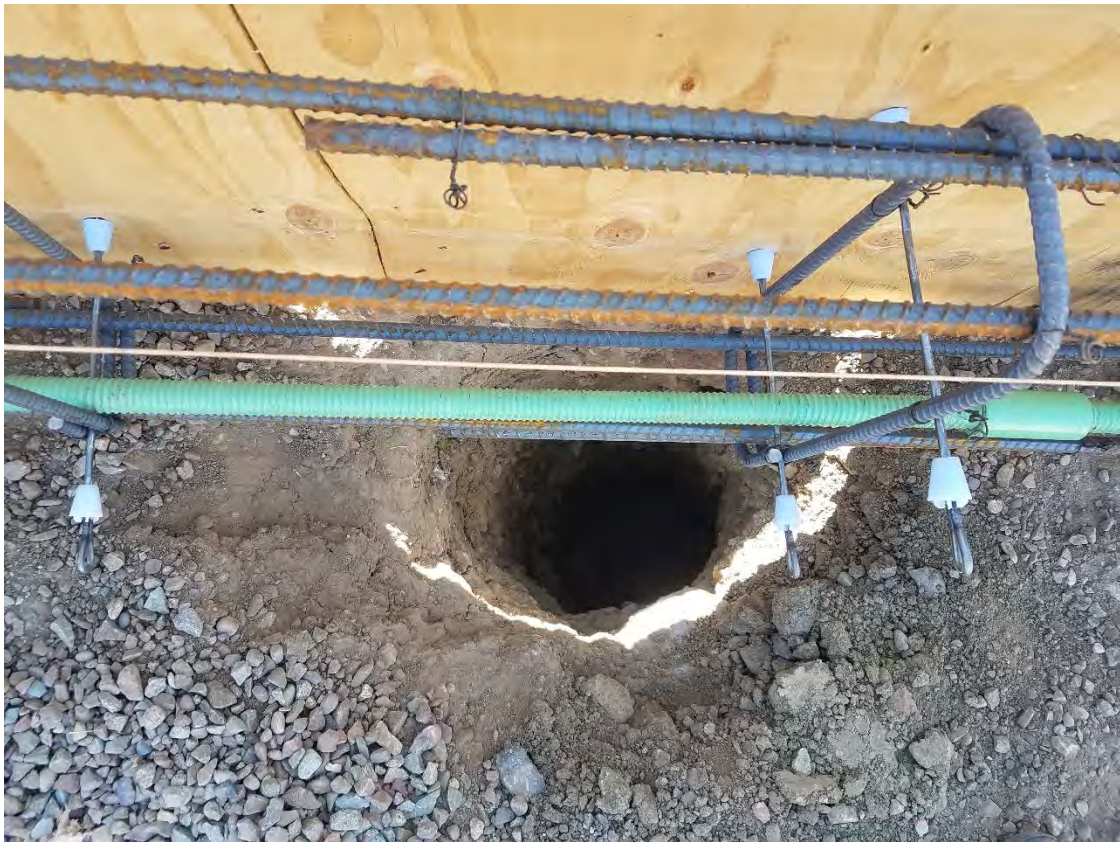
*Photo 7 Pier holes dug; rebar placed in holes (not shown here)*

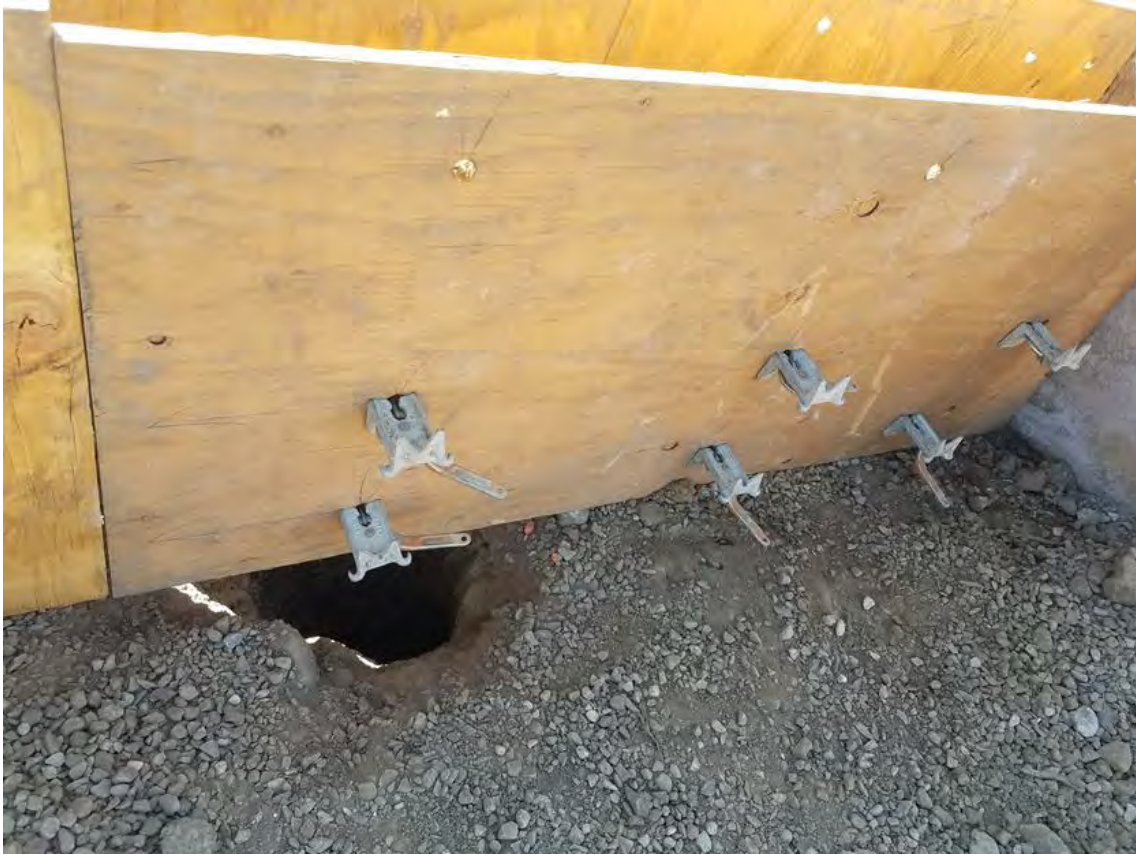
*Photo 8 Form locks in place at bottom of beam*

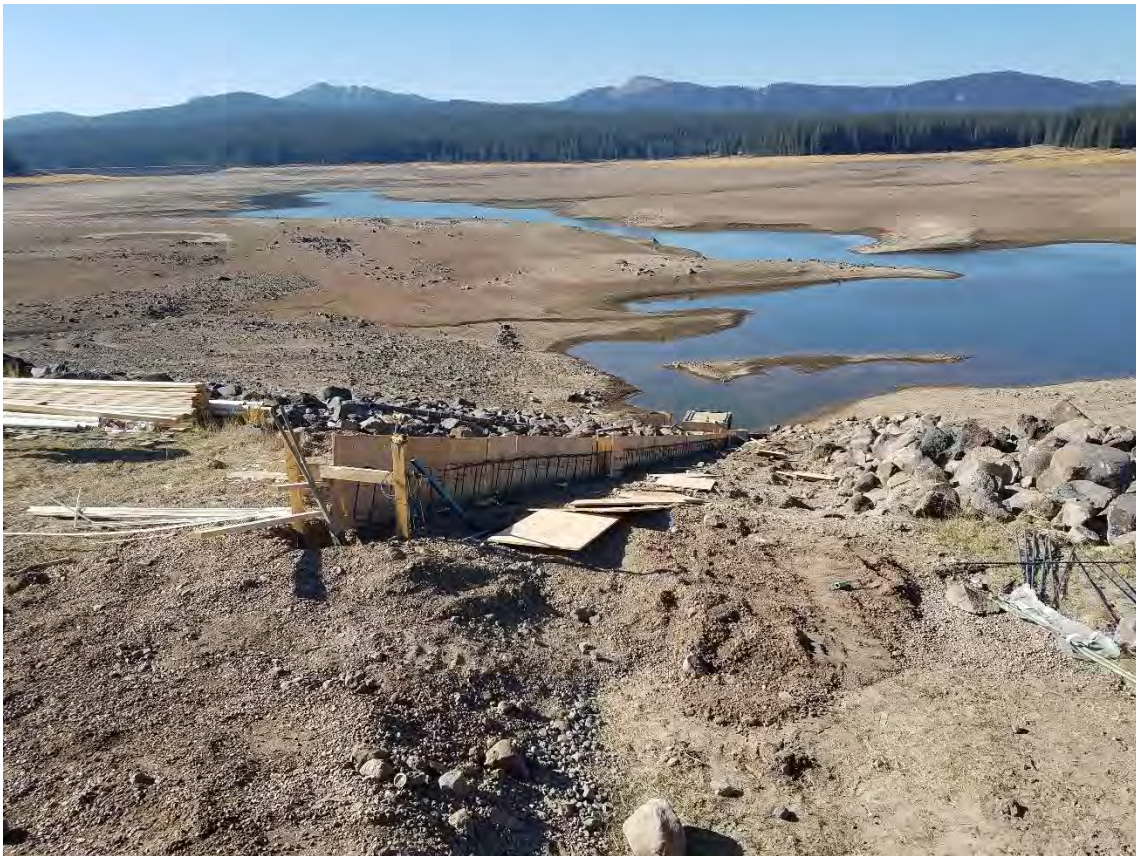
*Photo 9 Gauge beam work site from top of dam*

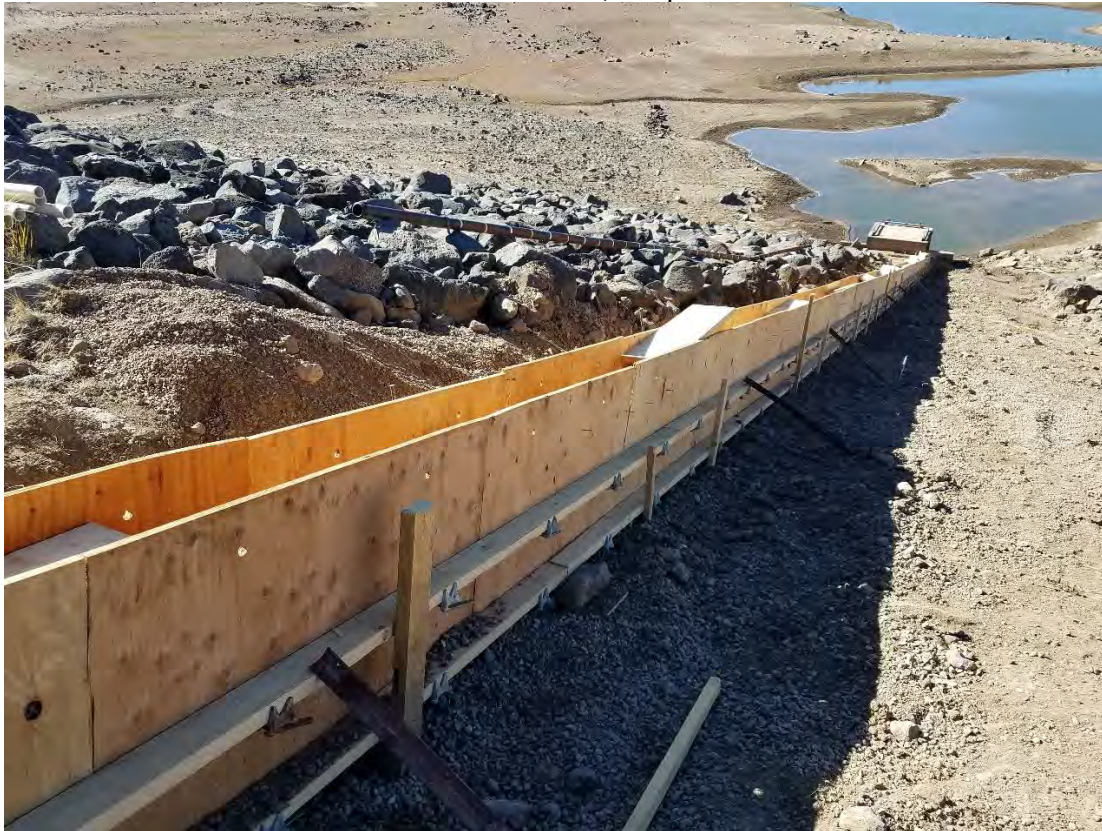
Photo 1 Forms ready for pour

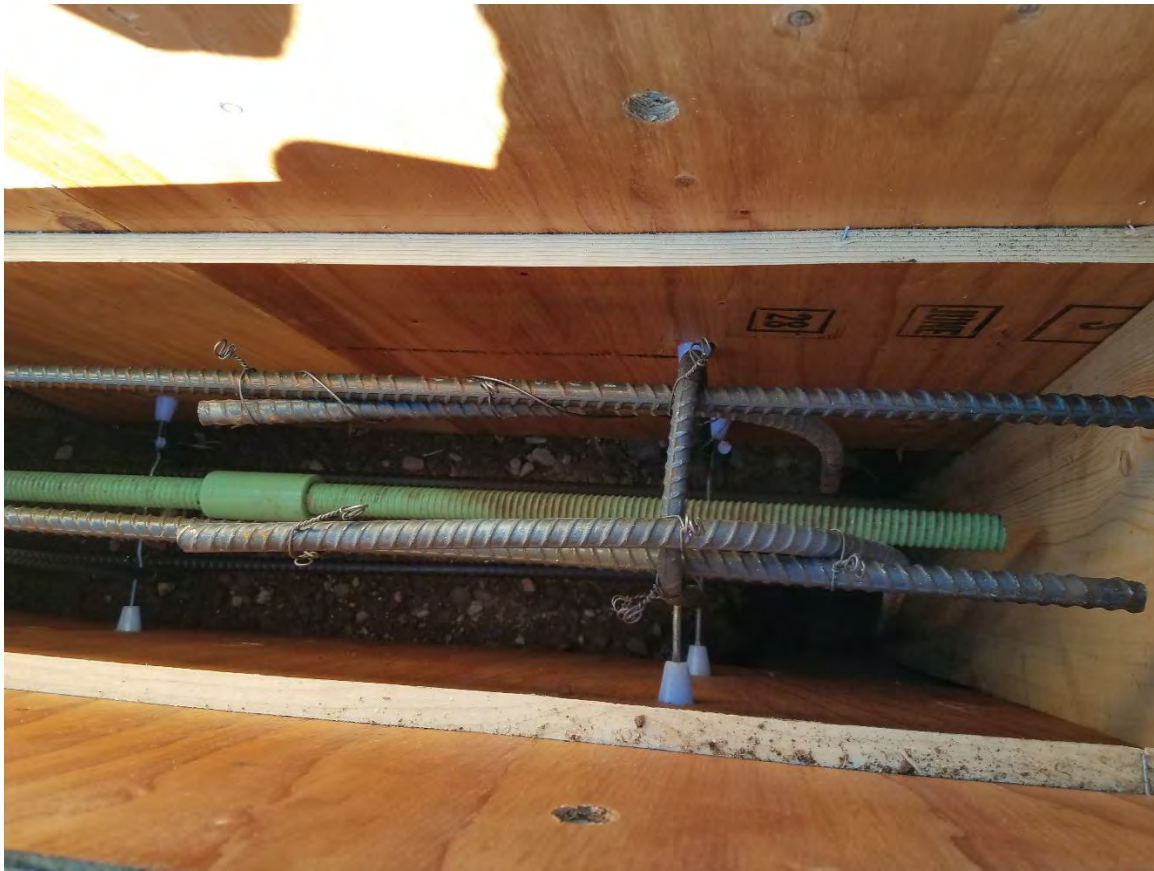
*Photo 2 Rebar and tension rod in place over pier*

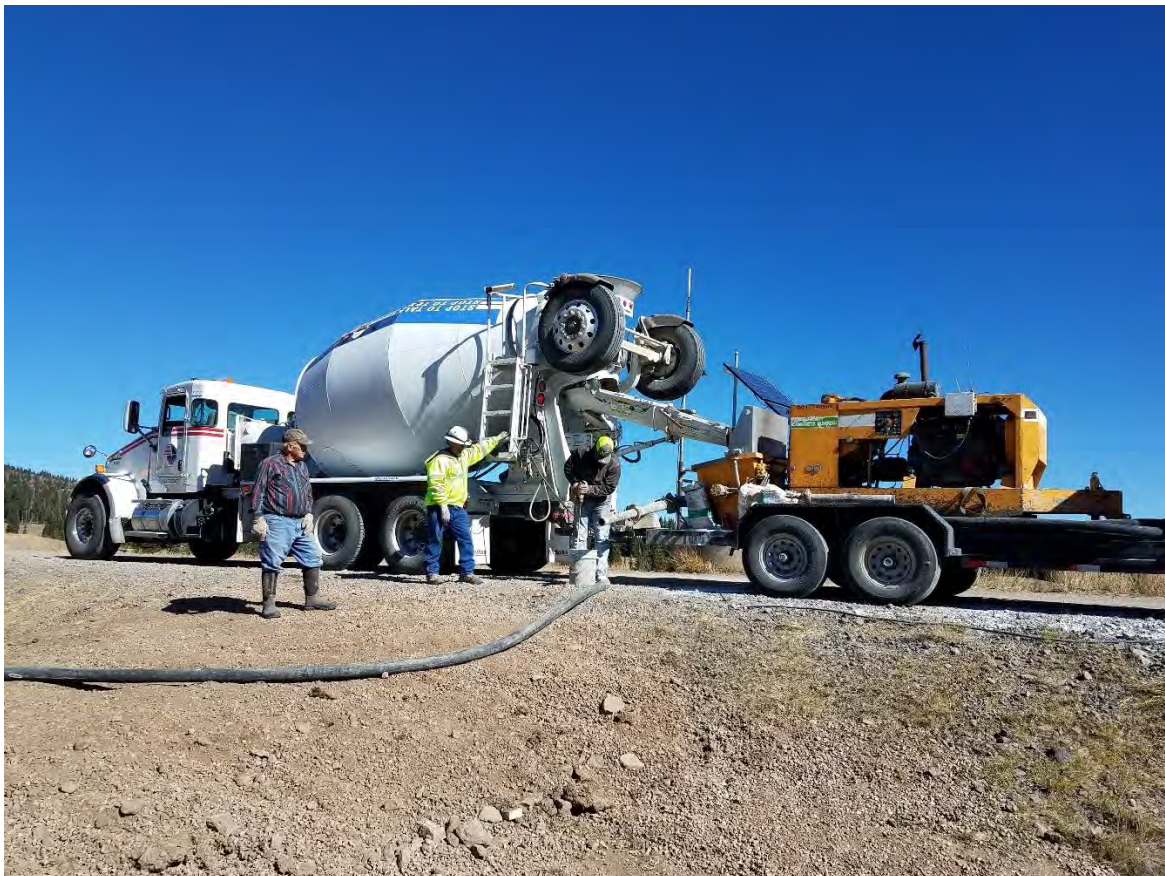
*Photo 3 Truck #1 begins pour 11:59 am*

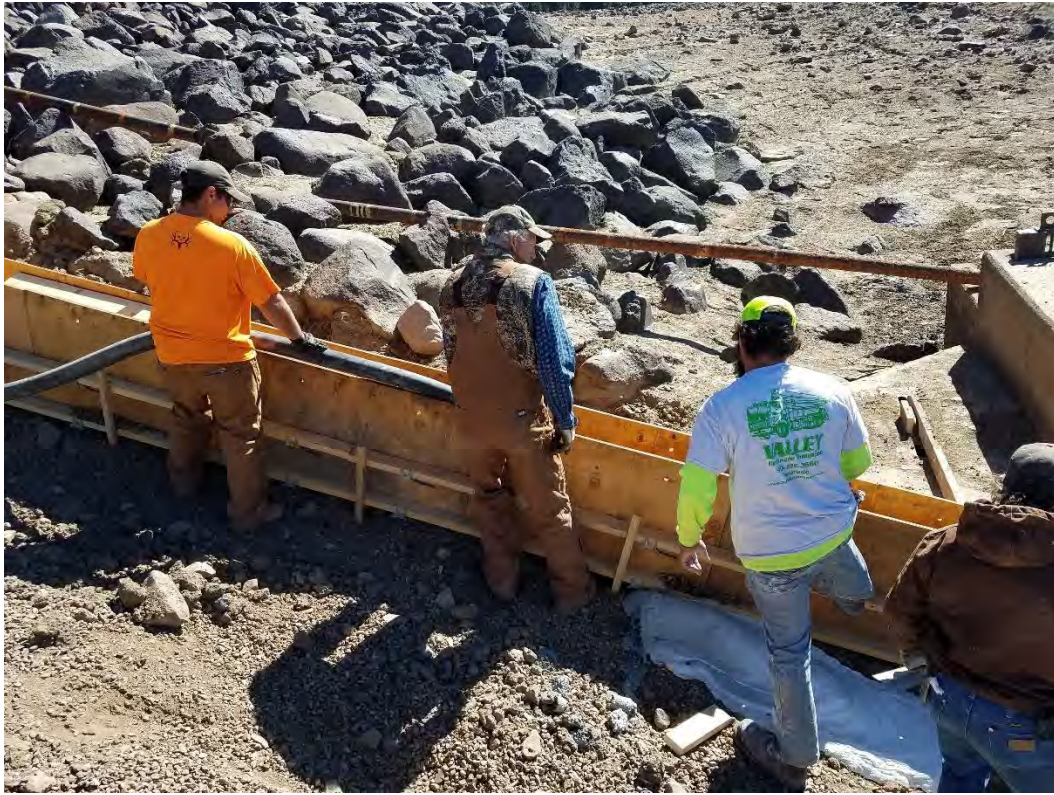
*Photo 4 Beginning pour*

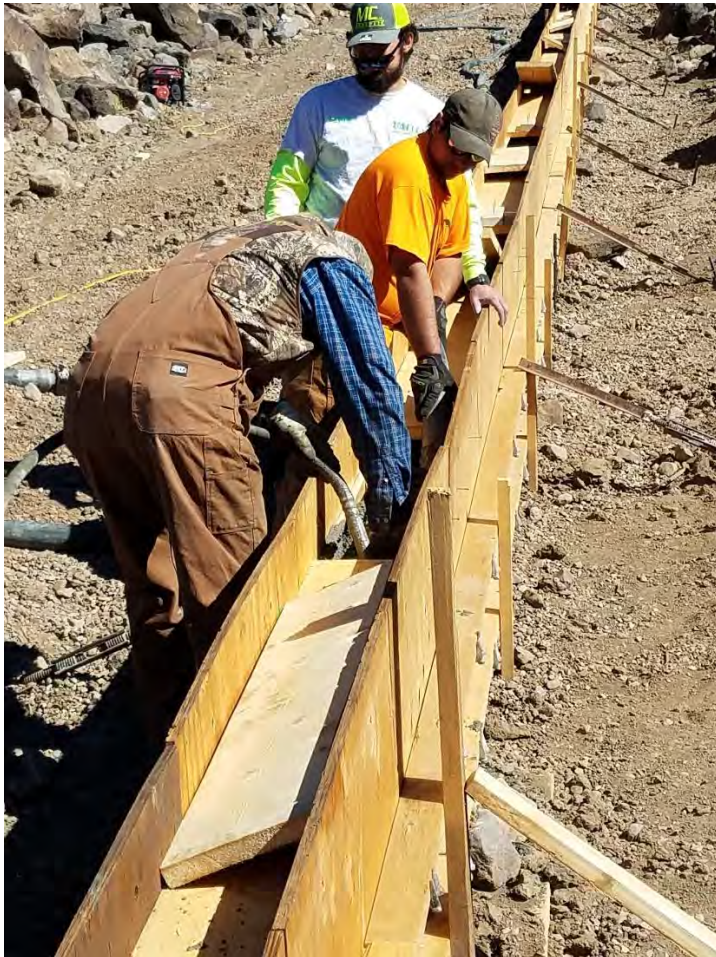
*Photo 5 Vibrating to fill under form cap*

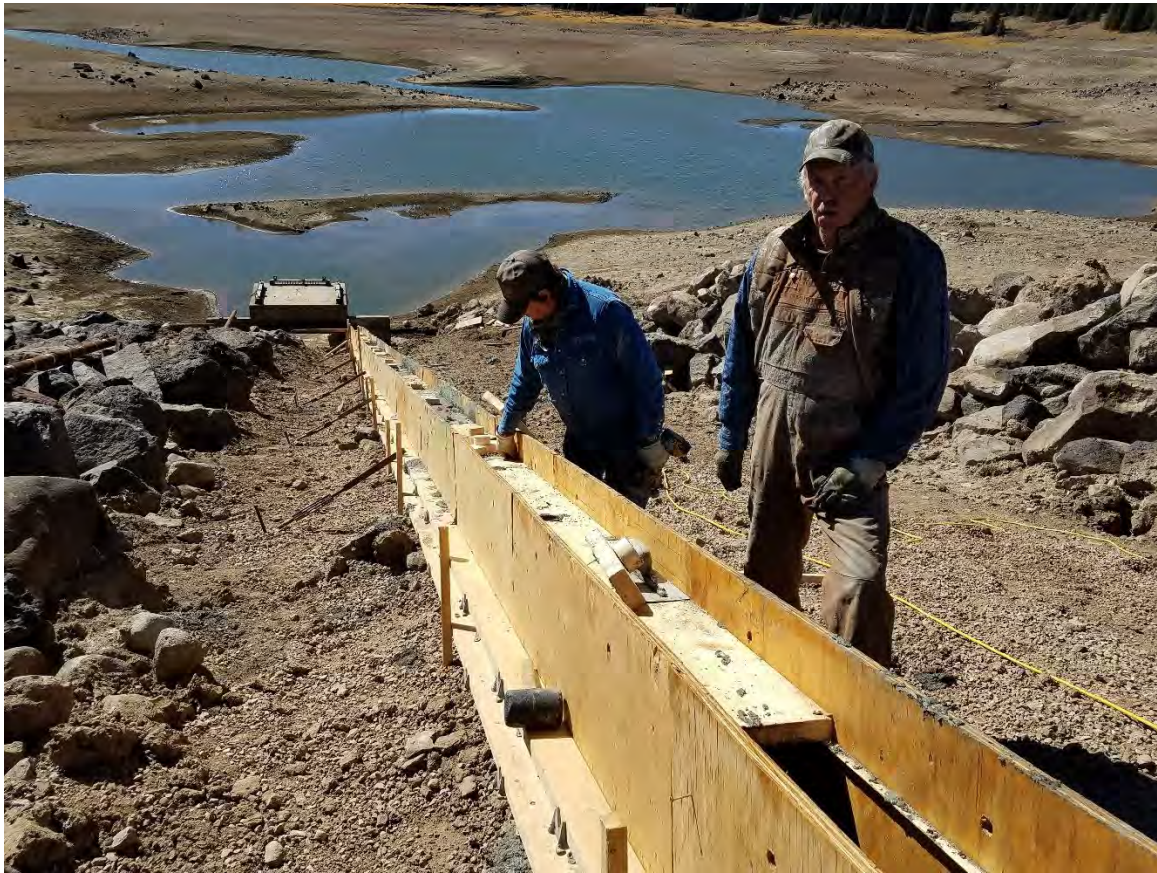
Photo 6 Waiting to begin Truck #2 pour at 1:37 pm

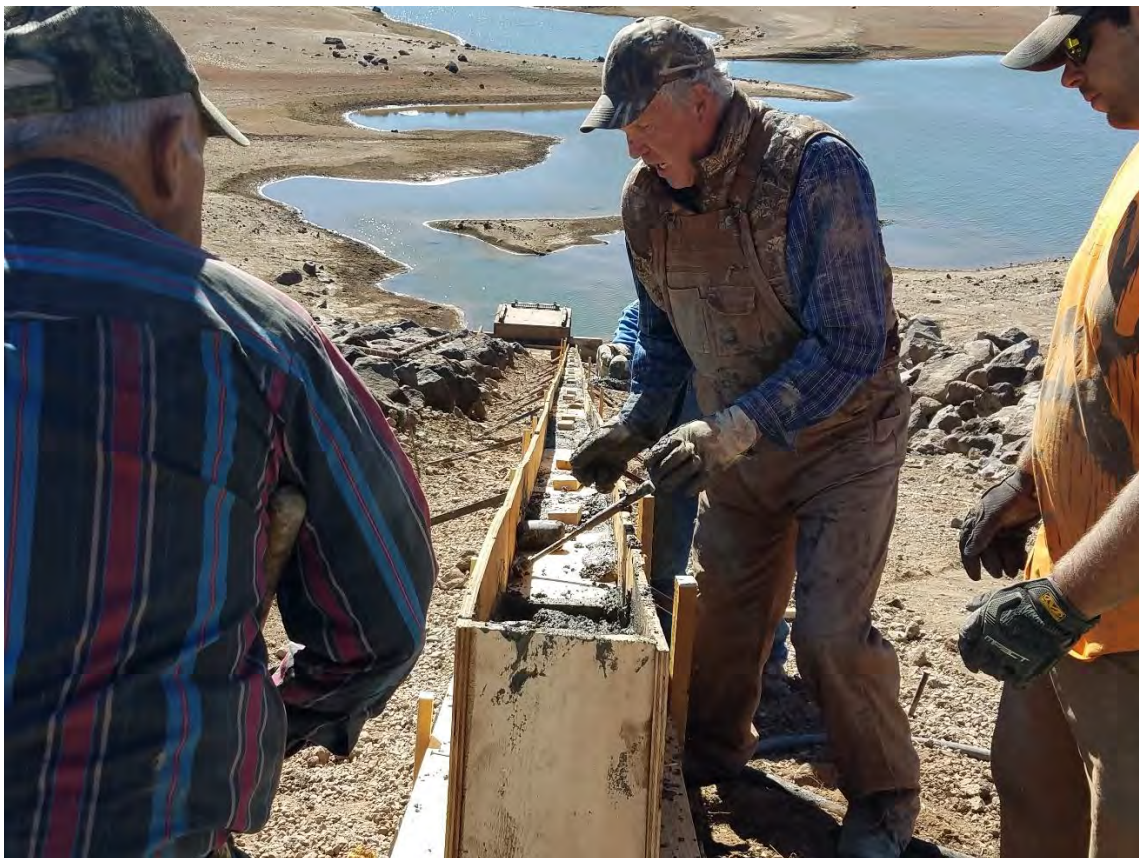
Photo 7 Pour complete at 2:21 pm
