Junkins Fire, Final Report

Coalition and Collaboratives

PREPARED FOR LAVWCD, CWCB (PO # POGG1 PDAA 201700000986)

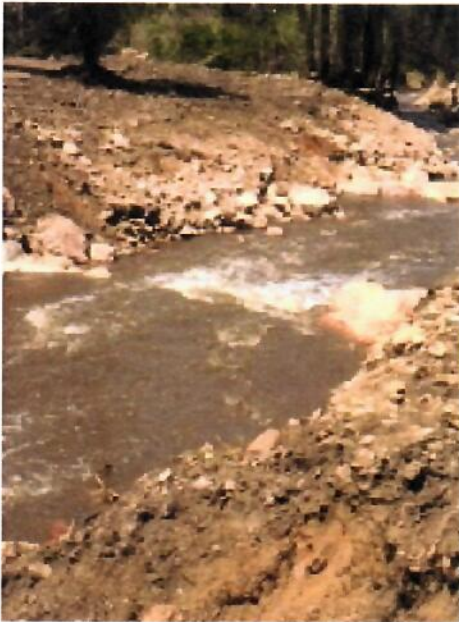
Actual Deliverables: The main objectives were met. The steep bank below the home is intact. To the left of the two stumps in the picture is a 30" diameter buried tree. This photo was taken after an estimated 50 year event that took place during construction. The J-hook is fully exposed. The footer thalweg rock weathered the storm. The top rock is farther down stream. Sediment is starting to build between and behind the rocks. Burned trees jammed up during the flood in the live trees just down stream of this photo. This caused an hydraulic lift, when the dam broke it then sucked the first structure in the channel down stream. The vertical bank in this area is about three feet high. We believe it will continue to heal over time.

A lot of large boulders passed over the vane during the July flood. I believe the key to this structure holding is the overflow channel that was enhanced. The channel

diversion is just upstream of this photo, and the channel is to the right, out of the view in this photo.

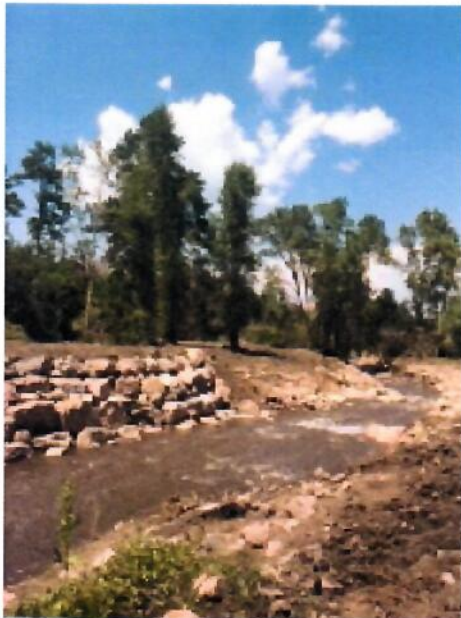
The photo at left is of the cut off wall to the channel that was near the steep bank. It held during the flood. The vanes where the water tumbles were replaced after the event. The boulders from these vanes (which were in construction when the flood occure) were found ¼ mile down stream.

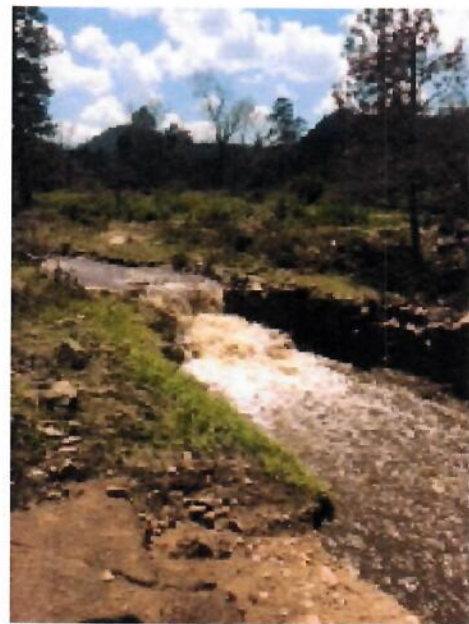
Below is a photo that shows the overflow channel the day of the flood. The creek has to rise about ½ a foot above bank full to be utilized, so it will not routinely flow during spring run off. It runs

between the trees. It has now started to grass over, and should continue to provide overflow capacity during extreme events.

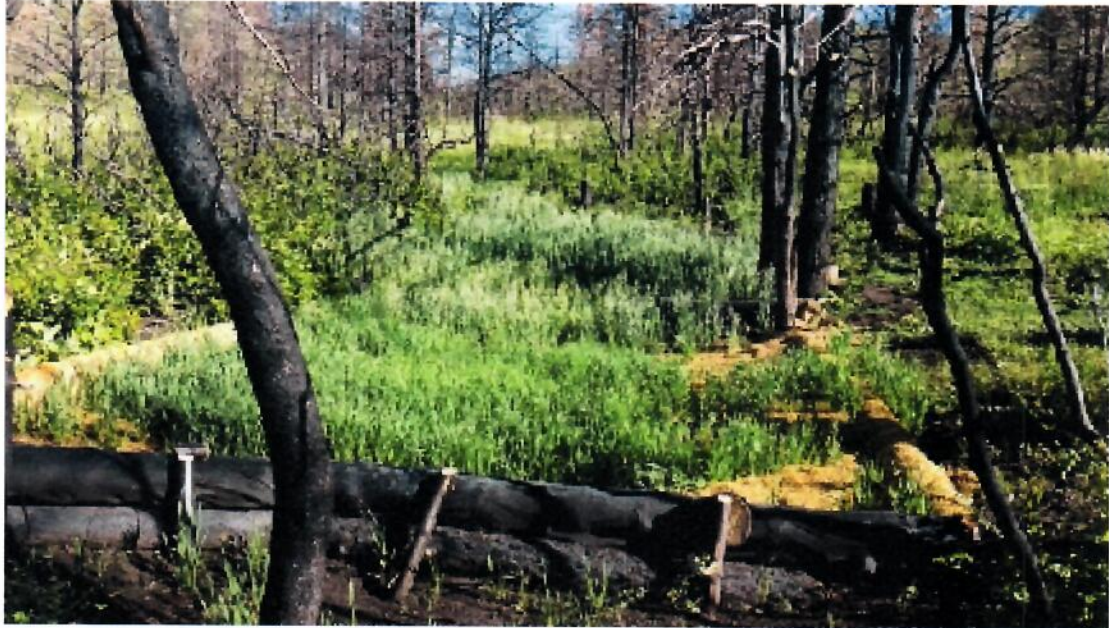
The modified crib walls were mentioned heavily in our monthly reports; below are some after pictures. It is hard to find the structures. This was taken after a storm event.

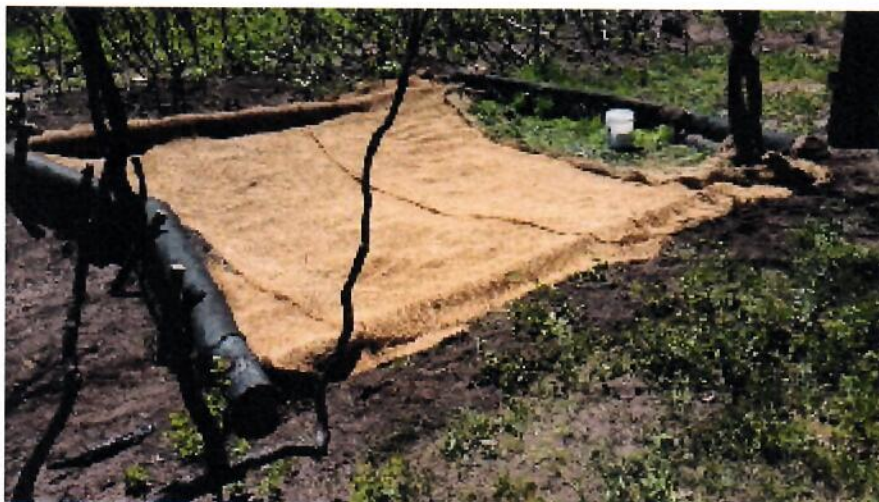
Many of the other Modified crib walls can not be seen at all. The landscape looks like grassy steps.

The photo shows a different angle but same place as the photo above.
