# Unnamed Tributary 3 Post-Fire Restoration Project

## Final Report

January 31, 2019

Coalition for the Poudre River Watershed  
Grant Amount: \$75,000  
Prepared by: Hally Strevey

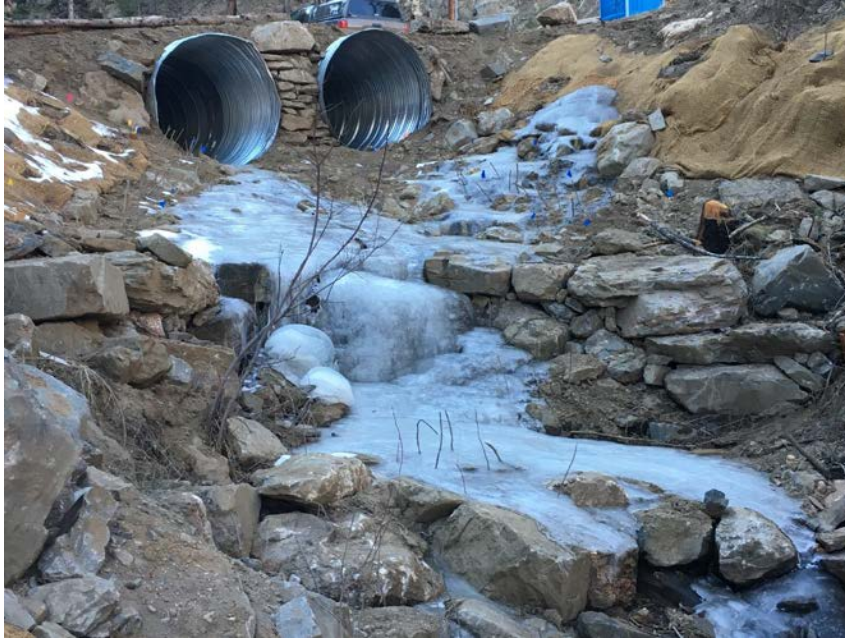
**Photo 4.** Two 72" culverts installed (replaced two 36" culverts) Stone toe was placed on both banks for approximately 30', along with coir matting, seed, container plantings, and willow stakes

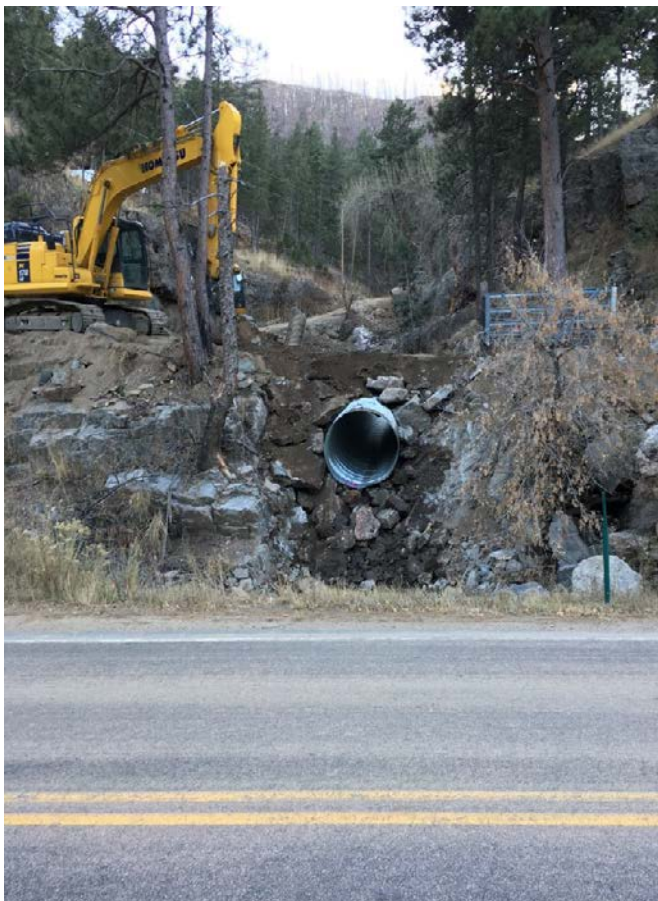
**Photo 5.** 60" bottom culvert installed (replaced 18" culvert)

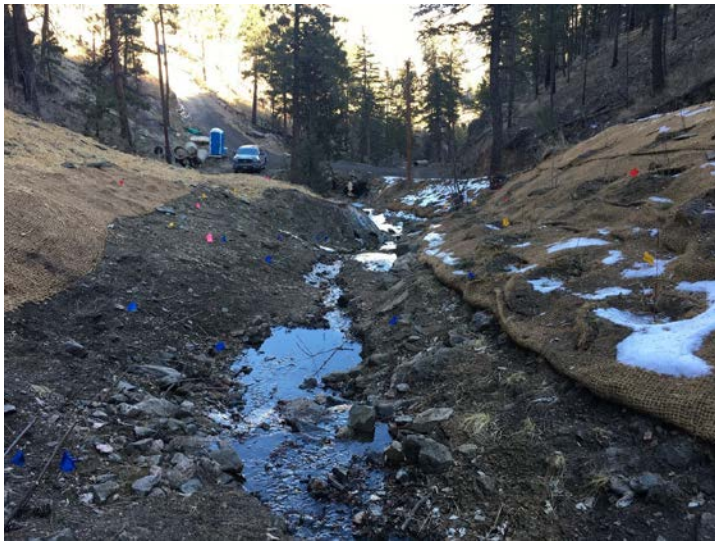
**Photo 6.** rock crossvane was installed to reduce the risk of head cutting upstream, and to stabilize the stream bankfull channel, floodplain re connected to stream.

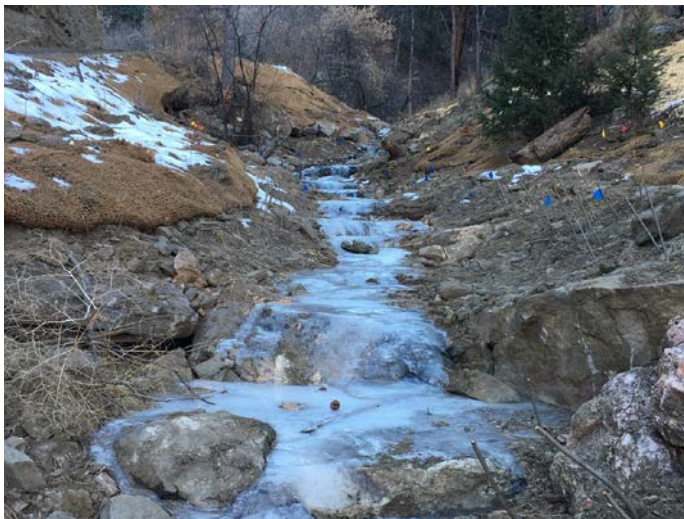
**Photo 7.** Rock cross vanes and a rock sill were installed to complete the grade drop to the elevation of the downstream culverts

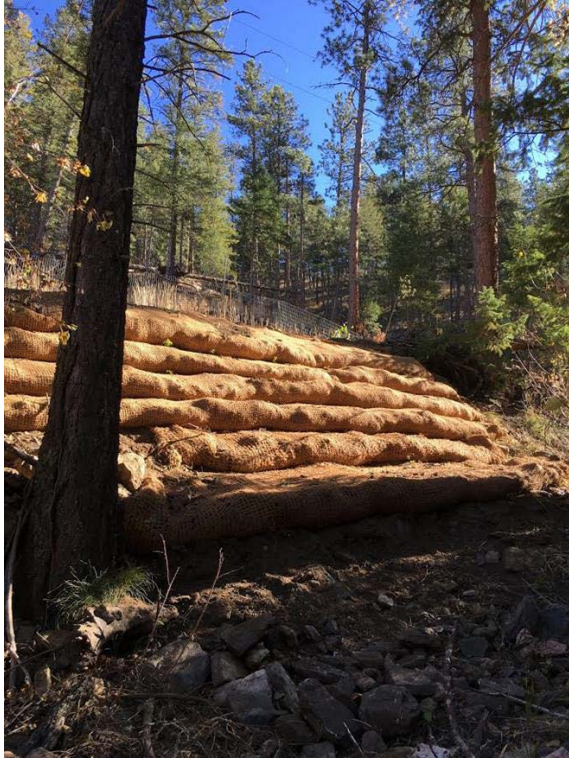
**Photo 8.** Vegetated Soil lifts installed to address bank hazard in two areas along the road embankment, where sparse vegetation, steep slopes, and poor soil dominated

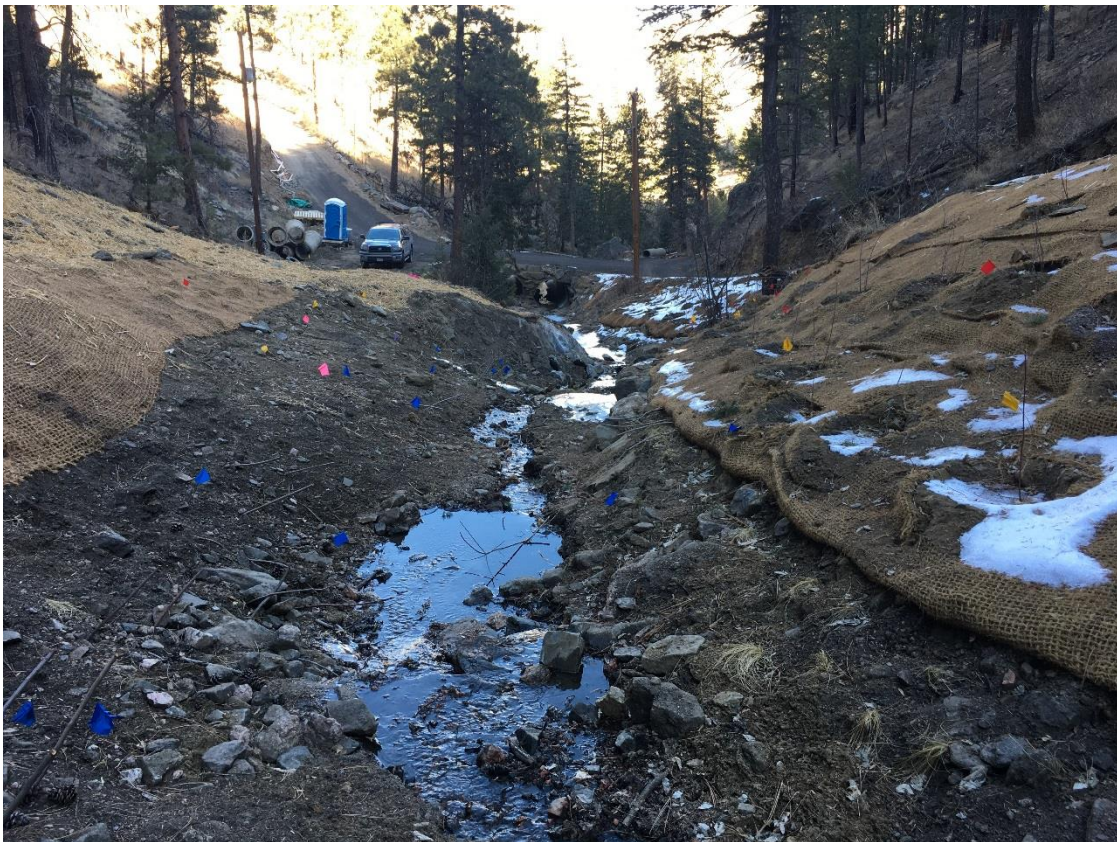
**Photo 1.** View Downstream Station 0+00

**Problem Area #2:** An approximately 35-foot long detention pond has been constructed by a property owner upstream of this crossing. The berm and check dam of this pond would likely fail under high flows of 200 cfs or greater. It has captured multiple cubic yards of fine sediment over the year or so since it was constructed. The undersized sediment basin is constructed with a check dam above the profile of the existing reach slope. This configuration could result in up to 20 TNs of sediment being transports downstream with a failure of the check dam. It is likely that the check dam will see partial failure with a discharge of greater than 200 cfs. This problem area is located at Station 0+00 to 1+90 on the existing Longitudinal Profile.

**Work Completed to Address Problem Area #2:** The effort to restore this area required complete channel and bank grading from 0+00 through +- 1+00. Starting at Station 0+00 a rock crossvane was installed to reduce the risk of head cutting upstream, and to stabilize the stream bankfull channel (**Photo 1**). Moving downstream through station 0+90 bedrock was encountered in the stream channel bottom as well as multiple areas on the left bank. Excavation of this area was sufficient to increase the bankfull width increasing the capacity of the channel. The left bank was stabilized with seed and wood straw, as well as tree and shrub containers, and willow cuttings were installed where bedrock was not encountered. In this reach the right stream bank was stabilized with coir matting 700, as well as seed, willow cuttings, tree and shrub containers, as well as wetland plugs. Earlier design iterations had included using log drop structures in this reach. However, due to the presence of bed rock, it was determined that installing the log drop structures at an appropriate depth would require excavation through bedrock which was not possible. Furthermore, the bedrock would not allow for adequate securing of the logs.

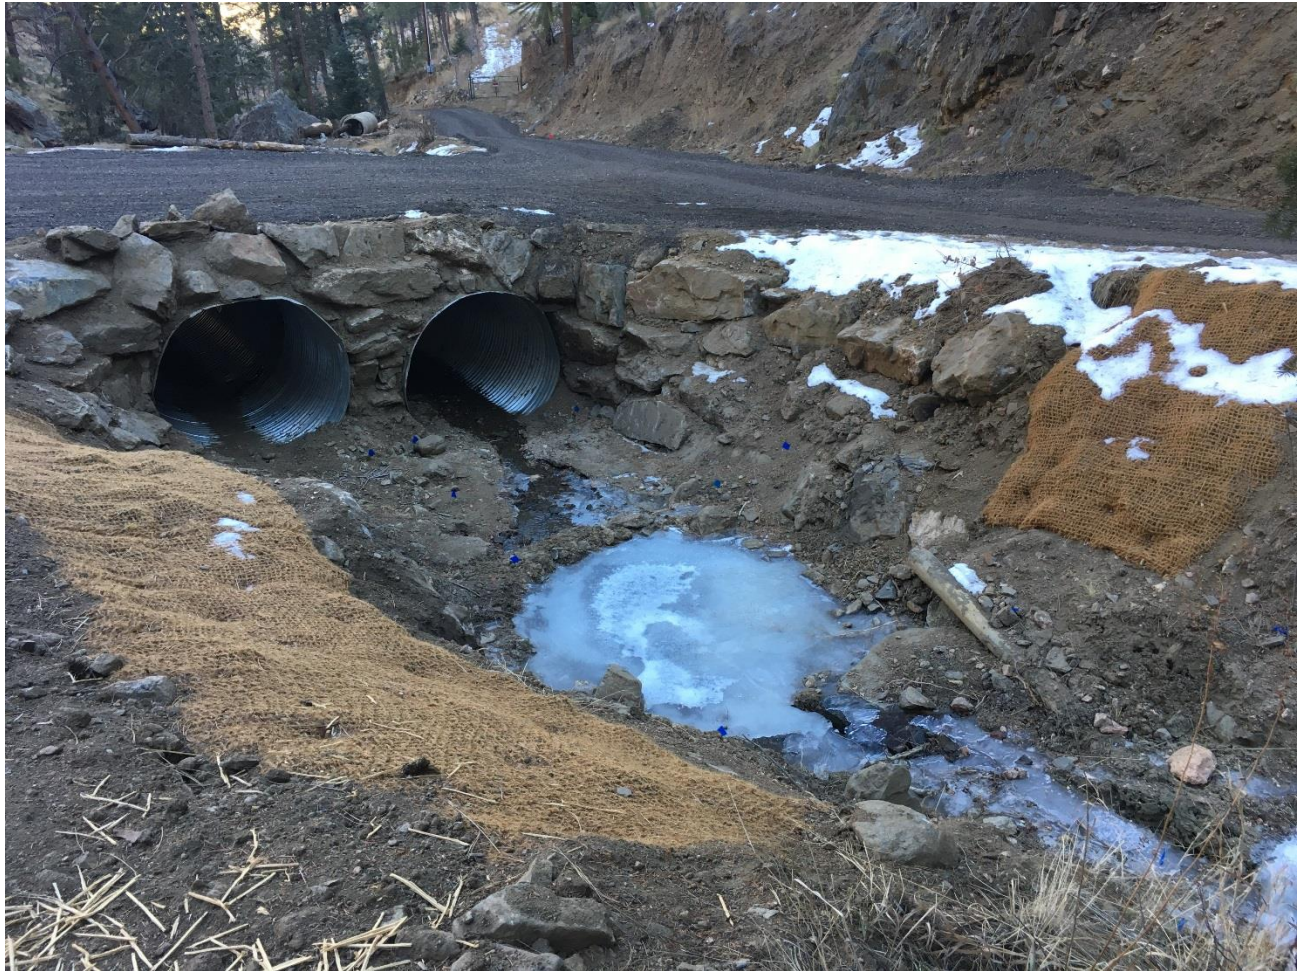
**Photo 3.** View Downstream Middle Culverts and Rock walls

**Problem Area #3:** This second road crossing involves a large amount of fill. There are two culverts, 36" and 30", that could potentially convey 90 cfs before the roadway is overtopped. The 30" CMP is buried somewhere within the crossing, whose outlet is still visible on the downstream side of this crossing. At flows above 90 cfs, these culverts and the roadway would be overtopped with water flooding over the road. These culverts are not sufficient, undersized, and also partially clogged. The existing culverts currently convey less than the calculated 90 cfs combined before the roadway will be overtopped. This configuration could result in up to 150 TNs of sediment being transported downstream with a failure of these culverts. It is likely that the existing culverts and roadway fill will experience partial failure with a discharge of greater than 150 cfs. This problem area is located at Station 1+90 to 2+50 on the existing Longitudinal Profile.

**Work Completed to Address Problem Area #3:** All existing culverts were removed and replaced with two 72" culverts (**Photo 3**). Hand stacked rock protection was installed on both the upstream and downstream faces of the embankment around the culverts. Additionally, on the upstream streambank walls, stacked boulder walls were installed to protect the inlet to the culvert pipes and driveway width. Bedrock was encountered during the excavation of the existing culverts resulting in an inability to install the new culvert pipes to the designed depth. In an effort to stabilize this downstream section,

the following prescription was adapted. Immediately downstream of the culverts, a fifteen-foot constructed reinforced rock ramp was installed to the width of the culvert egress. Willow cuttings as well as wetland plugs were placed within the rock ramp. Right and left banks were stabilized with stacked rock walls immediately adjacent to the egress. Stone toe was placed on both banks for approximately 30', along with coir matting, seed, container plantings, and willow stakes (**Photo 4**). Downstream of the rock ramp, a rock vane was installed. The throat width of the vane was set to match the width of both culverts combined. The arms of the vane also were installed from valley wall to valley wall. The resulting structure will serve to greatly reduce head cutting in the stream channel, provide a preferred drop in elevation, as well as serve to protect both the constructed streambanks and upstream valley walls. At station 2+40 and 2+50, two rock sills were installed to prevent head cutting upstream to the crossvane, as well as to provide an opportunity for aggradation within the stream channel, reducing the immediate chance of silt moving downstream during the first runoff flows post construction.

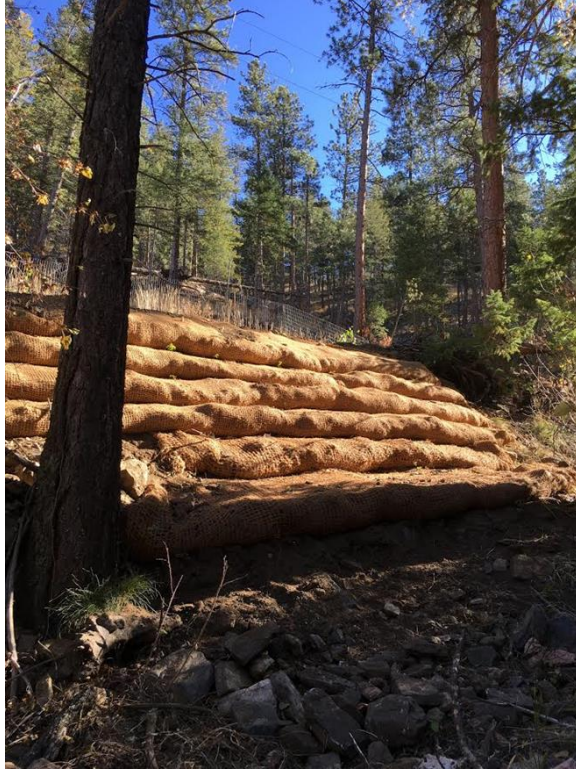
**Photo 5.** View Upstream Station 4+00 Vegetated Soil lifts

**Problem Area #4:** Area #4 is defined along the channel profile stations 4+00 through 5+00. The existing driveway access runs parallel to the stream channel through this reach. The channel shows signs that it has recovered and revegetated since flooding, however the road embankment shows evidence of high erodibility potential.

**Work Completed to Address Problem Area #4:** Vegetated soil lifts were installed to address the bank hazard in two areas along the road embankment, where sparse vegetation, steep slopes, and poor soil dominated (**Photos 5 & 6**). Tree enhancement was performed throughout the reach as well to help vegetative reestablishment.

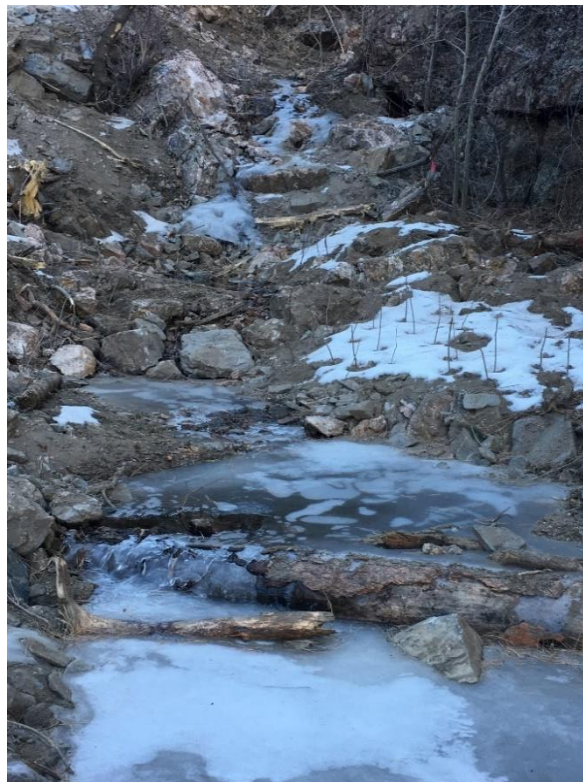
**Photo 7.** View Upstream Station 7+00

**Problem Area #6:** Three check dams and small undersized sediment basins are constructed with check dams above the profile of the existing reach slope. This configuration could result in up to 45 TNs of sediment being transports downstream with a failure of the check dams. It is likely that the check dams will see partial failure with a discharge of greater than 200 cfs. This problem area is located at Station 6+00 to 7+25 on the existing Longitudinal Profile.

**Work Completed to Address Problem Area #6:** At station 6+00 a bedrock outcrop was jack hammered and removed to reduce horizontal scour on the right bank as well as providing additional channel capacity. The excavated rock was used to build a constructed rock ramp. The rock ramp served as a steep vertical drop stabilization measure that was then supported by a constructed rock cross vane. Additional grade control structures were added moving further downstream to reduce headcutting potential. Three log drops, a crossvane, and a step pool sequence completed the reach providing proper grade drop to the downstream culvert, as well as reinforcing the newly constructed stream bed (**Photos 7 & 8**).

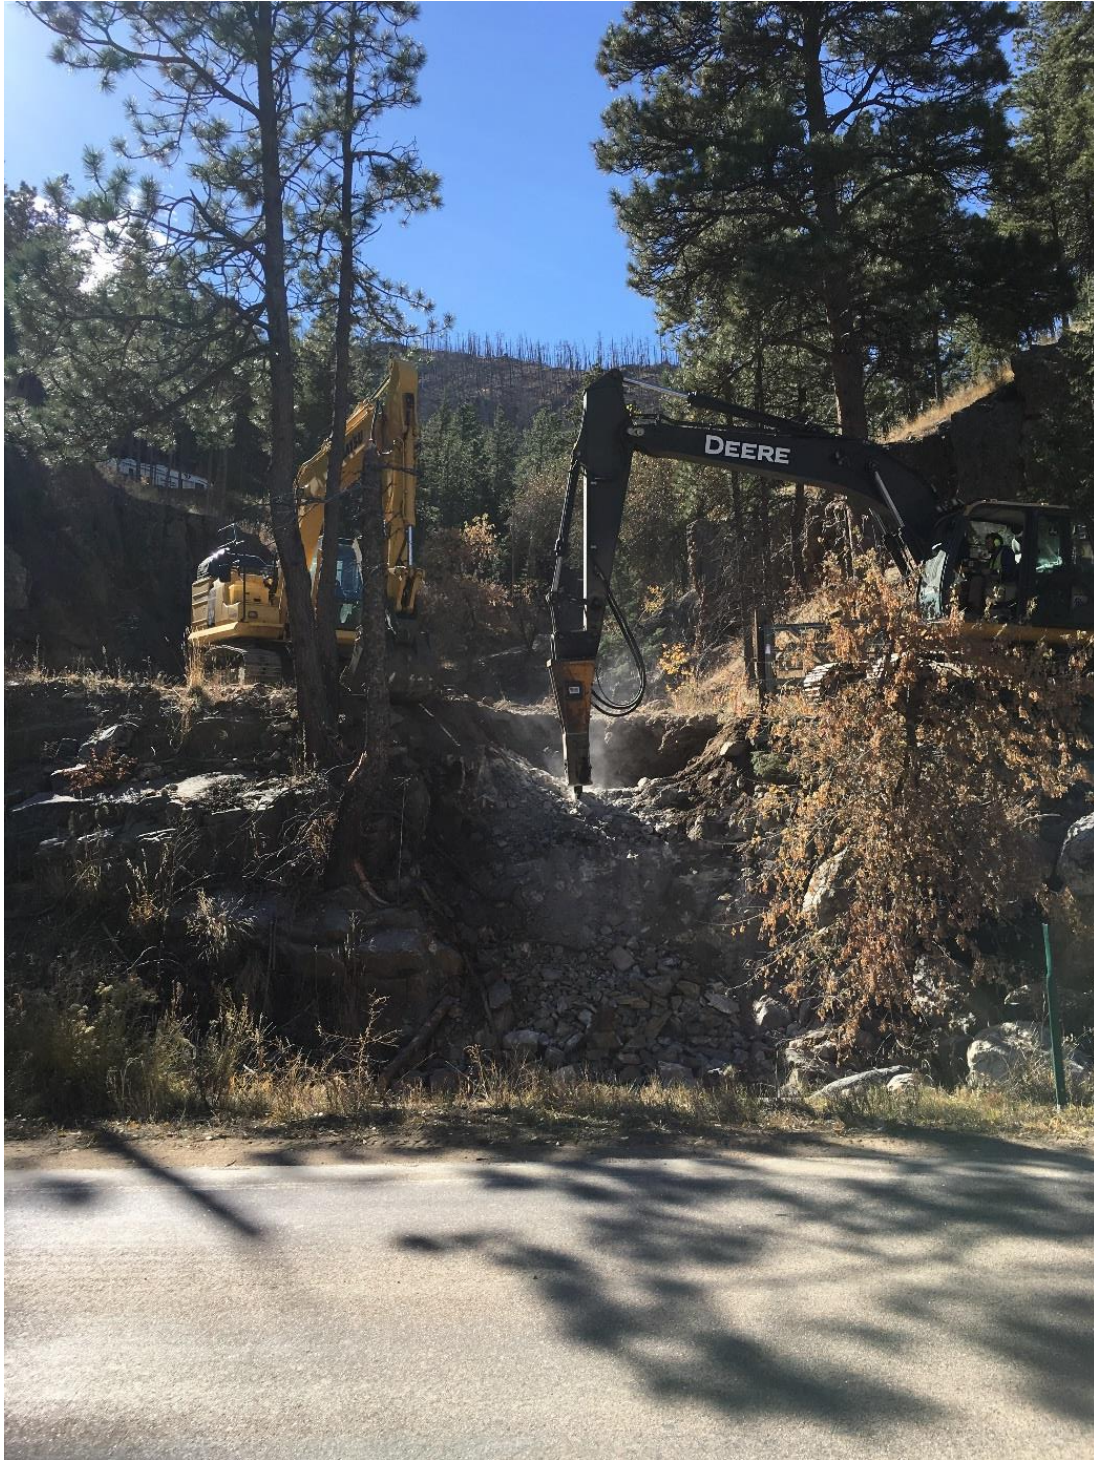
**Photo 9.** View Upstream Station 8+00 Jack hammering

**Problem Area #7:** The undersized and partially clogged culverts currently convey less than 18 cfs before the roadway will be overtopped. This configuration could result in up to 20 TNs of sediment being transported downstream with a failure of these culverts. It is likely that the existing culverts and roadway fill will see partial failure with a discharge of greater than 100 cfs. This problem area is located at Station 8+40 to 8+65 on the existing Longitudinal Profile. Currently, low flow from the main channel is shunted at an angle into a 30" corrugated metal pipe culvert under the roadway.

**Work Completed to Address Problem Area #7:** Jack hammering was required to excavate bed rock throughout this reach to install a 60" culvert (**Photos 9 & 10**). The rock that was excavated in this area was used throughout problem area 4. The upstream side of the culvert was protected with hand stacked boulder walls. The downstream side of the culvert was stabilized with rock that was excavated during the cutting process.
