Centennial & Sun Cup Mine Restoration Project CLOSEOUT REPORT

COLORADO
Division of Reclamation,
Mining and Safety
Department of Natural Resources

Prepared by Camille Price, February 2017

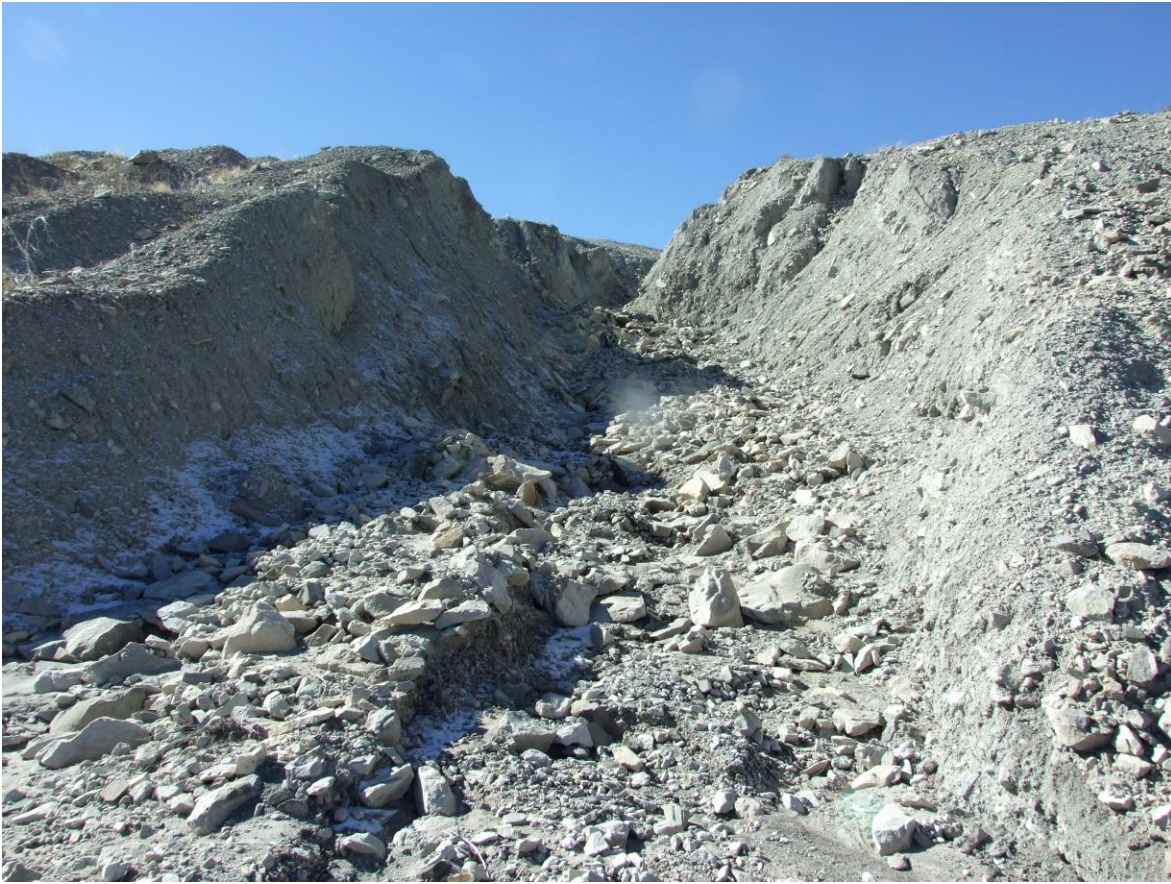
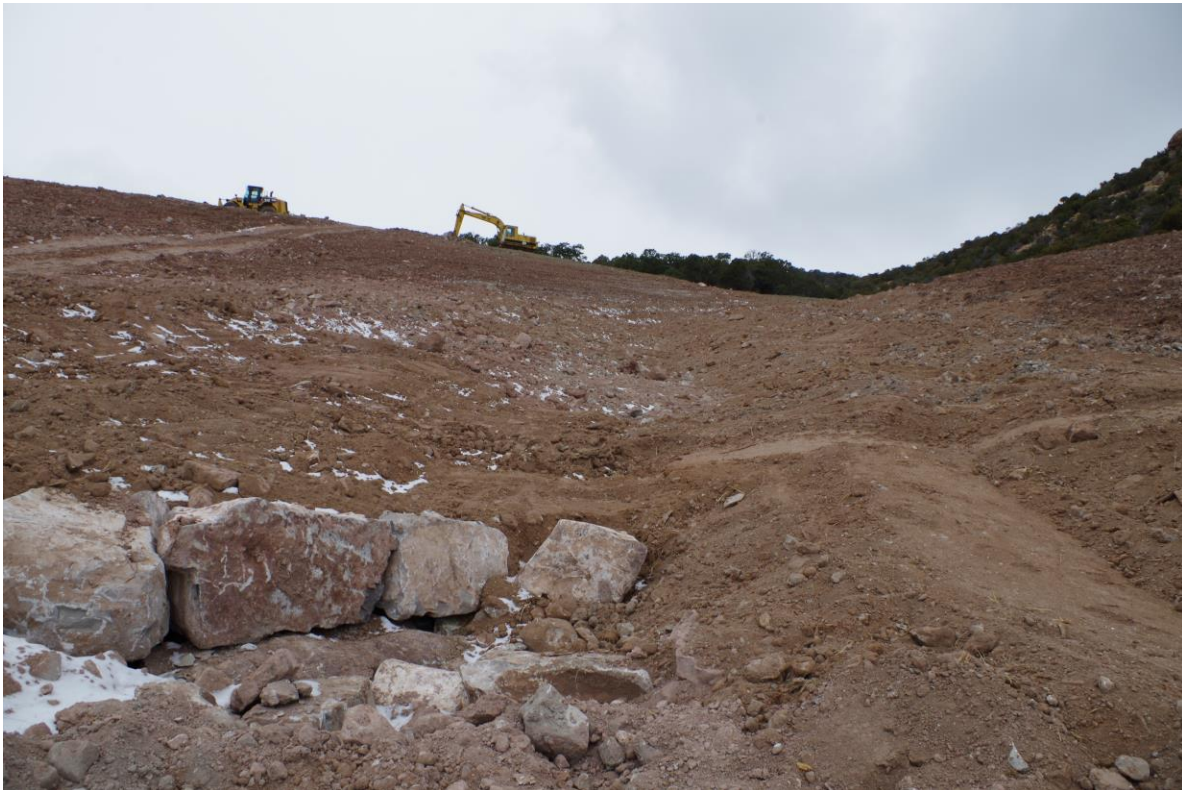
Centennial Drainage Channel Before and After

Approximately 36,000 cubic yards of uranium waste rock material was relocated to restore the Centennial Mine ephemeral drainage channel and create stable slopes no steeper than 3H:1V. Excavation of waste rock was conducted to provide the finished channel profiles, elevations, grades, sinuosity, and construction of scour pools and sediment basins.

The restored three-staged drainage channel, measures approximately 700 linear feet long by 55 feet wide. The three stages consist of the “water’s edge”, “bank-full” and floodplain terraces. The “water’s edge” terrace was over-excavated by three feet and back filled with non-radioactive “Angular Compacted Material” salvaged from the site. Seven grade control structures were constructed of large boulders salvaged from the immediate vicinity. A rock-reinforced sediment detention basin was constructed at the terminus of the restored channel.

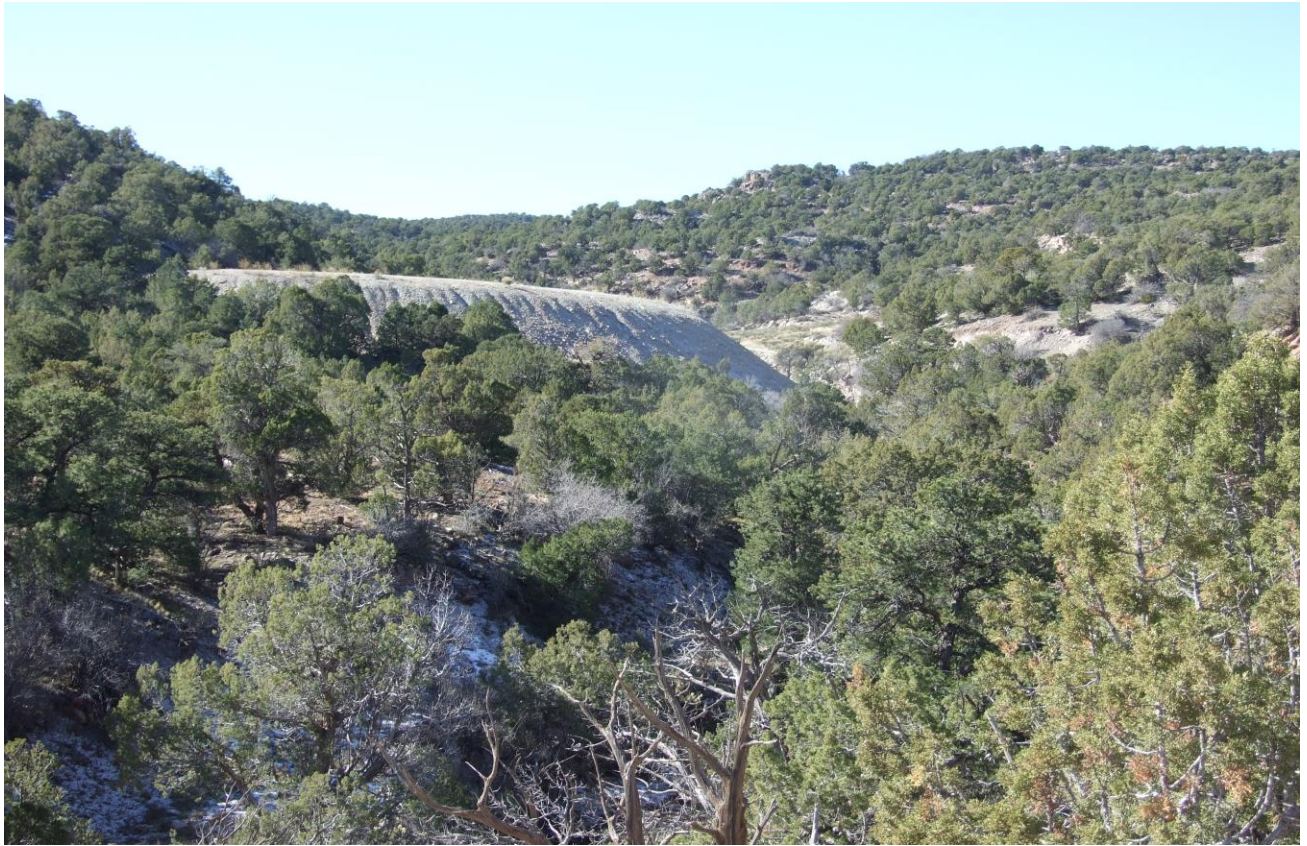
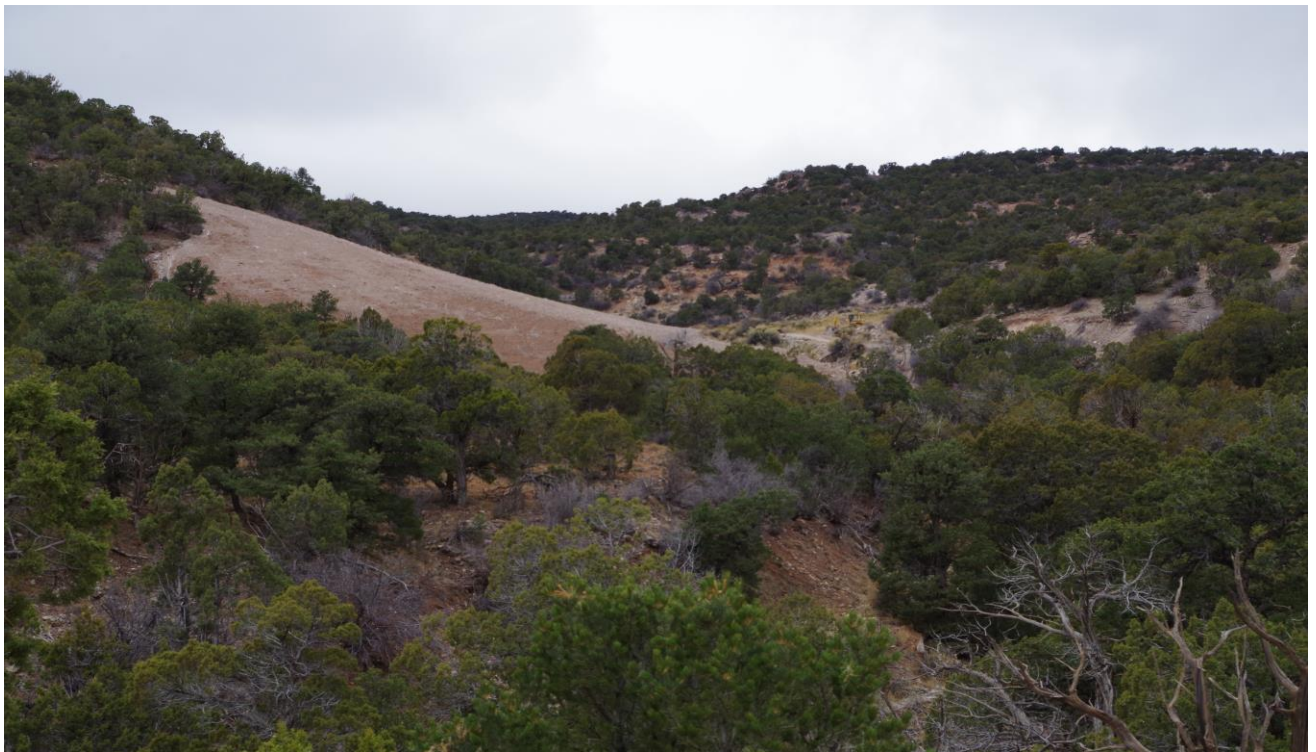
Sun Cup Profile Before and After

The north facing toe of the Sun Cup Mine Waste Rock Pile East was relocated approximately 20 feet away from the adjacent ephemeral drainage channel, leaving it at a slope no steeper than 3H:1V. Approximately 15,500 cubic yards of material was relocated away from the stream channel.

Approximately 3,900 cu. yds. of the excavated material was placed on the east facing slope to create compacted fill slopes no steeper than 3H:1V. Prior to placing the fill, the existing surface of the east facing slope was scarified using dozer-mounted rippers to provide a roughened and un-compacted surface to minimize a slip plane and subsequent sloughing of the new fill. The remaining 11,600 cu. yds. of the excavated material was placed on the top surface of the Sun Cup Mine Waste Rock Pile East, blending into the hillside above it.
