RE: Swan River Restoration Project: Year Four Monitoring Report (SPK-2015-00780)

## Monitoring Report-Swan River Restoration Project Summit County, Colorado 2020 Year Four Monitoring

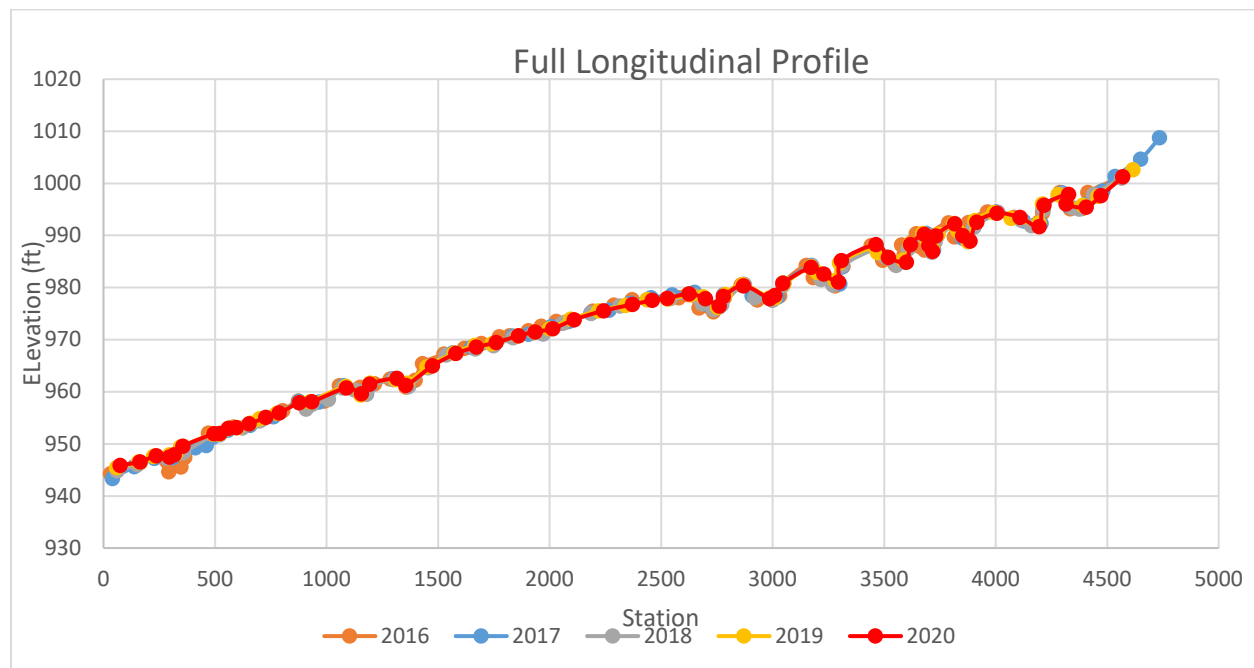
**Graph 1. Longitudinal Profile of Full Restoration Reach**

The numeric results indicate that on average there is very little change from year to year in the profile. The largest variations that have occurred from 2016 to 2020 are at Stations 16+50 (0.6-foot increase), 20+75 (0.4-foot increase), and 42+95 (0.4-foot decrease). All other points were within +/- 0.3 feet from the as-built condition. The magnitude of all changes is small, particularly given the limits of accuracy when surveying on cobble sized material. Any changes are very minor and indicate that the channel profile has remained stable.

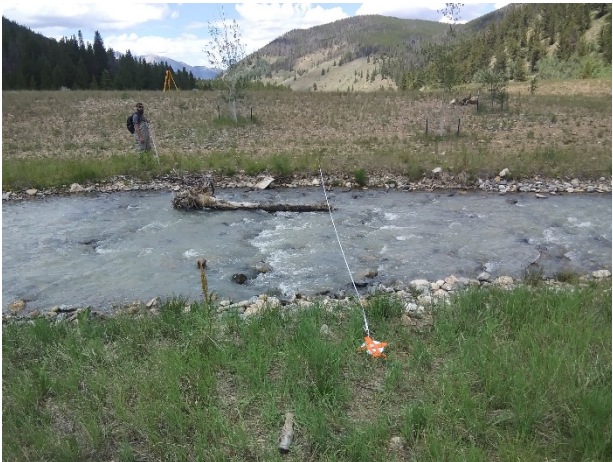
**Photo 1.** View from the right bank looking west towards the left bank at Cross Section 1 (XS-1). July 2020.

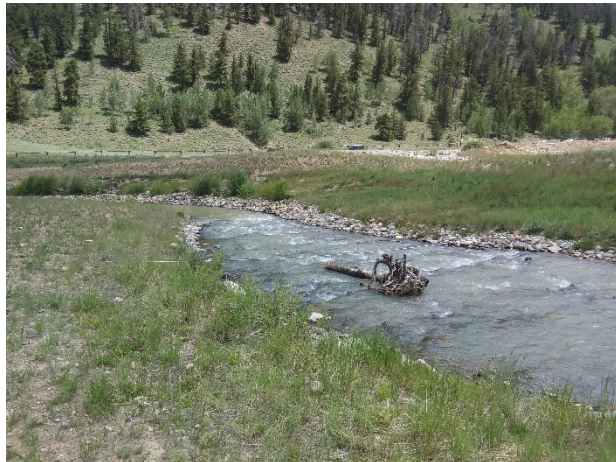
**Photo 2.** View looking downstream from the left bank at XS-1. Aug 2019

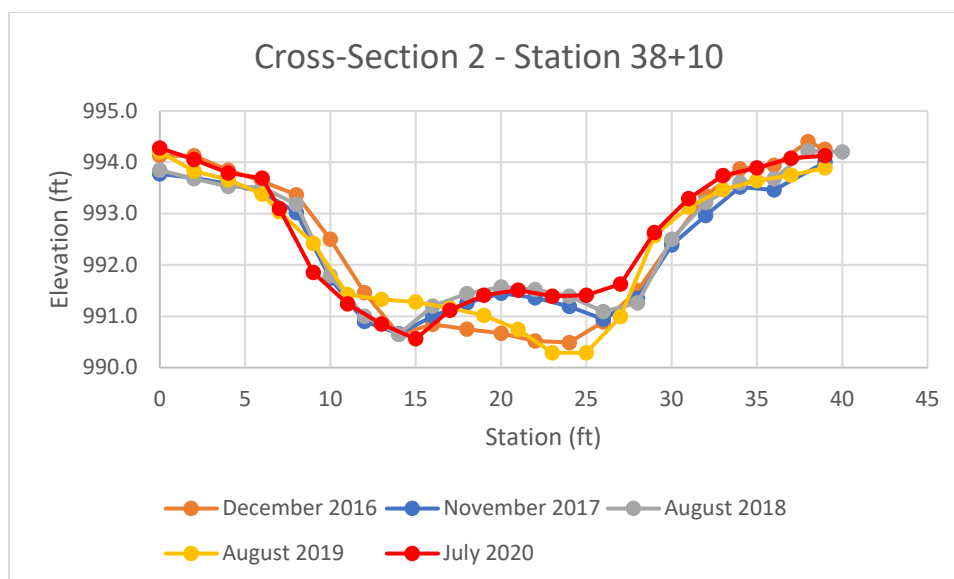
**Graph 6. Cross Section 2 Survey**

- Cross Section 2 had aggraded a maximum of about 0.9 feet from 2016 to 2018. Following the higher flows of 2019-2020, the cross section scoured minor amounts reverting back to approximately the as-built conditions. The location of the thalweg in Cross Section 2 moved away from the right bank towards the left bank of the channel.

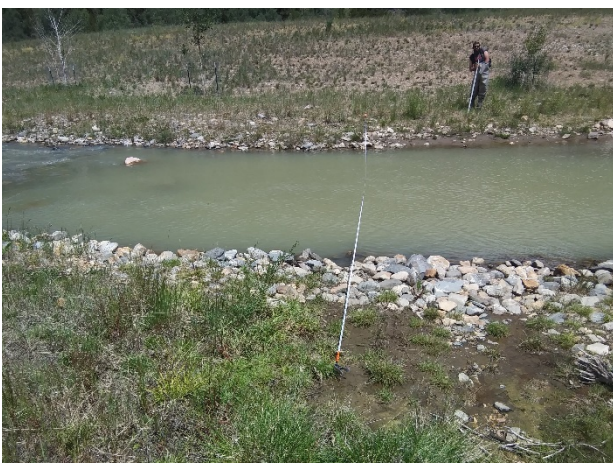
**Photo 3.** View from the left bank looking north towards the right bank at Cross Section 2 (XS-2). July 2020

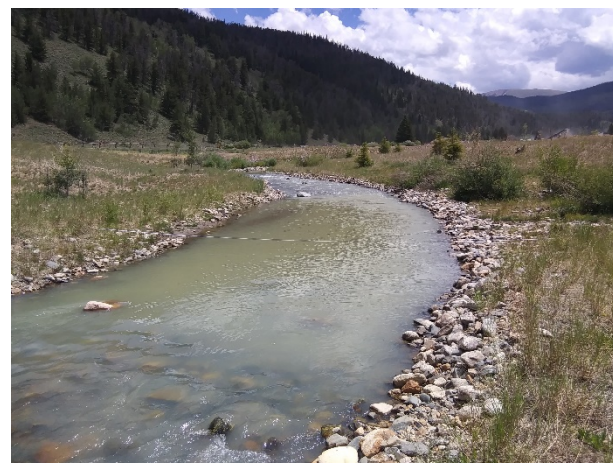
**Photo 4.** View looking upstream from the left bank at XS-2. July 2020.

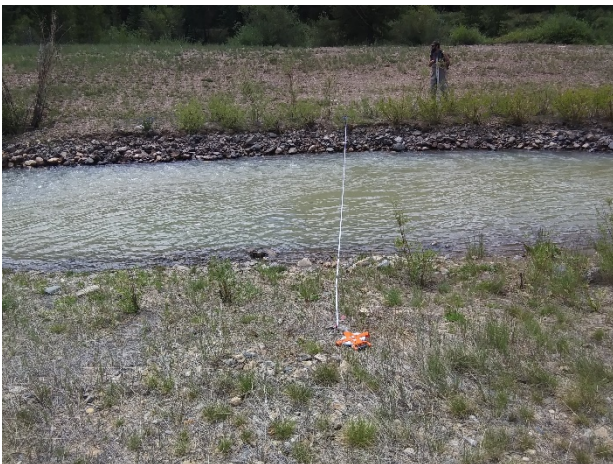
**Photo 5.** View from the right bank looking south towards the left bank at Cross Section 3 (XS-3). Aug 2019

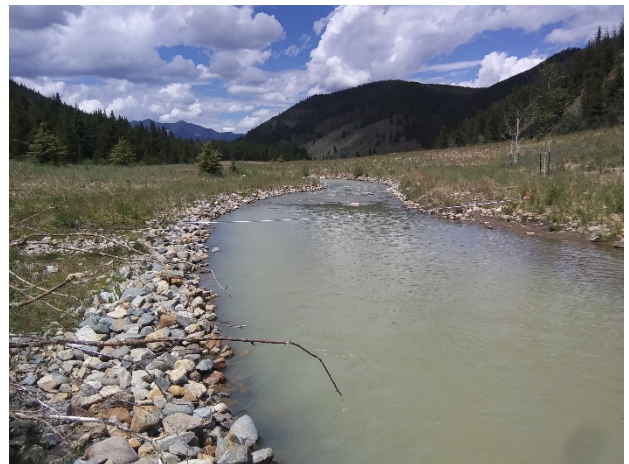
**Photo 6.** View looking downstream from the left bank at XS-3. Aug 2019

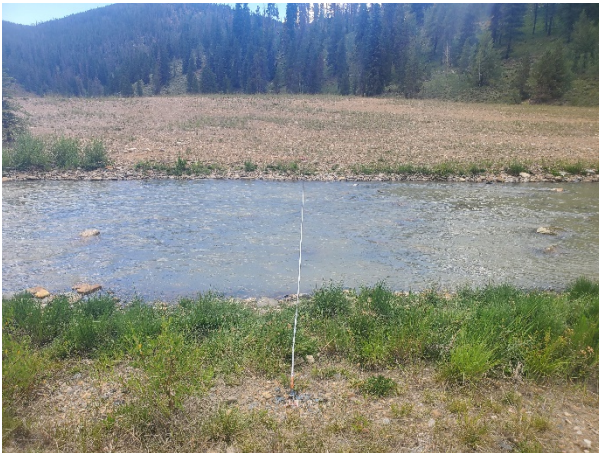
**Photo 7.** View from the left bank looking north towards the right bank at Cross Section 4 (XS-4). July 2020

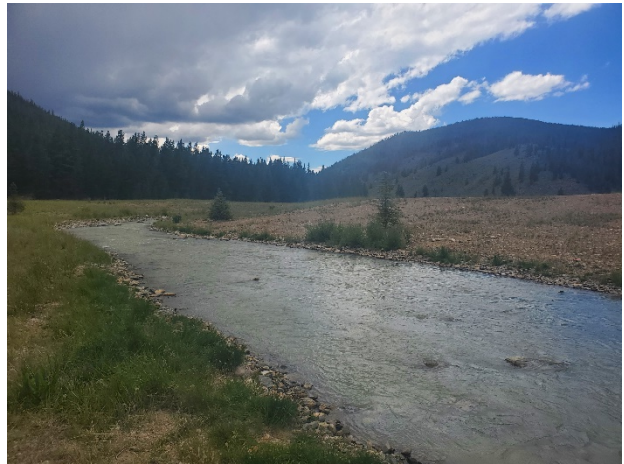
**Photo 8.** View looking upstream from the left bank at XS-4. July 2020

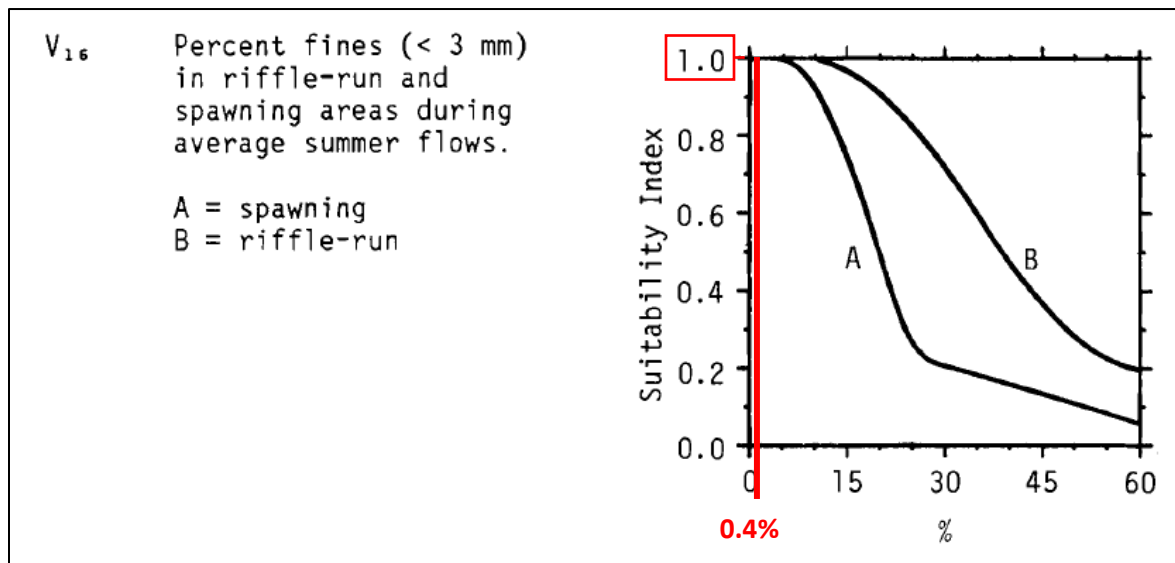
**Figure 1. Sediment Transport and Substrate Conditions - Percent Fines in Riffle- runs (HSI V<sub>16</sub>)**

Based on gradations, substrate material at all locations classifies as well graded coarse-grained gravel. Minimal fines observed result in a high HSI score of 1, which indicates that from a sediment standpoint the riffle sections are fully functional (See **Figure 1** below). A comparison of gradations from the pebble count show a slight trend of having slightly less coarse material at the surface in 2020 than in 2019. This minor change could be the result of some coarser material being transported out of the reach during the return to more normal flows of 2020.

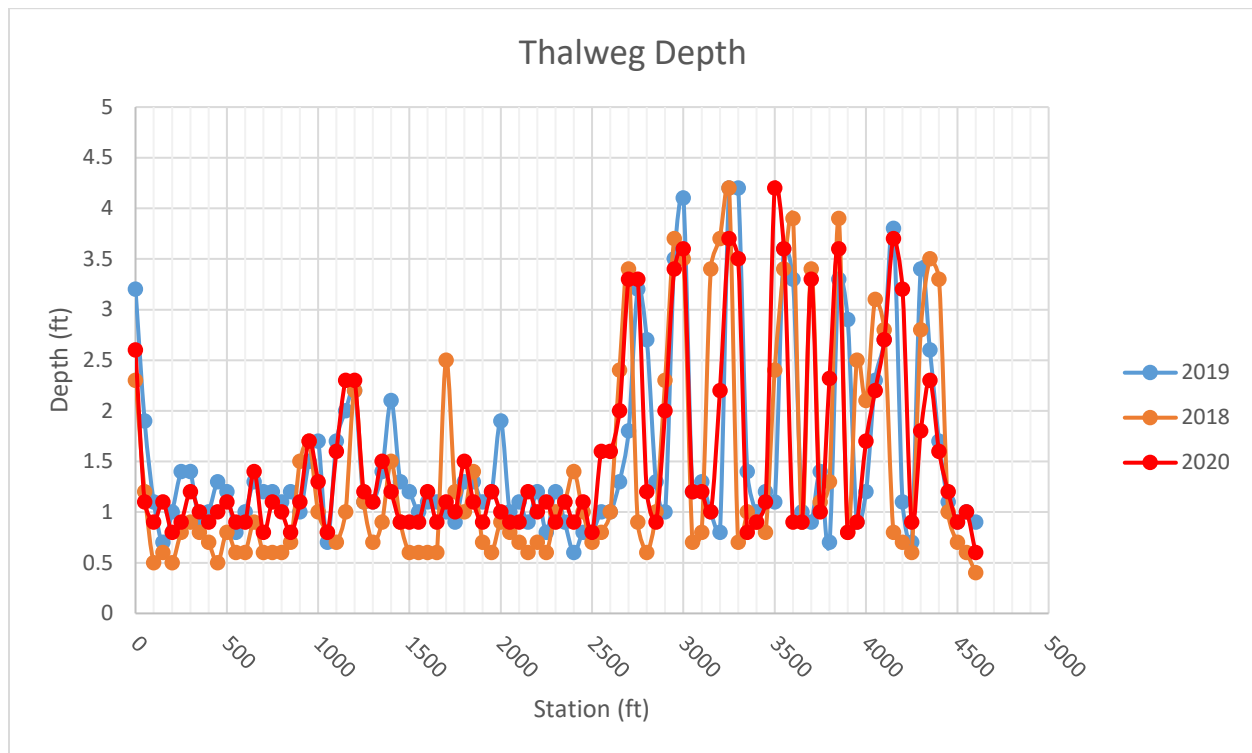
**Graph 13. Thalweg Depth Along Restored Reach**

The consistency in depths following the high flows of 2019 are another indication of overall channel stability.

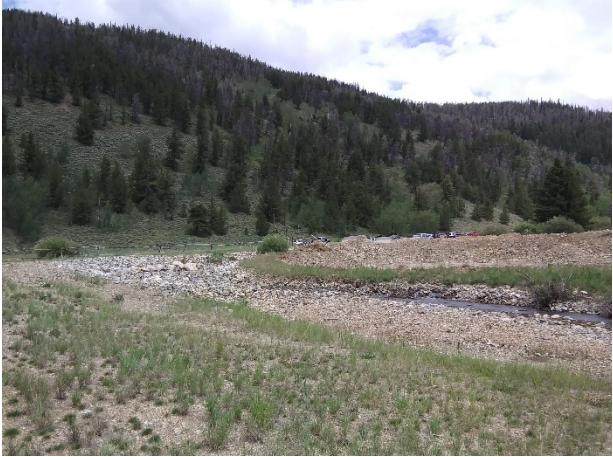
**Photo 9.** View of upstream end of channel from right bank looking northeast

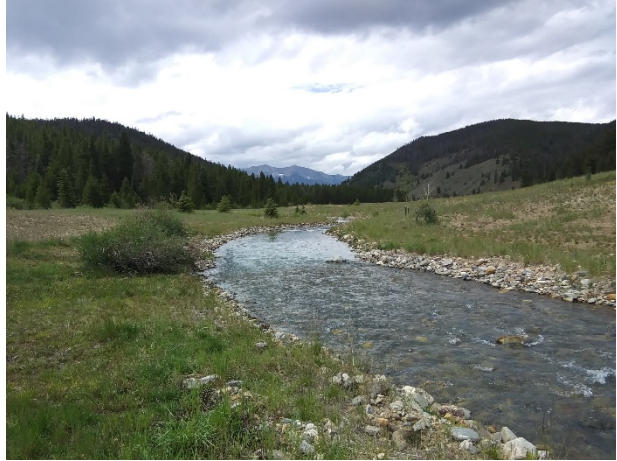
**Photo 10.** View of channel looking west from the left bank at approximately Station 39+05.

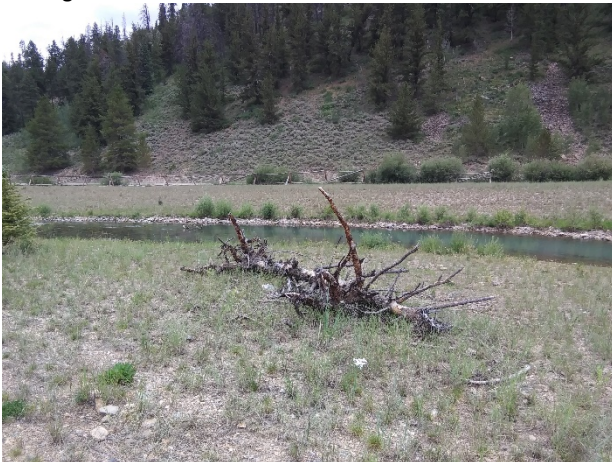
**Photo 11.** View of channel looking north from the left bank at approximately Station 34+00.

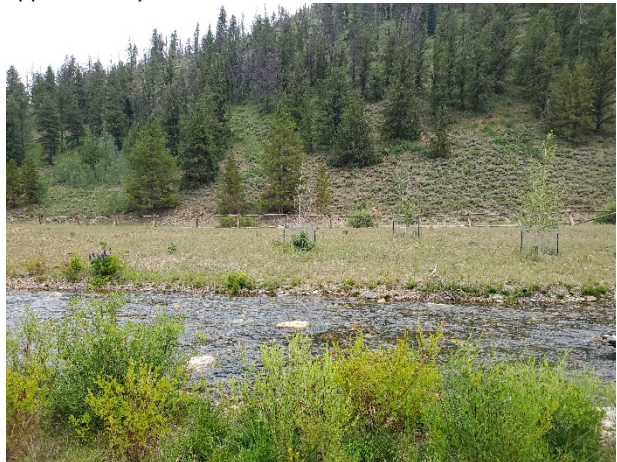
**Photo 12.** View of channel looking north from the left bank at approximately Station 25+00.

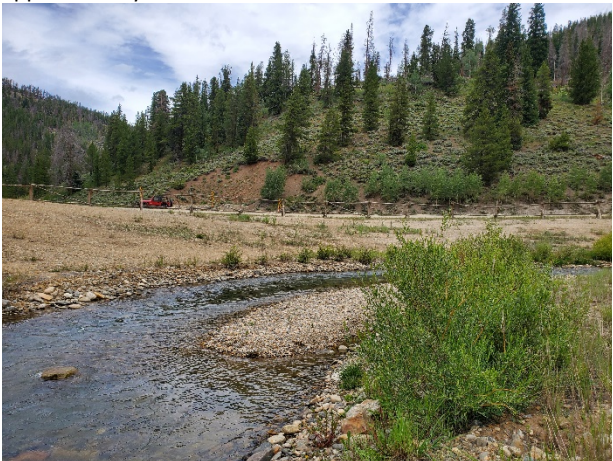
**Photo 13.** View of channel looking northeast from the left bank at approximately Station 13+00.

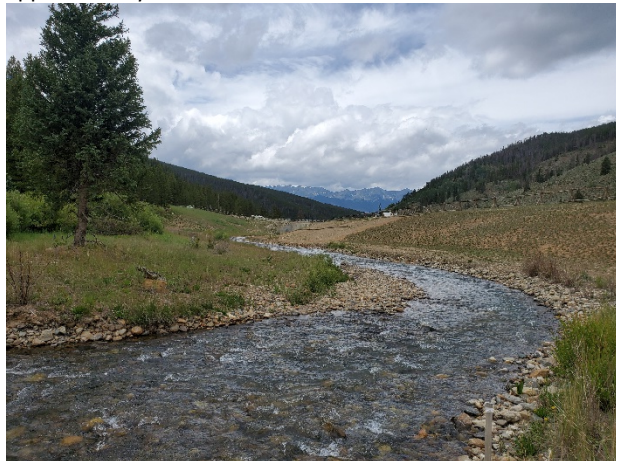
**Photo 14.** View of channel looking west from the right bank at approximately Station 10+50.

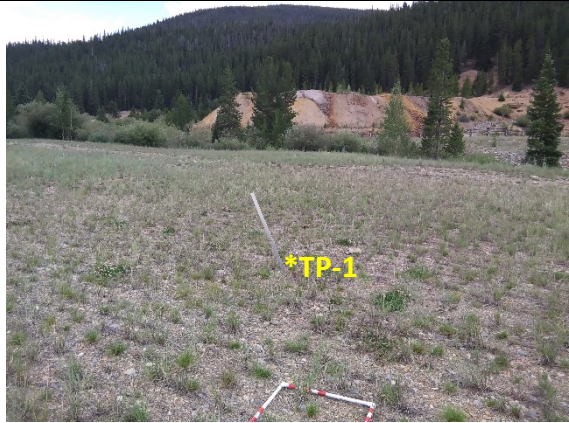
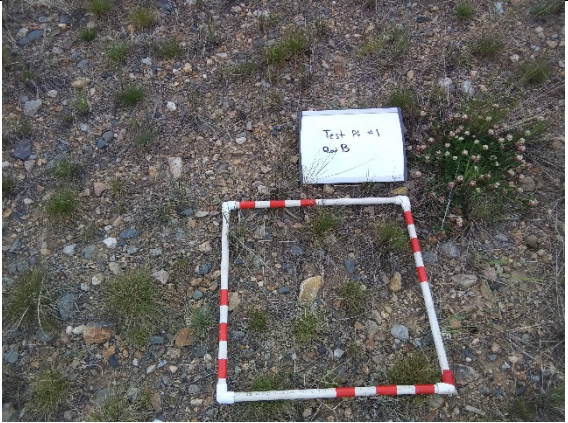
| UPLAND HERBACEOUS VEGETATION COMMUNITY ASSESSMENT | | | | | | |
|---|---|---|---|---|---|---|
| <b>General Comments:</b><br>Identified species appear to be in good health. Vegetation is robust and exhibits reproductive structures on most species within the quadrat, indicating that it has undergone a full growth cycle for three growing seasons (2018-2020). | | | | | | |

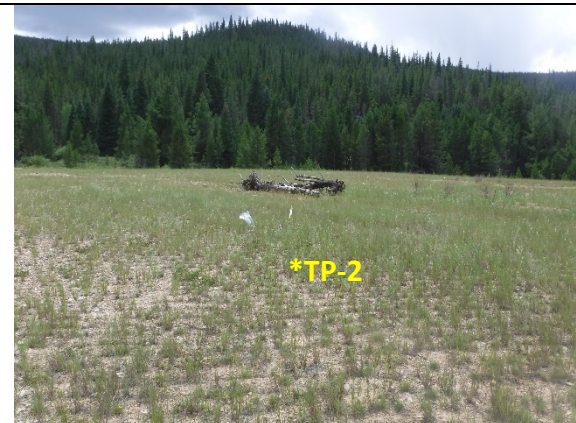
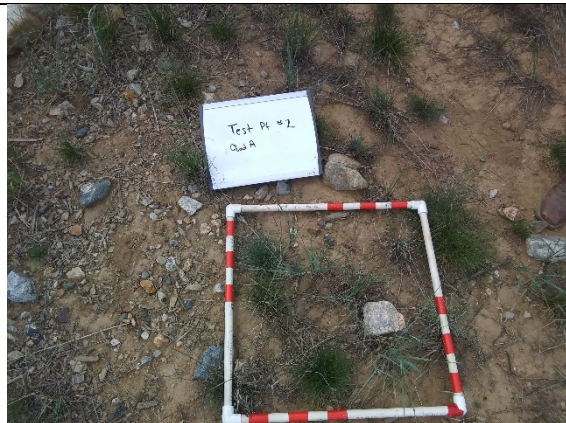
| UPLAND HERBACEOUS VEGETATION COMMUNITY ASSESSMENT | | | | | | | |
|---|---|---|---|---|---|---|---|
| <b>General Comments:</b><br>Identified species appear to be in good health. Vegetation is robust and exhibits reproductive structures on most species within the quadrat, indicating that it has undergone a full growth cycle for two full growing seasons (2018-2020). Scentless chamomile ( <i>Matricaria perforata</i> ) is present at the test point location in sparse areas, mainly existing as individual plants at less than 1% cover of the 20' radius of the test point. Scentless chamomile is listed in the State of Colorado as a List B noxious weed species. Red clover ( <i>Trifolium pratense</i> ) was also identified at the test point location which was present in isolated clumps but appeared to exhibit excellent health and vigor. | | | | | | | |

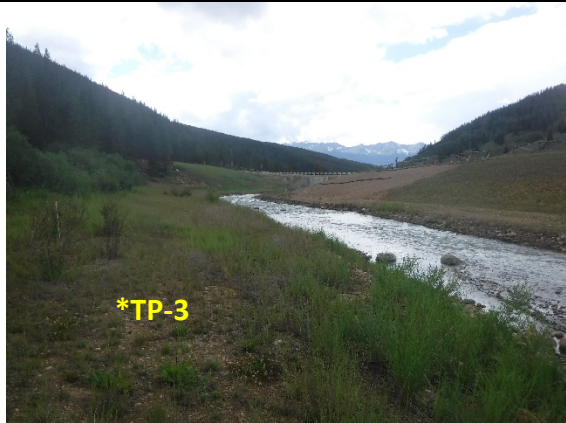
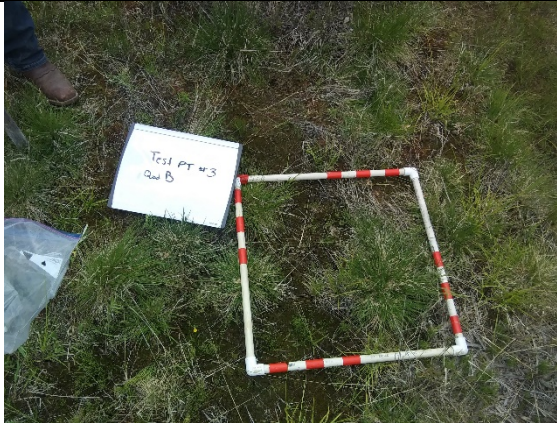
| UPLAND HERBACEOUS VEGETATION COMMUNITY ASSESSMENT | | | | | | |
|---|---|---|---|---|---|---|
| <b>General Comments:</b><br>Identified species appear to be in excellent health. Vegetation is robust and exhibits reproductive structures on most species within the quadrat. Soil development appears to be good with the most root mass and organic material observed at any test point location. The location within a riparian area adjacent to the stream channel likely promotes moisture retention which improves the health and vigor of vegetation species. Some areas around the test point location are beginning to exhibit a moss-like ground cover. | | | | | | |

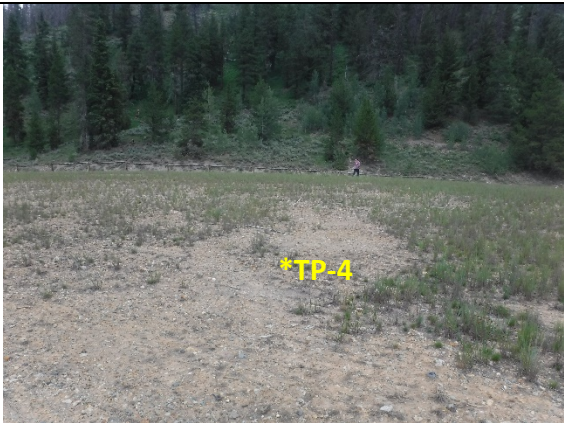
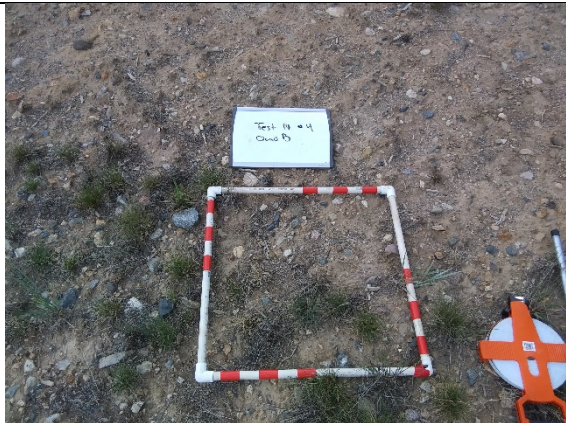
| UPLAND HERBACEOUS VEGETATION COMMUNITY ASSESSMENT | | | | | | |
|---|---|---|---|---|---|---|
| <b>General Comments:</b><br>Identified species appear to be in good health. Vegetation is robust and exhibits reproductive structures on most species within the quadrat, indicating that it has undergone a full growth cycle for two full growing seasons. No weedy species, erosion potential, or other concerns observed. Overall vegetation establishment appears to be slow at this particular test point location and continued watering is recommended for the remainder of the 2020 and the 2021 growing season. | | | | | | |
