RE: CWCB Grant – St. Vrain Creek Coalition Monitoring & Outreach grant final report

## Memo – Annual Inspection Report

## Annual Inspection Report

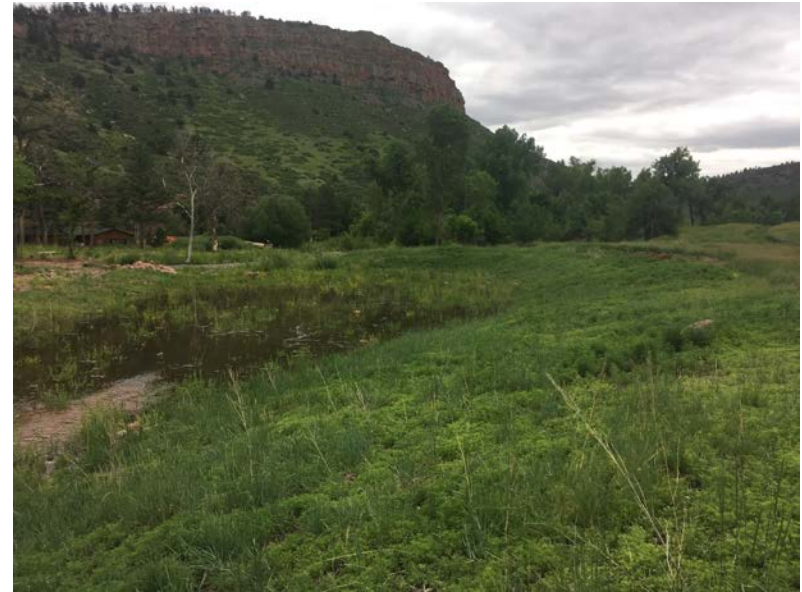
1. Areas of Concern
  - Upstream overflow overrun with Kochia, likely from imported topsoil. Warranty addressed, but issue needs additional work.
2. Areas of Success
  - Overall good cover and willow recruitment

1. Areas of Concern
  - Weeds and Kochia in transition zone, hand pulled in June 2019.
2. Areas of Success
  - Overall good cover

Kochia on bank of overflow, AVN, 6/20/2019

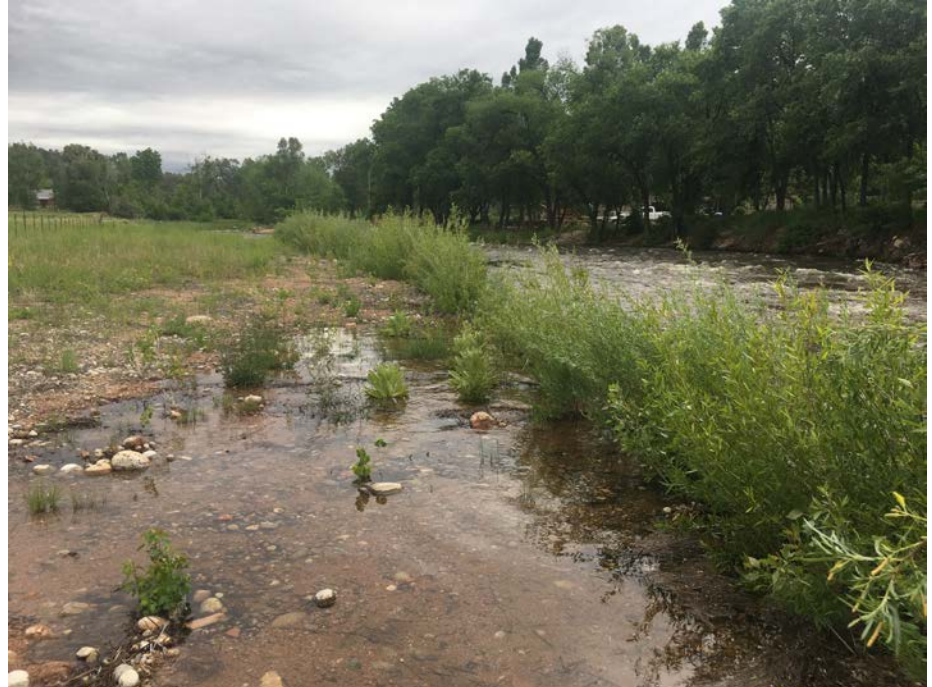
1. Areas of Concern
  - Major Kochia infestation in top soil areas
2. Areas of Success
  - Overall good cover

Upland/seeded areas downstream end of reach, AVN,  
6/20/2019

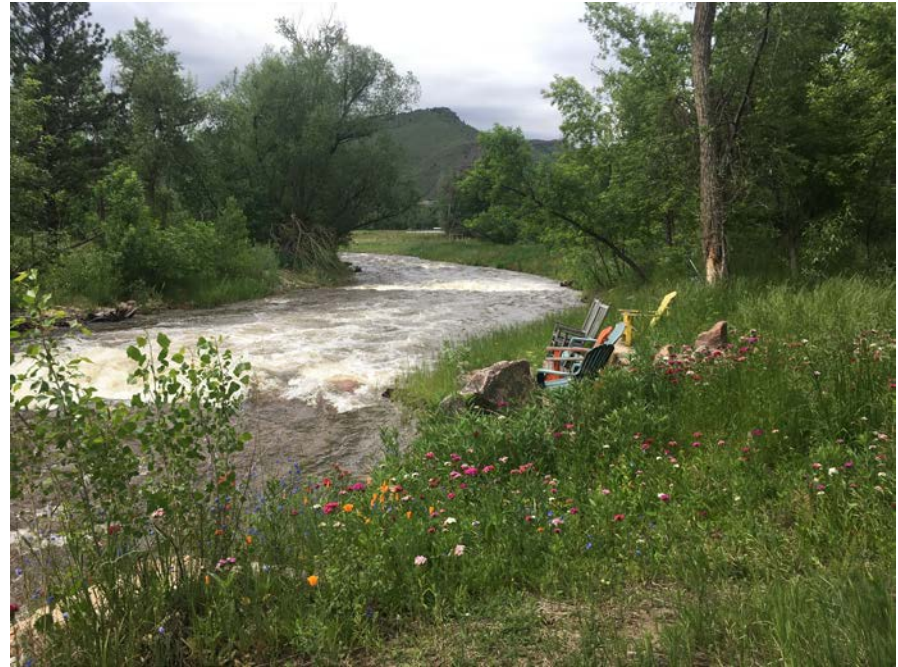
1. Areas of Concern
  - No notable areas of concern
2. Areas of Success
  - Structures maintaining form and function

Pools at Rooney property, ANV, 6/20/2019

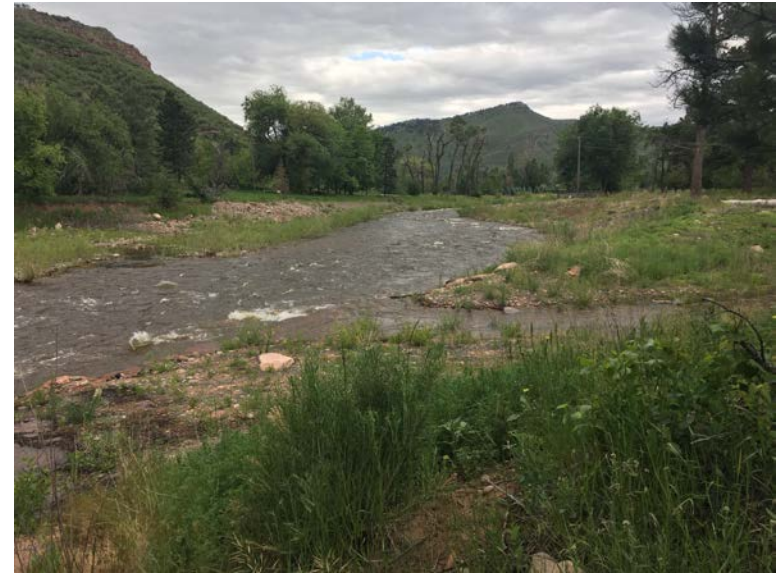
Upstream end of reach/overflow, AVN,  
6/20/2019

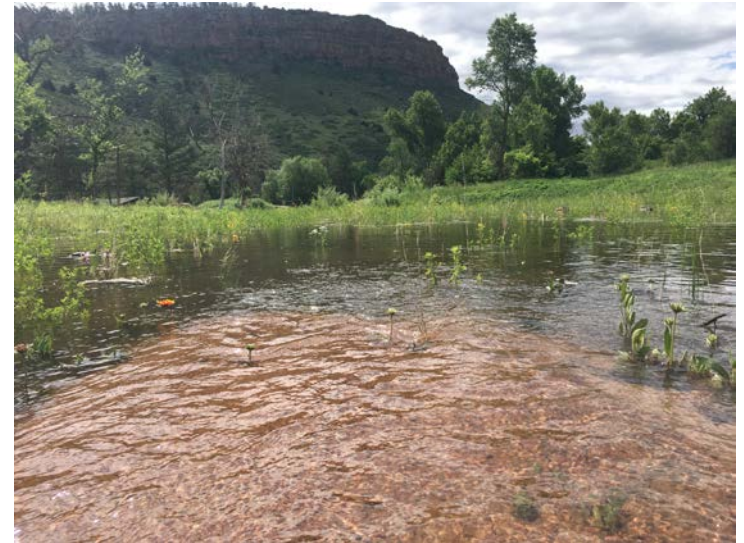
- a. *Sedimentation in the outflow of the overflow channel may cause bankfull widening. No cause for immediate concern.*
8. Has any Large Woody Material become dislodged? Has any Large Woody Material lost its backfill?

1. Areas of Concern
  - Sedimentation occurring in overflow channel, no cause for immediate concern
2. Areas of Success
  - Sedimentation and debris occurring naturally

Sedimentation in downstream end of overflow, AVN, 6/20/2019

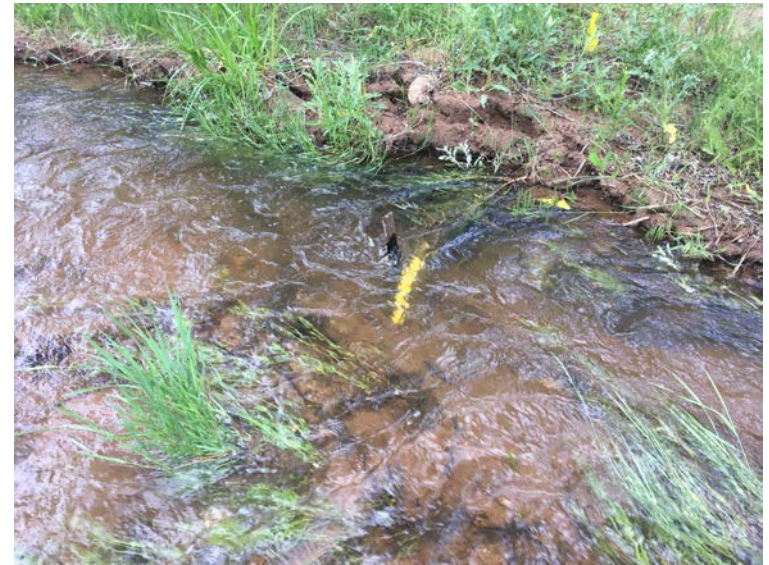
1. Areas of Concern
  - Gas pipeline exposed during high flows in overflow channel. We've contacted PG&E and they are working on scheduling a time to lower the pipe.
2. Areas of Success
  - Overall reach is in good condition aside from on-going weed issues.

Pipeline in overflow channel, AVN, 9/20/2019

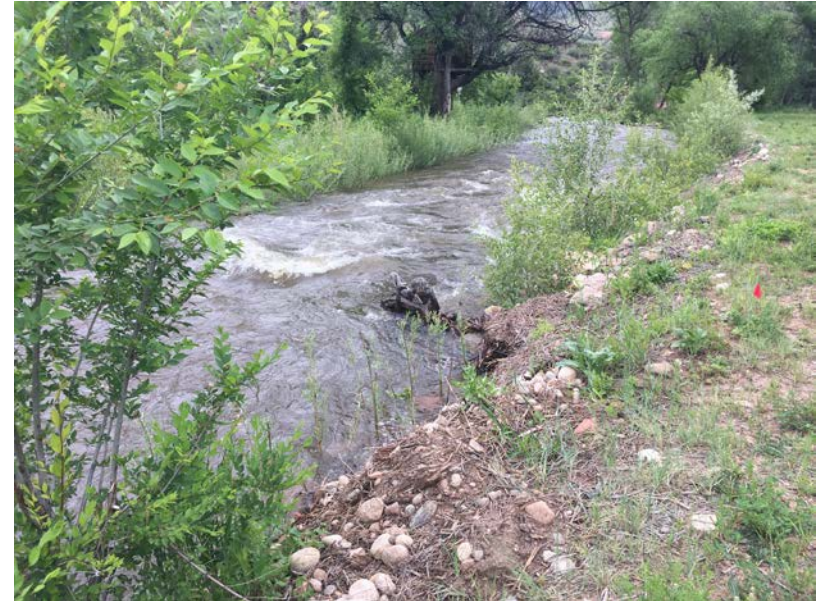
1. Areas of Concern
  - Low willow survivorship, replanted in April 2019
2. Areas of Success
  - High survival of willows after replanting

Willow stakes, mid reach AVS, 6/20/19

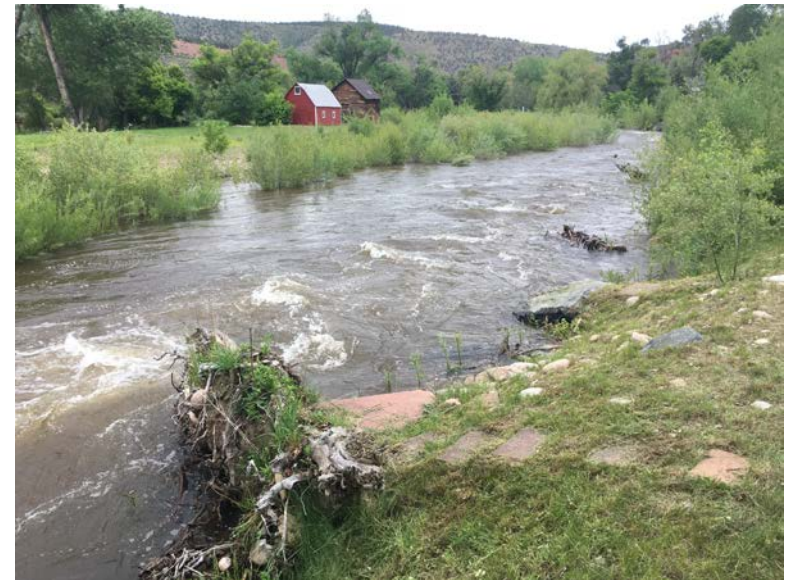
Mid reach AVS, 6/20/2019

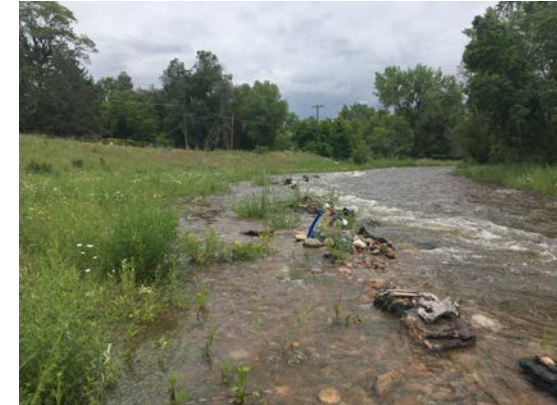
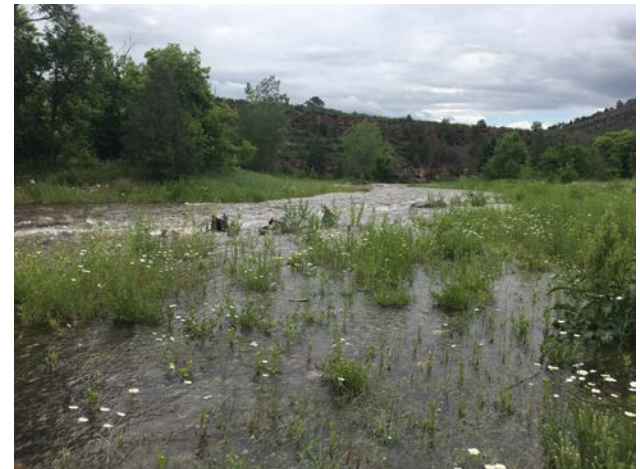
3. Is there any erosion that is threatening property, structures, or infrastructure?
  - a. *High flows inundating an area behind a large wood revetment in the upstream section of the project area at the Singer's property, but do not appear to be actively causing erosion. The revetment is designed to protect property and Apple Valley Road. We will continue to monitor to assess whether active erosion is occurring and connect with engineer as appropriate.*

1. Areas of Concern
  - Upstream large wood revetment submerged at high flow and running water in banks behind the wood toe
2. Areas of Success
  - Other structures maintaining form and function

Wood revetment at Singer's property, AVS,  
6/20/19

1. Areas of Concern
  - Upstream wood revetment may be diverting high flows towards Singer's home and Apple Valley Road
2. Areas of Success
  - Other floodplain wood causing no concern

- a. *Peak flows occurred between 6/12-6/22/2019 with the greatest discharge of 402 cfs on 6/12.*
10. Have you reviewed the monitoring and inspection data with the engineer of record?
  - a. *Our monitoring program is designed to identify potential triggers that may influence key stream functions. We recently identified a possible trigger with the wood revetment at high flow and will contact engineer of record.*

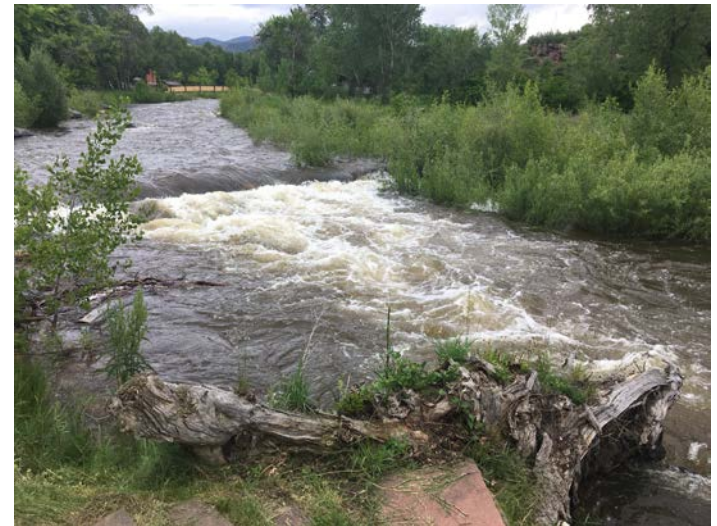
Instream wood downstream of King property, AVS, 6/20/19

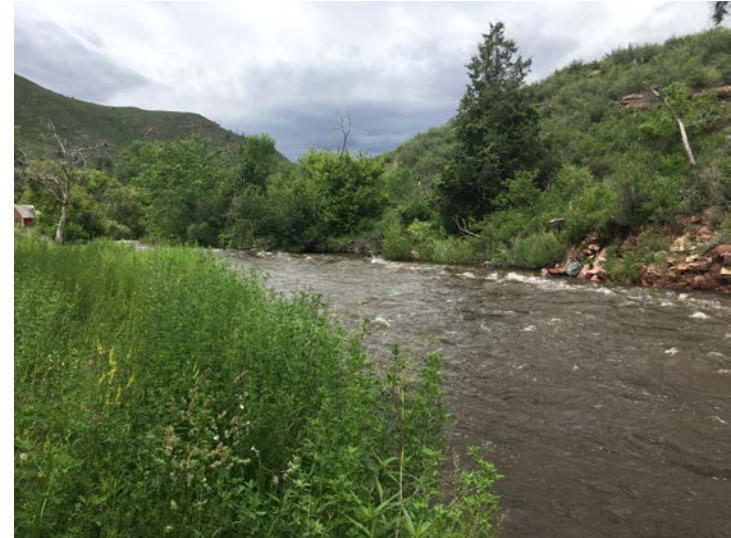
Downstream reach, AVS, 6/20/19

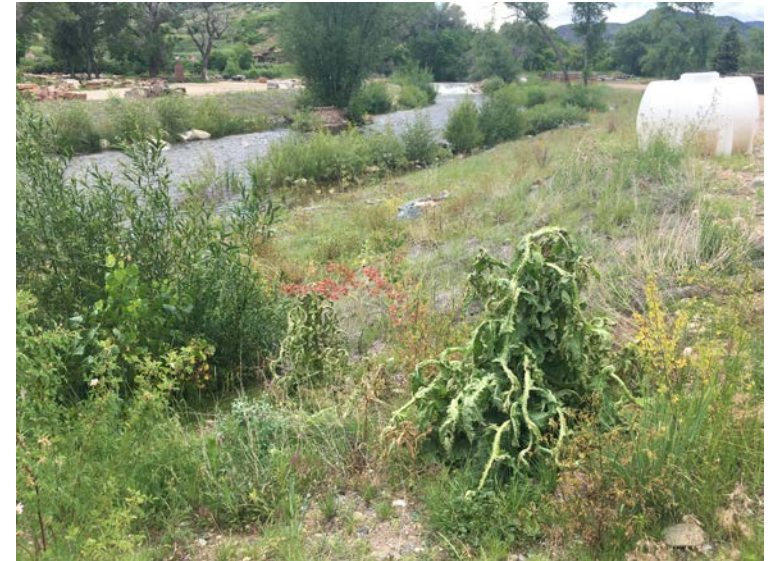
1. Areas of Concern
  - Weeds in transition zone treated with herbicide in June 2019. Container stock had low survivorship and warranty (replanting) was addressed in April 2019.
2. Areas of Success
  - Overall good cover

Riparian vegetation, McConnell, 6/21/2019

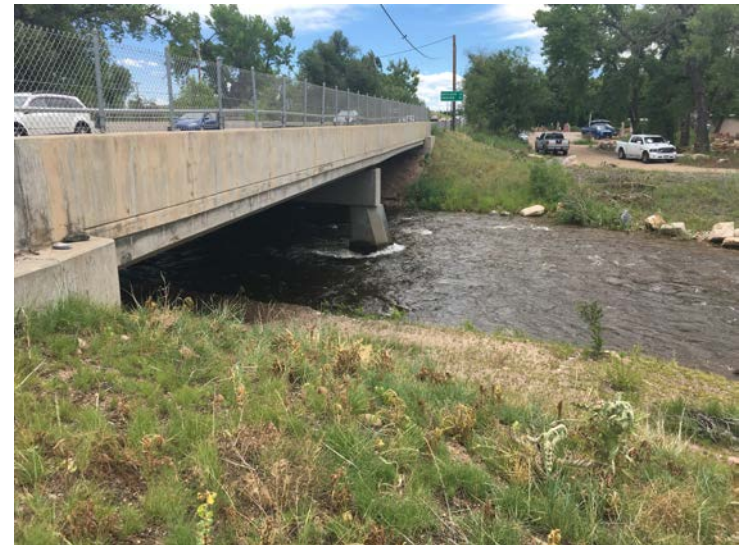
1. Areas of Concern
  - Seeded areas had low germination in zone 3. Warranty reseeding was completed in April 2019
2. Areas of Success
  - Overall good cover

Upland vegetation, McConnell, 6/21/2019

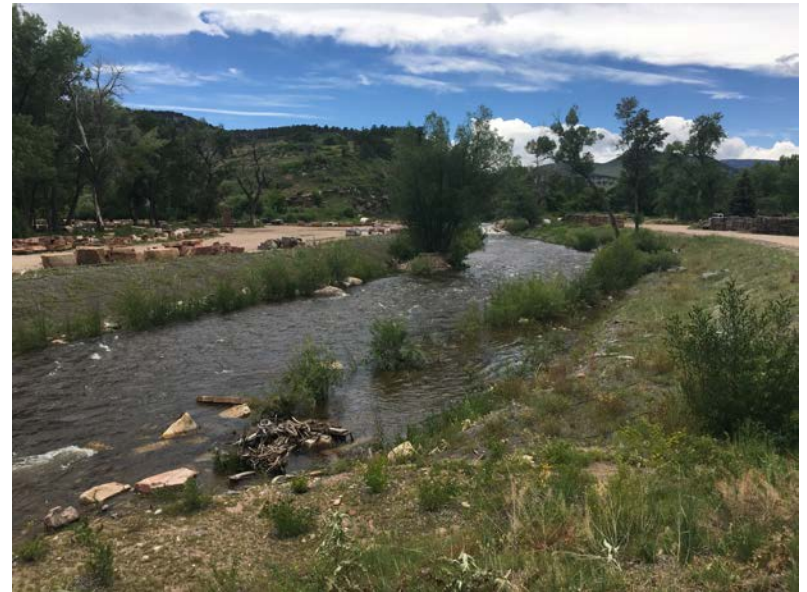
3. Is there any erosion that is threatening property, structures, or infrastructure?
  - a. *No evidence of erosion threatening property, structures or infrastructure. High flows are cutting behind a large willow on river left on the Loukonen Stone property, but no present issue.*

1. Areas of Concern
  - Water flowing behind large willow. Will monitoring for scouring/erosion.
2. Areas of Success
  - Other structures maintaining form and function

Water flowing behind large willow river left next to open lot, McConnell, 6/21/2019

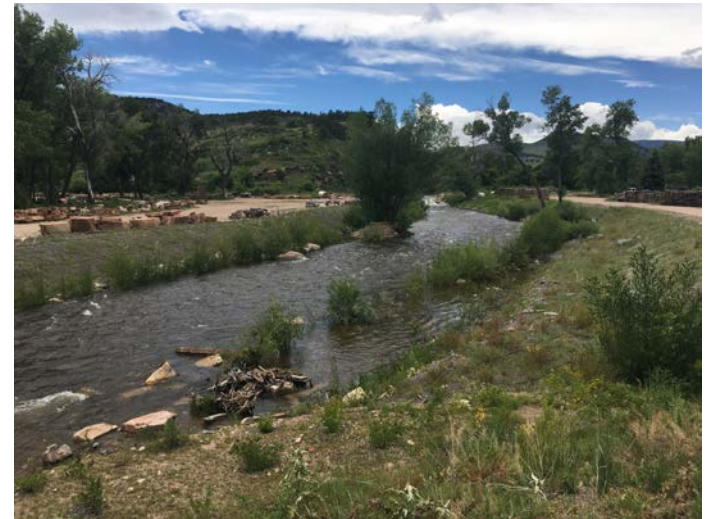
Instream wood, McConnell , 6/20/19

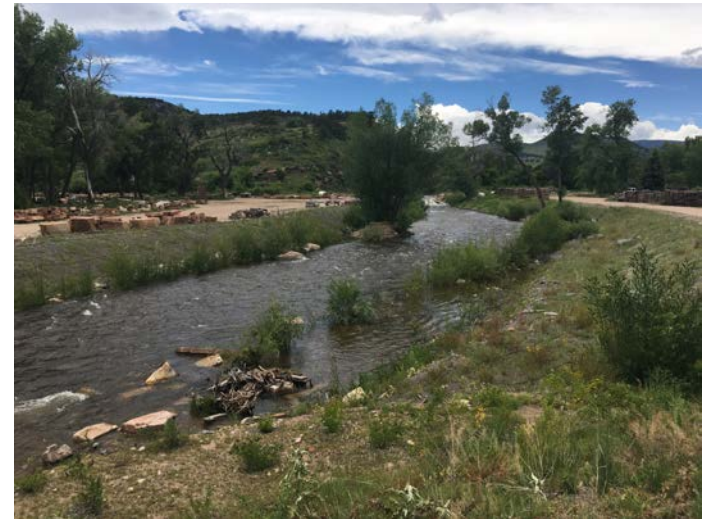
Downstream reach, McConnell, 6/21/19
