FINAL PROJECT REPORT- POGG1 2020-2979

REPORT DATE	PROJECT NAME	PREPARED BY
February 7, 2022	WSRF Grant – Arkansas-Cottonwood Irrigation Ditch #2 Project	Gracy Goodwin Project Manager
	Grantee: St. Charles Mesa Water District	David Simpson

**ST. CHARLES MESA COTTONWOOD
IRRIGATING DITCH #2
HEADGATE/ AUGMENTATION
STATION**

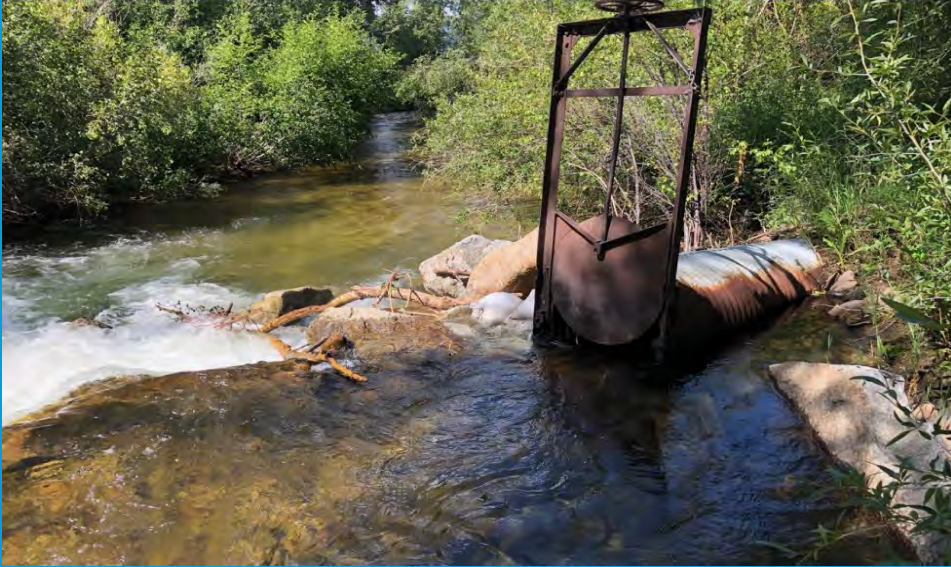
Wing wall failing causing a drop in water level at the headgate.

The channel substrate is such that it moves during high flows and pushes the larger riprap down stream or makes it sink changing water levels.

Goal: Looking for a permanent fix, more accurate water measuring, and better utilization of resources.

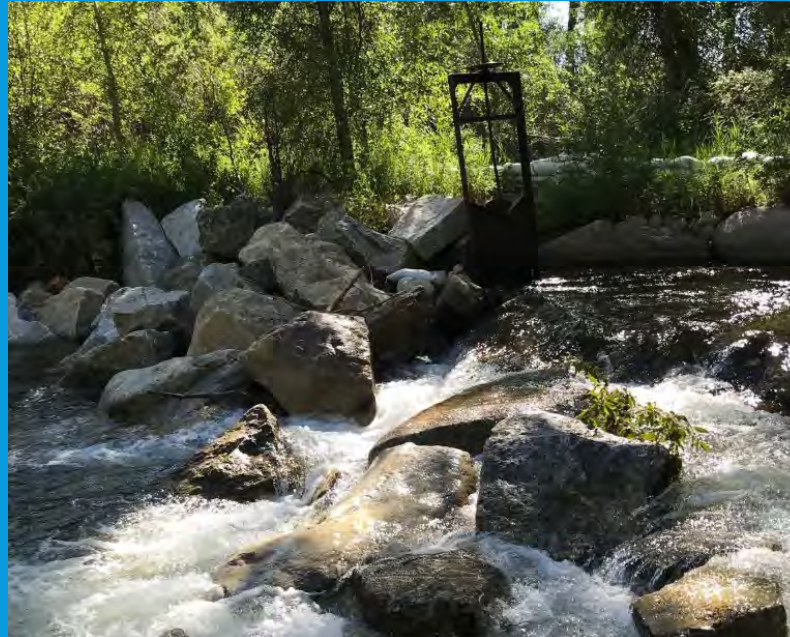
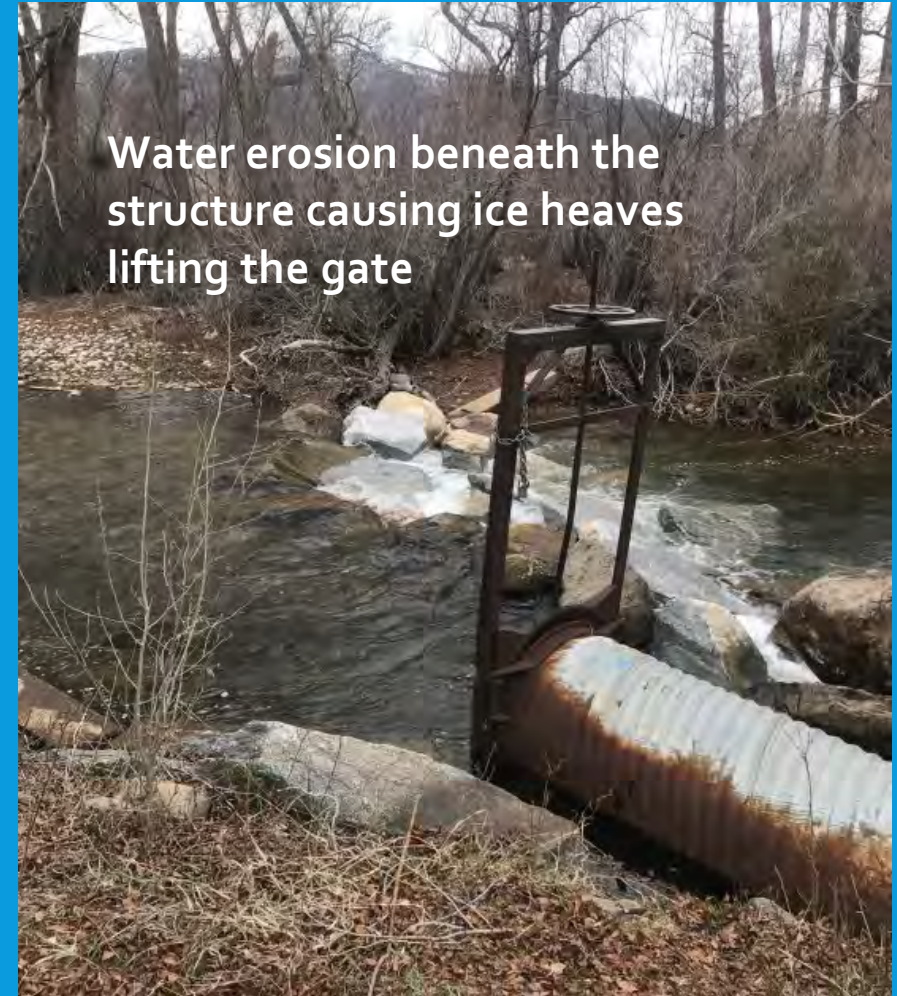
Water erosion beneath the structure causing ice heaves lifting the gate
