# Colorado Burned Area Emergency Response Assessment

## MARSHALL FIRE

May 27, 2022

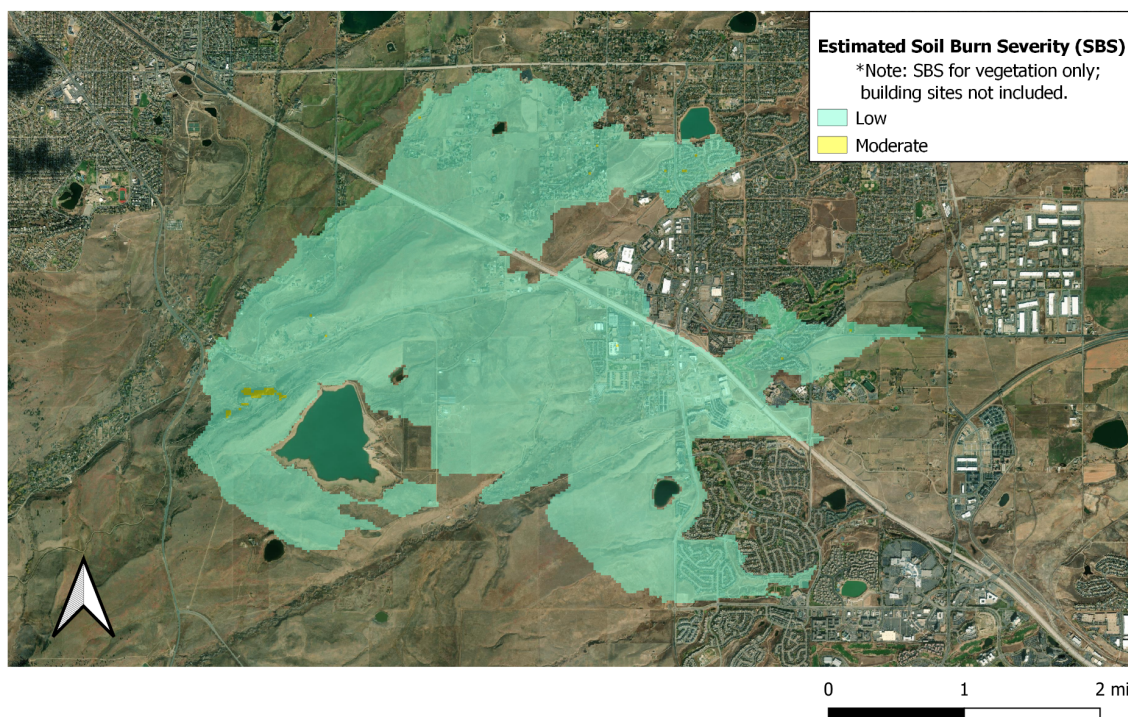
SBS field surveys determined that the vast majority of the burn area burned at low severity, and confirmed some small pockets of moderate burn severity. The initial BARC image was reclassified based on these observations to provide a map of estimated SBS (Figure 2). Soils on building sites were not evaluated.

- Grass-dominated areas within the burned area were mapped as low SBS.
- Small areas of moderate SBS occurred in conifer-covered areas.
- Small patches of moderate SBS occur within the Coal Creek riparian zone but the vast majority of that area has low SBS.
- The imagery does not provide a reasonable approximation of SBS in urbanized and developed areas within the burn perimeter.

Figure 2. Estimated soil burn severity (SBS) for the Marshall Fire, showing low burn severity across most of the burned area, with small pockets of moderate burn severity. Note: This map only shows estimated SBS for open space and vegetation, not building sites. Most buildings destroyed in the fire burned at high intensity and soil burn severity at building sites was not

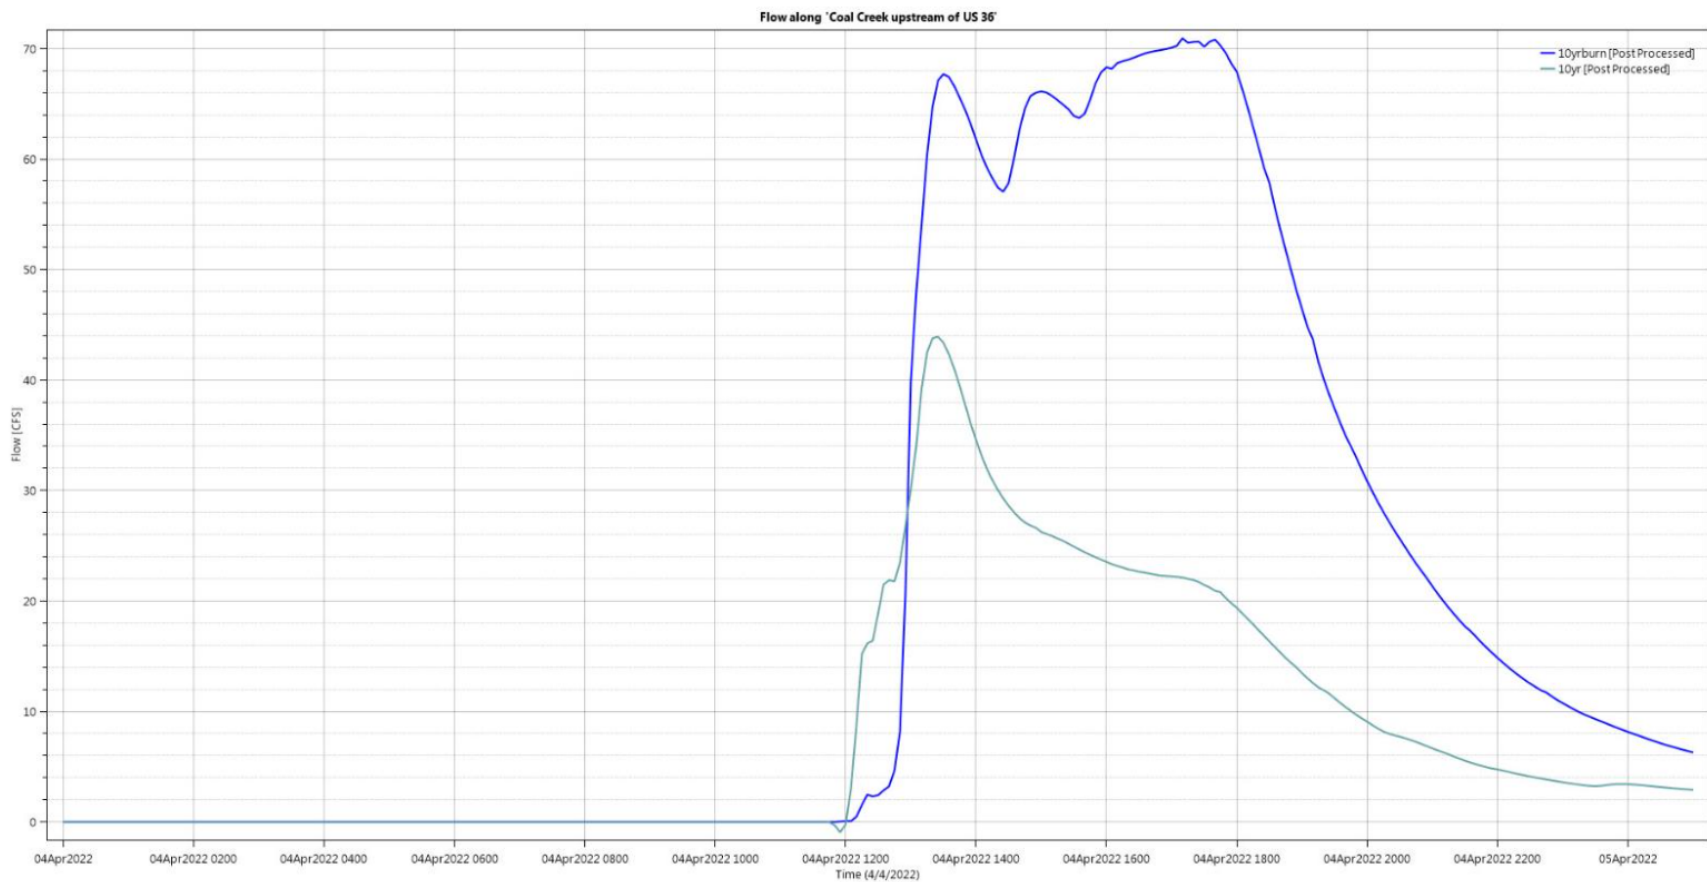
The Marshall Fire consisted of a small portion of Coal Creek and Boulder Creek Drainages. The larger upstream watershed controls the floodplain peak flow. The analysis indicates that the small burned portion of the watershed that burned will have localized increases in flows, but does not change the larger flood wave, which is dictated by the broader unburned upstream watershed (Figure 3).

Figure 3. Hydrograph for the 10-year thunder burst over the Marshall Burn scar in Coal Creek, upstream of U.S. 36. Curves indicate that the predicted maximum 10-year rain event would yield 42 CFS of flow if the fire had not occurred (green line), and 71 CFS of flow following the fire (blue line). These flows are not anticipated to cause flooding or other major impacts.

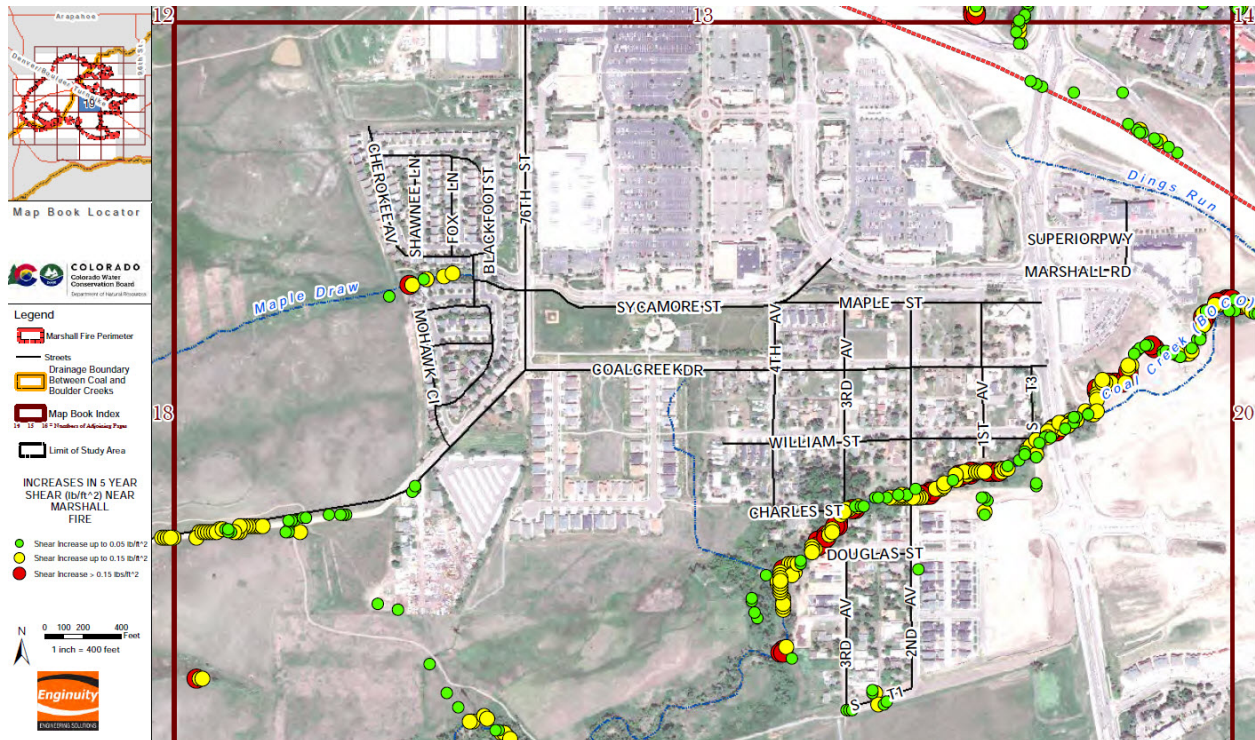
Mapbooks showing flow depth and shear increases present more detail for local entities to assess erosion hotspot locations (Mapbook available [here](#)<sup>3</sup>; Figures 4 and 5). Depth and shear were combined to yield a ranking of low, medium, and high likelihood of increased erosion. Shear represents an erosive hydraulic force on the channel and streambanks. Together, values for shear and flow depths can indicate risk of erosion to waterways, and inform locations for monitoring and potential mitigation actions by local governments and flood districts.

Figure 4. Example of Low, Medium, and High Ranking for increases in Shear Stress (5 Year Shear in  $\text{lb/ft}^2$ ) at Coal Creek upstream of Highway 36.

Overall, this analysis indicated minor or no anticipated risks to values-at-risk from post-fire hazards. The CoBAER team recommends local agencies conduct monitoring in “hotspots” with increased erosion risks rather than recommending specific control measures at specific locations.

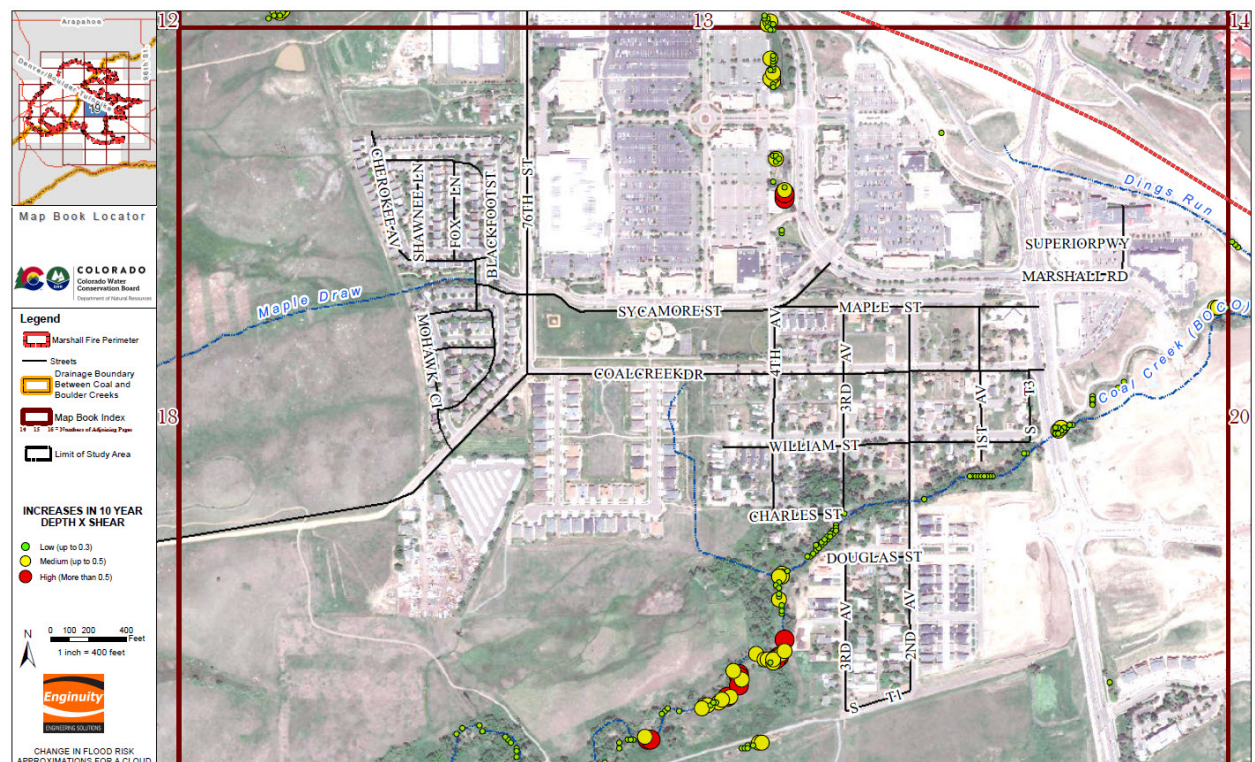
As presented below, a section of Coal Creek may have a few high risk areas (hotspots) but also has lower and medium-forecasted changes. Such changes may warrant looking at a given stretch as a whole, and not just individual spots.

Figure 5. Example of Low, Medium, and High Ranking for increases in 10 year Depth X Shear (a measure of erosion susceptibility) at Coal Creek upstream of Highway 36.

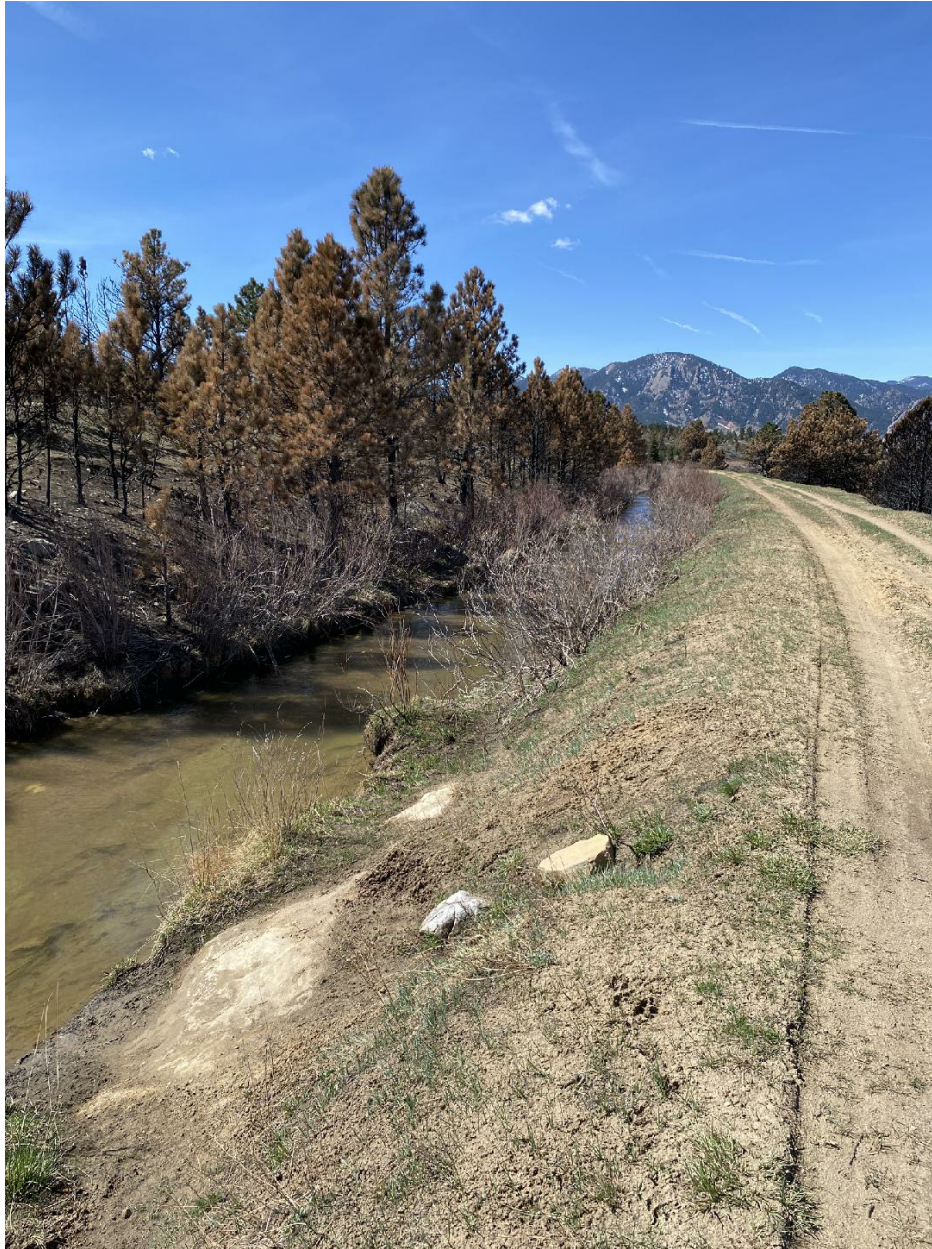
Figure B1. Low soil burn severity (SBS) above Community Ditch.

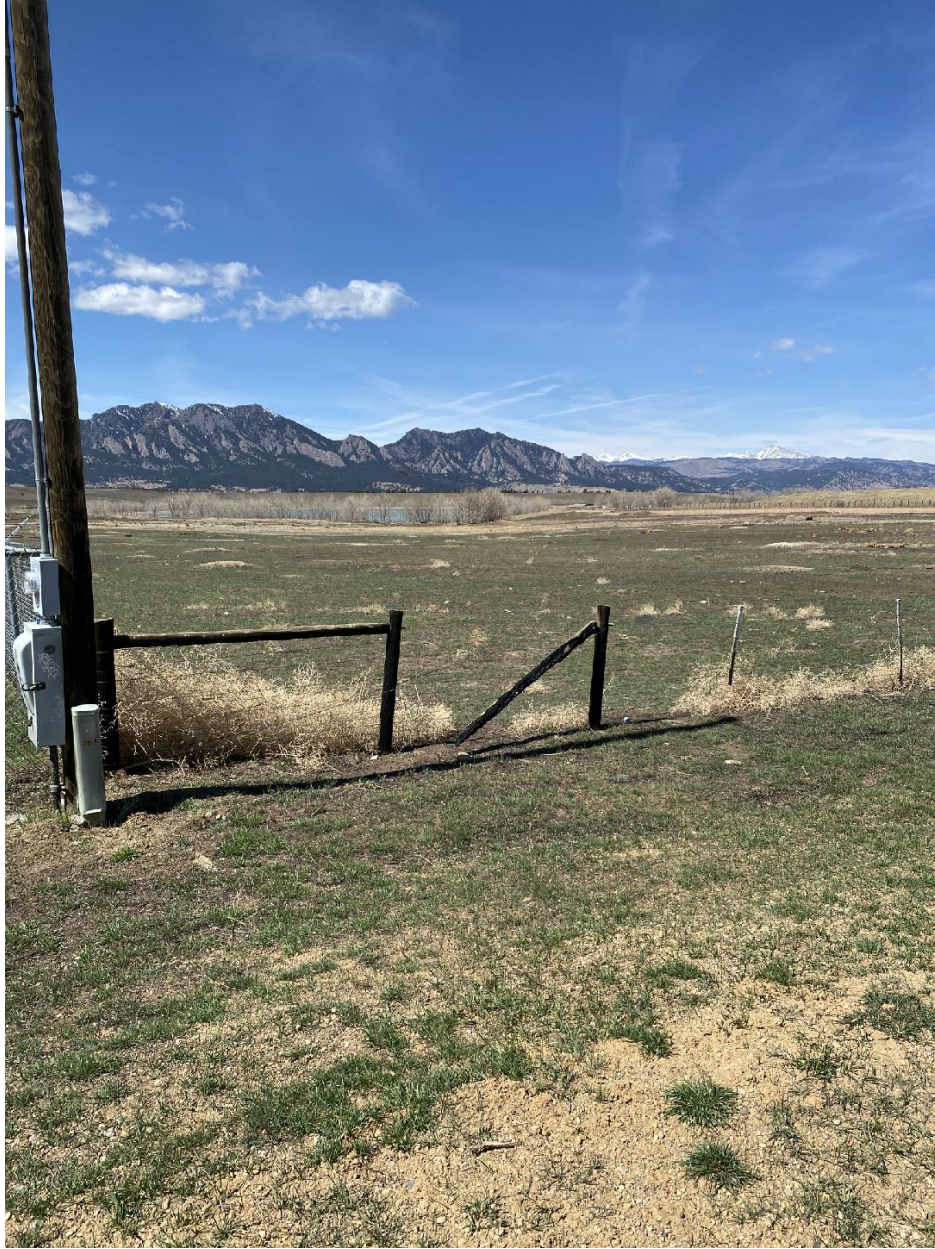
Figure B2. Low SBS around Marshall Lake.

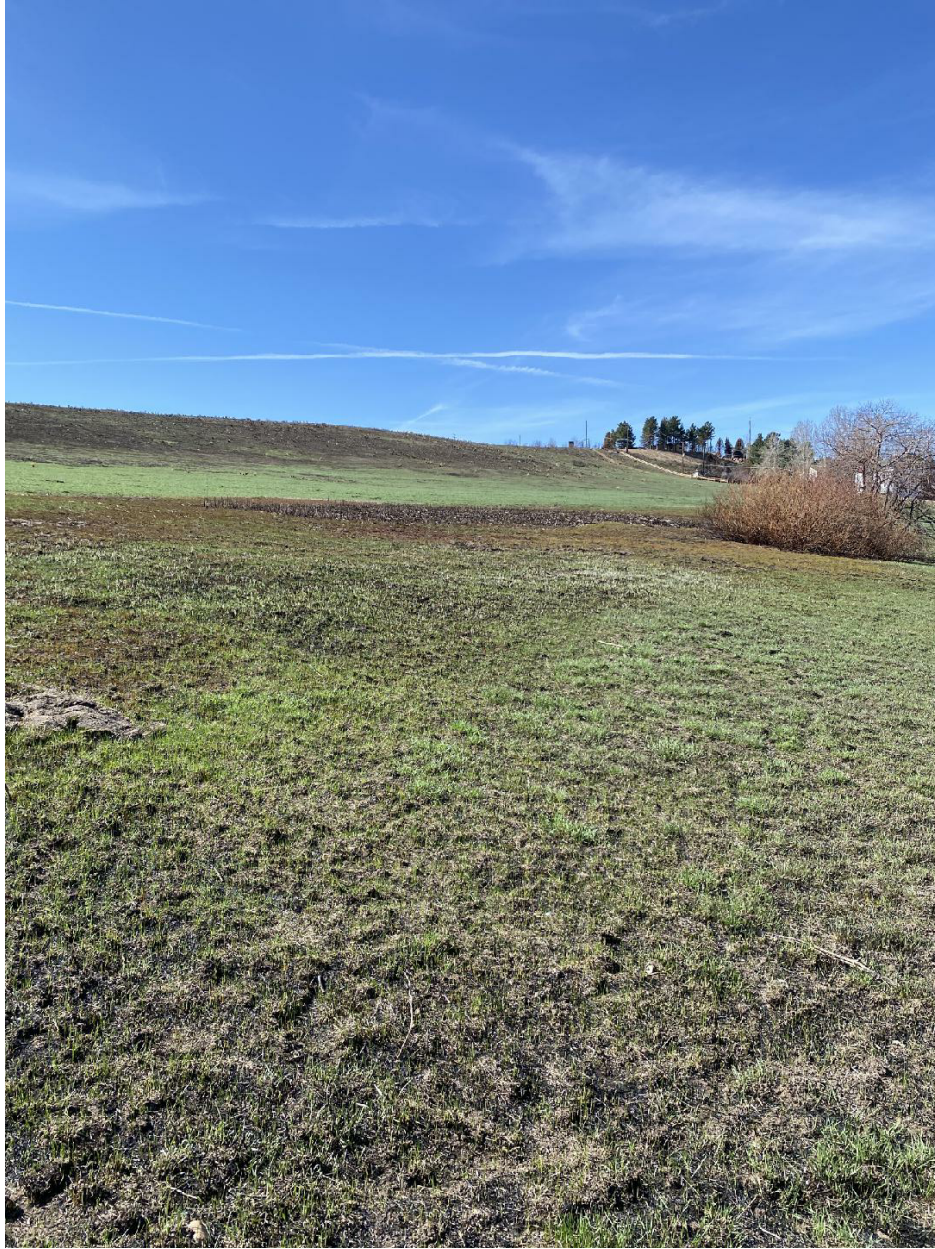
Figure B3. Low SBS; grass and small wetland recovering.

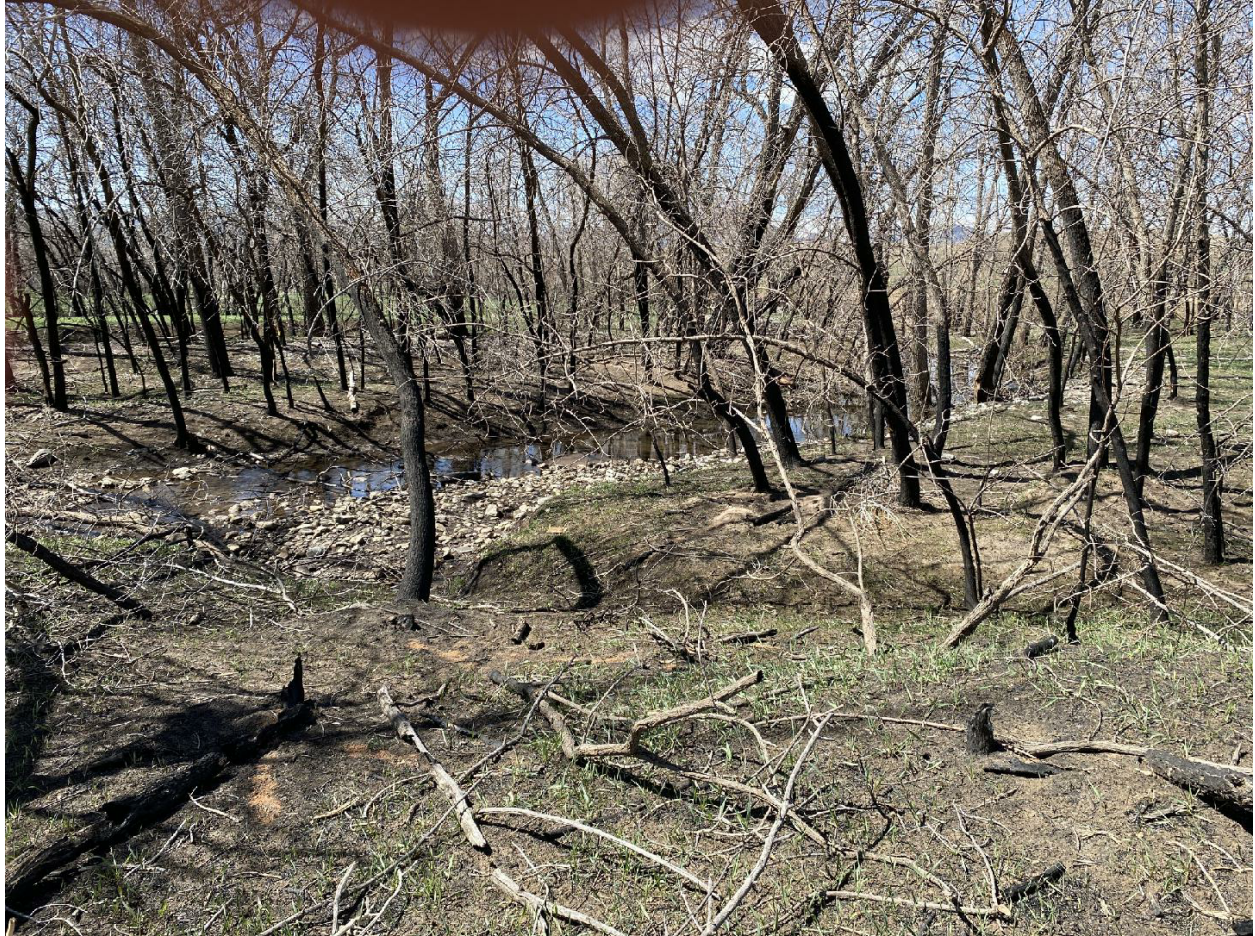
Figure B4. Low SBS; some burned floatable material in the channel. Coal Creek South of Founders Park.

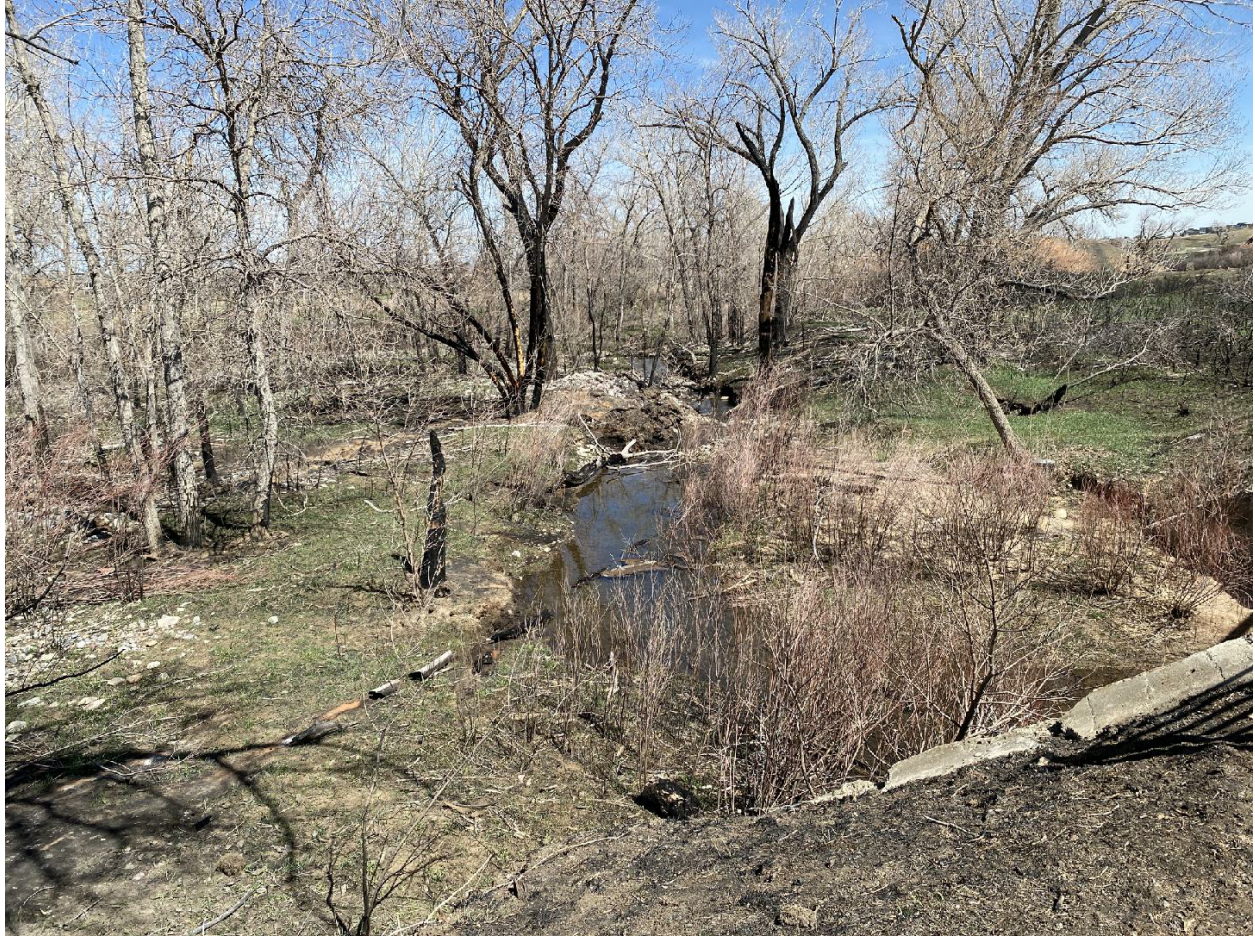
Figure B5. Low SBS in Coal Creek riparian zone. Some additional floatable material.

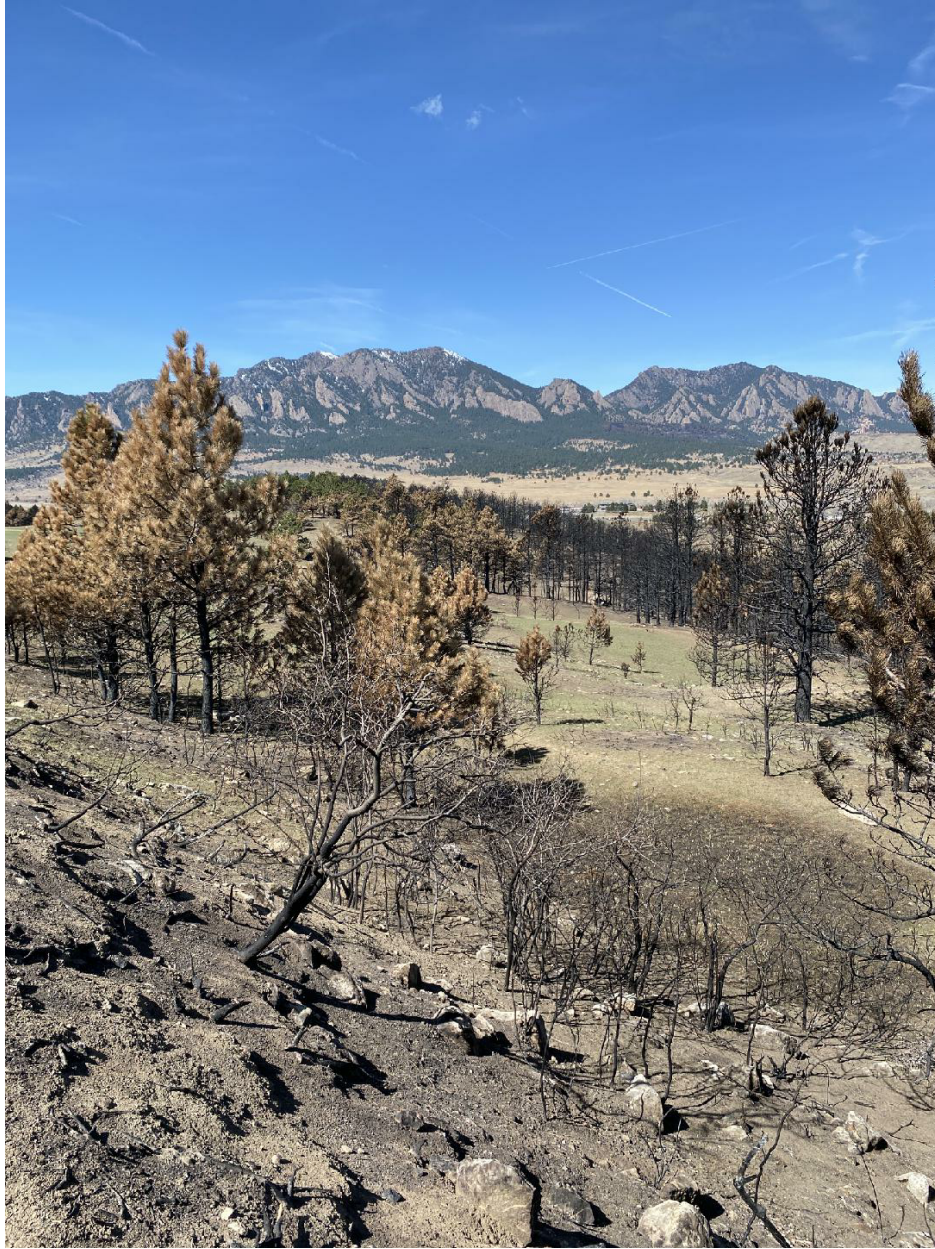
Figure B6. Mosaic of Low and Medium SBS; Ponderosa pine woodland south of Davidson Ditch.
