**Colorado Trout Unlimited and Boulder Flycasters
Lower South Boulder Creek
Stream Management Plan Phase II - Final Report
September 30, 2022**

Colorado Trout Unlimited and Boulder Flycasters
Lower South Boulder Creek Stream Management Plan Phase II
Final Report

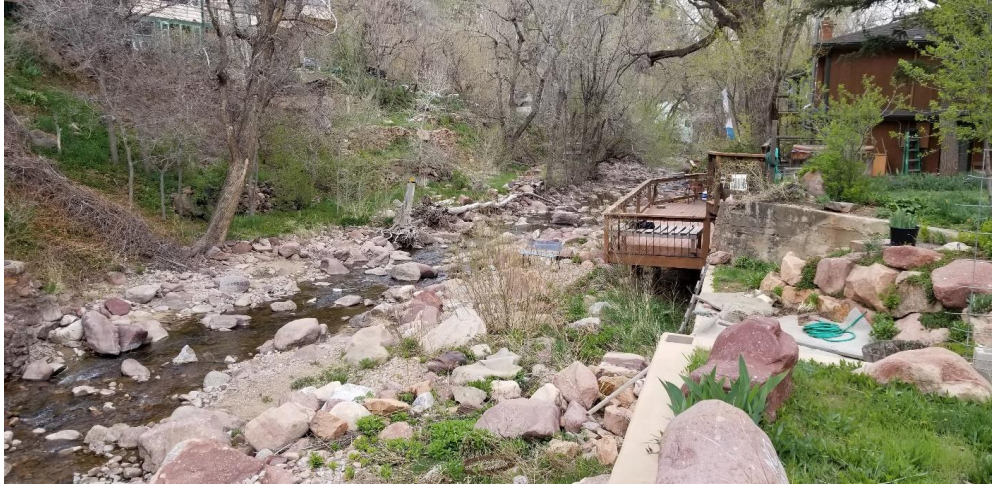
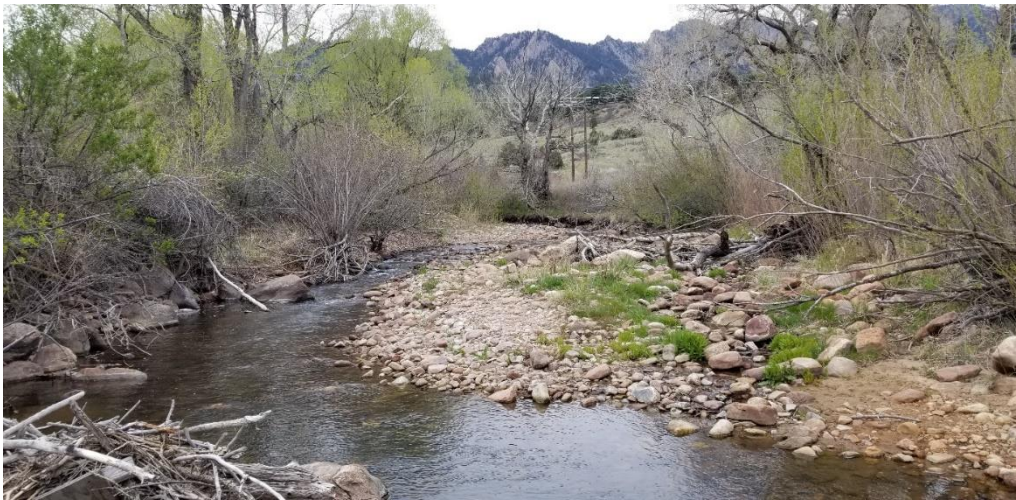
Ratings		
Flow		2.8 functioning
Riparian	Left	3.0 functioning
	Right	3.0 functioning
Landscape	Left	4.0 high functioning
	Right	3.0 functioning
Geomorphology		3.0 functioning
Aquatic Habitat		2.5 functioning
Recreation		no impact / limited access

Detailed Observations: Although much of Reach 2.2 is privately owned, development is minimal, and this reach represents a very natural channel. Floodplain connectivity is good, and an adequate margin of thriving and regenerating riparian vegetation provides resistance to bank erosion. Upland connectivity within the reach is mostly unimpeded. Emergent wetlands are on an upland terrace on the south side. Water chemistry is likely compromised from upstream stressors. The Davidson diversion and ditch is a barrier to aquatic connectivity / fish passage at low flows. For potential improvements, plant installation could be relatively low-cost, but the benefits would not be as measurable without more expensive grading to optimize floodplain connectivity.

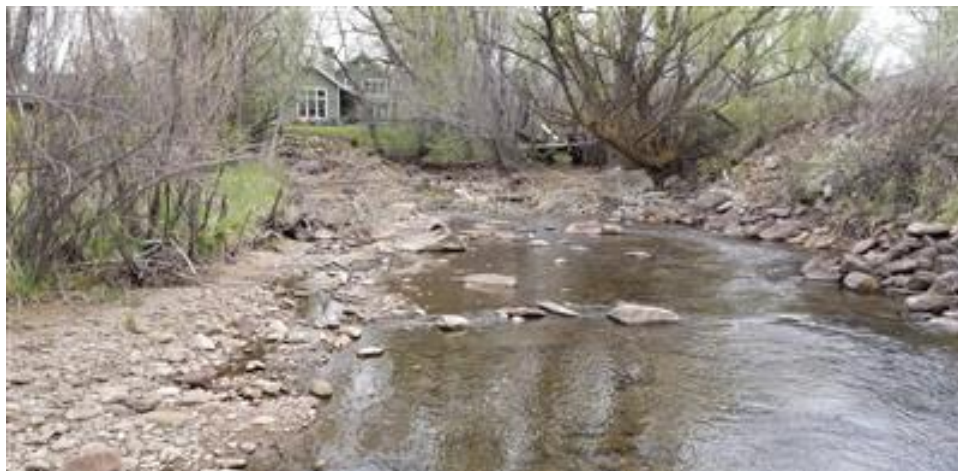
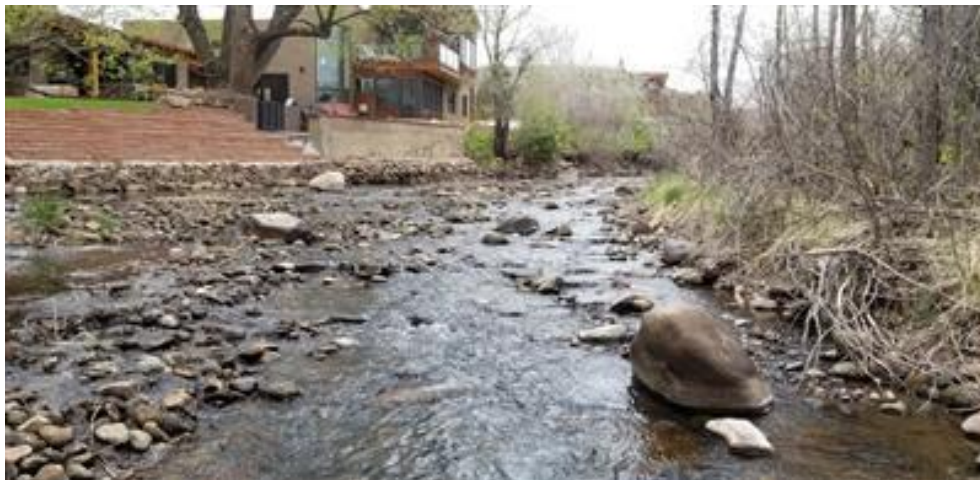
Ratings		
Flow		2.3 functioning
Riparian	Left	2.3 functioning
	Right	1.3 partly functioning
Landscape	Left	3.0 functioning
	Right	2.0 partly functioning
Geomorphology		2.5 functioning
Aquatic Habitat		1.0 poorly functioning
Recreation		No impact / few points of access

Detailed Observations: Landscaping (mostly on the right / south bank) and lawn care are presumed to be conventional, and with negative impacts to water quality. Some properties have walls along the bank (see photo). In-stream structures, many simply stacked rock to create drops and pools, but also some relatively permanent, restrict channel connectivity and creek function. Water quality impacts on the north side from OSMP grazing are likely negligible due to fencing. Long, shallow pools and few riffles characterize aquatic habitat, and diversions at upstream and downstream ends impede aquatic connectivity / fish passage. Although floodplain connectivity is only mildly impaired, there is no vegetation on the lower banks, and riparian trees are all mature to decadent. Vegetation on the right (residential) bank is characterized by canopy species and an herbaceous understory with no subcanopy, while the left (open space) bank has several layers well-represented. There are some very limited occurrences of obligate wetland species (speedwell, *Veronica* sp.) on the left bank.

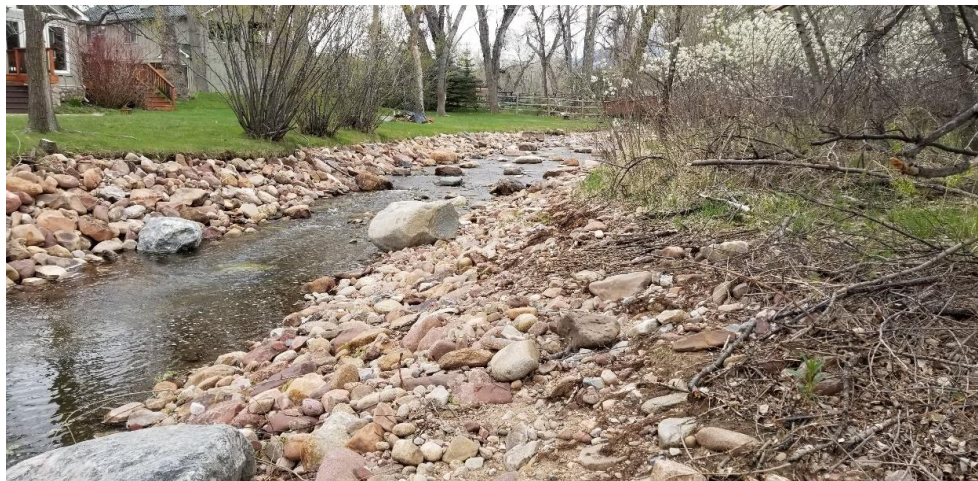
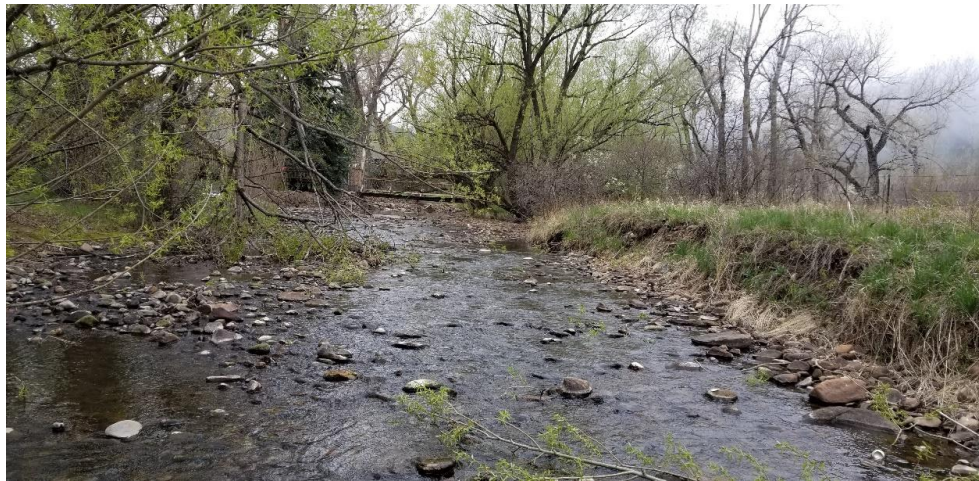
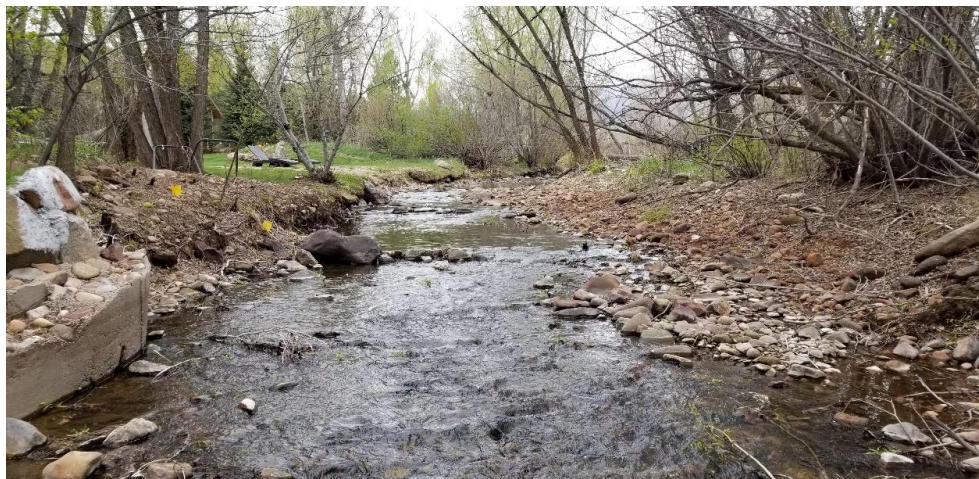
Reach 2.4 Goodhue Diversion and Ditch Structure to Dry Creek #2 Ditch Structure

Ratings		
Flow		1.8 partly functioning
Riparian	Left	2.7 functioning
	Right	2.0 partly functioning
Landscape	Left	3.0 functioning
	Right	2.0 partly functioning
Geomorphology		2.5 functioning
Aquatic Habitat		1.5 partly functioning
Recreation		No impact / limited points of access

Detailed Observations: Landscaping on the right/south bank and lawn care are presumed to be conventional and with negative impacts to water quality. Some properties have walls along the bank (see photo). In-stream structures, many simply stacked rock to create drops and pools, but also some relatively permanent, restrict channel connectivity and creek function. Water quality impacts on the north side from OSMP grazing are likely negligible due to fencing. Goodhue diversion at upstream end impedes aquatic connectivity / fish passage. Riparian vegetation on the left (open space) bank represents diverse structure while that on the right (residential / private) bank is more homogeneous. Floodplain connectivity is mildly impeded. Private property spans both sides of the creek in some areas.

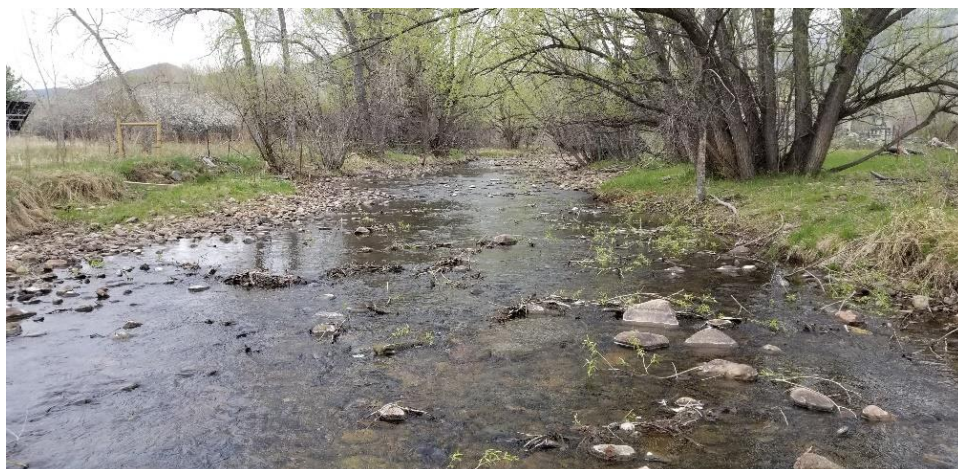
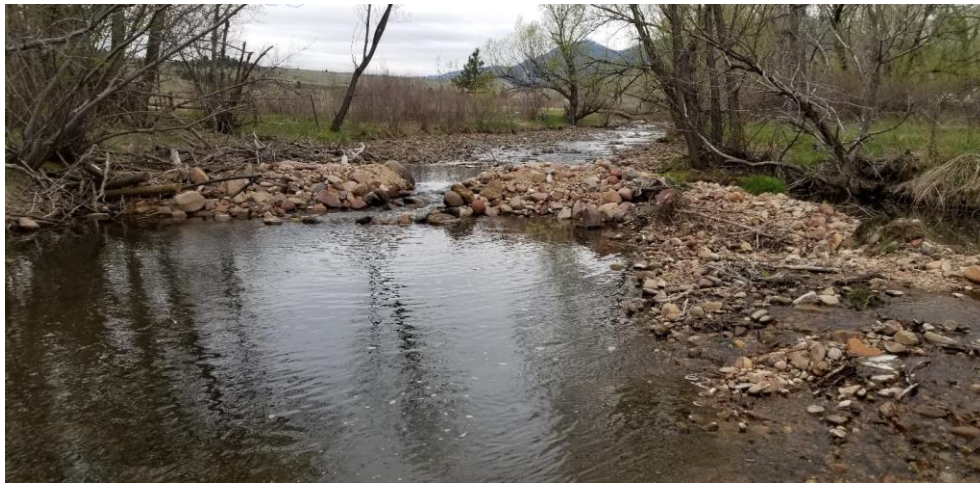
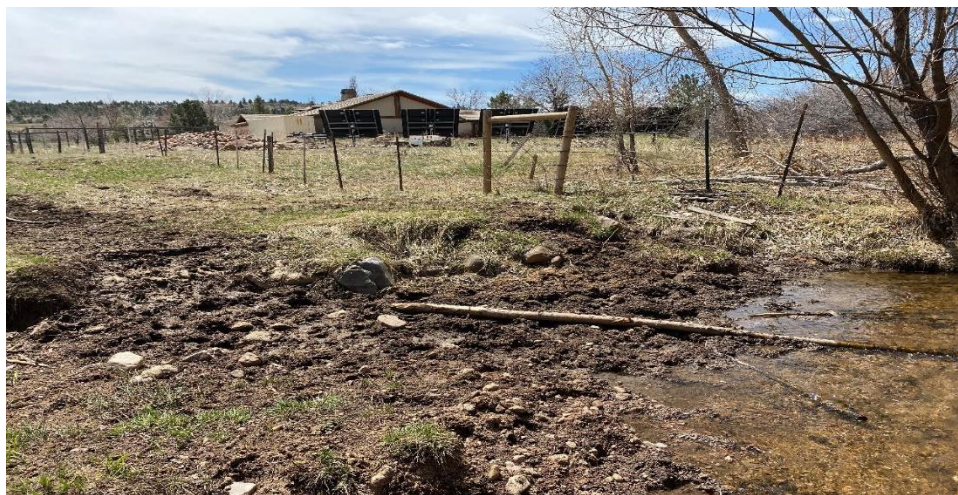
Ratings		
Flow		1.8 partly functioning
Riparian	Left	3.0 functioning
	Right	1.3 partly functioning
Landscape	Left	2.5 functioning
	Right	1.0 poorly functioning
Geomorphology		2.3 functioning
Aquatic Habitat		2.0 partly functioning
Recreation		No impact / limited points of access

Detailed Observations: Ownership is approximately evenly divided between City of Boulder and private property. Stressors to the creek are greater in the downstream portion where there is more development including lawns, road crossing, and paving in the surrounding landscape. In-stream structures built by property owners, many simply stacked rock to create drops and pools, but also some relatively permanent, restrict channel connectivity and creek function. There is grazing in the reach that causes localized degradation (see photo) but, in general, fencing keeps livestock out of the channel with ample buffer. Riparian vegetation is structurally diverse and landscape connectivity is fair. Marshallville diversions at downstream end impedes aquatic connectivity / fish passage, except at very high flows.

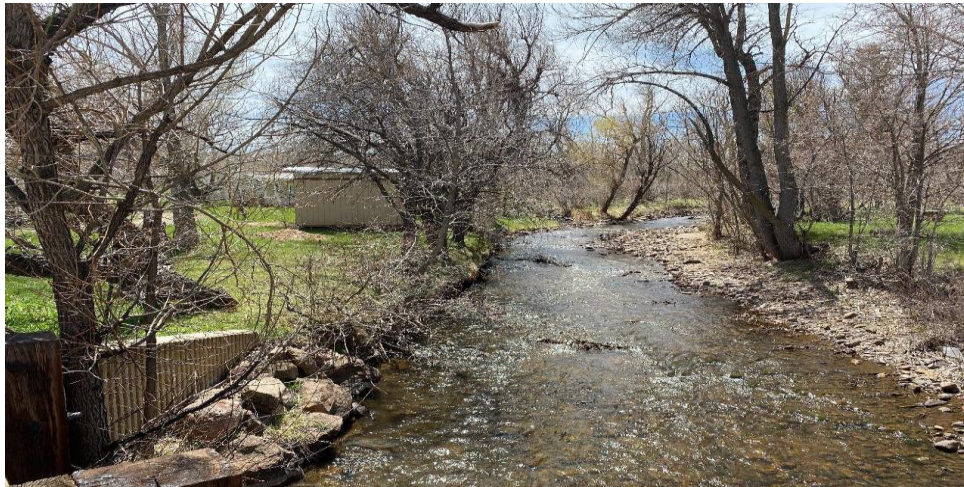
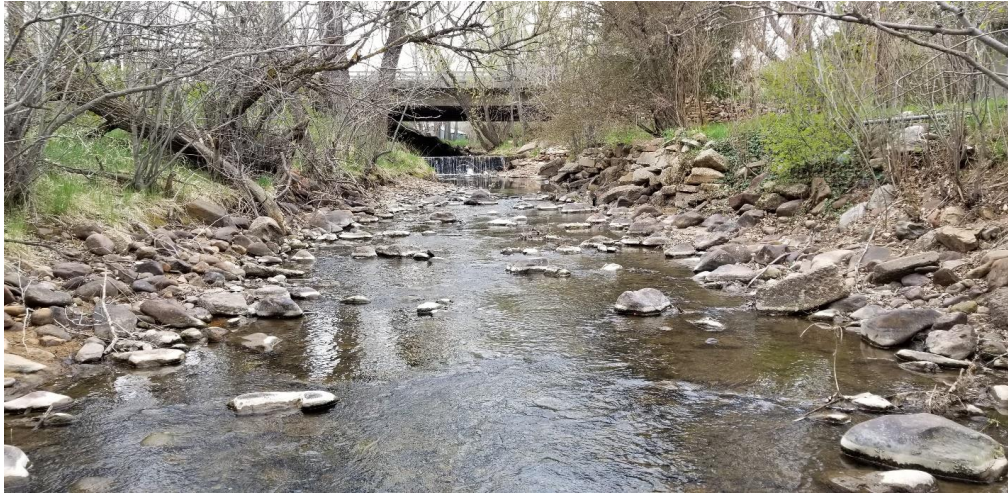
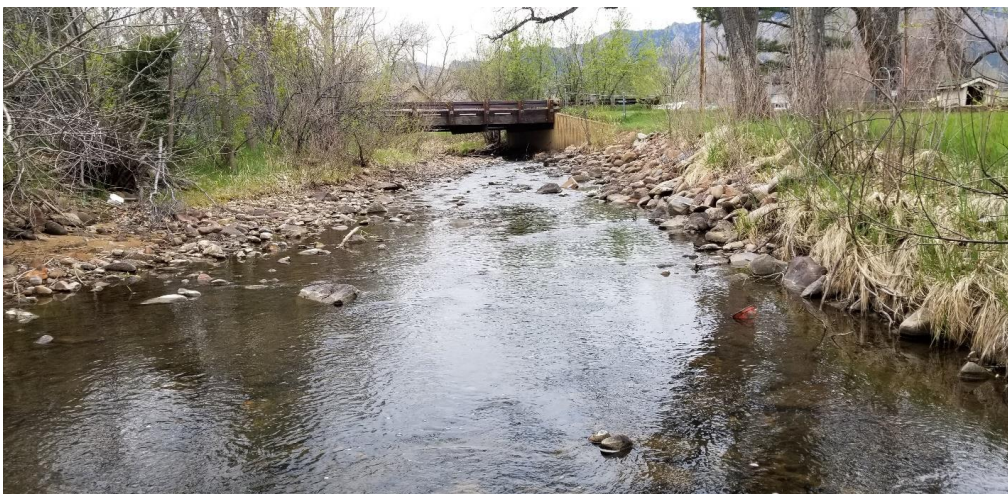
Reach 2.5.2 Marshallville Diversion and Ditch Structure to City of Boulder Open Space & Mountain Parks Property Line

Detailed Observations: Scoring reflects functional averages of up- and downstream reaches, which are lower and higher functioning, respectively. Hwy 93 and Marshall Road (see photos) impact aquatic and terrestrial connectivity, water quality, and related land use. The Marshallville diversion grade control structure at the upstream end is a barrier to aquatic connectivity / fish passage. Floodplain connectivity is fair, although banks appear artificially high. Upstream landscaping and lawn care are presumed to be conventional, and with negative impacts to water quality. Riparian trees are maturing to decadent. Low herbaceous understory is throughout, and a subcanopy layer is mostly restricted to the left (north) bank. Downstream private property was not accessible for direct assessment. However, past interactions between property owner and City of Boulder Open Space & Mountain Parks indicate that the channel morphology and stream bank vegetation are in good shape, relative to the reaches in this study, and might be rated as “functioning.”

Recommended Project: None within the project planning (3 years) horizon of this assessment, although possible longer-term potential for stream bank and channel improvement.

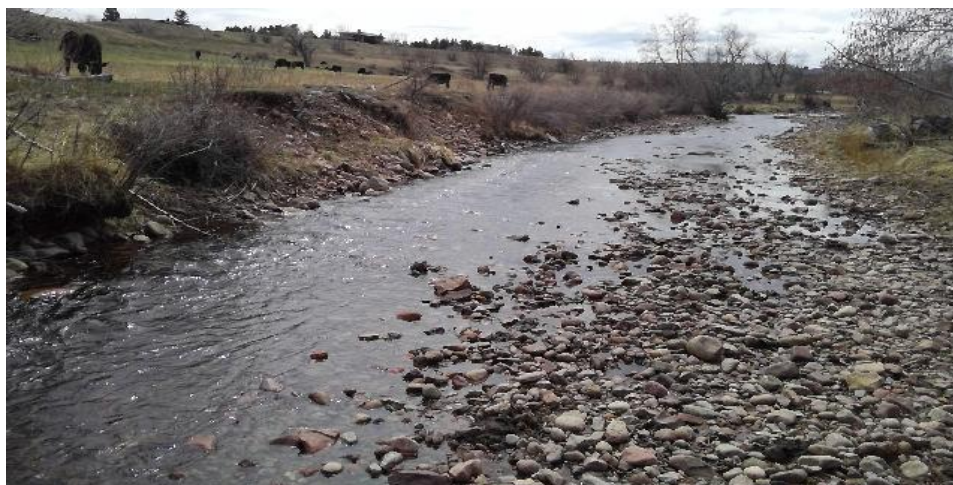
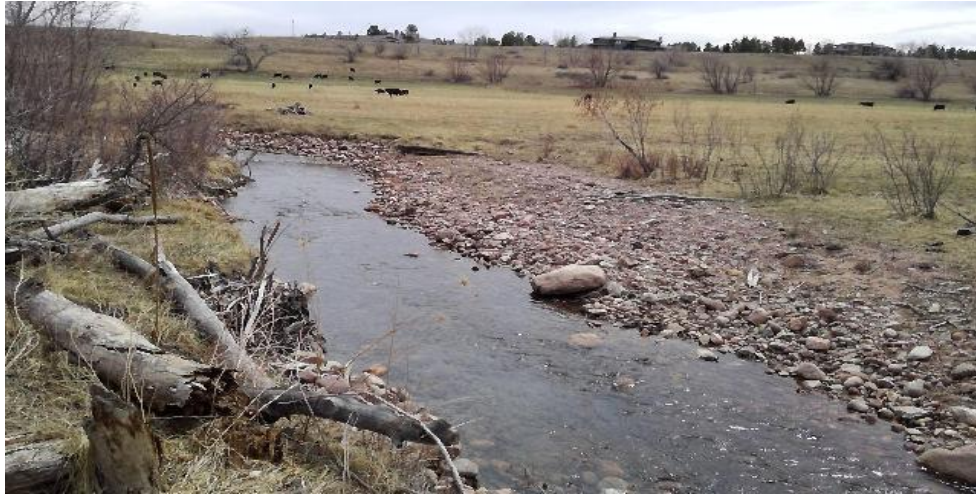
Ratings		
Flow		1.8 partly functioning
Riparian	Left	2.0 partly functioning
	Right	2.0 partly functioning
Landscape	Left	3.5 high functioning
	Right	3.0 functioning
Geomorphology		2.5 functioning
Aquatic Habitat		2.0 partly functioning
Recreation		No impact / access restricted by fencing

Project Narrative: Riparian vegetation, bank erosion, water quality, floodplain access, and aquatic habitat could be improved by installing fences to keep cattle out of the creek and the riparian buffer. Excluding cattle from the creek would entail installation of alternative watering methods. Long rooted nursery stock should be utilized, or regular nursery stock installed in extra deep planting pits to ensure roots reach groundwater. Plantings may require supplemental watering for the first few years. Some eroding banks should be graded / stabilized to ensure vegetation establishment. This may include the installation of toe wood to provide bank stabilization, provide aquatic habitat, and add large wood to the system. More frequent floodplain access could be achieved by installing large wood structures in the creek. These engineered log structures mimic woody debris jams – essentially raising the channel invert, creating deeper pools, and adding large wood into the system.

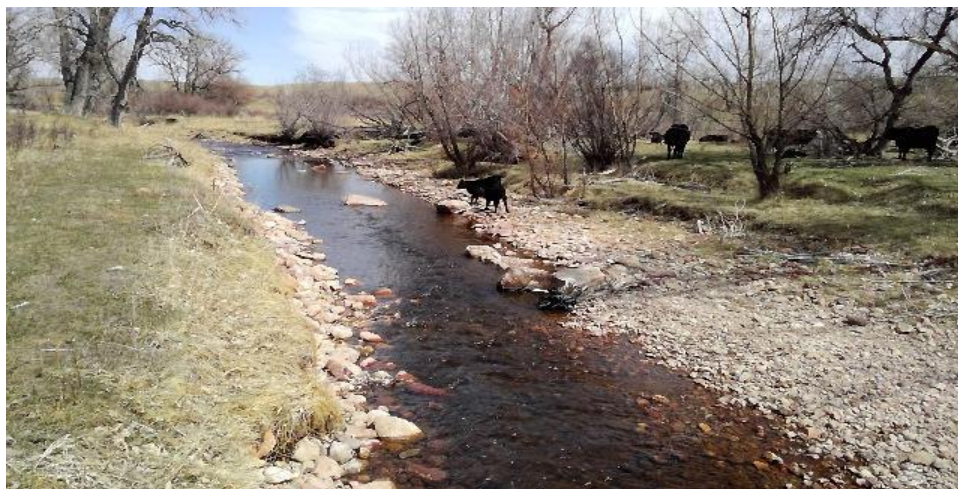
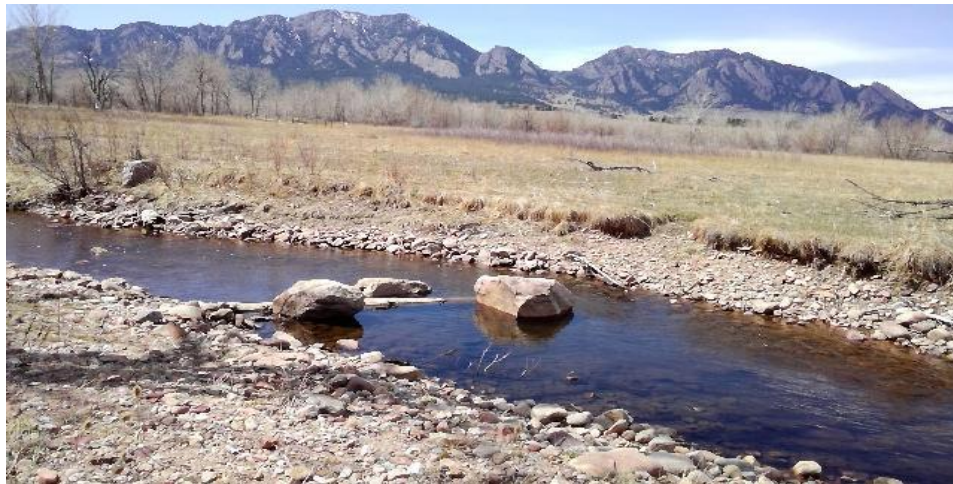
Ratings		
Flow		1.7 partly functioning
Riparian	Left	1.7 partly functioning
	Right	1.7 party functioning
Landscape	Left	3.0 functioning
	Right	3.0 functioning
Geomorphology		2.3 functioning
Aquatic Habitat		2.5 functioning
Recreation		No impact / access limited by fencing

Project Narrative: Riparian vegetation, bank erosion, water quality, floodplain access, and aquatic habitat could be improved by installing fences to keep cattle out of the creek and the riparian buffer. Excluding cattle from the creek would entail installation of alternative watering methods. Fencing should be placed to allow cattle access to some existing shade trees. Long rooted nursery stock should be utilized, or regular nursery stock installed in extra deep planting pits to ensure roots reach groundwater. Some eroding banks should be graded / stabilized to ensure vegetation establishment. This may include the installation of toe wood to provide toe stabilization, provide aquatic habitat, and add large wood to the system. More frequent floodplain access could be achieved by installing large wood structures in the creek. These engineered log structures mimic woody debris jams – essentially raising the channel invert, creating deeper pools, and adding large wood into the system.

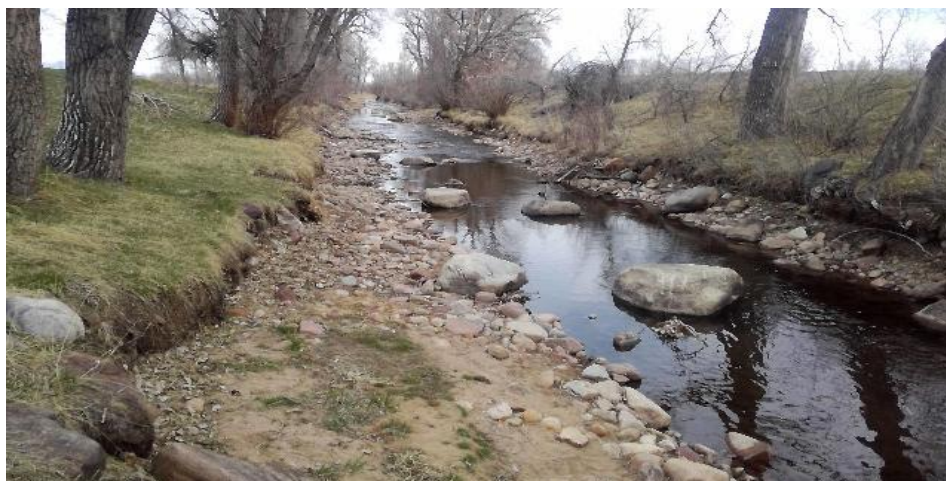
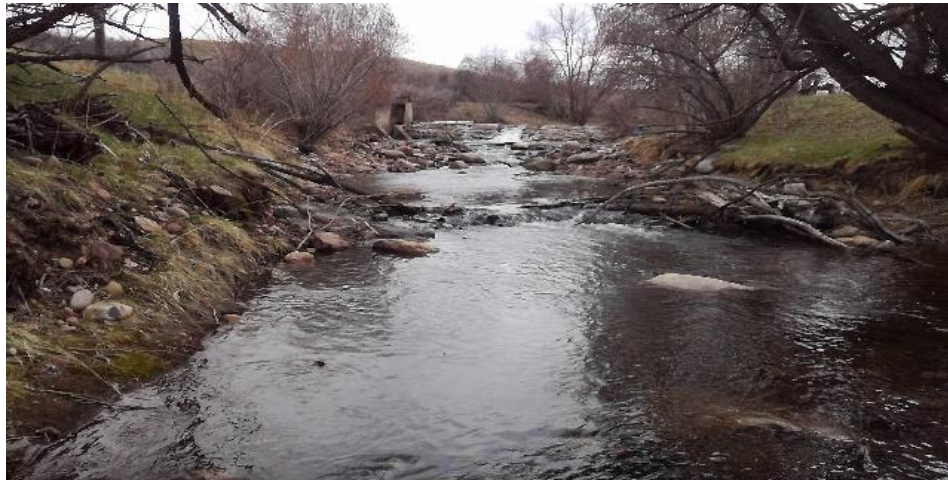
Ratings		
Flow		1.7 partly functioning
Riparian	Left	1.0 poorly functioning
	Right	2.0 partly functioning
Landscape	Left	2.5 functioning
	Right	2.5 functioning
Geomorphology		2.0 partly functioning
Aquatic Habitat		2.5 functioning
Recreation		No impact / access limited by fencing

Project Narrative: The floodplain is 8' to 10' above channel due to past channelization. This severe entrenchment makes it difficult for any potential improvements to be successful. Establishing woody vegetation that high above groundwater would be difficult without several years of irrigation. In-channel structures would have to be hardened to withstand shear stresses during very high flows. A combination of raising the channel invert and grading to create floodplain benches in appropriate areas would decrease shear stress to allow for large wood structures and improved aquatic habitat.

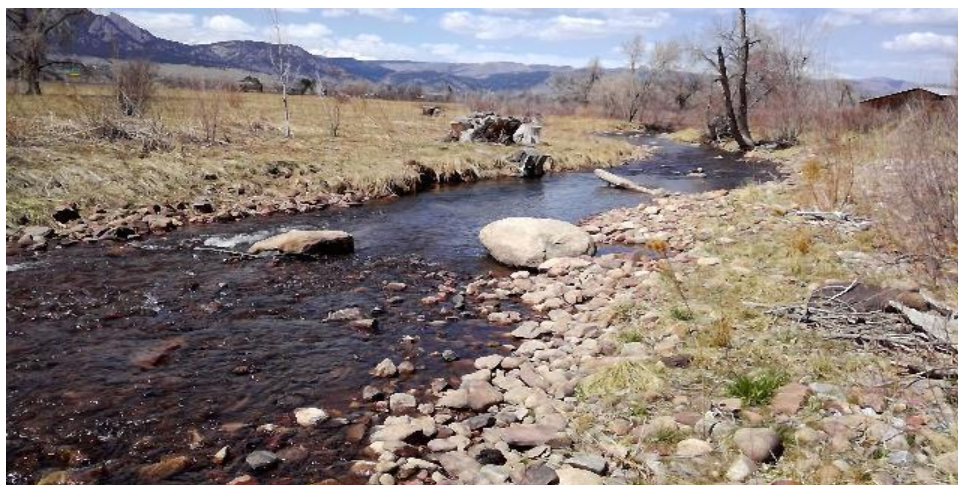
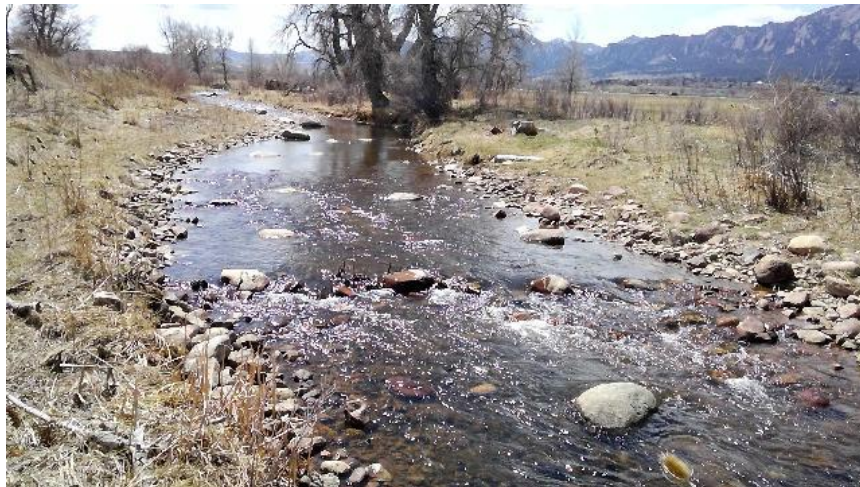
Ratings		
Flow		1.2 partly functioning
Riparian	Left	1.3 partly functioning
	Right	2.3 functioning
Landscape	Left	1.5 partly functioning
	Right	1.0 poorly functioning
Geomorphology		1.8 partly functioning
Aquatic Habitat		2.0 partly functioning
Recreation		No impact / access limited by fencing

Project Narrative: Riparian vegetation, bank erosion, water quality, floodplain access, and aquatic habitat could be improved by installing fences to keep cattle out of the creek and the riparian buffer. Excluding cattle from the creek would entail installation of alternative watering methods. Fencing should be placed to allow cattle access to some existing shade trees. Long rooted nursery stock should be utilized, or regular nursery stock installed in extra deep planting pits to ensure roots reach groundwater. Some eroding banks should be graded / stabilized to ensure vegetation establishment. This may include the installation of toe wood to provide toe stabilization, provide aquatic habitat, and add large wood to the system. More frequent floodplain access could be achieved by installing large wood structures in the creek. These engineered log structures mimic woody debris jams – essentially raising the channel invert, creating deeper pools, and adding large wood into the system.

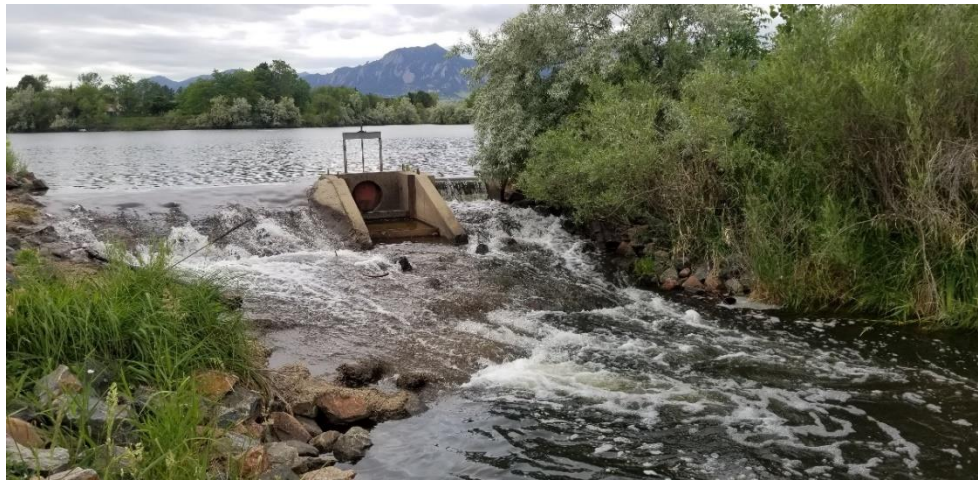
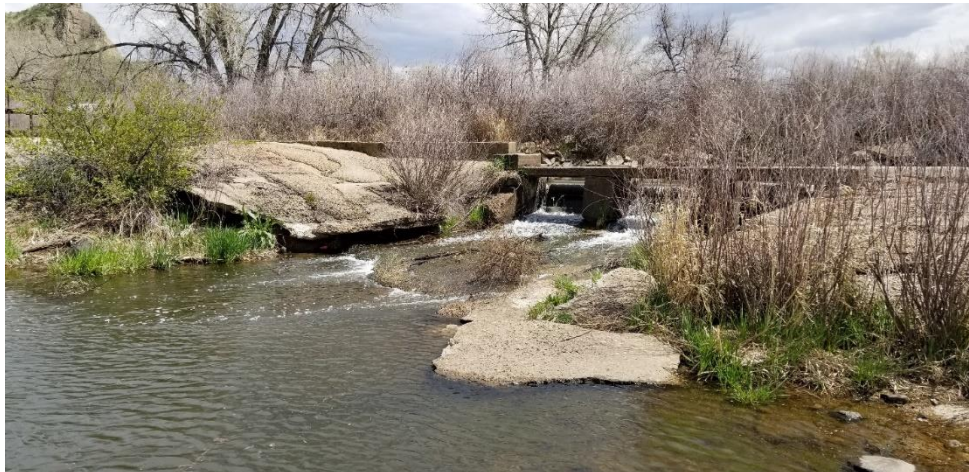
Reach 3.6 KOA Lake to Butte Mill Ditch Structure

Ratings		
Flow		1.0 poorly functioning
Riparian	Left	1.3 poorly functioning
	Right	0.7 not functioning
Landscape	Left	0.5 poorly functioning
	Right	0.5 poorly functioning
Geomorphology		not applicable
Aquatic Habitat		not applicable
Recreation		KOA Lake fishing / picnicking

This reach (and the downstream reaches to the confluence with Boulder Creek) often has no to very low flows from upstream water (less than 1 cfs) during the winter months. There is some runoff / return flow from storms and snow melt during the winter months.

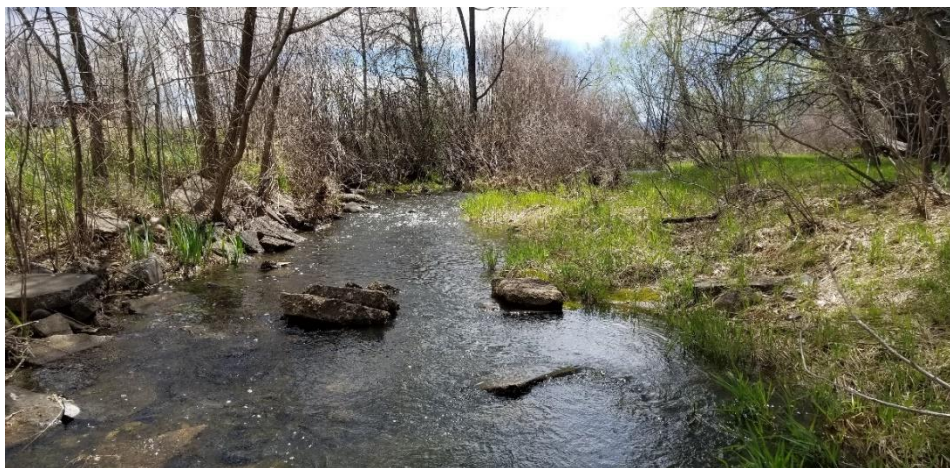
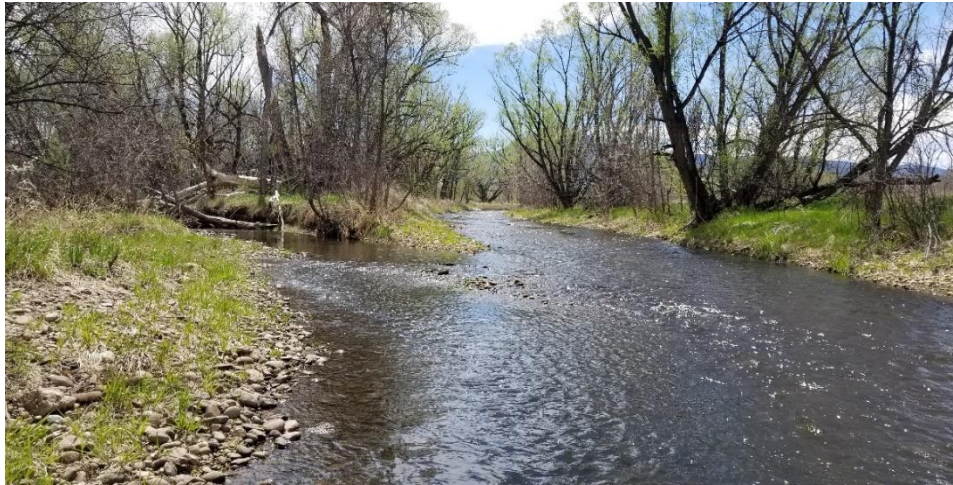
Ratings		
Flow		1.0 poorly functioning
Riparian	Left	1.7 poorly functioning
	Right	1.7 poorly functioning
Landscape	Left	3.0 functioning
	Right	2.0 partly functioning
Geomorphology		2.0 partly functioning
Aquatic Habitat		2.5 partly functioning
Recreation		No impact

This reach often has no-to-very-low flows from upstream water (less than 1 cfs) during the winter months. There is some runoff / return flow from storms and snow melt during the winter months.
