Larimer County Cameron Peak Fire Post-Fire Flood Recovery

Final Report

Prepared for:
Colorado Water Conservation Board
Colorado Watershed Restoration Program (CWRP) Grant
Attn: Chris Sturm

August 14, 2023

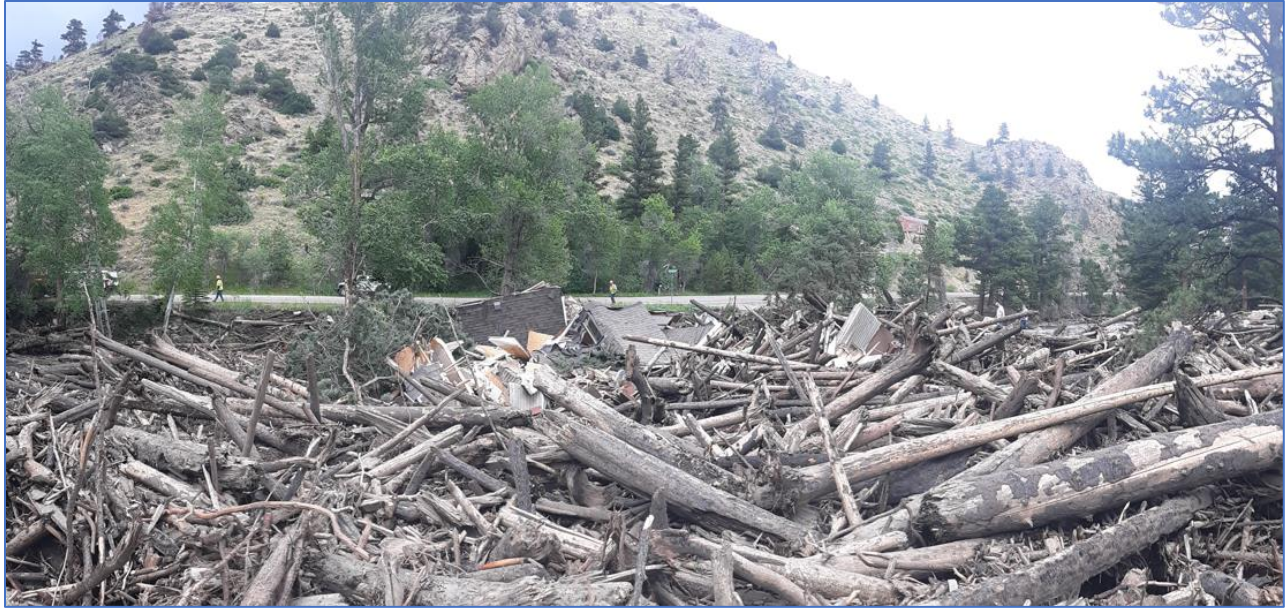
On July 20, 2021, a rainfall event moved over the Poudre Canyon, and was observed by the National Weather Service Denver/Boulder at approximately 1600 hrs. A Flash Flood Advisory was issued at 1629 hrs followed by a Flash Flood Warning at 1653 hrs and another at 1724 hrs. Heavy rainfall occurred in the Poudre Canyon. Rainfall totals over the Upper Poudre Basin were approximately one- to two- (1 to 2) inches per sixty (60) minutes. Mandatory evacuations were issued in the area on July 20, 2021. The Black Hollow drainage had a massive debris flow that came down onto SH 14, causing the destruction of multiple structures and the death of four people. A damage assessment team completed an initial assessment on July 21, 2021, confirming six residential structures destroyed, one damaged, and one detached garage destroyed.

Photo 3: Black Hollow Disaster Debris Field – looking North towards SH 14 (July 20, 2021)

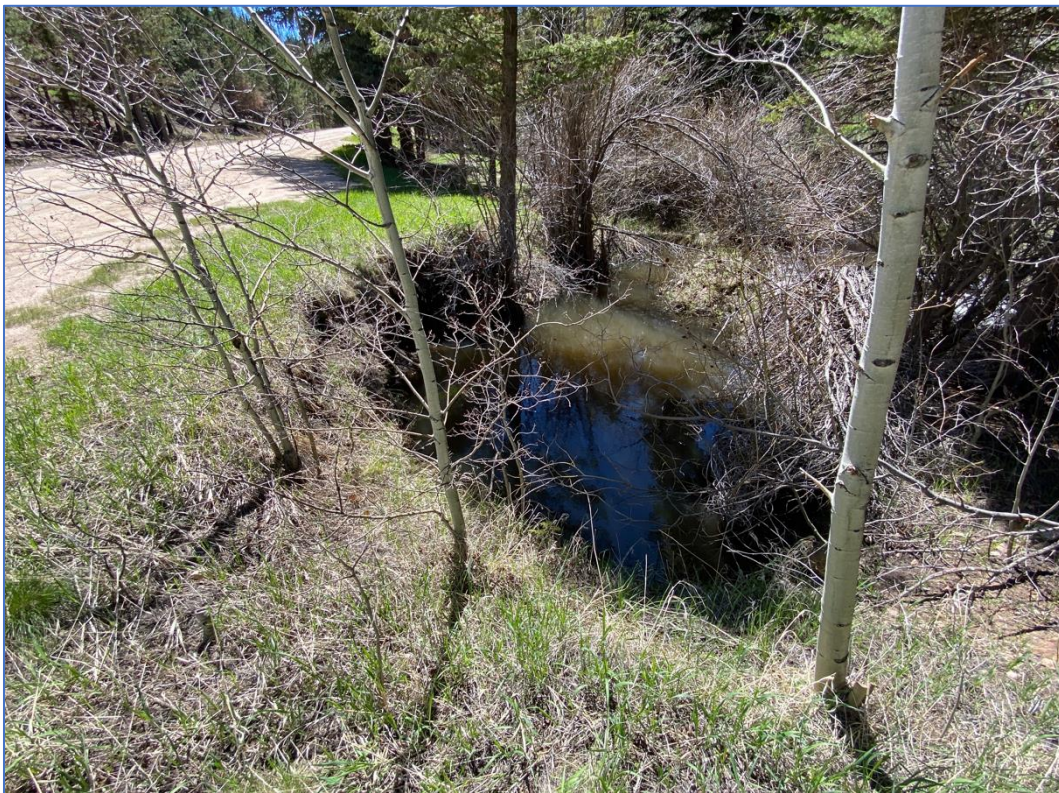
A field visit of the site was conducted, and it was observed that the existing culvert was in good condition with plenty of established vegetation at both the upstream and downstream faces. Two areas of the road embankment had already experienced significant erosion and were identified as priorities for installation of protective measures. Figure 5 shows the approximate location of the Bennett Creek project area.

Photo 4: Pre-Construction – Stream erosion and large erosion hole (2021)

ACE then developed an Existing Condition HEC-RAS model utilizing field survey information, the 2013 DEM produced by FEMA, Manning's n values determined by ACE, and Enguinity's hydrology. The Existing Condition model was used to analyze the 2-, 10-, and 100-year flood events. Results of the Existing Condition Hydraulic Modeling can be found in Appendix C for each project area. Erosion countermeasure design was calculated in the FHWA Hydraulic Toolbox (version 4.4). The most severe hydraulics were associated with the 100-year event and resulted in sizing and recommending that Class 18 rock riprap be installed with a thickness of 3-ft along identified road embankment areas. Two primary areas were identified which had significant bank erosion received riprap to stabilize the bank slopes and roadway prism.

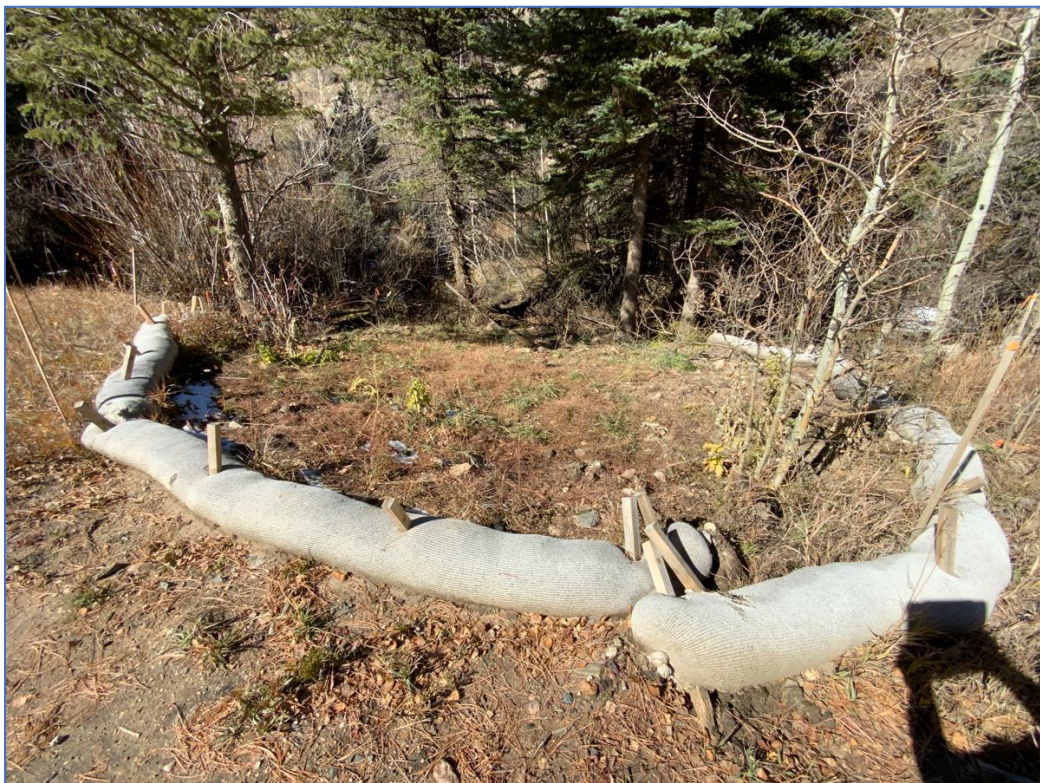
Photo 5: Post-Construction: Seeding and planting to stabilize erosion hole (2022)

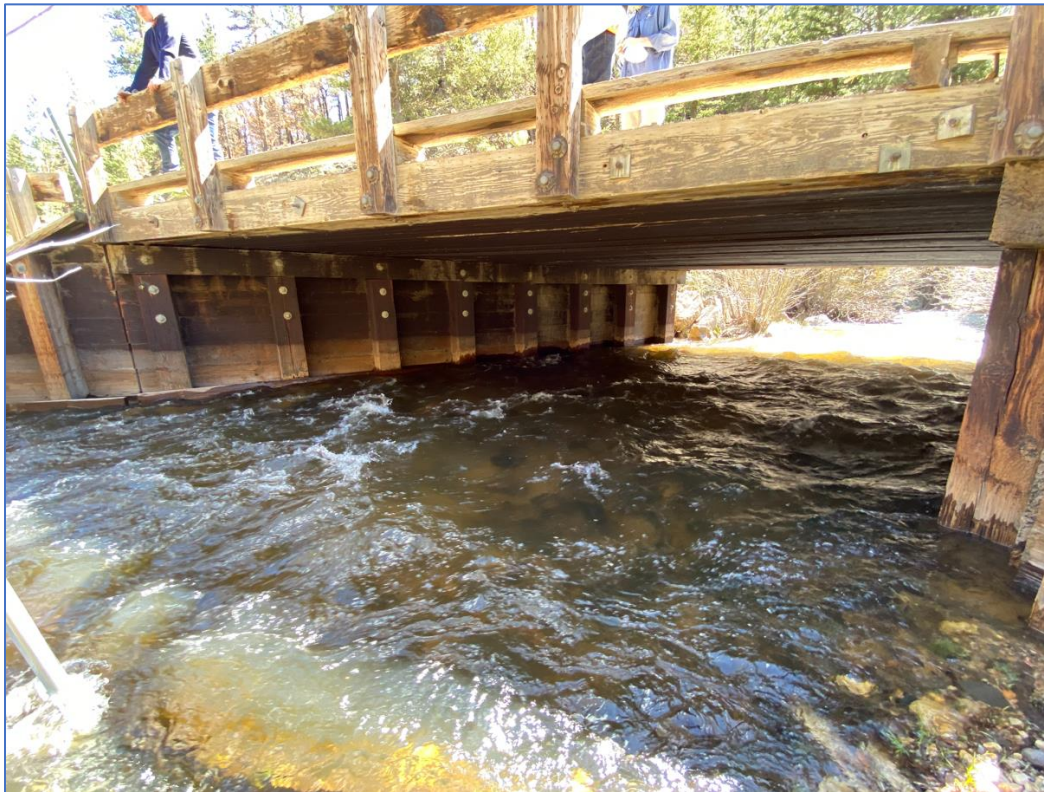
Photo 6: Pre-Construction - Existing Bridge (2021)

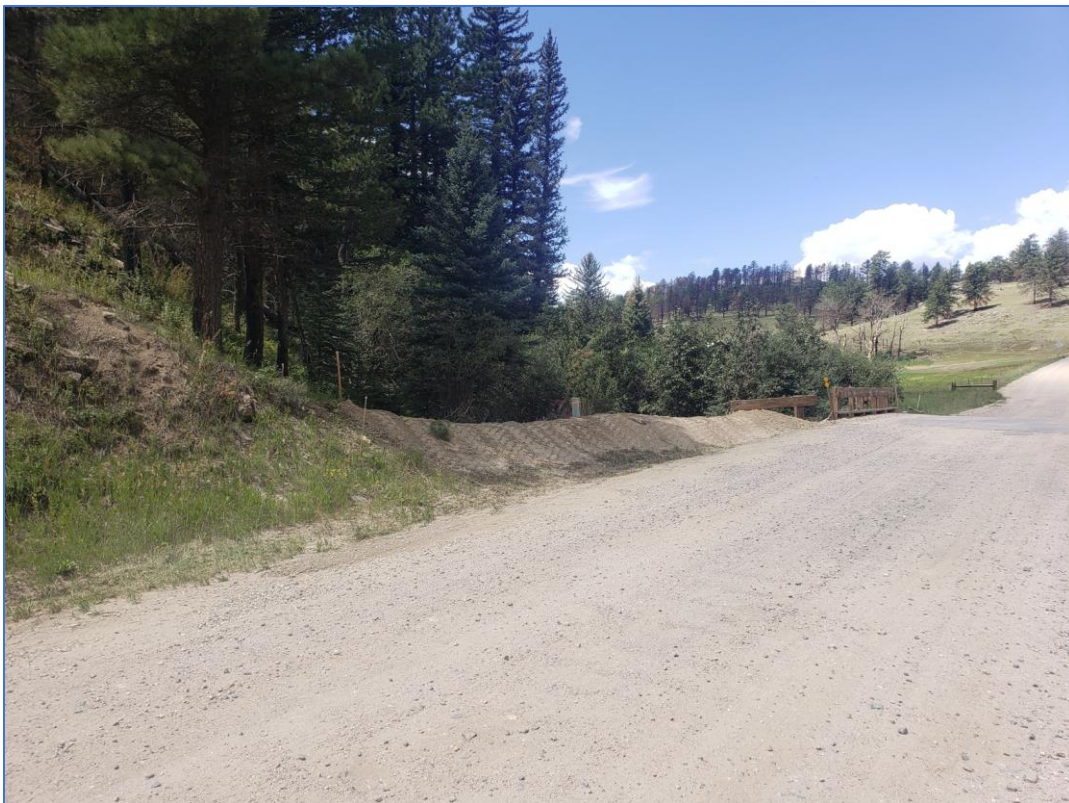
Photo 7: Post-Construction - Installation of the Earthen Berm (2022)

Erosion countermeasure design was calculated in the FHWA Hydraulic Toolbox (version 4.4). The most severe hydraulics were associated with the 100-year event and resulted in sizing and recommending that Class 12 rock riprap be installed with a thickness of 2-ft along identified road embankment areas. Riprap was installed on the stream side of the proposed berm and down the bank to the edge of the existing rocks. The upstream northern bank was also armored with riprap from the top of bank down to the edge of the active channel. The downstream face of the bridge has gentle slopes and is well vegetated and Larimer County opted to minimize channel grading in order to keep the heavily-vegetated willow bushes intact.

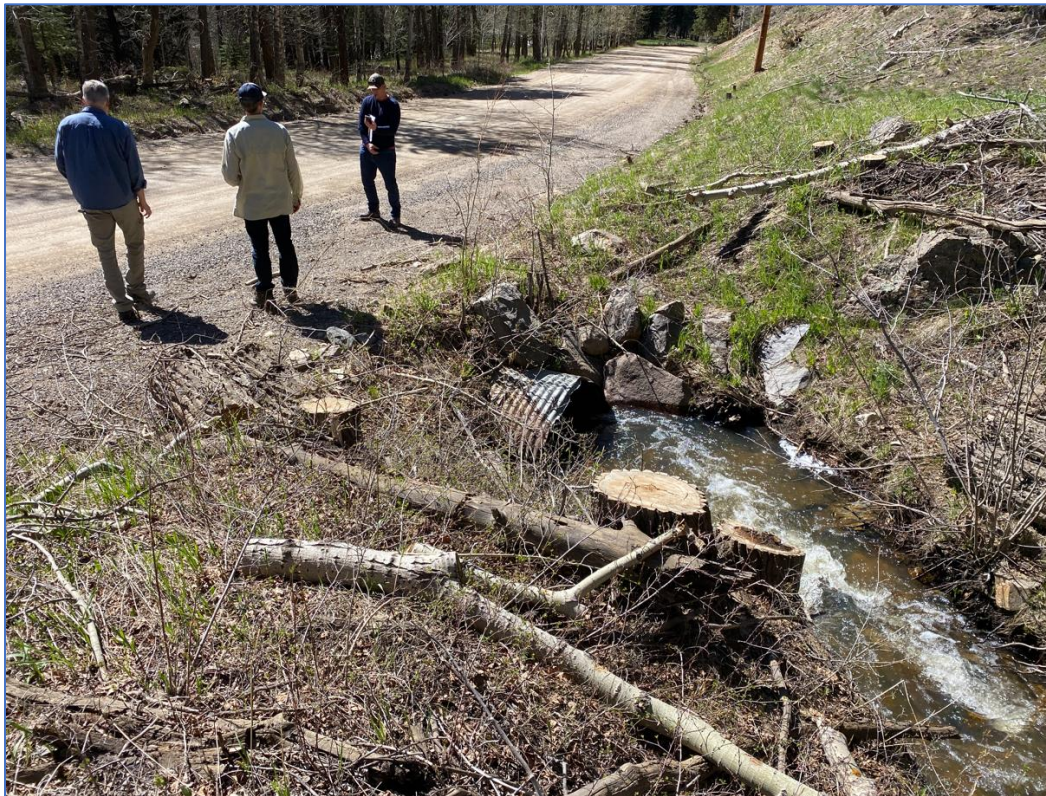
Photo 8: Pre-Construction - Undersized Culvert Inlet (2021)

The new 84" CMP was modeled with an upstream invert of 7927-ft and a downstream invert of 7925-ft. ACE proposed the construction of one 18" rock drop structure using 36" diameter boulders to help regrade the channel directly upstream of the proposed culvert to an elevation of 7927-ft. The HEC-RAS model indicated that a hydraulic jump was likely to occur at the proposed culvert for multiple flow events. ACE recommended placing grouted 24" boulders directly upstream and downstream of the culvert. Riprap with a D50 of 12" and a thickness of 2-ft was placed alongside the road adjacent to the grouted boulders on the downstream end of the culvert to minimize erosion from overtopping flows.

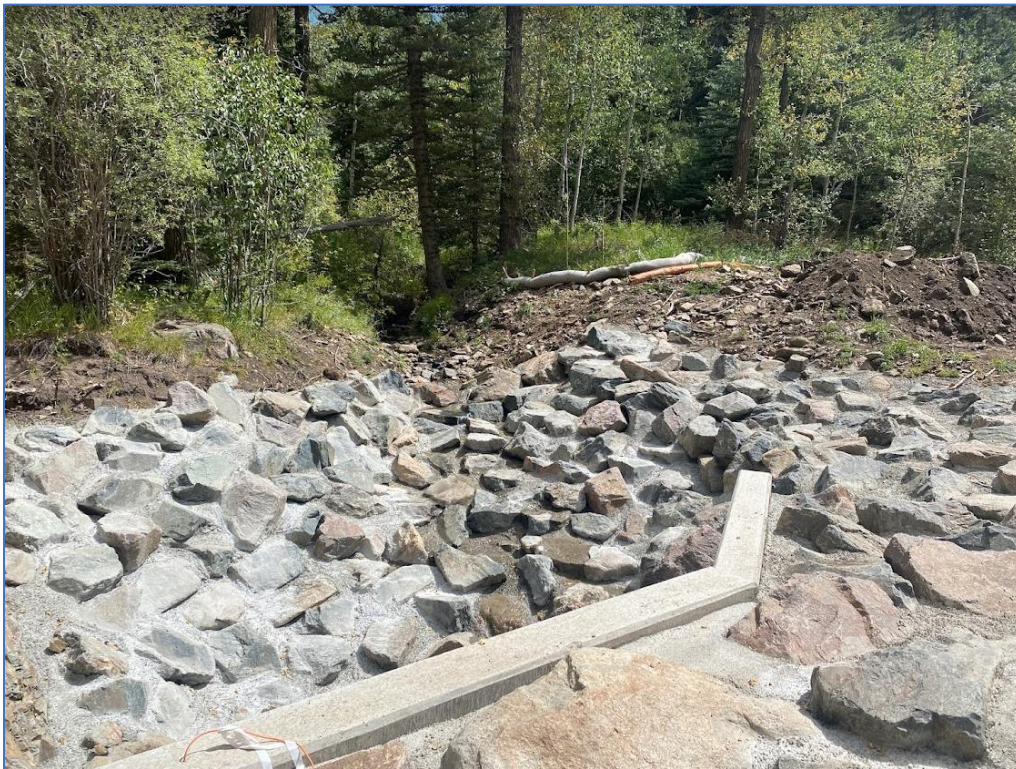
Photo 9: Unnamed Tributary looking Upstream at the grouted boulders (2022)

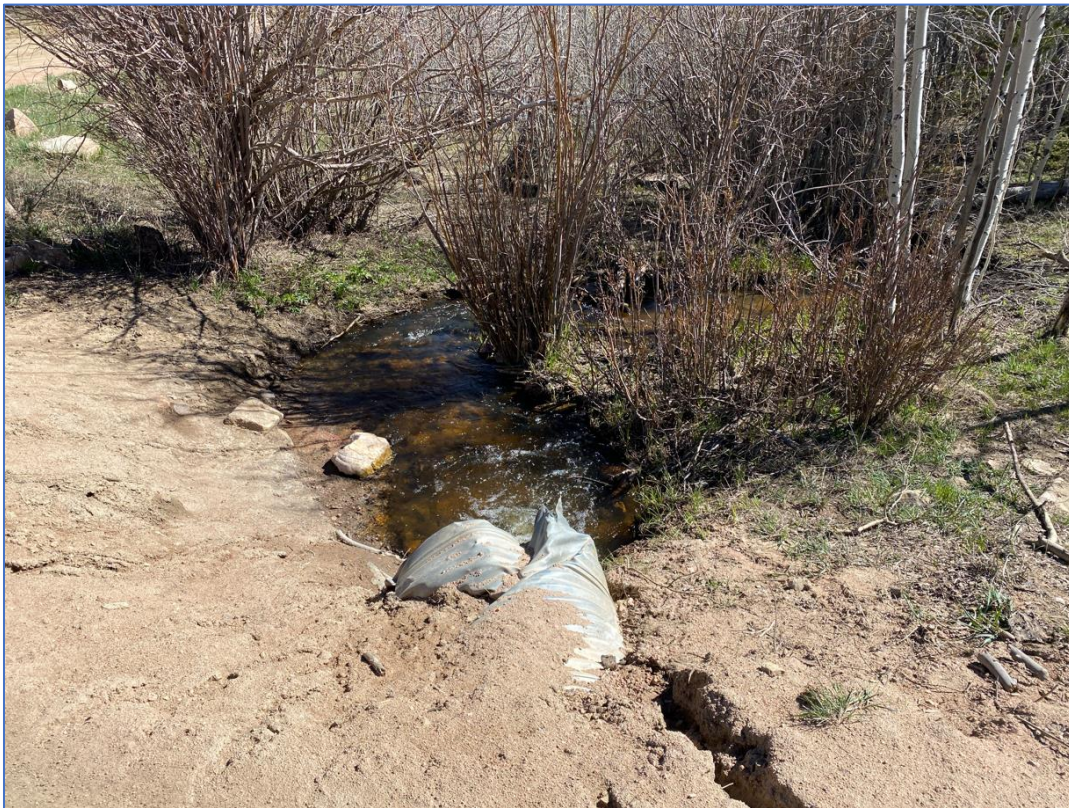
A field visit of the site was conducted and it was observed that the downstream face of the culvert (identified as a 40" CMP by surveyors) was damaged but deemed serviceable. The areas immediately upstream and downstream of the existing culvert were identified as locations where erosion protection measures could be installed to provide protection to the road embankment. Figure 8 shows the location of the Swamp Creek culvert project area.

Photo 10: Pre-Construction - Existing Swamp Creek Culvert Conditions (2021)

The Hydraulic Toolbox rock riprap sizing methodology indicated that riprap with a d50 of 9 inches, would be stable. ACE recommended that Class 12 rock riprap be installed with a thickness of 2 feet along the identified road embankment areas.

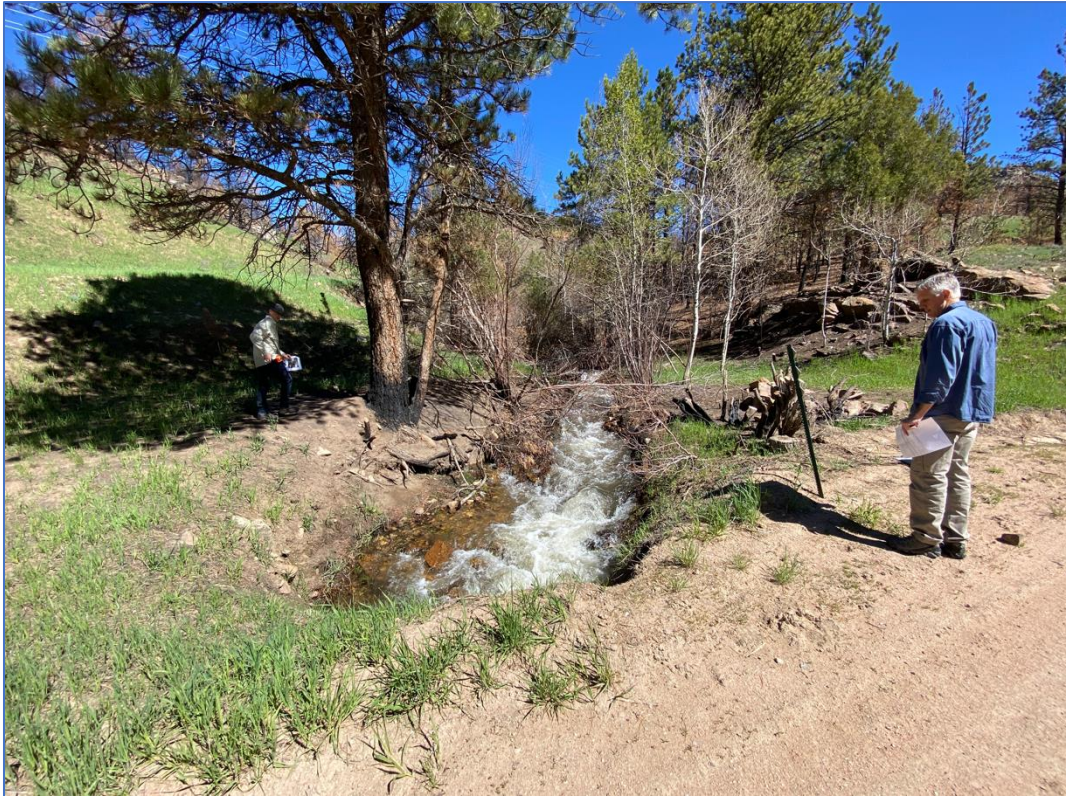
Photo 12: Pre-Construction - Inlet of the existing 069-0.43-S14 culvert (2021)

Riprap sizing for the road embankment was calculated in FHWA Hydraulic Toolbox (version 4.4) using the results from the Existing Condition HEC-RAS model. The most severe hydraulics are associated with the 100-year event, and accordingly, modeling results for the 100-year discharge were evaluated through the area of concern upstream of the culvert crossing. The Hydraulic Toolbox rock riprap sizing methodology indicated that riprap with a D50 of 23 inches, would be stable. ACE recommends that Class 24 rock riprap be installed with a thickness of 4 feet along the identified road embankment areas.

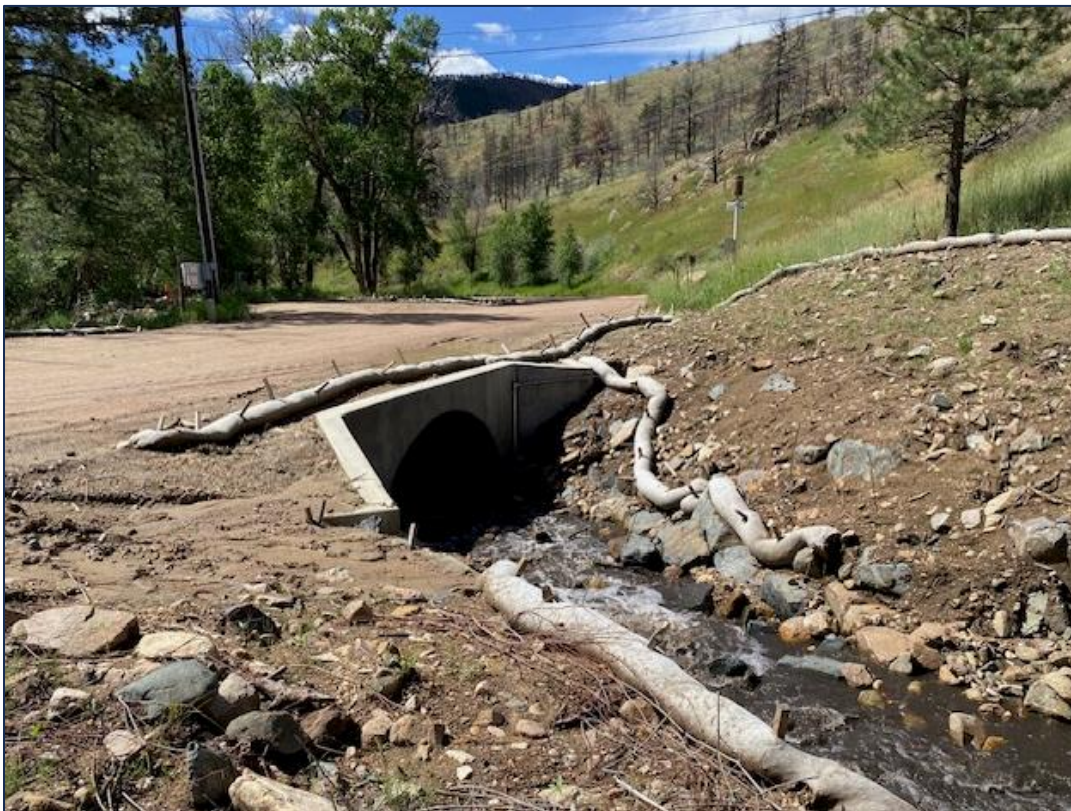
Photo 13: Post-Construction - View looking downstream (2023)

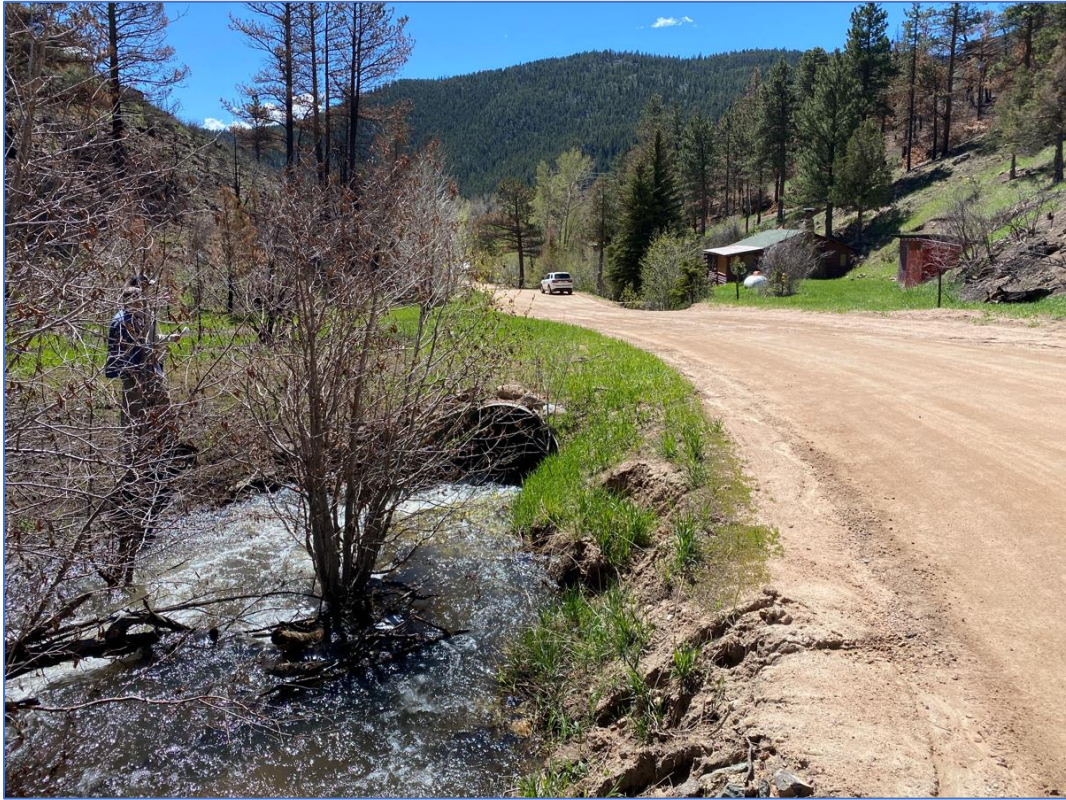
A field visit of the site was conducted, and it was observed that a berm in the channel upstream of the culvert was deflecting water towards the road embankment where erosion was already occurring. The existing culvert was a 68" x 51" horizontal elliptical corrugated metal pipe (CMP). Figure 8 shows the location of the Sevenmile Creek project.

Photo 14: Pre-Construction - Looking South towards the line of cabins; the existing culvert had frequent overtopping events (2021)

Finally, structure protection was proposed at three of the four cabins downstream of the culvert. To mobilize in the equipment necessary to install either concrete block walls or flood barrier bags, two property culvert accesses were removed and replaced (construction access) to accommodate the larger equipment necessary to set the structure protection.

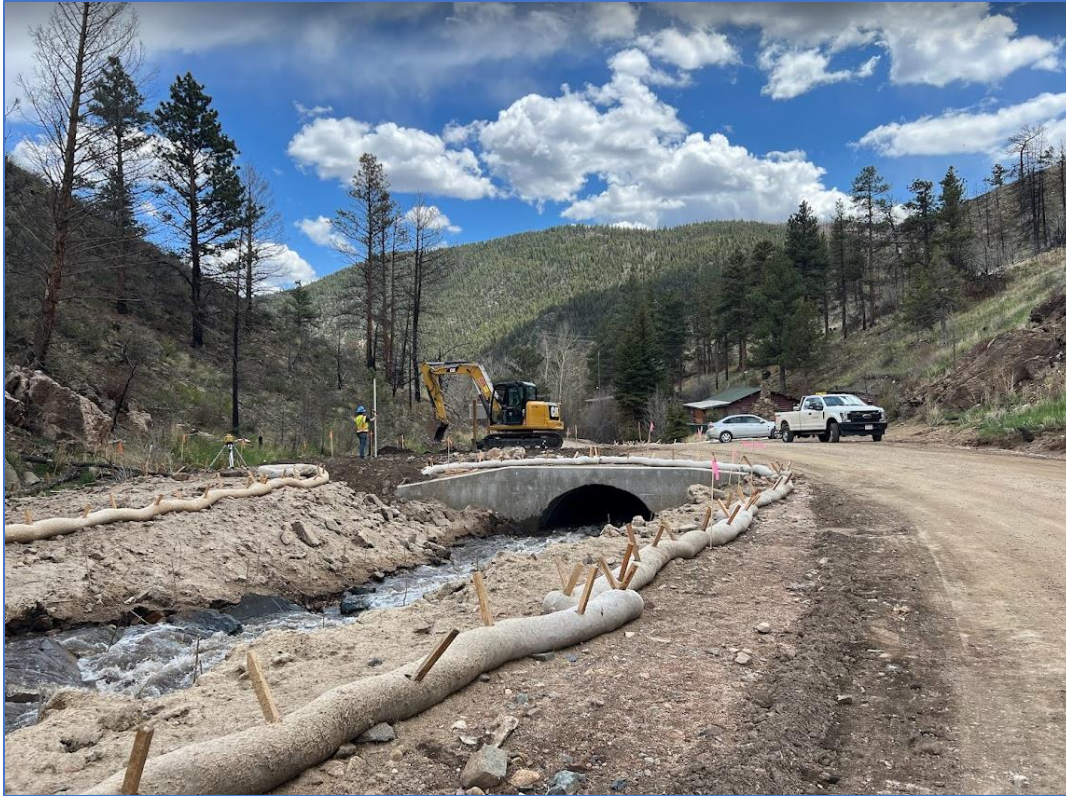
Photo 15: Post-Construction - Looking downstream at the culvert inlet and construction of a low-water crossing to help facilitate flows back into Sevenmile Creek past the downstream end of the structure (2023)

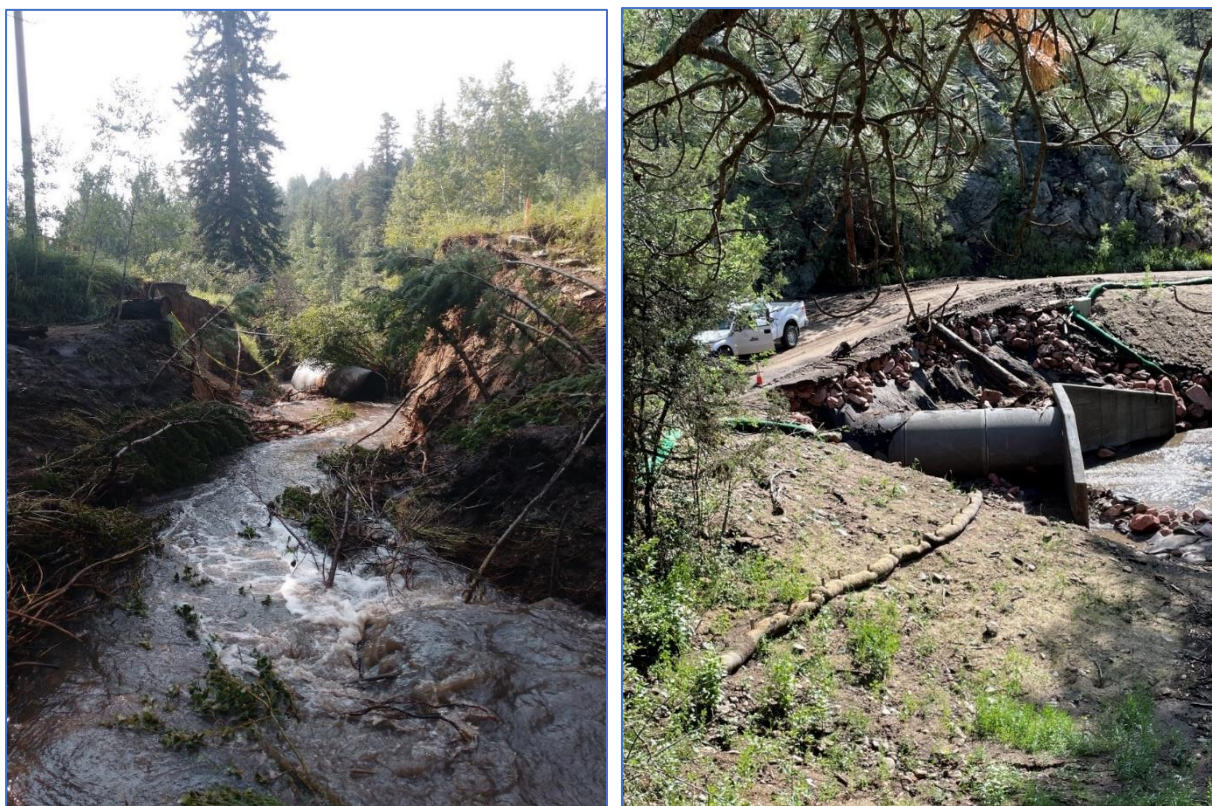
In July of 2021, The Retreat subdivision saw multiple flood events in both the Black Creek and Miller Fork drainages. The flooding caused severe damage to Streamside Drive and Black Creek Drive, as well as damage to private accesses, property, and homes. In July of 2022 the area saw more flood events causing severe damage to repaired areas that were constructed in 2021. Photo 16 and Photo 17 show resulting damage from 2021 and 2022 events, respectively. Additional photos are included in Appendix C.

Photo 16 (Left): Upper Streamside Drive Culvert (The metal pipe clogged with debris which resulted in severe erosion), 2021. Photo 17 (Right): Upper Streamside Drive – July 2022 Flooding: An 84" reinforced concrete pipe (RCP) was installed after the 2021 flood; however, the culvert was overtopped during multiple storm events in 2022. The D50 24" riprap (ungROUTED) was replaced with D50 12" matrix (partially-grouted) riprap in 2022 to improve resiliency.

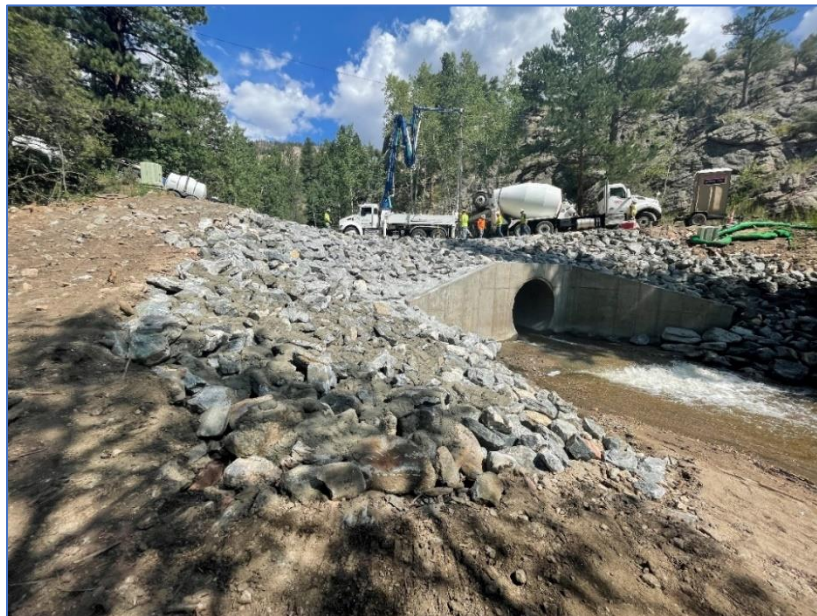
Photo 18: Upper Streamside Culvert – This photo shows the grouting operation for the overtopping protection

During the 2021 construction efforts, due to time constraints, constructability and material availability, the decision was made to substitute matrix riprap along the downstream side of the upstream crossing of Miller Fork with D50 24" riprap. The flood events that occurred in July 2022 caused that D50 24" riprap to fail. The team then worked to come up with a solution to implement and construct the matrix riprap to be the permanent solution for flood overtopping resilience. The resulting crossing can be seen below in Photo 18.

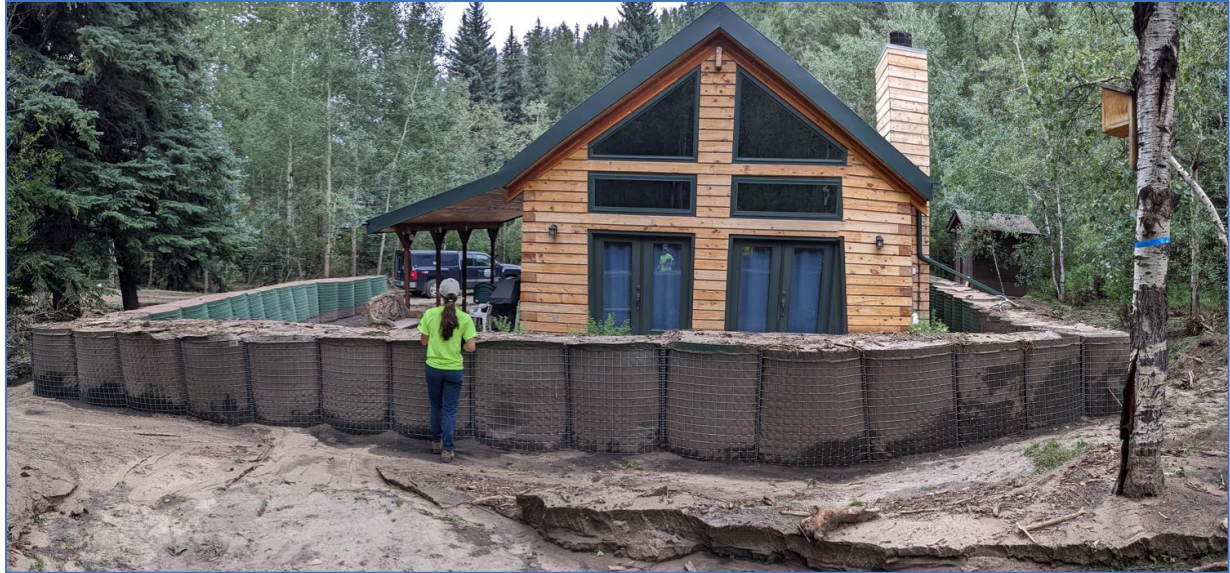
The mitigation measures were instrumental in the protection of lives and property. The bags were installed in 2021, prior to major flooding seen in 2022. Photo 19 shows post July 21, 2022, event at 719 Streamside Drive. High water can be seen by the mud on the sides and tops of the bags, there were also several debris indentations seen along the bags. After the 2022 event, more property owners requested bags and there were some minor adjustments made to existing layouts.

Photo 19: Post-flood event at 719 Streamside - Flood barrier bags surround the home and were fully activated by the flood

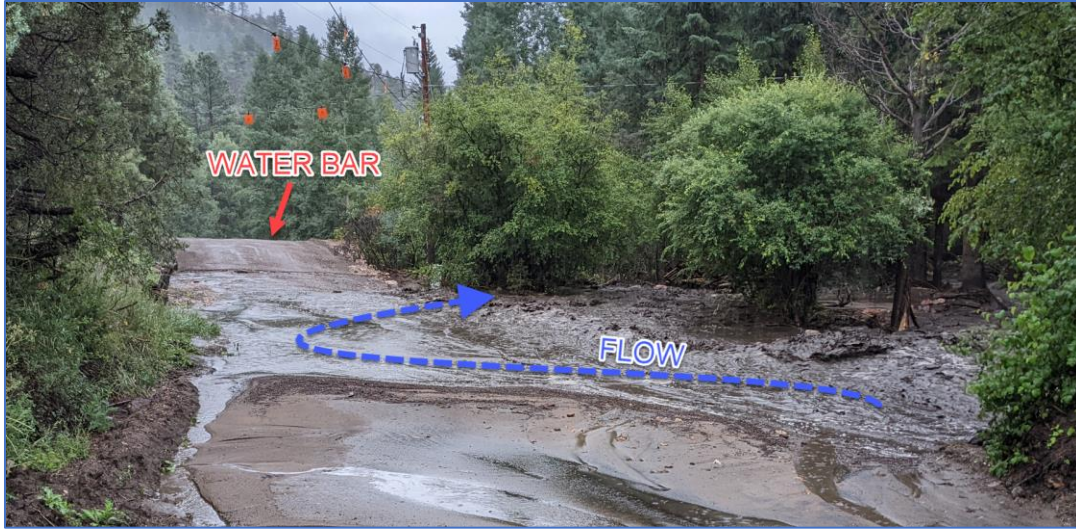
Photo 20: Effectiveness of Water Bar Demonstrated During High Flow Event

Two water bars were installed along the road for Black Creek in 2021 in an effort to keep flow in the channel. In late-2022, two more water bars were added to the road along Streamside Drive upstream of the confluence of Black Creek to prevent further property damage. All locations were strategically placed to line up with flood barrier bags to combine mitigation efforts. The water bars were designed to provide protection from the 25-yr post flood event using the 2D model calculated depth values. The locations of the two additional water bars are shown in Figure 10. The effectiveness of the water bars and keeping the water in channel and off the road is shown in Photo 20 below during a high flow event on August 19, 2022. The updated plans for these locations are included with the plan revisions included in Appendix C.

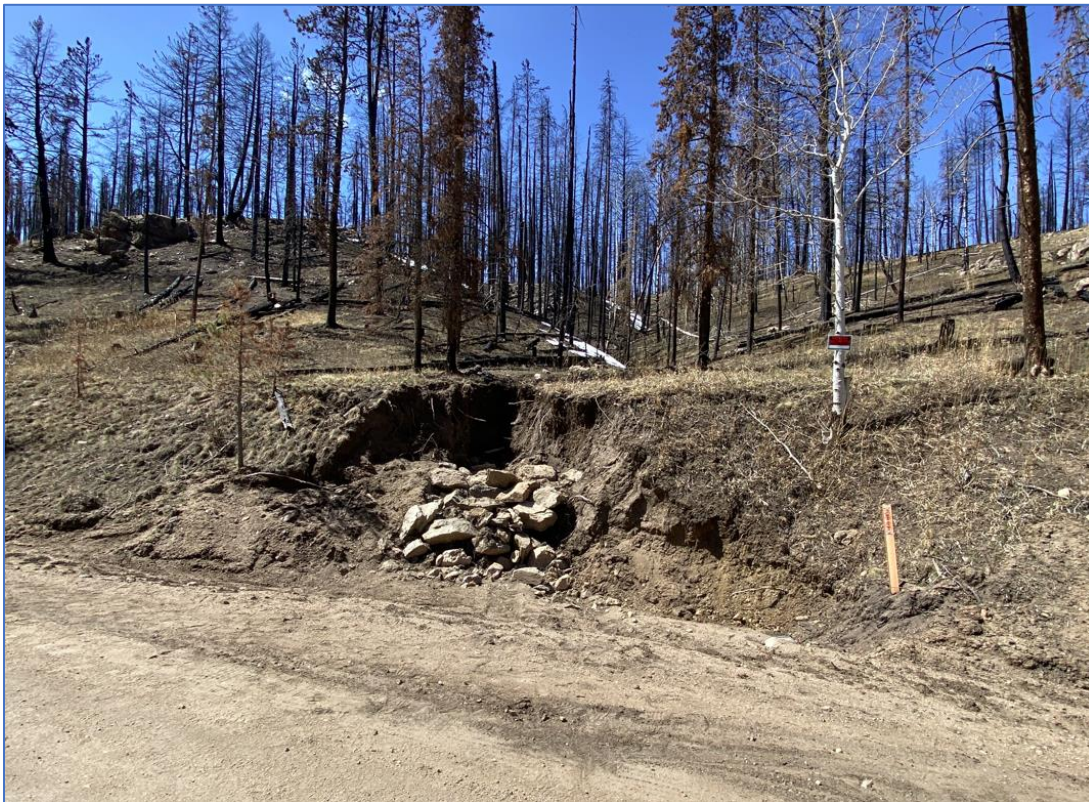
Photo 21: Pre-Construction – Example of roadway embankment erosion at 063E-0.26-44H (2022)

Several areas along LCR 63E were added to the project areas in 2022. Private property owners in the vicinity of Lazy D Ranch, approximately 0.2-miles North of the intersection of LCR 63E and LCR 44H, contacted Larimer County about active roadway bank erosion and headcutting at several drainages which drain into Pennock Creek and the South Fork of the Cache la Poudre River. Several field visits were conducted along LCR 63E and it was determined that there were two drainages in particular, which fed into existing 18" CMP cross-culverts, would benefit from a series of rock check dams and regrading to minimize incising of the hillslope. A rock chute was also proposed at one of the culvert inlets. Erosion protection was also proposed at the other three culvert locations. Figure 11 shows the approximate locations of the five culverts. Additional details can be found in the as-built plans in Appendix C.

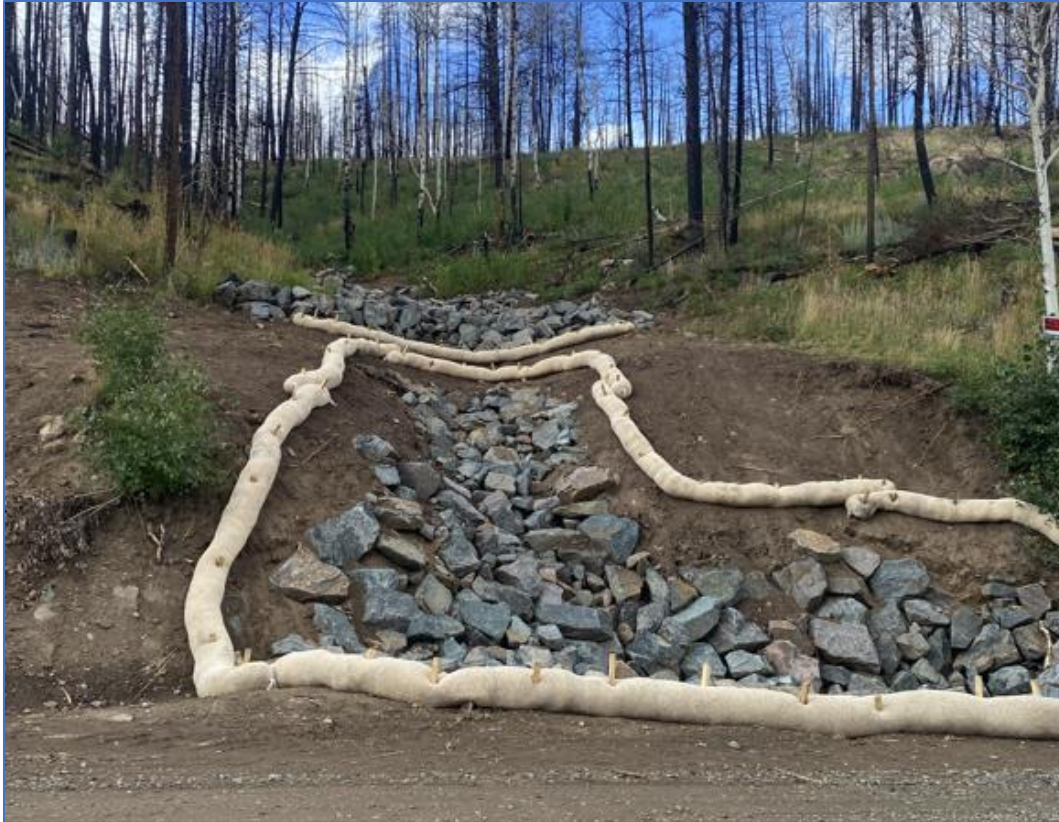
Photo 22: Post-Construction – Example of rock checks and rock chute at culvert inlet (2022)

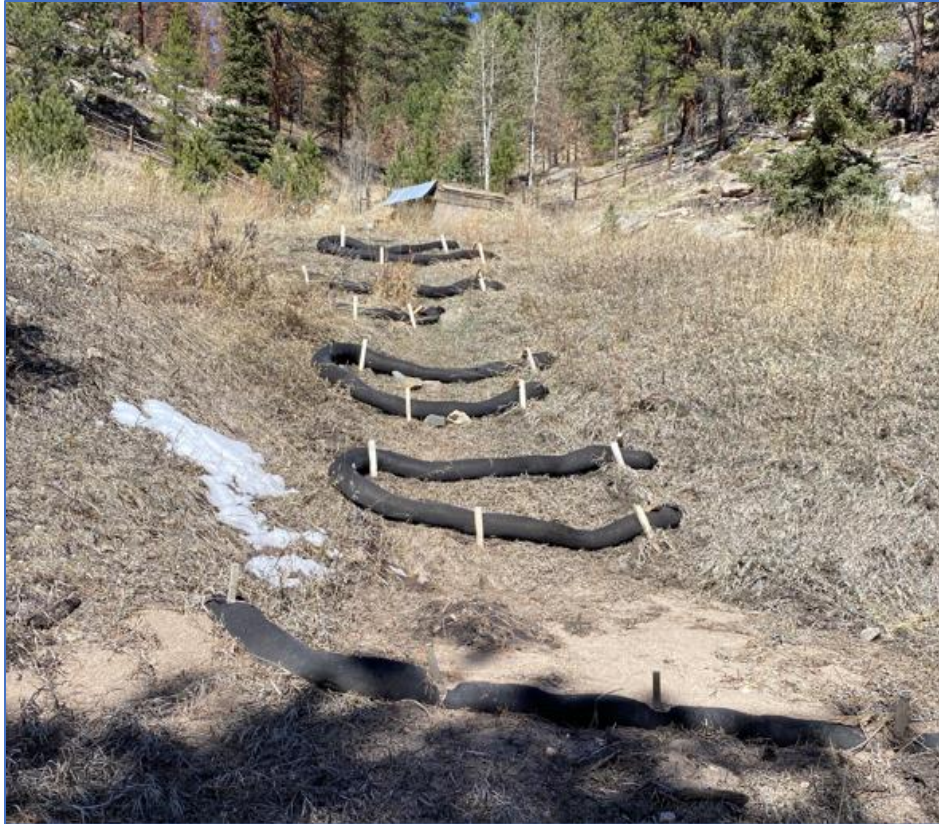
Photo 23: Pre-Construction – View of the Alluvial Fan at Lazy D Ranch Road

An earthen berm was installed at the mouth of drainage above Lazy D Ranch Road to force runoff to remain closer to the center of the hillside and away from the existing structure to the west. Below the berm, the roadway was lowered to concentrate flows across a concrete pan and into a rock chute. Additional details can be found in the as-built plans in Appendix C.

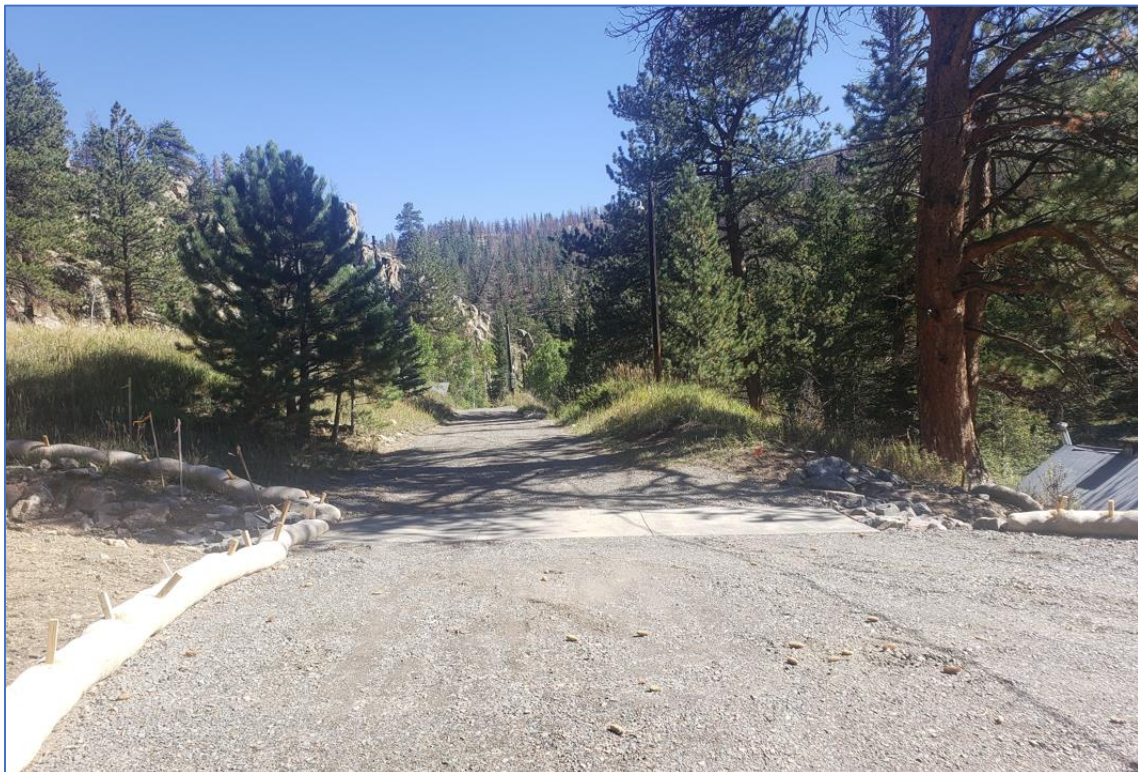
Photo 24: Post-Construction – View looking East of armored concrete low-water crossing (2022)

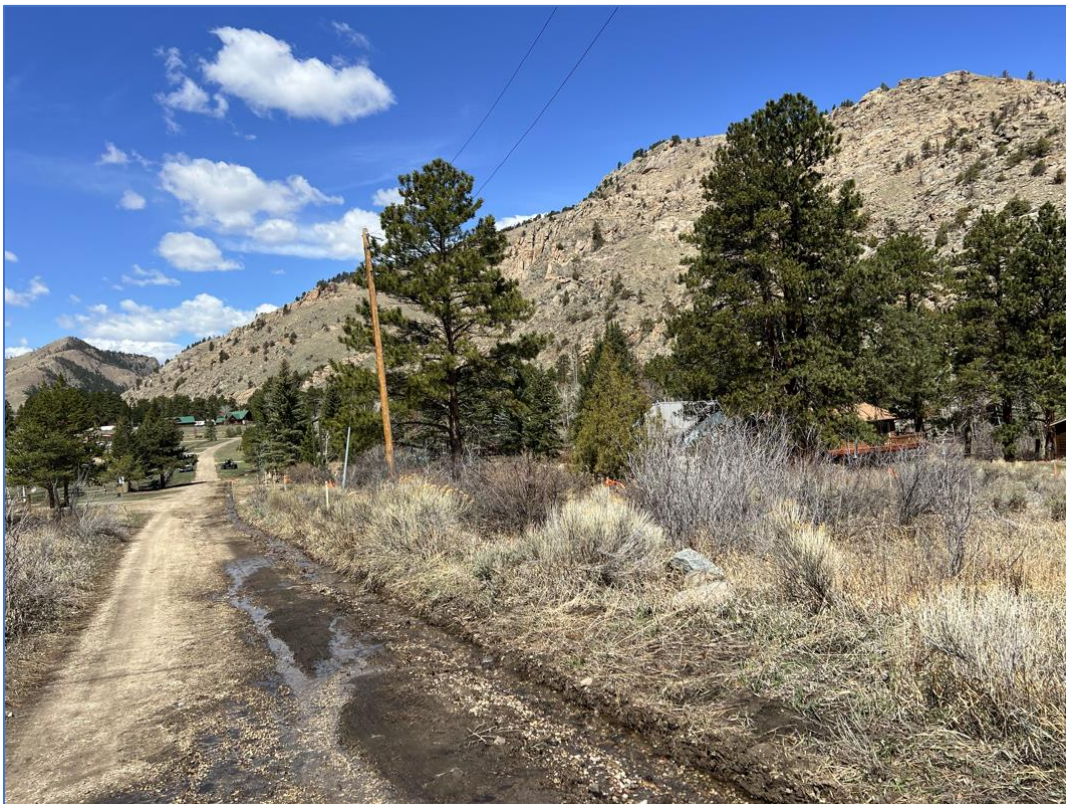
Photo 25: Pre-Construction - Looking West along Crown Point Drive (2023)

To concentrate runoff into an existing preferred flow path, rock check structures were installed near the mouth of the gulch. These dams forced runoff to flow to stay within an engineered path rather than fanning out, uncontrolled. It was generally agreed to by the majority of the homeowners that flow paths should be created to direct the flows to the Poudre River. A roadside ditch was installed on the north side of Crown Point Drive and tied in to two different drainage ditches which were graded and armored to get flood flows to the Poudre River. The eastern diversion ditch was engineered with a D50 18" rock chute at the outlet end and several smaller rock checks. Low water crossings were needed at each driveway to direct flows. Additional details can be found in the as-built plans in Appendix C.

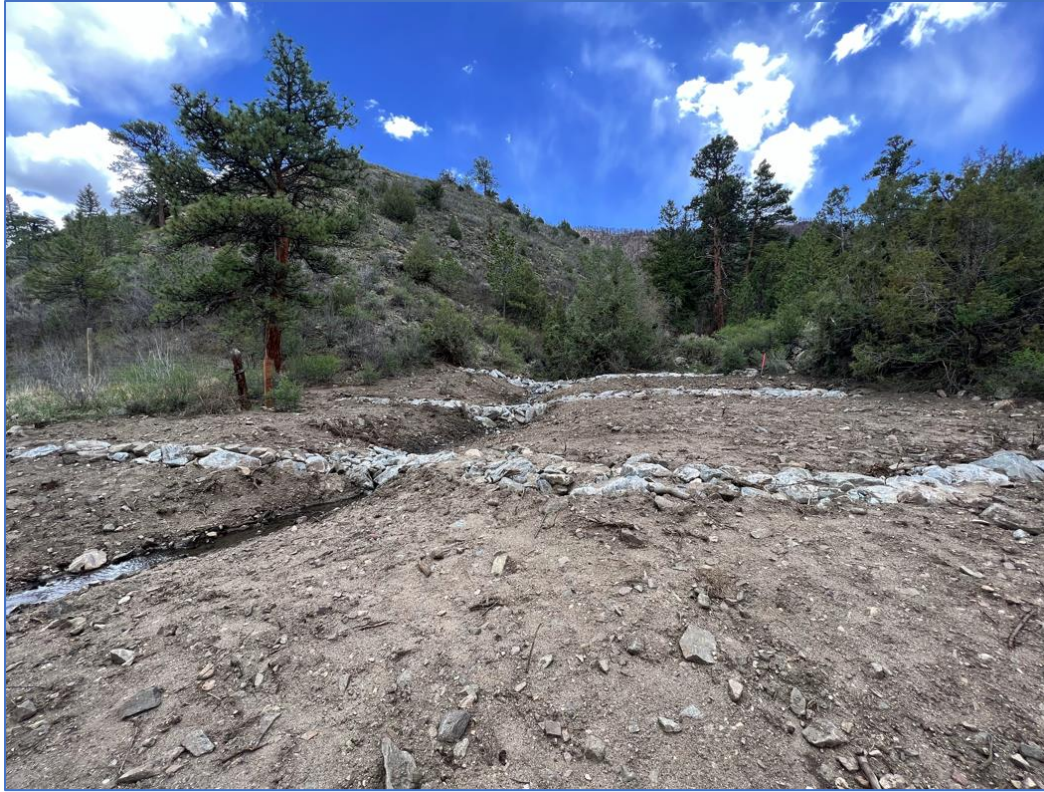
Photo 26: Post-Construction – Looking South at the rock check dams installed at Bears Gulch (2023)

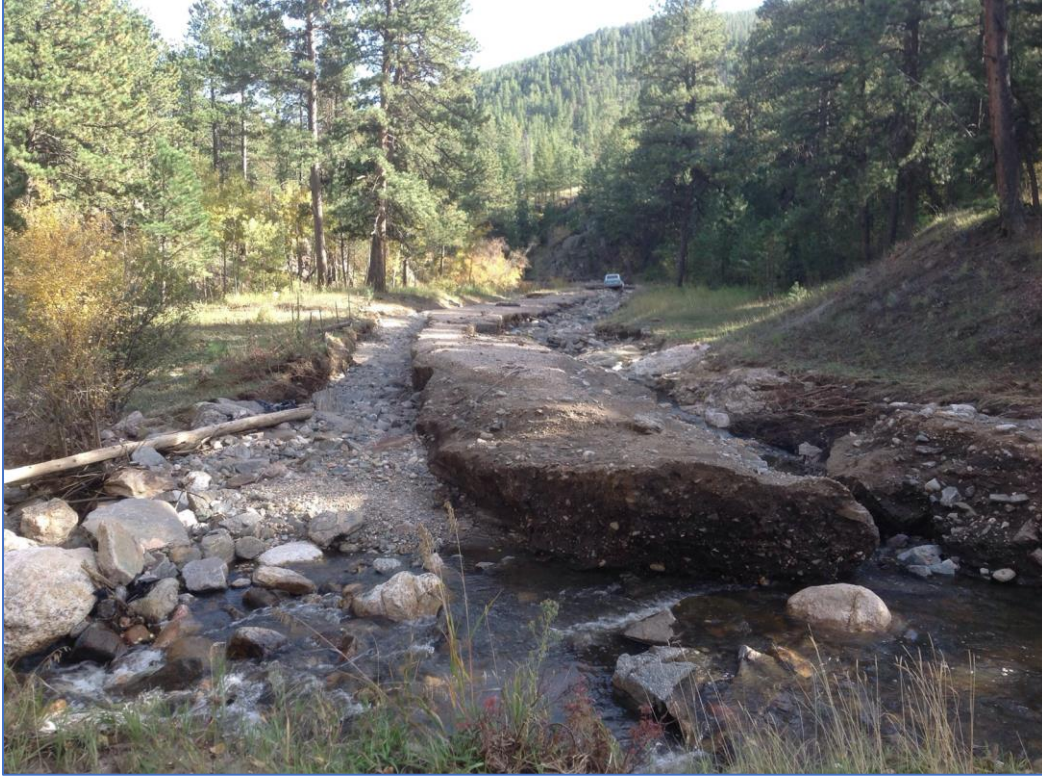
Flood damage that occurred following the Cameron Peak Fire confirmed the need for revetment of the LCR 44H road embankment and for increased numbers and sizes of cross-culverts. Locations where new or more robust measures were needed correlated well with locations identified in the preliminary 2013 Flood recovery design. However, the 2013 Flood recovery design was not intended to protect the road from extreme post-fire hydrologic conditions; therefore, subsequent 2021 and 2022 post-fire flooding events informed where additional and/or increased measures were needed. Post-fire hydrology suggested a 25-year discharge of greater than 6,000 cfs above Twin Cabin Gulch, and 8,400 cfs below Stove Prairie Creek.

Photo 27: Typical Damage Sustained along LCR 44H (October 2020)

During 2020 and 2021, Larimer County constructed flood mitigation measures along LCR 44H using the original 2013 design as a starting basis. Three riprap gradations were utilized for the post-fire revetment. For most locations, 24" D50 rock riprap was used, installed to a depth of 4 feet. At locations where augmentation of existing protection was required on the upper portion of the embankment, 12" D50 riprap was installed to a depth of 2 feet. Finally, at some narrow locations in the canyon, 36" D50 riprap was stacked steeply to maintain the minimum width necessary for two vehicles to pass and maintain conveyance capacity of Buckhorn Creek. A variety of cross-culvert sizes were installed after the fire, in some cases up-sizing culverts that were installed prior to flooding; the new culvert sizes generally exceeded those identified in the 2013 design to better serve post-fire flooding conditions. Sizes ranged from 15" diameter CMPs for nuisance flow collectors, to much larger installations such as corrugated plate arch installed at the LCR 44H crossing of Sheep Creek.
