Larimer County Cameron Peak Fire Post-Fire Flood Recovery

Final Report

Prepared for:
Colorado Water Conservation Board
Colorado Watershed Restoration Program (CWRP) Grant
Attn: Chris Sturm

August 14, 2023

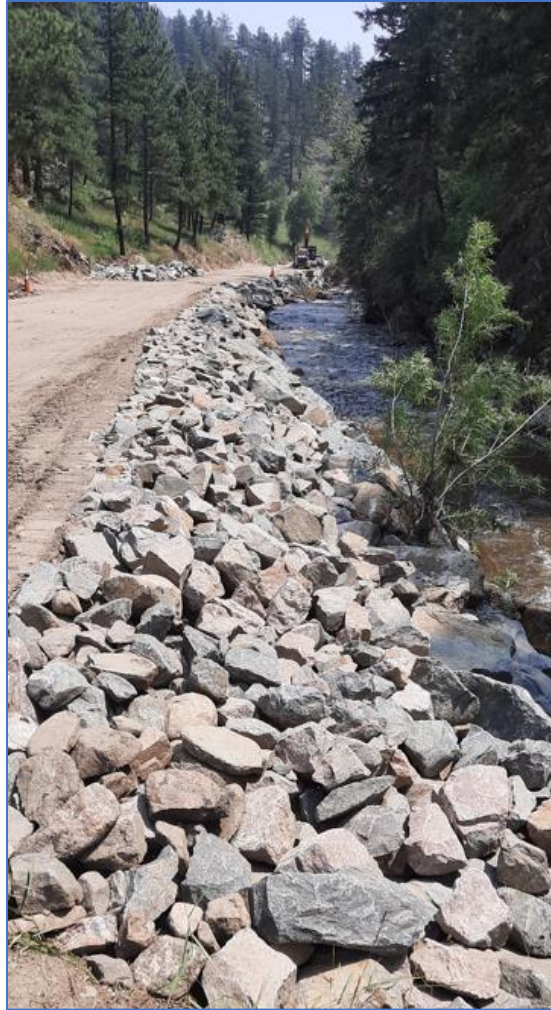
Photo 28: Typical Riprap Installation (Completed in August 2021)

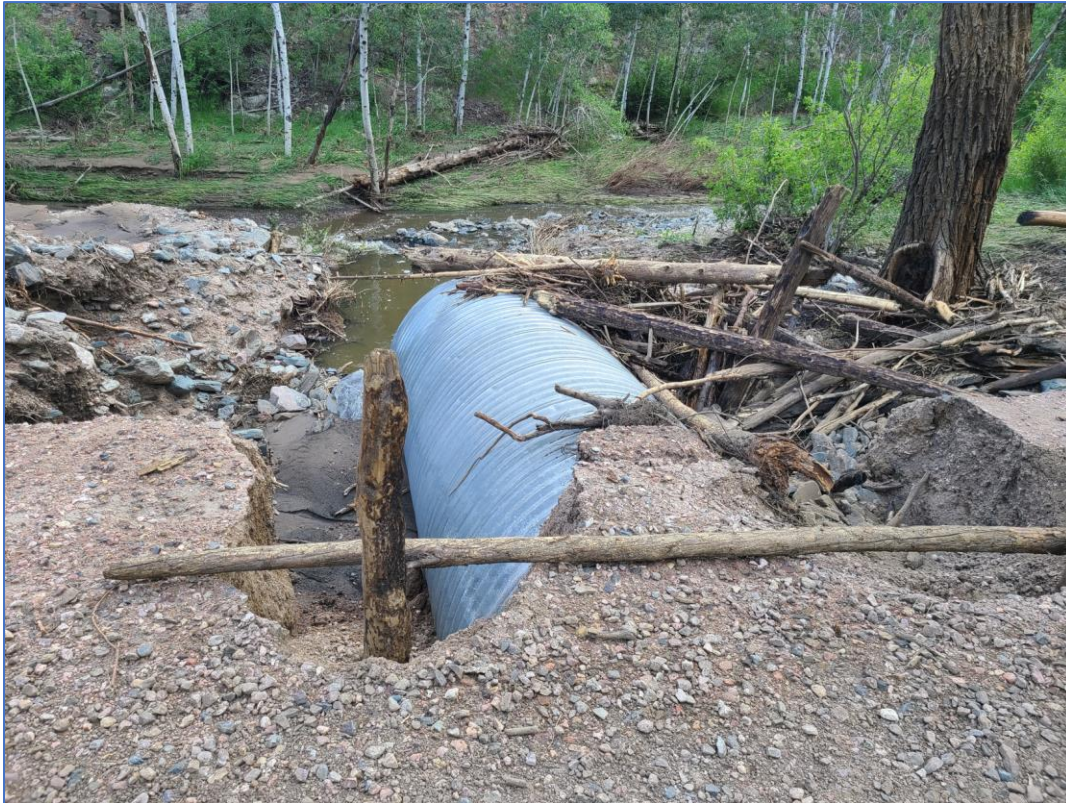
Photo 29: Typical Sheep Creek Damage (Looking North at Outlet end of Sheep Creek Culvert) 2022

The Sheep Creek crossing was reconstructed with a 16.3-ft by 5.9-ft aluminum box culvert with concrete headwalls at the culvert entrance and exit. The pre-project non-overtopping capacity of the crossing was 200 cfs; the post-project non-overtopping capacity is 650 cfs. The post-project crossing conveys the 25-year post fire discharge of 550 cfs without overtopping. Erosion countermeasures were designed for the 50-year event; the riprap sizing analysis yielded 18" D50 riprap, 36 inches deep for the LCR 44H road embankment and 24" D50 riprap, 48" deep for the Sheep Creek channel.

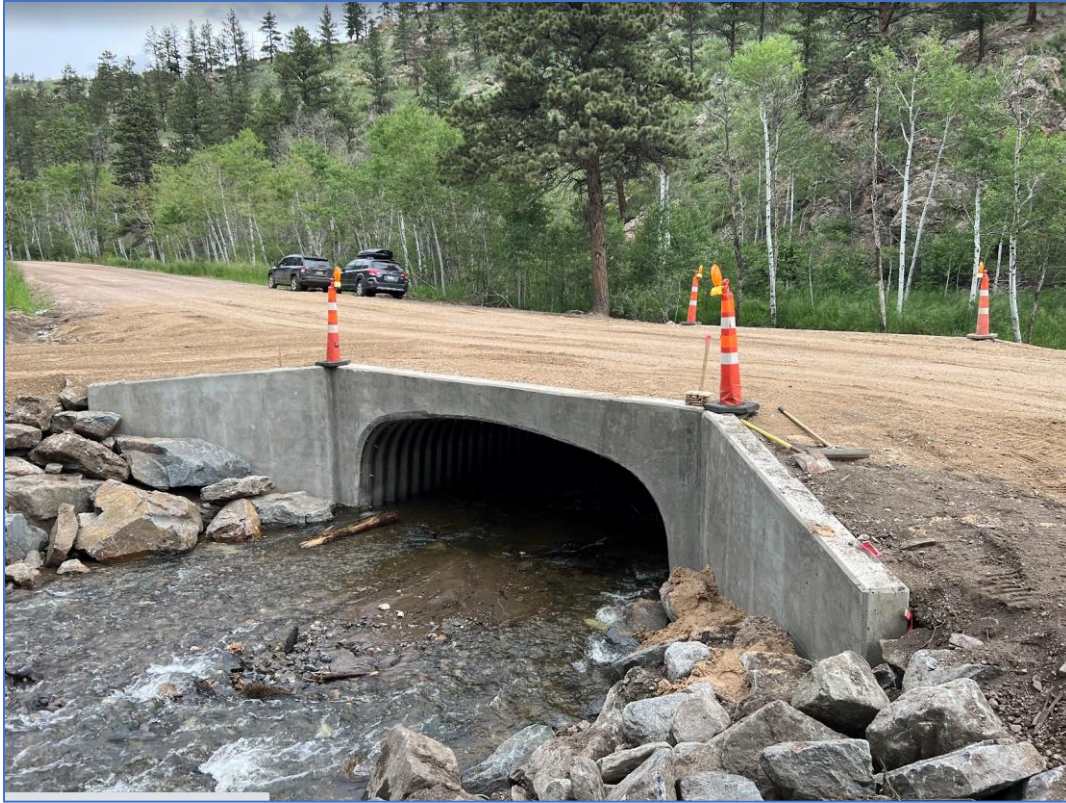
Photo 30: Post-Construction - Sheep Creek Corrugated Plate Arch Structure – substantially complete (looking North) June 2023

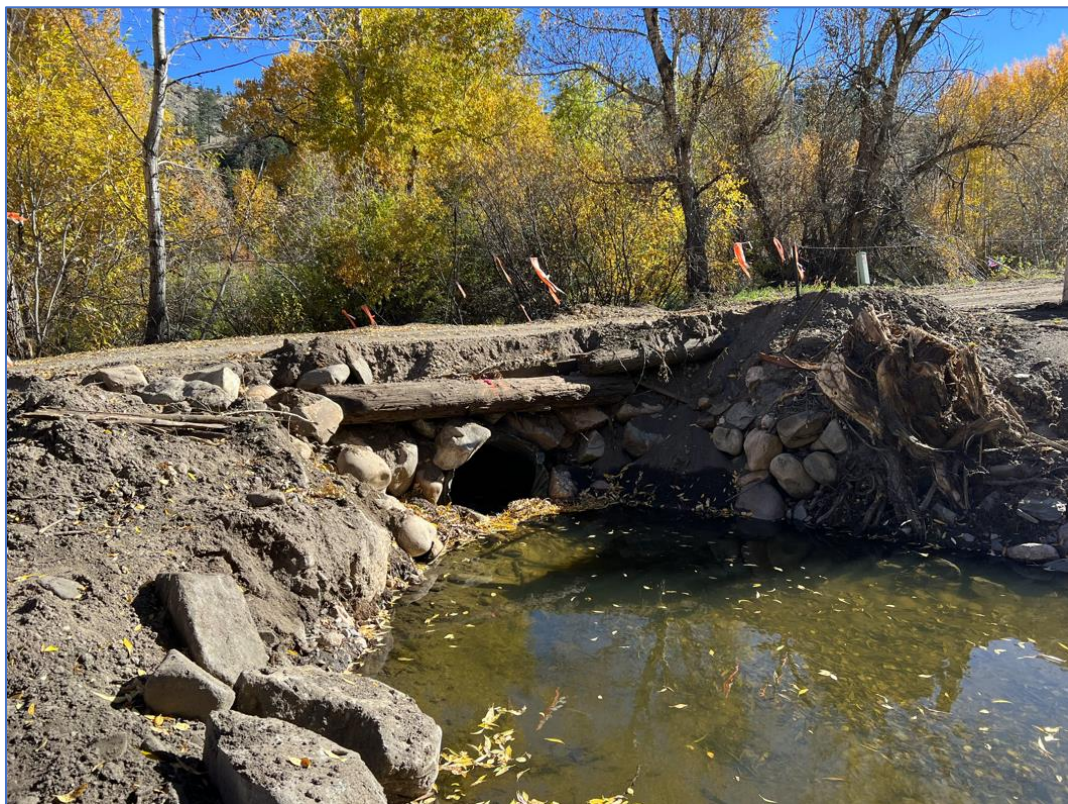
Photo 31: Pre-Construction - Wildsong Post-2022 Flooding

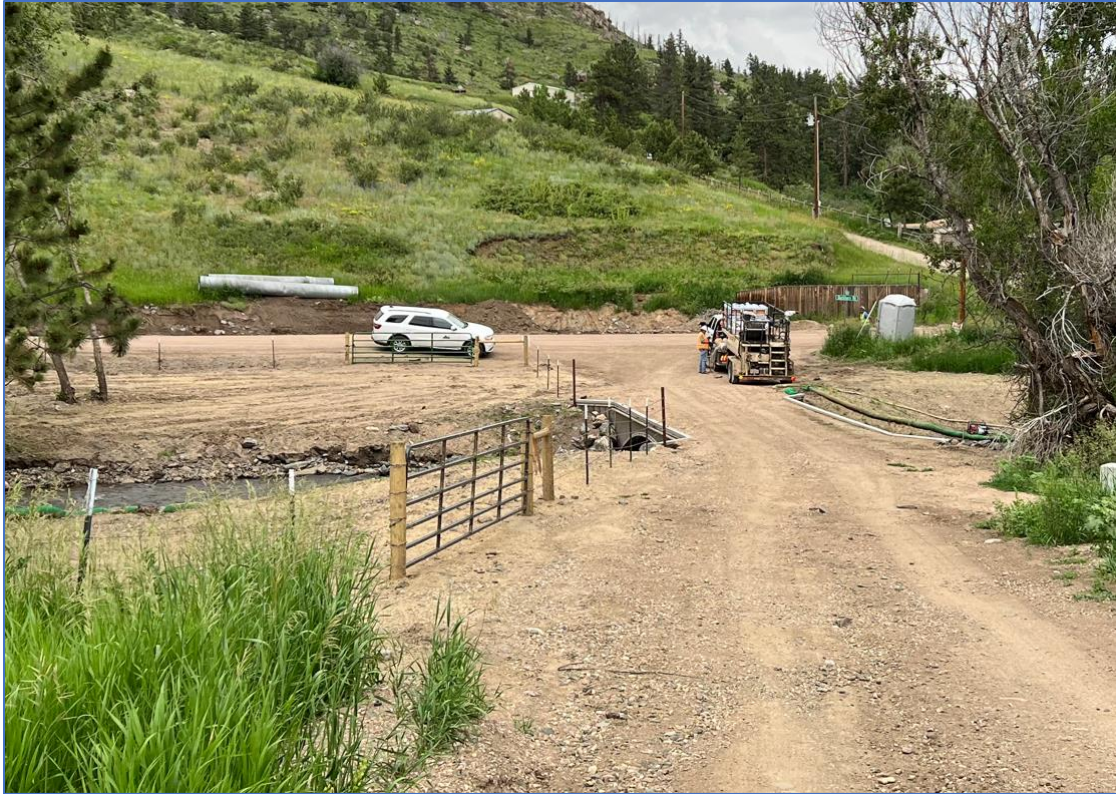
Photo 32: Post-Construction – looking North at new culvert crossing at Wildsong (2023)

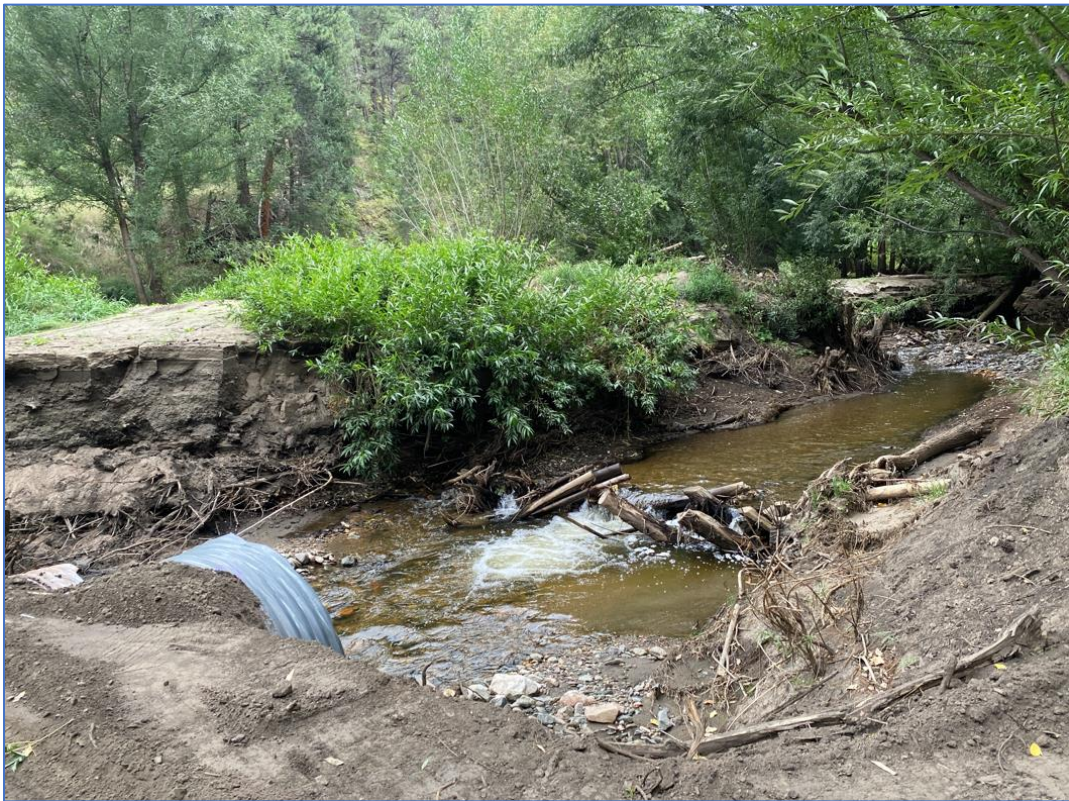
Photo 33: Pre-Construction – Debris deposit on the upstream side of the Deerpath culvert (2022)

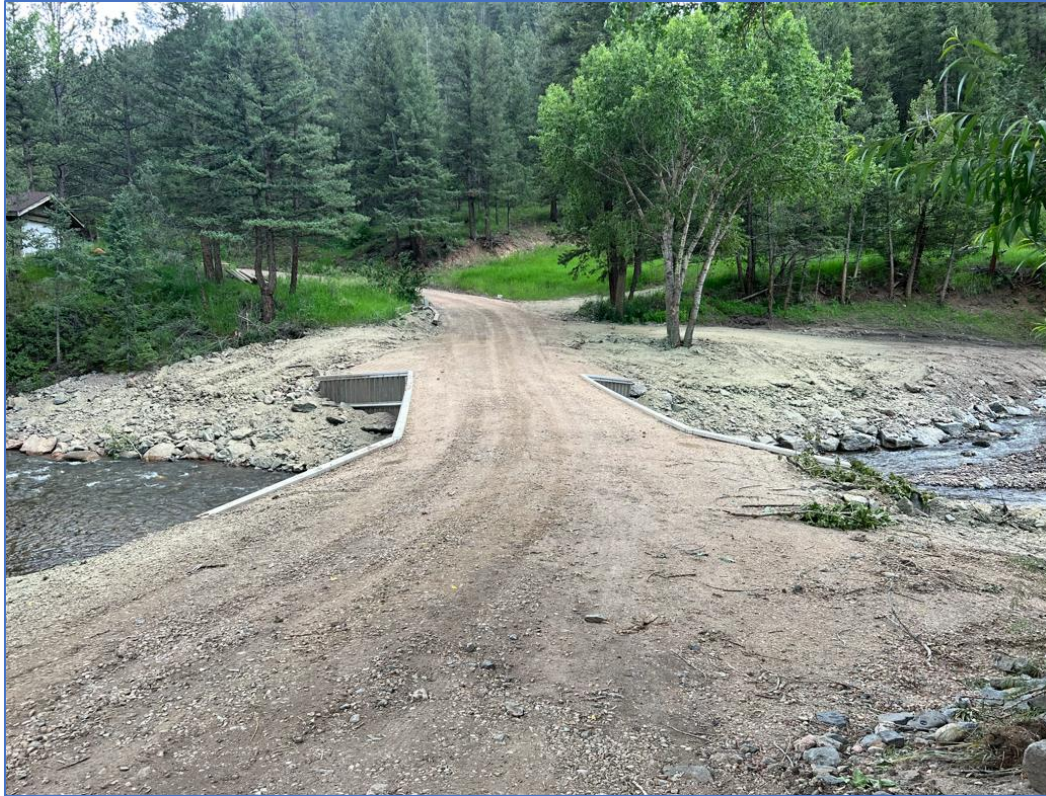
Photo 34: Post-Construction – Deerpath culvert looking South (2023)

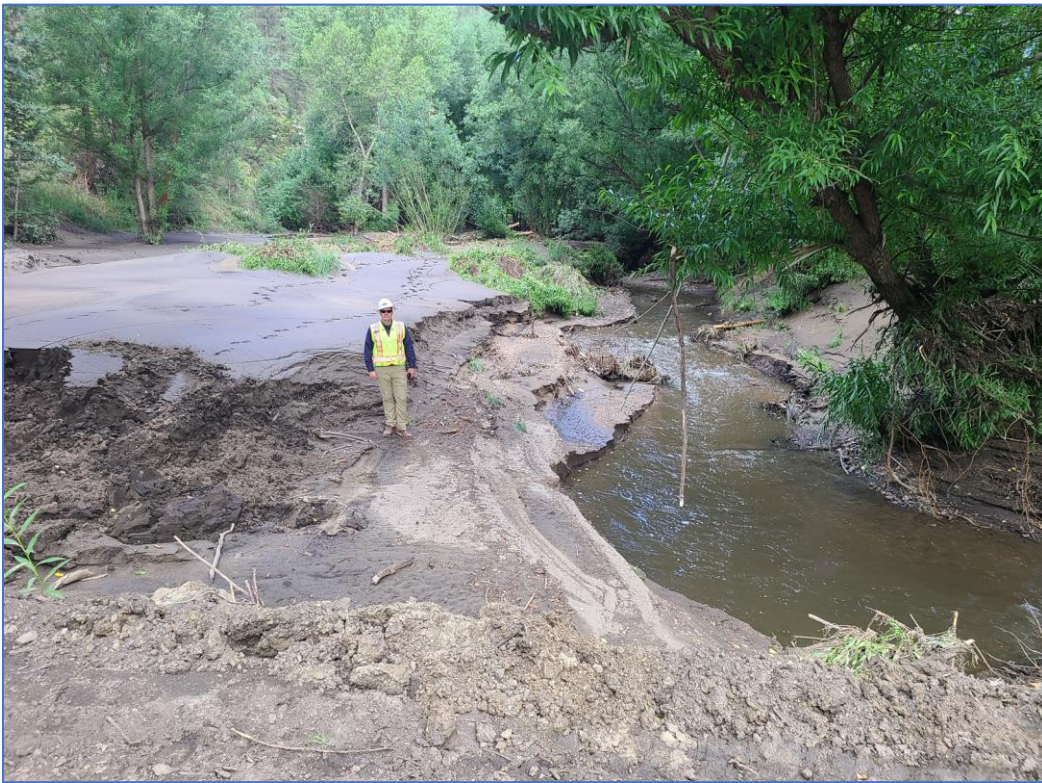
Photo 35: Typical deposition (looking upstream of Deerpath) on Buckhorn Creek (2022)

Larimer County utilized a debris removal contractor, DRC, to clean up the areas upstream of Wildsong. Approximately 8,600 CY of debris was removed from the area. Figure 12 shows the approximate limits of debris removal.

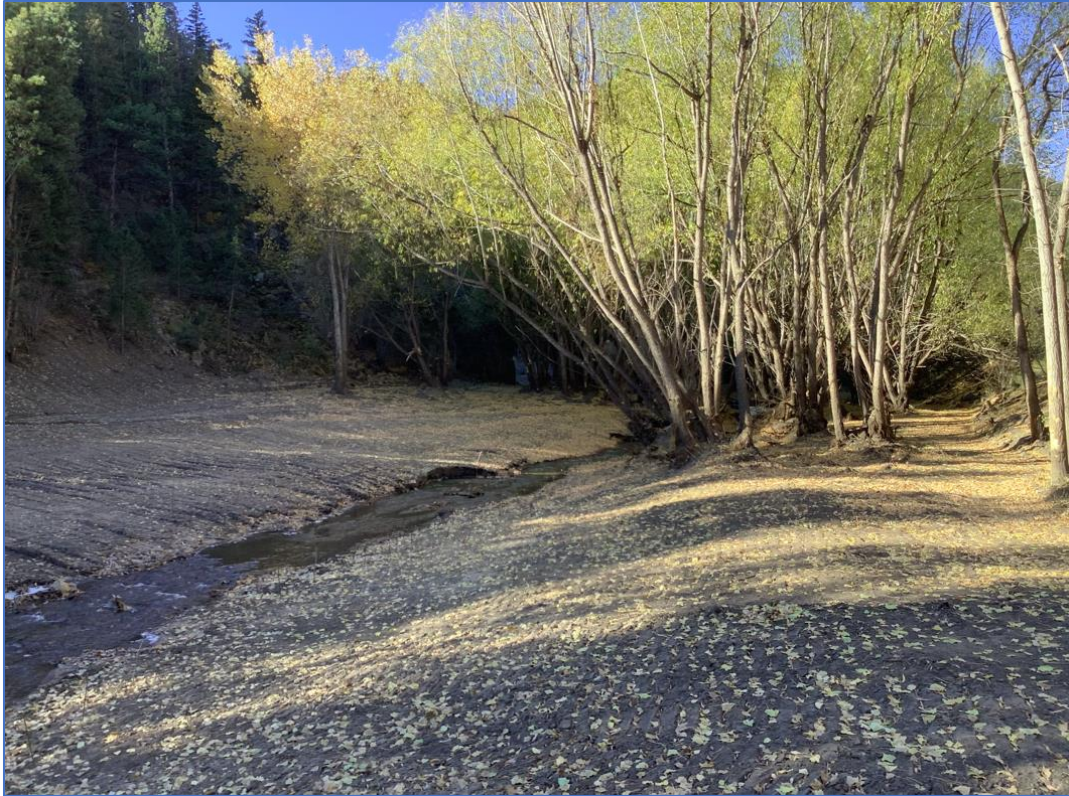
Photo 36: Post-Construction – Area upstream of Deerpath after debris removal (2022)

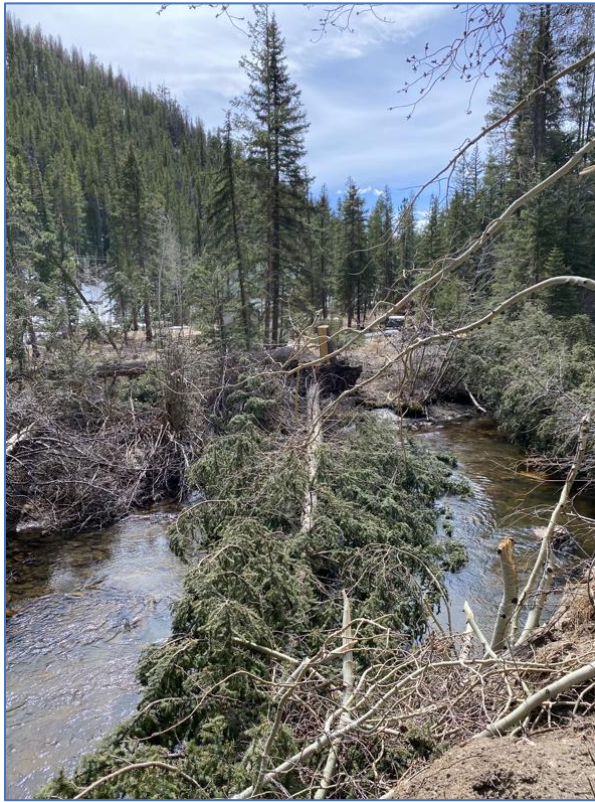
In other areas of the burn scar, there was more woody debris deposition; some of these areas were not caused by debris flows dislodging material directly. Rather, storm events knocked over large lodgepole pines and the concern Larimer County and the NRCS had, while conducting field visits, was the likelihood that these areas would trap additional smaller woody debris and cause flood flows to redirect onto roadways and private properties. The area surrounding Lazy D Ranch on LCR 63E was a prime example of the woody debris deposits.

Photo 37: (Left) Pre-Construction – Typical woody debris along the South Fork on LCR63E (2022)

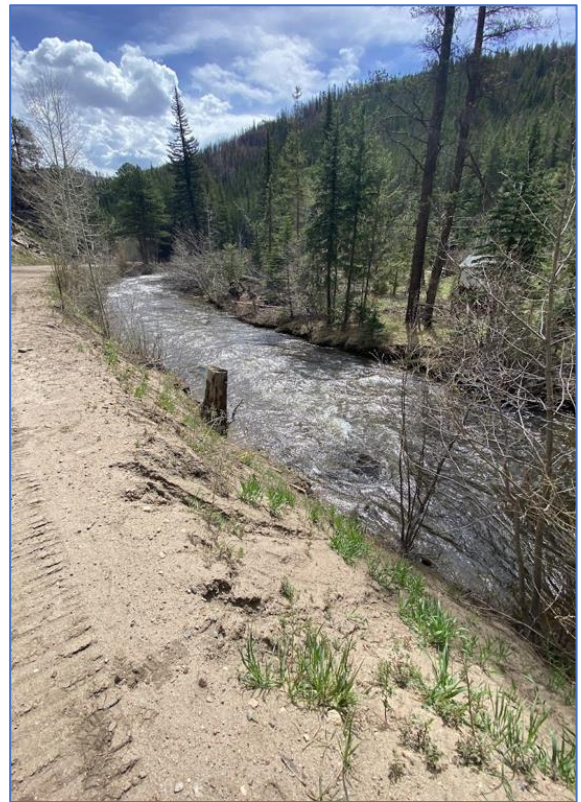
Photo 38: (Right) Post-Construction – Typical river corridor clear of fallen trees on LCR 63E (2022)

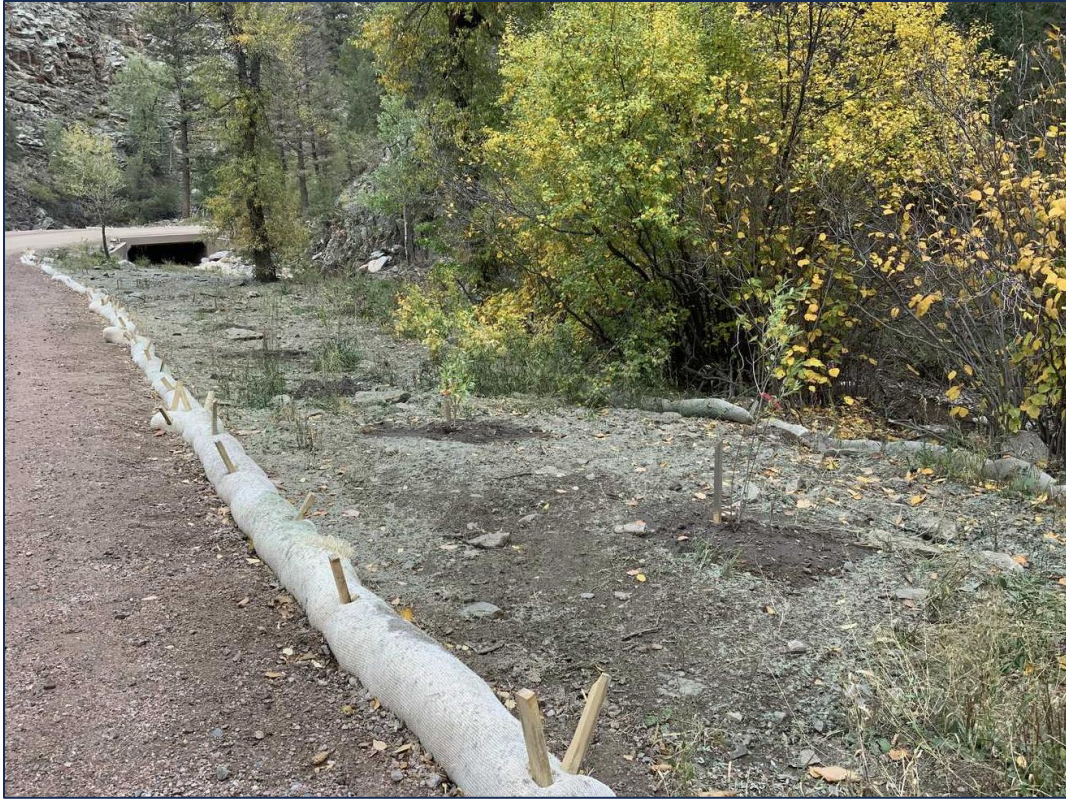
Photo 39: Representative area along LCR 44H with plantings and BMPs in place

- Buckhorn Creek on LCR 44H – Areas along LCR 44H at Buckhorn Creek were repaired as part of the EWP Program. Road locations washed out from overtopping by floodwaters were repaired using fill and regrading, and washed-out culverts were replaced, and in some cases upsized. In some areas between Buckhorn Creek and the road, riprap embankment protection was needed to prevent the road from continually washing out. All work completed was exigent and in response to flooding. The EWP Program work only occurred in the impacted riparian corridor and in disturbed areas including road and adjacent roadside pull-off areas. BMPs and Mitigation and Conservation Measures were implemented where possible and practical. Approximately 0.19 acres of PMJM habitat was permanently impacted by the implemented EWP Program work and mitigation occurred at a 2:1 ratio. The total PMJM habitat mitigation required for impacts on LCR 44H totaled 0.38 acres. Approximately 0.58 acres was available in this drainage for PMJM mitigation. A total of ten (10) sites were planted with riparian and/or upland shrubs, saplings, willow stakes and seeded with native grasses.

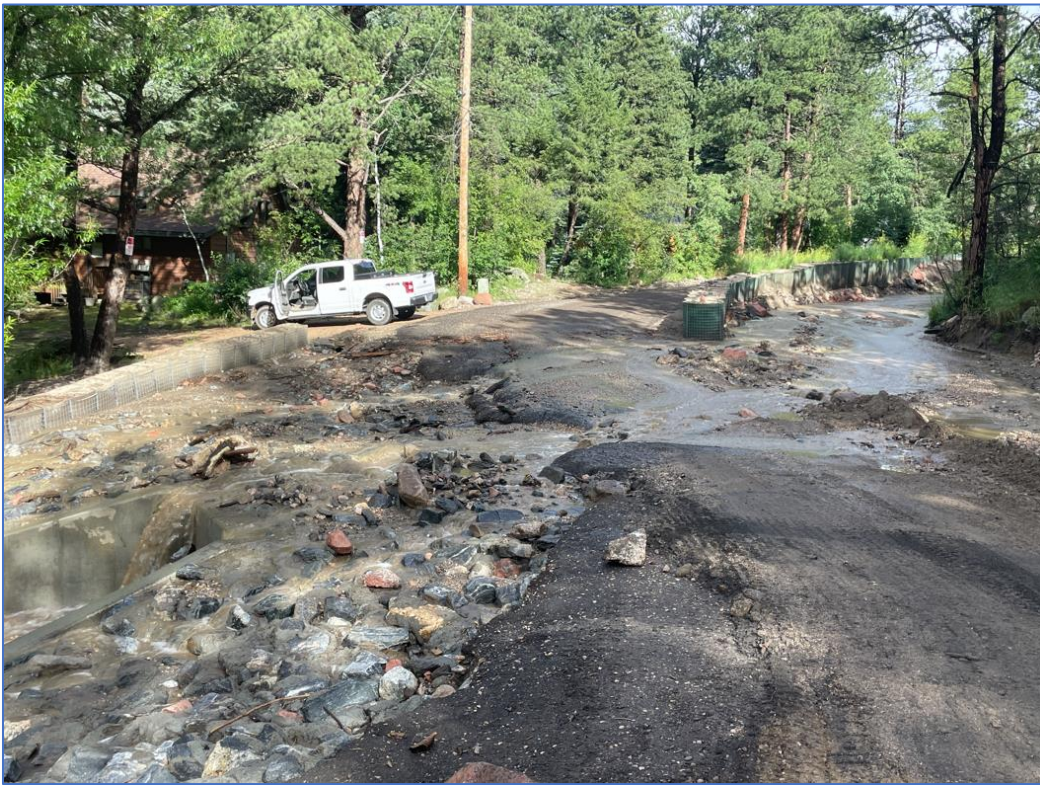
Photo 40: View of the Confluence of Black Creek and Miller Fork at the Box Culvert after the August 2023 Storm Event

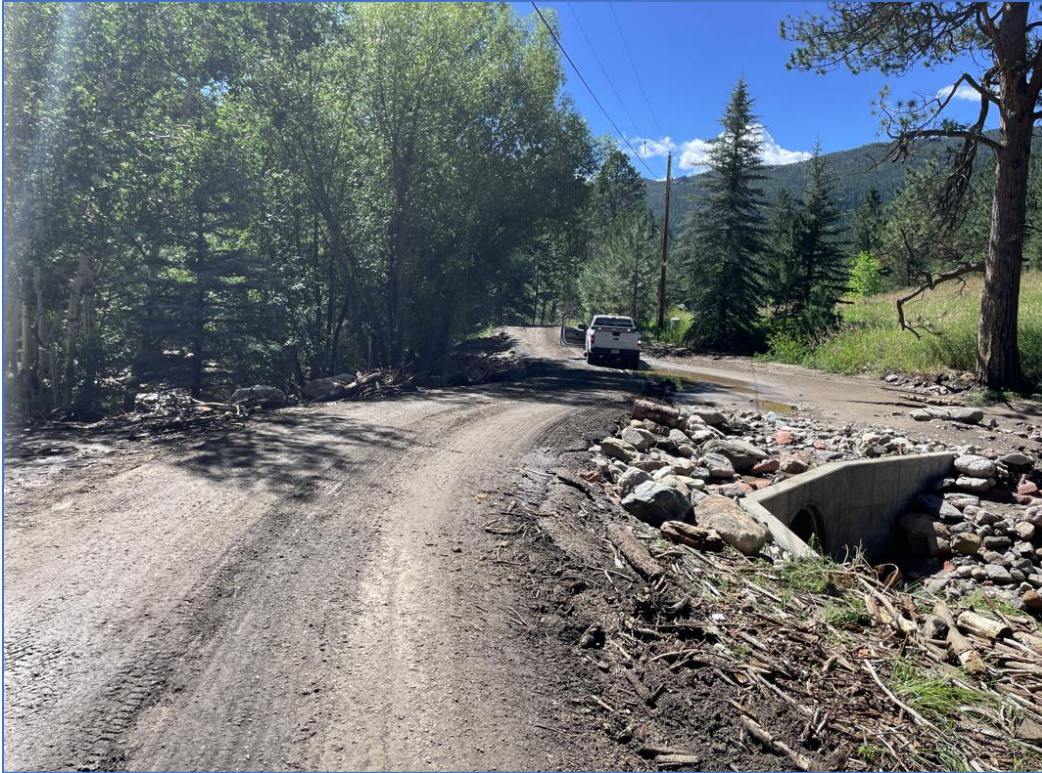
Photo 41: View of Lower Streamside Drive after the August 2023 Storm Event
