# San Luis Valley Aquatic Habitat Assessment

*Compendium of Reports  
for Purchase Order  
POGG1-2020-3208*

# San Luis Valley Aquatic Habitat Assessment: Compendium of Reports

This report was prepared by Matthew A. Reddy, Regional Biologist, Ducks Unlimited, Inc. & Cary Aloia and Jenny Nehring with Wetland Dynamics, LLC on June 30th, 2022.

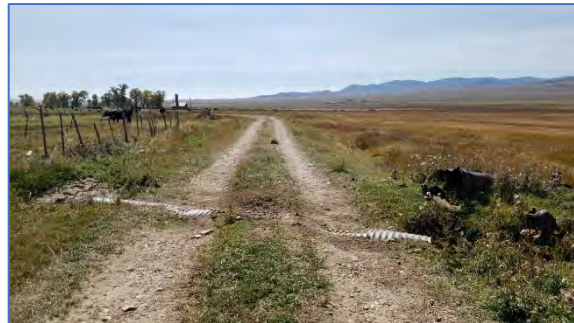
Dilapidated culvert.

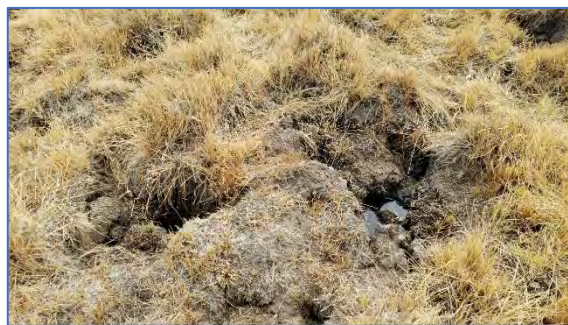
Ditch in need of repair.

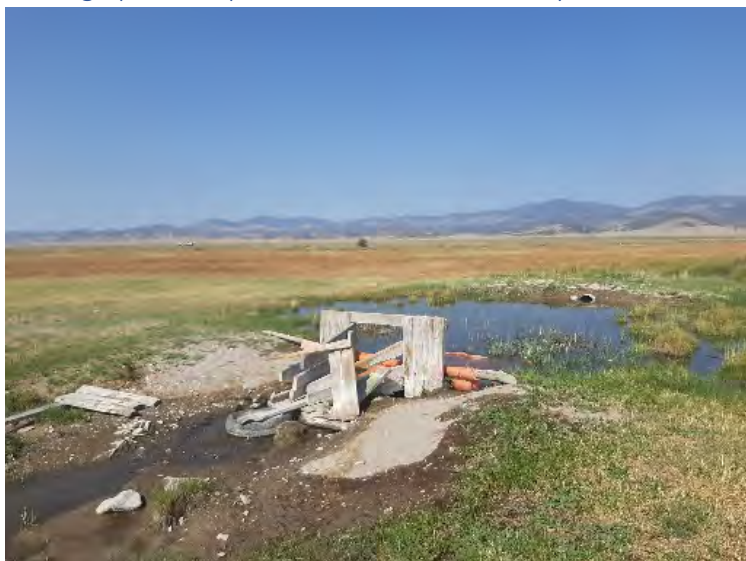
The Davey Ranch DU conservation easement along Russell Creek on the west side of the Russell Lakes SWA has project potential (Figure 9, Appendix II). The photo (right) is an example of the needed water control infrastructure upgrades including water control structure replacement, ditch maintenance, and levee work to improve surface water delivery along the historic Russell Creek drainage and wet meadows.

Photograph of dilapidated water control facility.

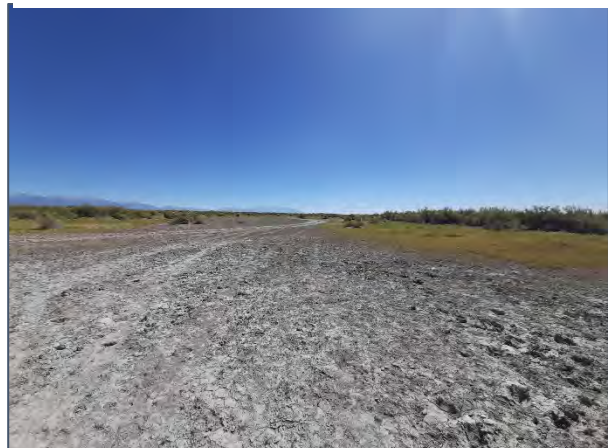
Vehicle disturbance of basins on Mishak Lakes.

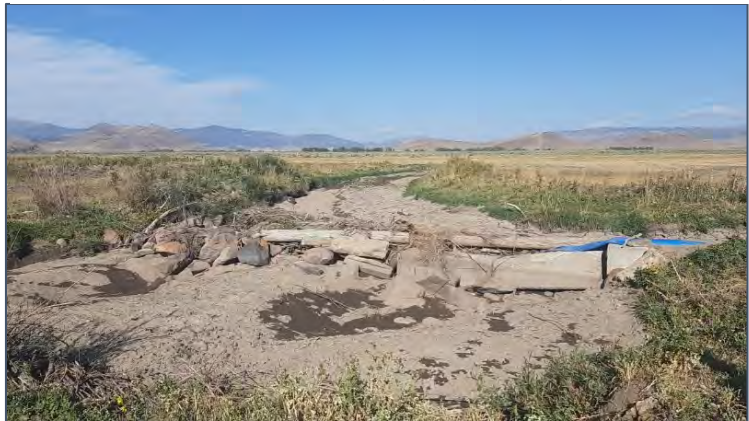
Water diversion on the Hill SLB property on Saguache Creek.

There are several water control structures that are in poor condition that could be replaced as well as ditches that could be repaired. Cattle annually graze the area and although there are a few cross fences, they are in various stages of disrepair and have large portions missing. A more strategic grazing management plan that incorporated rest and exclusion fences around areas where willows still exist would be beneficial to helping maintain creek banks, reducing water temperatures, improving bank storage, and improving wildlife habitat. This property contained two species on the Colorado State noxious weed list that are high priority for treatment; black henbane and tamarisk (Figures 15 and 16, Appendix II). These species are difficult to get rid of and treatment can be expensive. These locations should be treated and monitored closely to prevent any further spread. While this property has a number of restoration challenges it also appears to have a great deal of potential for recovery as it is an upstream location on the creek, contains a distinct channel, may maintain water resources for a longer duration during the year, and contains remnant riparian vegetation.

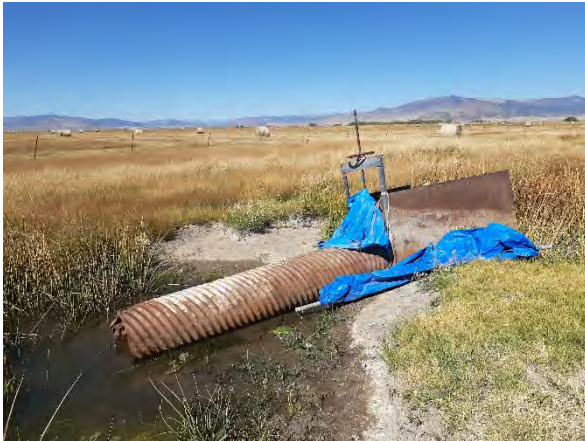
Water control structure with potential for rehabilitation and restoration.

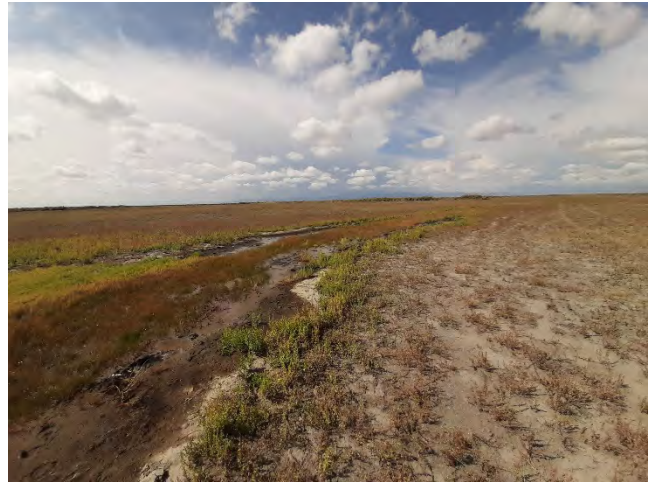
The remaining SLB properties downstream of this property have little modification. A maintained county road crosses the creek several times but appears to provide several culverts of appropriate size through the road at each crossing to maintain flow through the entire creek bed. A two-track allows access to AA1 and crosses and parallels several basins and a small artesian well provides some stock water that flows across the two-track (Photo Right). Restored flows are the primary need for these downstream properties to be fully functional aquatic systems. Should these flows be restored, some changes in the location of the two-tracks may be warranted to help maintain the health of the basins.

Riparian area with two-track road on State Land Board property in the northern San Luis Valley.
