ESTES VALLEY WATERSHED COALITION

**WATERSHED GRANT ESTES VALLEY WC
MAINTENANCE SVCS 13 PROJECTS**

FINAL REPORT

**OCTOBER 19, 2022
GRANT AMOUNT: \$18,684.25**

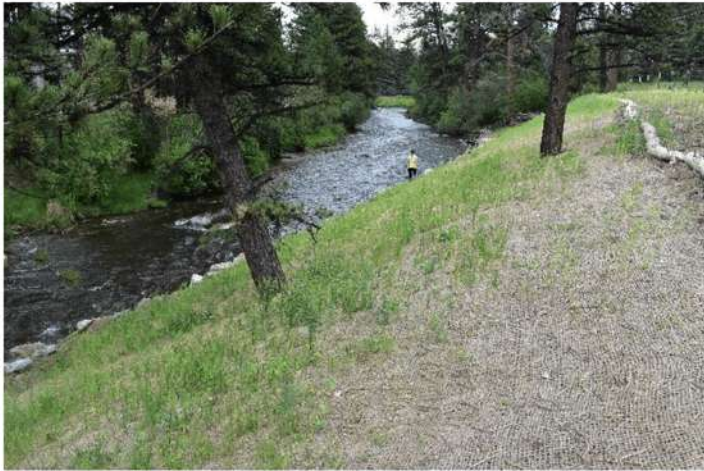
Riverside: Slope coverage, note mix of grasses and weed species.

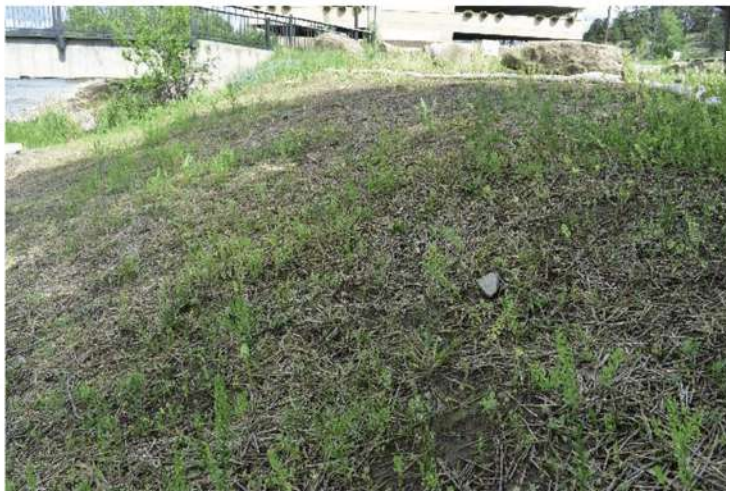
Visitors Center: Ground coverage is approximately 35%.

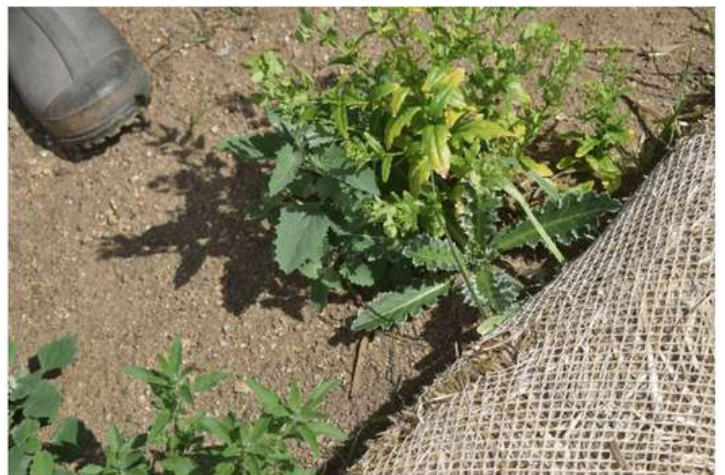
Rock-n Roll: Canada thistle, penny cress, and lambsquarter, as should be controlled before becoming more problematic.

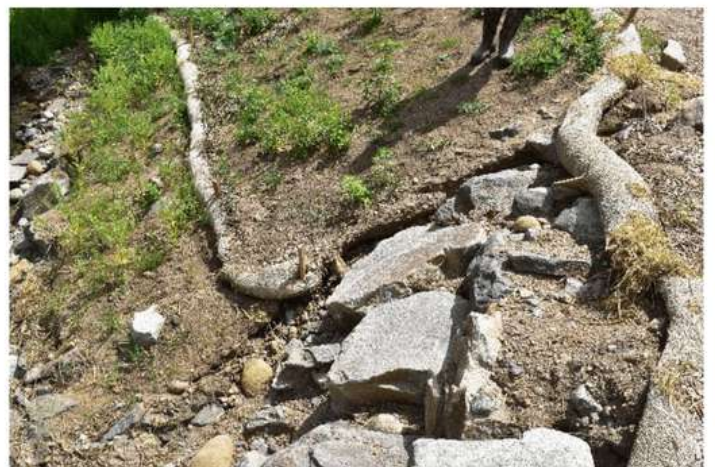
Rock-n Roll: Note initiation of rill erosion.

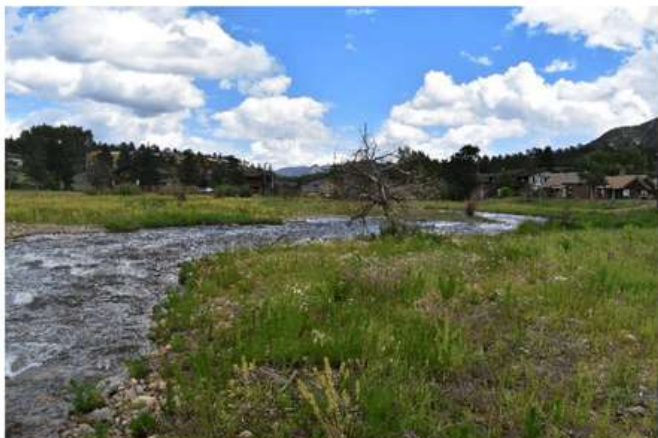
Elkhorn: Overview for zone 2 and 3 showing scentless chamomile and other weed species mixed with native grasses.

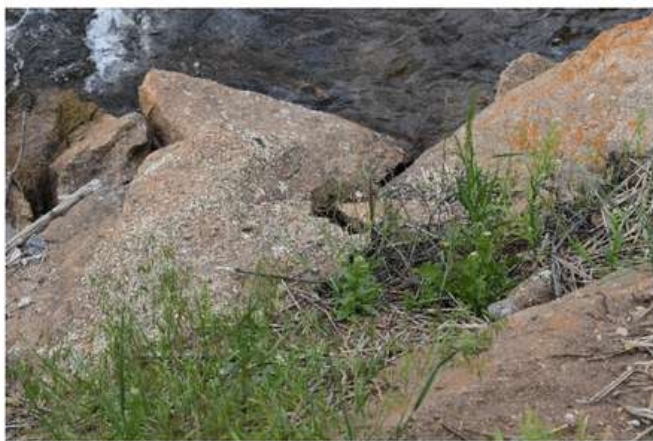
Broadview: Weed species present included hoary cress, cheatgrass, and Canada thistle.

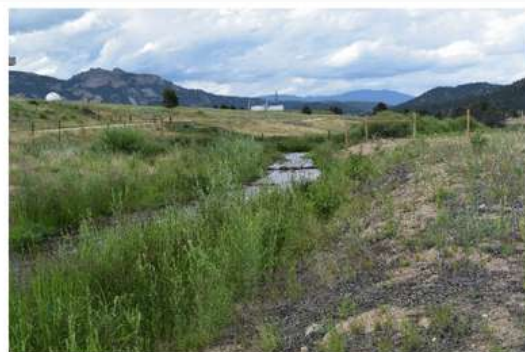
Lower Fish Creek R1: Where unimpacted from scour and blowout, containerized and staked willows are doing well.

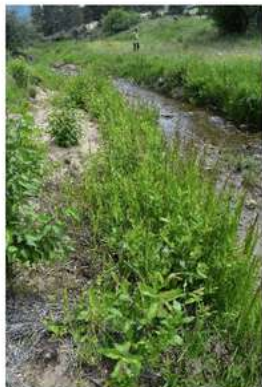
Lower Fish Creek R2 – R3: Superb establishment from combination of containerized and cutting materials.

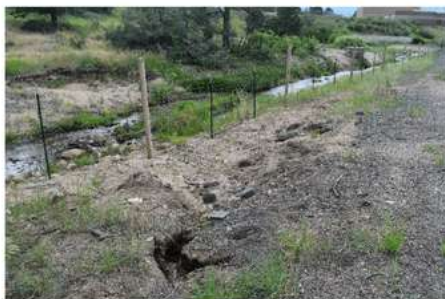
Lower Fish Creek R1: Erosion from adjacent roadway runoff as well as upland blowout areas is impacting planting through sediment accumulation.

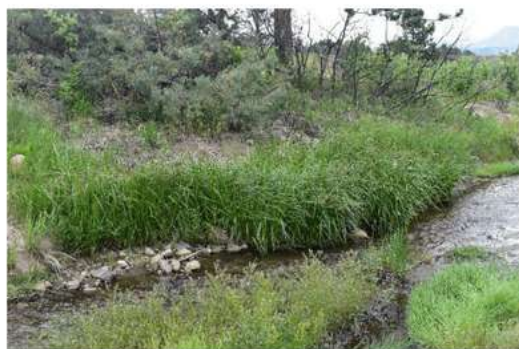
Lower Fish Creek R1: Where unaffected by erosion and bank scour, planted, seeded, and recruited vegetation is doing well.

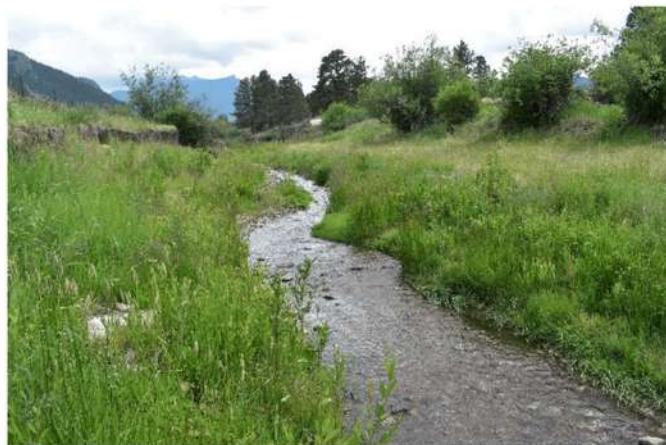
Lower Fish Creek R3: Excellent zone 1 – 2 response from combination of planted materials and existing seed and propagule bank

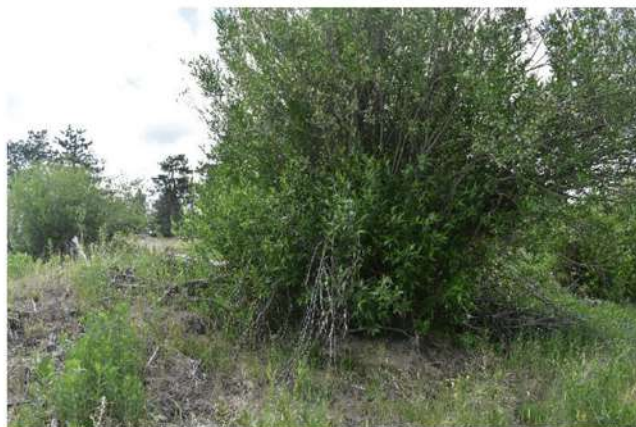
Lower Fish Creek R2 – R3: Excellent response from exclusion from elk browse from existing riparian vegetation.

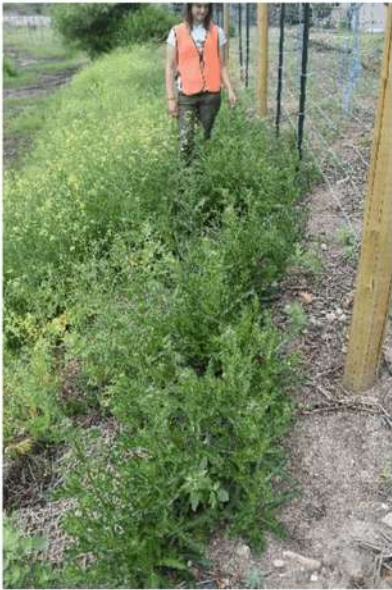
Middle Fish R2: Extensive Canada thistle needing control by river left fence line.

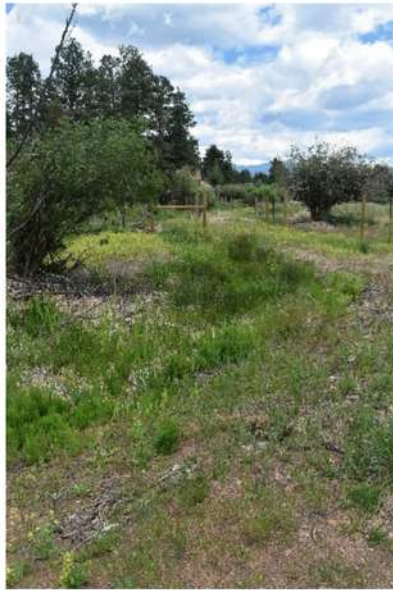
Middle Fish R1: Poor seed establishment within zone 4, better in zone 3.

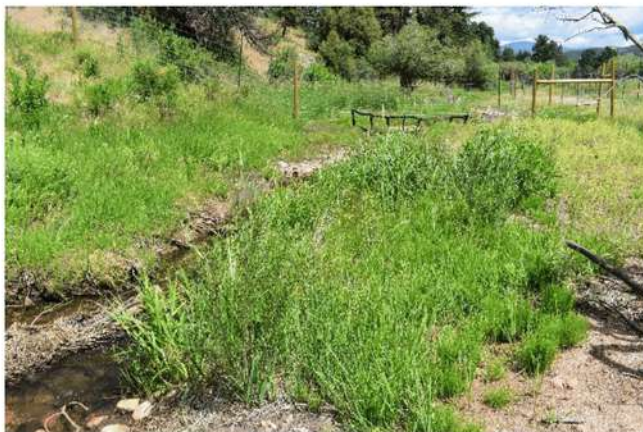
Middle Fish Creek R1: Note mix of native grasses, and noxious weeds.

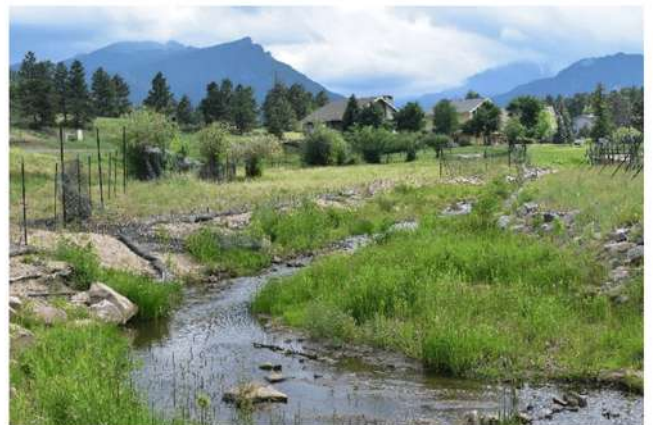
Lower Fish Creek R4: Note damaged elk fence and excellent zone 1, zone 2 establishment

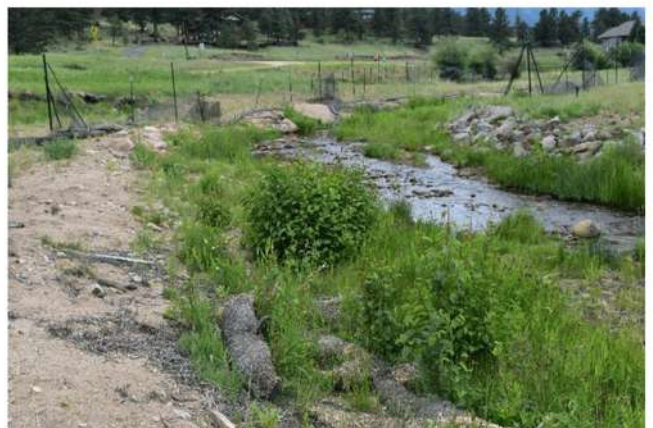
Lower Fish Creek R4: Excellent vigor displayed from containerized thinleaf alder installed Fall 2016.

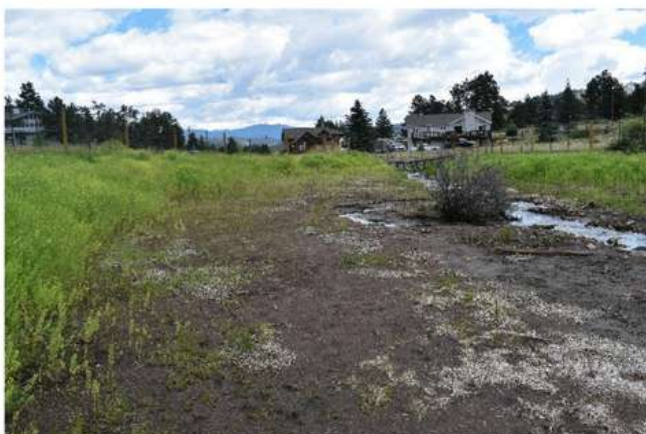
Middle Fish R2: Note variable coverage on overflow versus non-overflow areas.

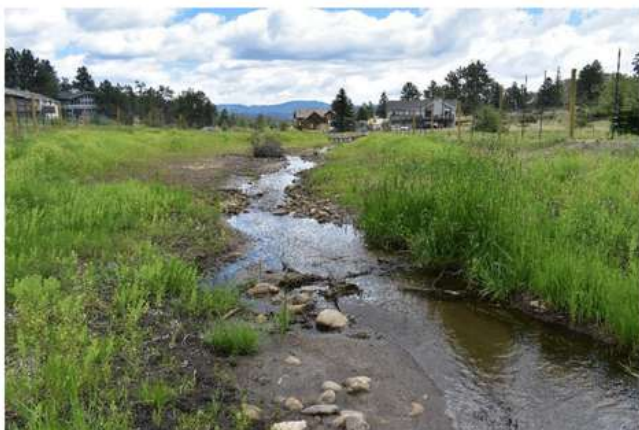
Middle Fish R2: Excellent natural recruitment from existing native seed and rhizome bank.

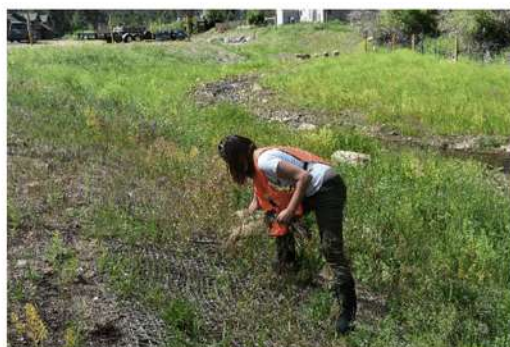
Middle Fish R5: Overall photo, showing coverage and weed presence.

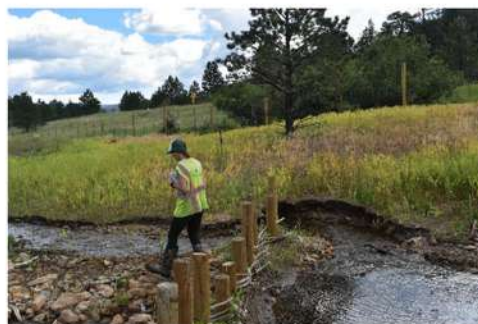
Middle Fish R4: Showing flanking around Beaver dam analogues and bank erosion and Vegetation Regrowth

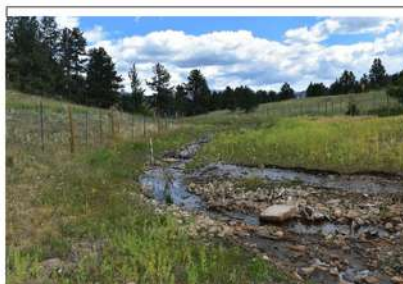
Middle Fish R4: Note degree of weed infestation through zone 3 and zone 4.

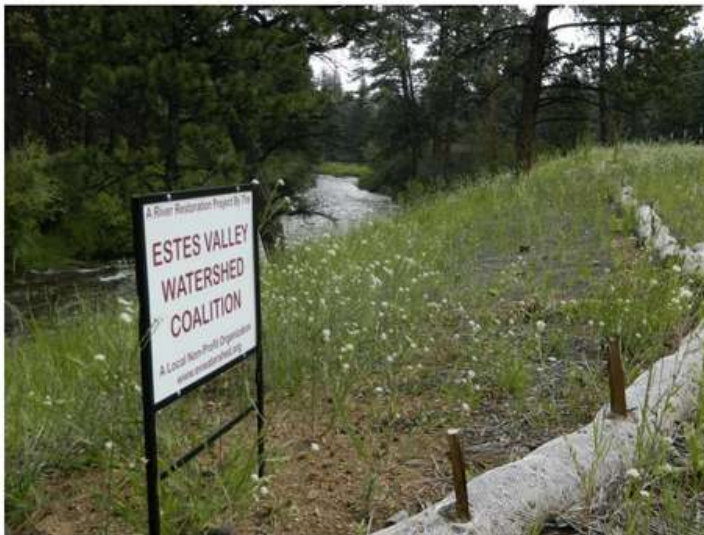
Riverside site-H. alyssum

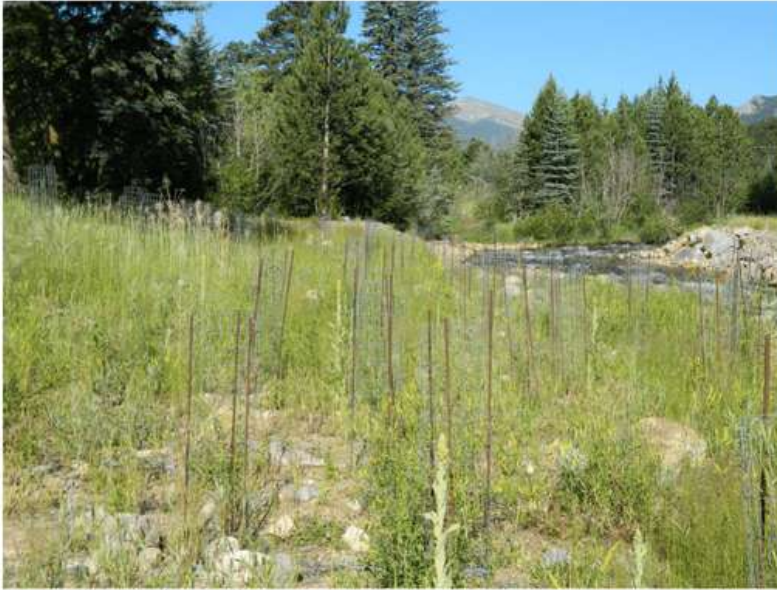
Bugle Point site-C. mullein

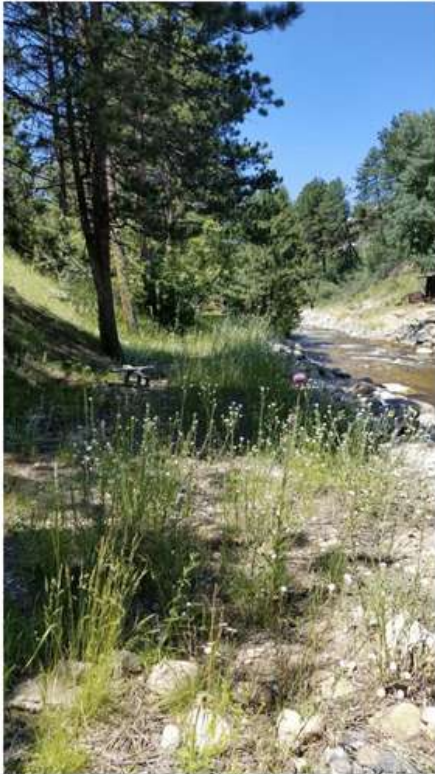
Fawn Valley site (Bowling alley)-H. alyssum and M. thistle

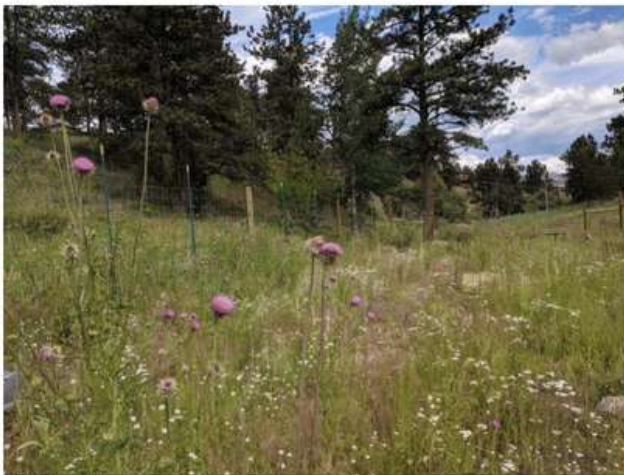
Middle Fish Creek 2- M. thistle and H. alyssum

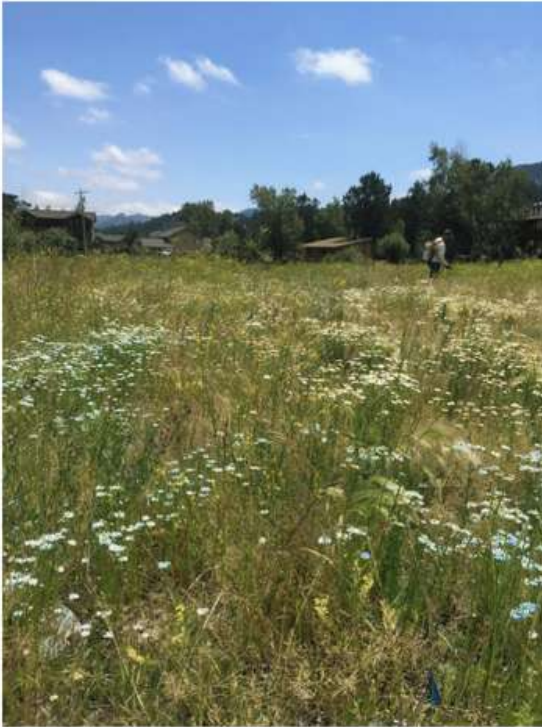
Elkhorn site- *S. chamomile*

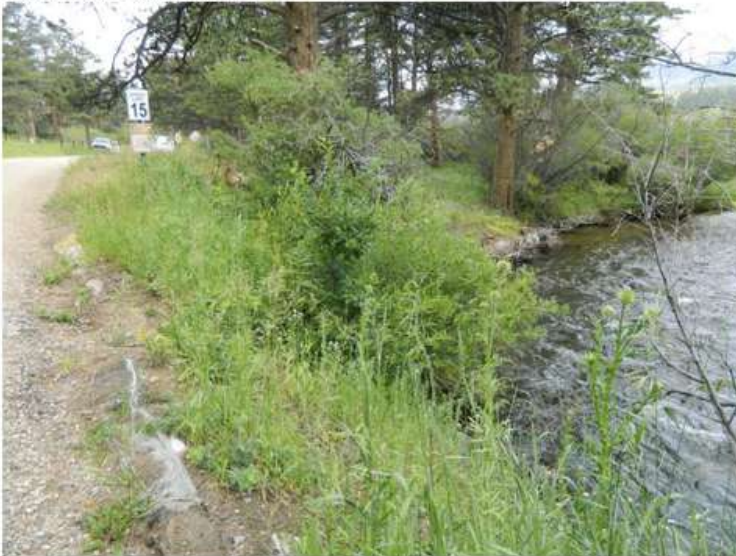
Broadview site: *M. thistle* and *H. alyssum*

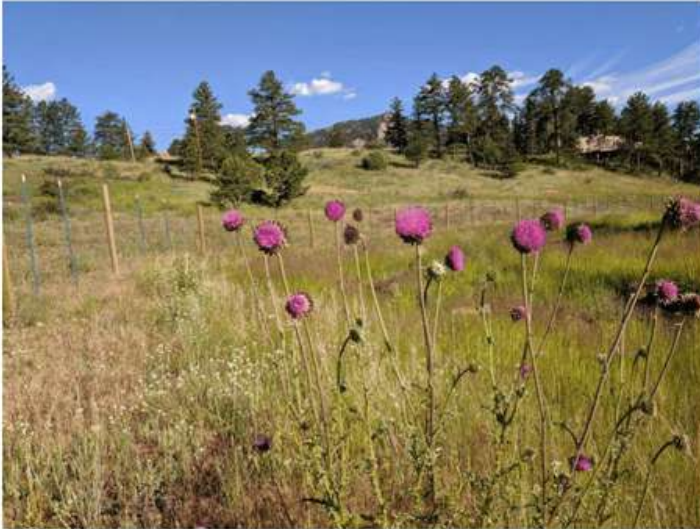
Upper Fish Creek: M. thistle and H. alyssum

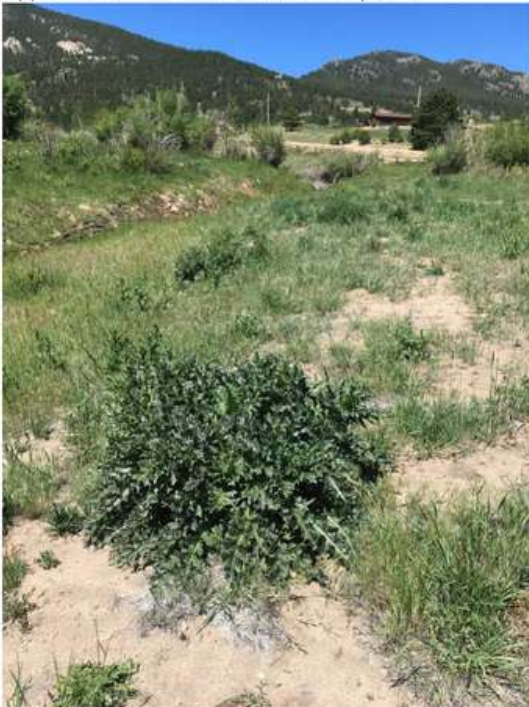
Upper Fish Creek (Cheley) site: M. thistle, cheatgrass

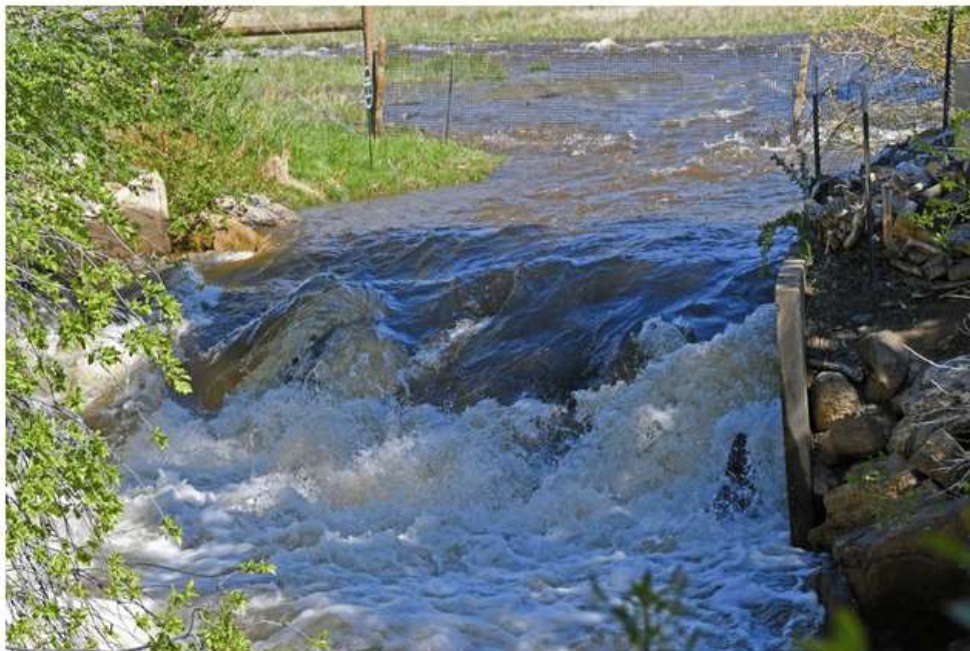
Photo 1. Manmade drop on Fall River at downstream end of Elkhorn Reach.

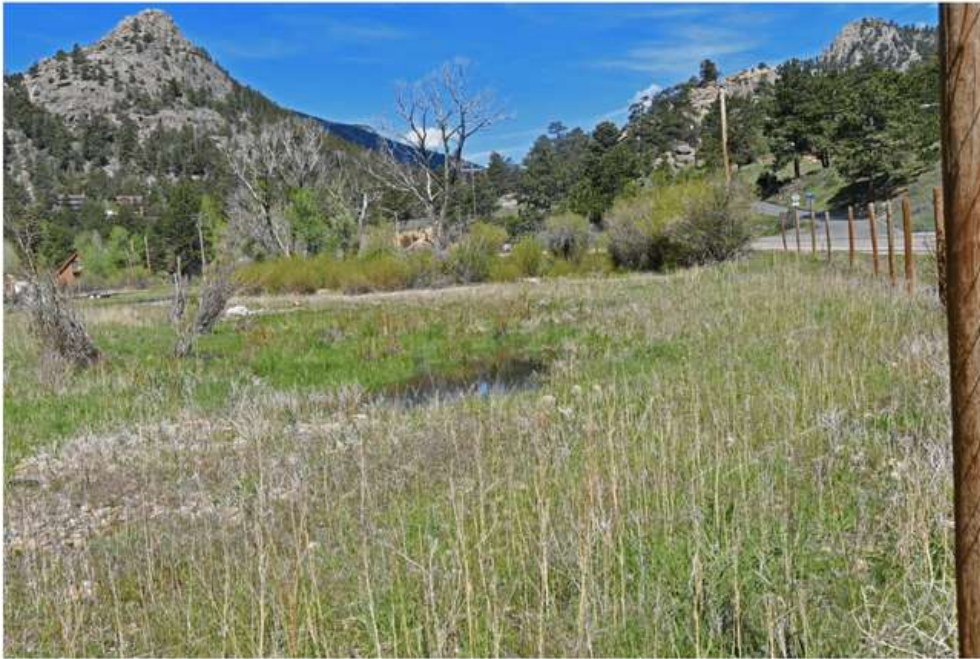
Photo 2. Buried riprap next to West Elkhorn Avenue (along fence line). Some water in the riparian area.

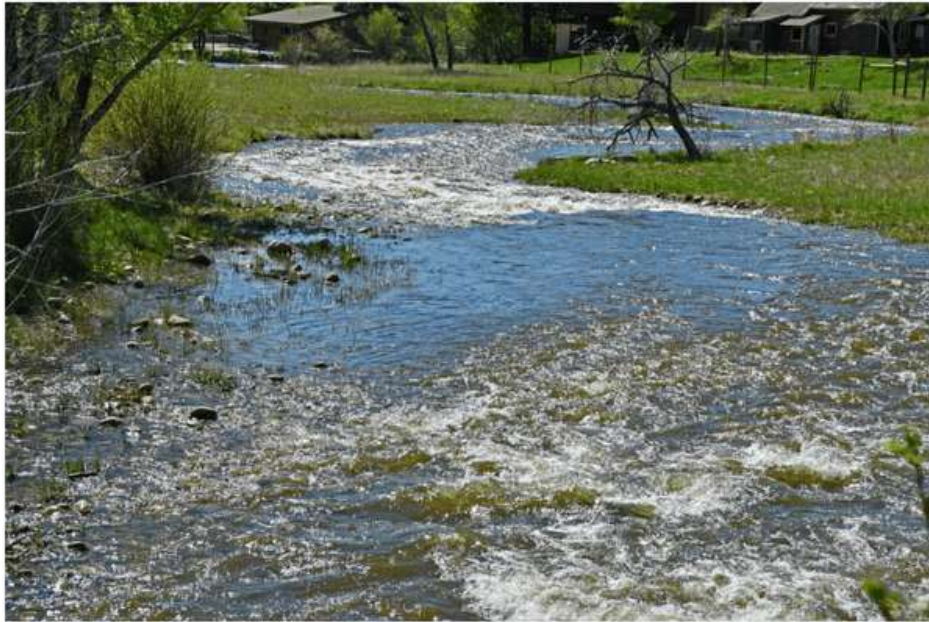
Photo 4. Fall River at Elkhorn Lodge showing riffles and pools and a meandering channel.

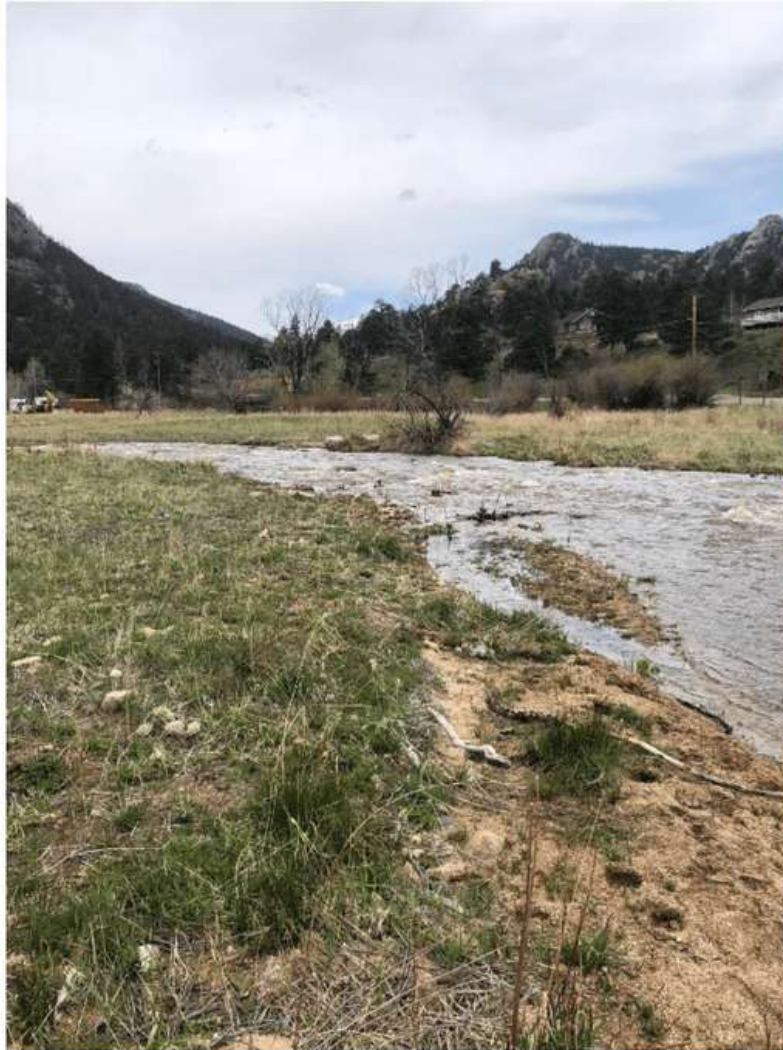
The stream channel is functioning as planned. Vegetation has been impacted by elk grazing (in spite of the fencing) but a reasonably good survival rate was noted. The fencing has eliminated horse grazing in this area allowing the vegetation to take hold. The fencing is in great shape except for a few sections. No recommended actions other than maintaining the fencing and adding to the vegetation if needed.

Photo 3. Fall River at Elkhorn Lodge. Good vegetative cover (many rushes, bunch grasses and willow sprouts) and stream flow.

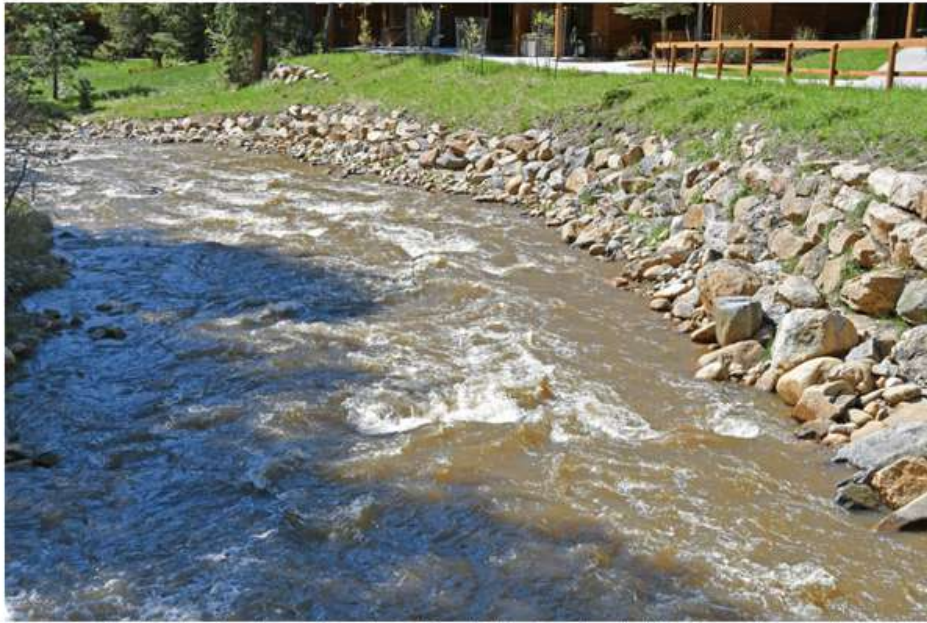
Stream channel looks good. Habitat boulders continue to provide intended function. On the day of the visit, flow had just increased to the point where some water was flowing on the 1.5-year flow benches. Poor survival of the willow plantings was observed. The willow stakes that were to be planted among the existing riprap on the upstream part of the reach either were either not planted or did not survive.

Photo 5. Fall River at Bugle Point showing riprap along banks (installed before the rehabilitation project) and poor willow stake survival.

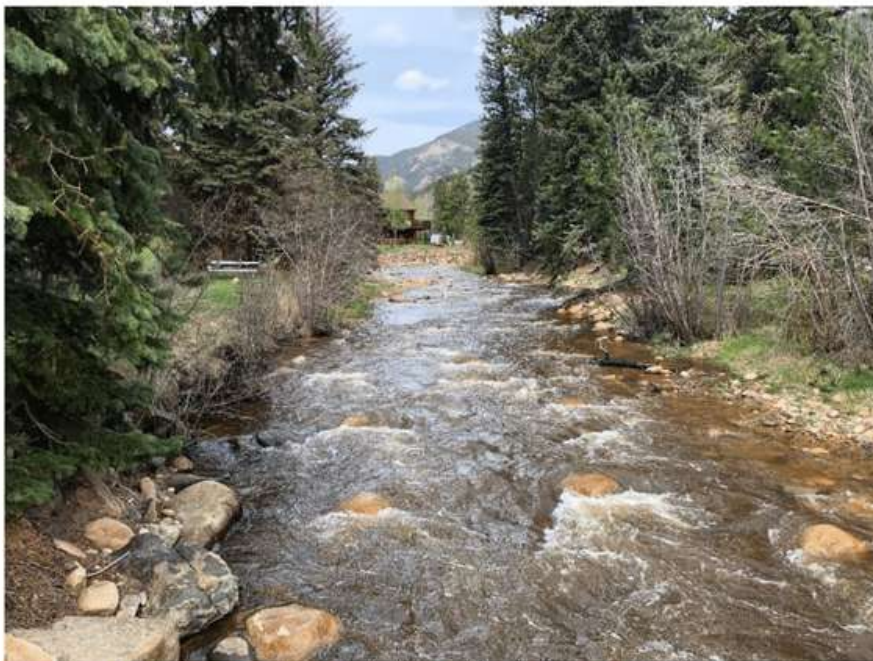
Photo 6. Fall River at Bugle Point - habitat boulders in place and some bank vegetation.

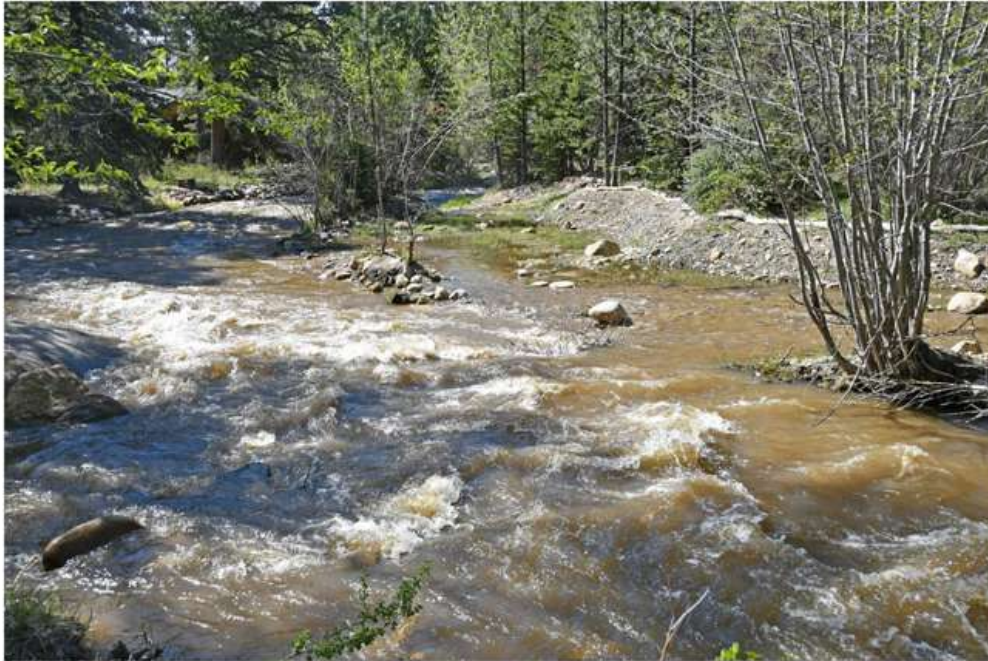
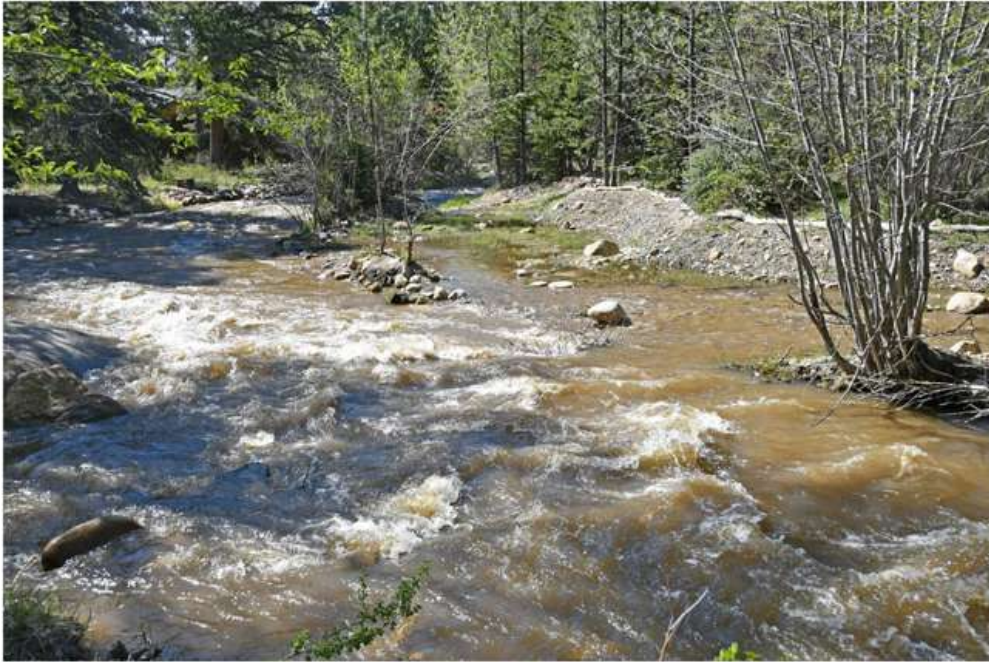
Photo 7. Fall River at Bugle Point - 1.5-year flow bench (right side) with some flow across it.

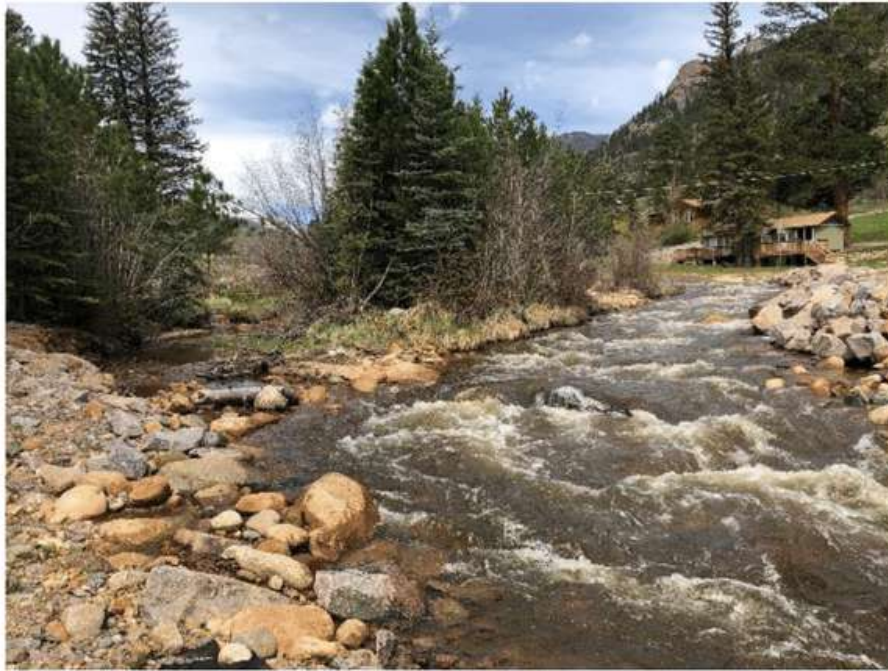
River channel looked good. Some flow was noted in the overflow channel. Vegetation survival was just OK. The section of the river next to the Fawn Valley property was not inspected due to lack of time and the fact that the work consisted of mostly bank stabilization.

Photo 8. Fall River at Workshire showing bank stabilization and flow in the overflow channel (left).

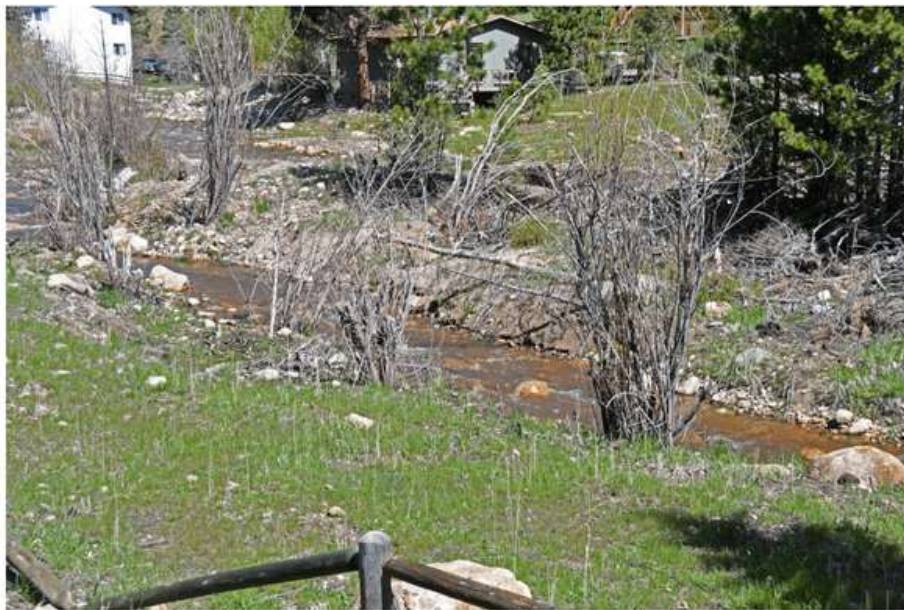
Photo 9. Overflow channel, foreground, and Fall River main channel, background.

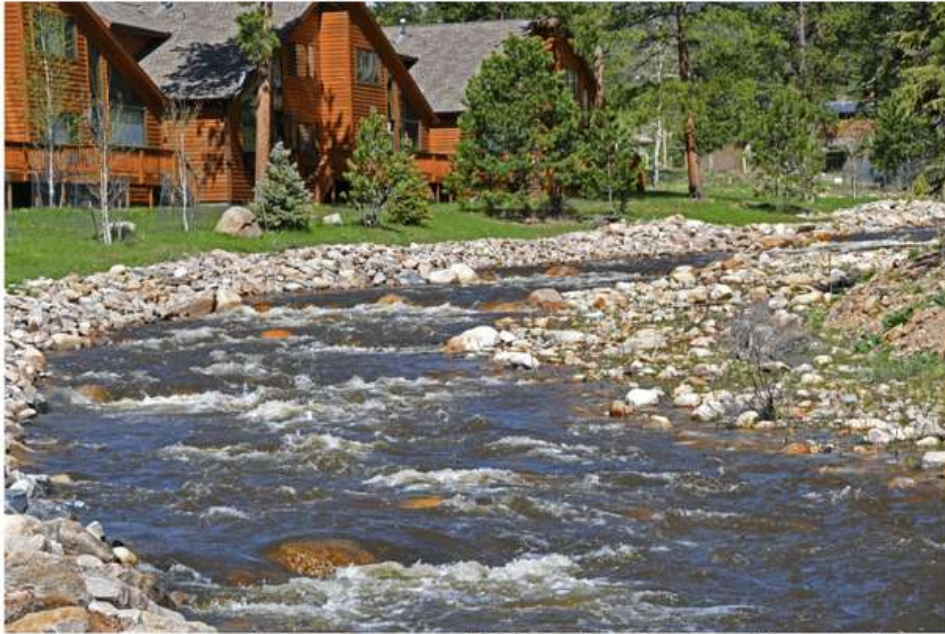
River channel looks good. Riffle crests don't show signs of significant adjustment. Benching still intact and split flow channel was flowing on the day of the visit.

Photo 10. Fall River at River's edge - river channel flowing well, showing riffles and habitat boulders.

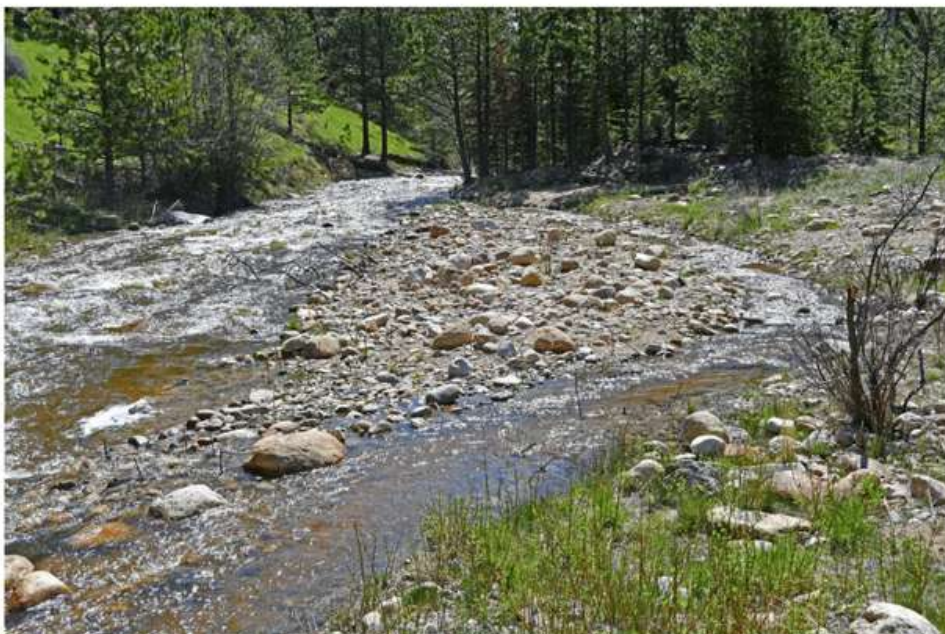
Photo 11. Fall River at River's edge - split flow channel at downstream end of the Reach.

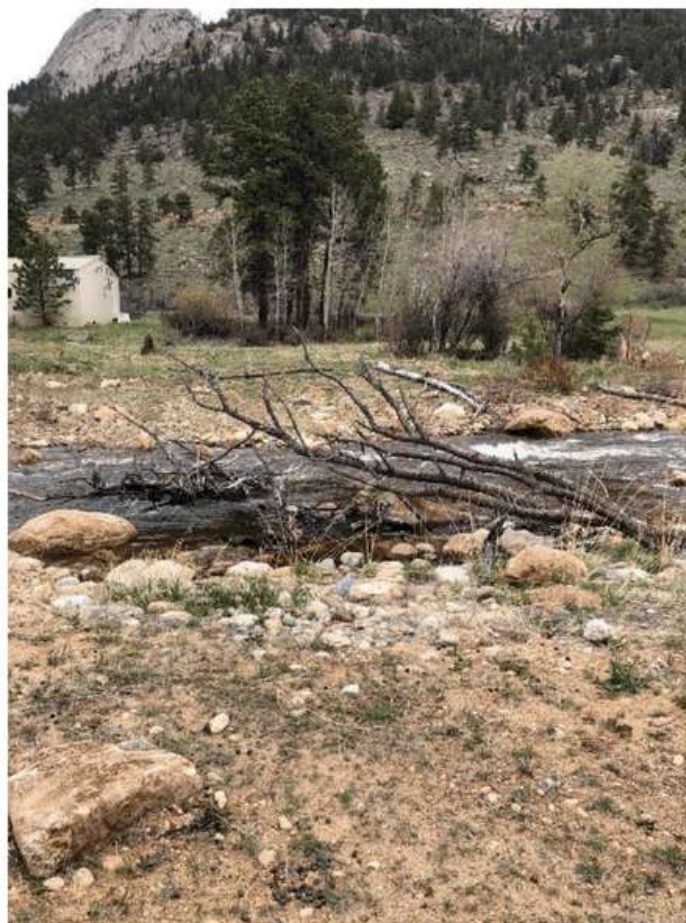
Photo 12. Fall River at Fish Hatchery Reach – large wood anchored in bank.

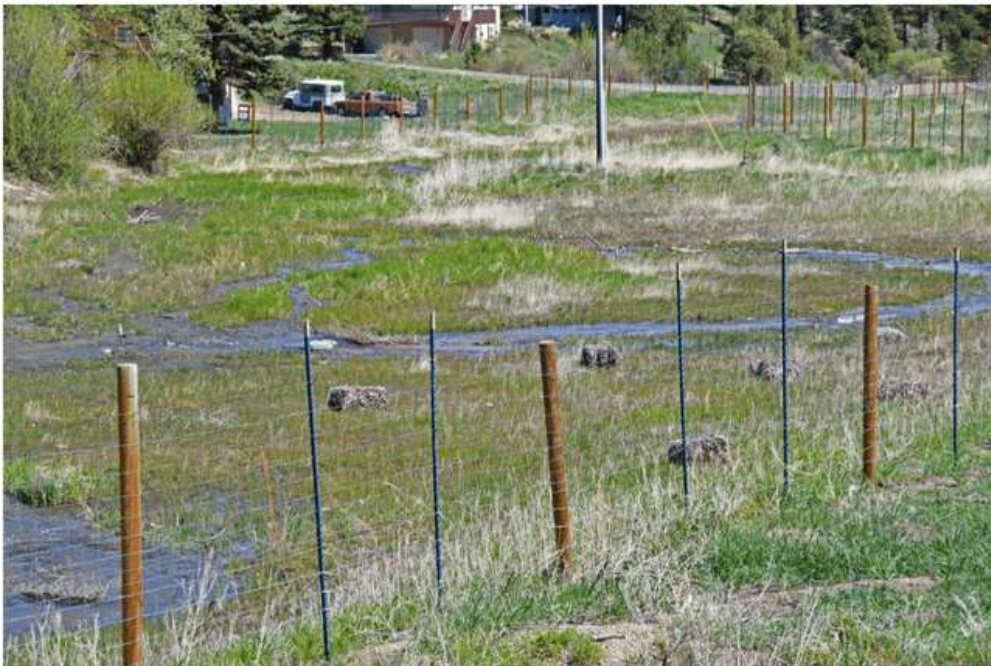
The channel re-construction created a large meander pattern. Now at moderate flow, threading is starting to occur. Three separate channels were observed at (approximate) peak flow this year. This was anticipated due to the low gradient; the fine, easily eroded substrate; and the shallowness of the channel. It is best to allow the stream to move naturally within the floodplain (as long as assets requiring protection are covered (e.g., by offset riprap).) No intervention is recommended; the vegetation is surviving well, and the fencing is in great shape.

Photo 14. Multithreading in the low gradient section of Fish Creek - Country Club to Brook Drive.

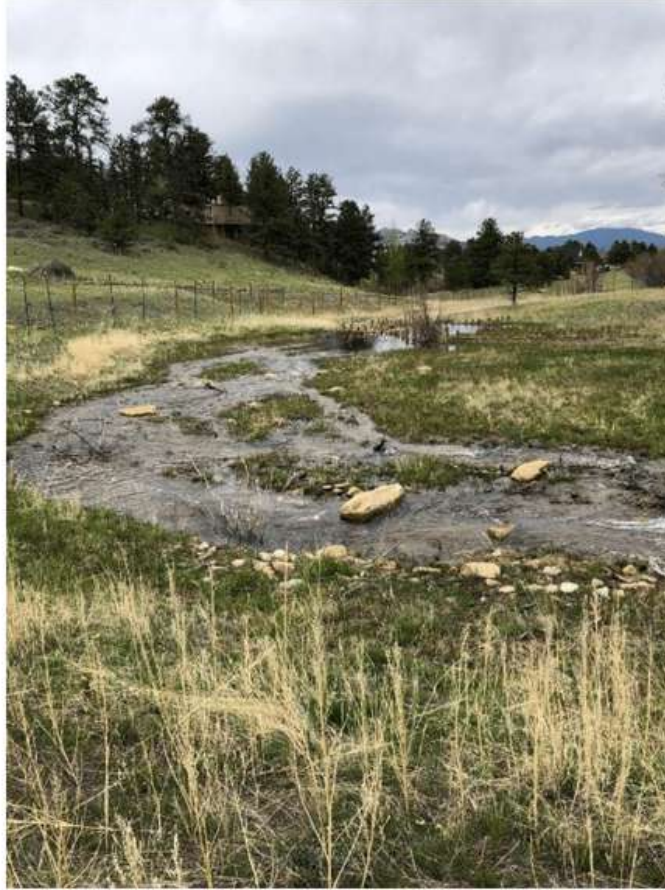
Photo 15. BDAs and channel doing well along with successful re-vegetation.

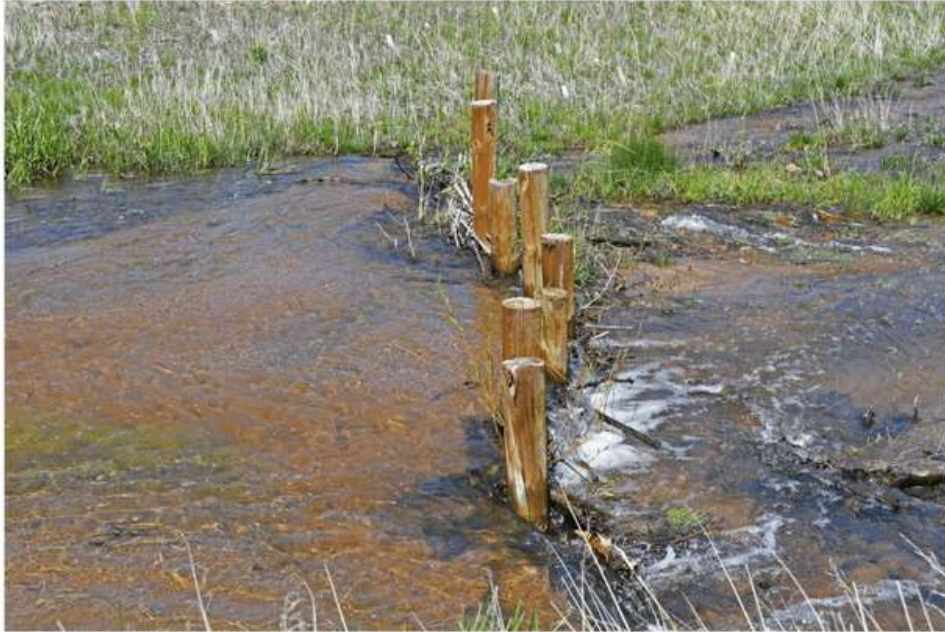
Photo 16. Fish Creek at Brook Drive - upper BDA showing sediment buildup and minor flanking.

The best option for maintenance on this project is to install additional small BDAs, especially as replacements when older ones fill in and/or flank. Monitoring and evaluation currently underway by Colorado State University (CSU) geomorphologists is suggesting that a higher number of smaller BDAs performs better for sustaining pool habitat and adjusting with the system over time. CSU is implementing strategies developed by Dr. Joe Wheaton at Utah State University and studying results on the ground at several Colorado project sites. The recommendation is to continue to monitor this BDA (along with the others) and either: (1) buy time by extending the woven portion of the primary check farther across the floodplain, and/or (2) installing additional small BDAs below this feature. The maintenance action to extend the woven portion can be easily accomplished via hand work as soon as the stream returns to low flow.

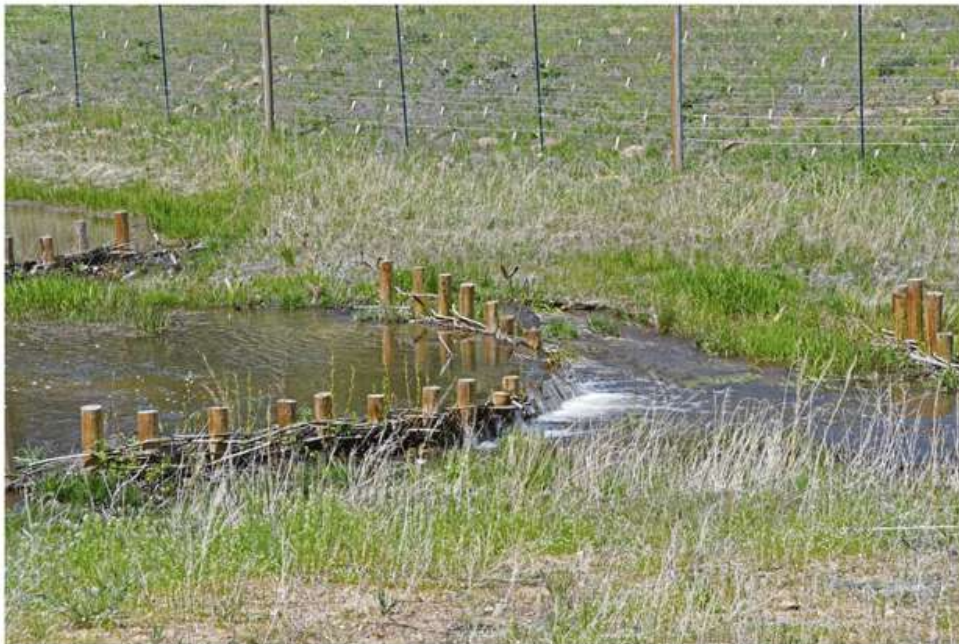
Photo 17. Fish Creek at Brook Drive - middle BDA functioning as expected (primary check structure in center of photo).

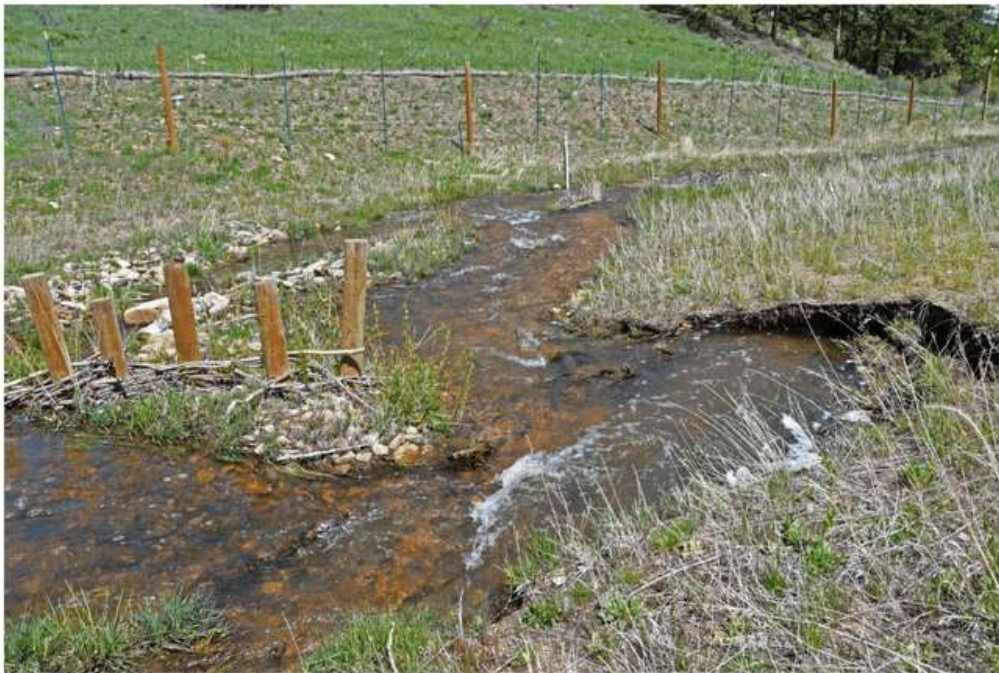
Photo 18. Fish Creek at Brook Drive - lowest BDA with largest extent of flanking (note this is a secondary check structure serving as grade control for the primary check located just upstream (and out of the photo) – pool habitat is not the goal of this structure.)
