**Subject: Flannery Dam and Deer Creek Dam Assessment,
Wheeler Project No. 1883.06**

This letter was prepared by W. W. Wheeler & Associates, Inc. (Wheeler) for the Western Divide Water Conservation District to document Wheeler's field assessment and recommendations from the site visit to the Flannery Dam on August 19, 2024.

Flannery Dam Background Information

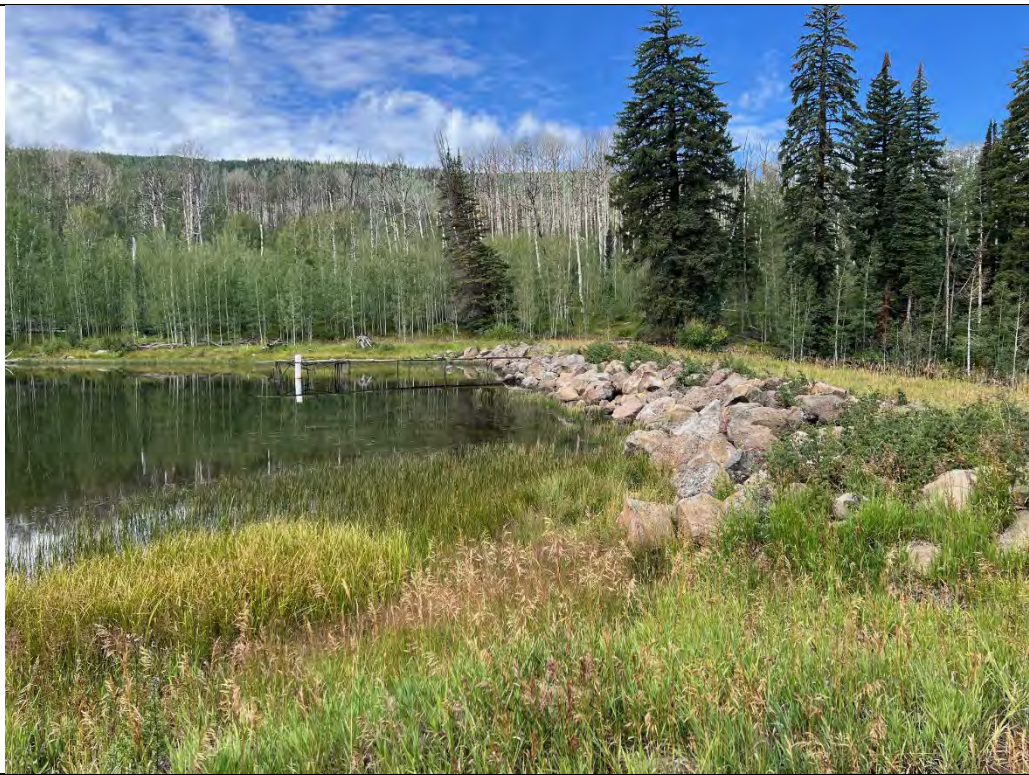
The upstream slope was observed to be in satisfactory condition with no major observed issues. The upstream slope protection riprap is very large and there does not appear to be adequate bedding under the riprap. The lack of adequate bedding under the riprap could lead to potential embankment erosion and reduced stability. There were no signs of wave erosion during this assessment. Minor vegetation was also observed growing between the riprap. The Owner has done a good job recently in maintaining this and it will have to be continued on an annual basis. The dam crest (elevation 8365) was observed to be in satisfactory condition. The dam crest was measured to have a nominal width of 15 feet. The crest has signs of animal trails that will need to be maintained to prevent settlement or low spots from developing. The downstream slope is relatively flat with approximately 3:1 side slope. There were no signs of cracking or bulges observed. Minor vegetation growing on the slope. Previous inspection reports have indicated seepage along the downstream slope near the discharge pipe. However, no signs of seepage were observed.

Photo 1. View of the upstream slope looking left from the right abutment. Note the large riprap and vegetation growing in the riprap.

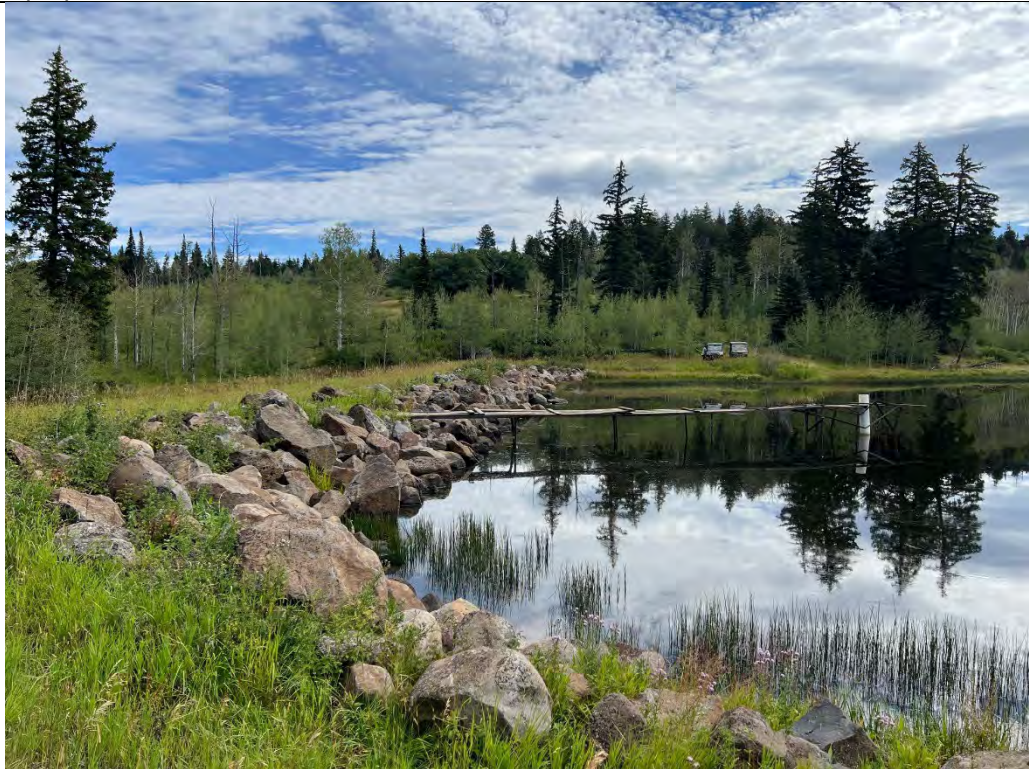
Photo 2. View of upstream slope looking right from the left abutment.

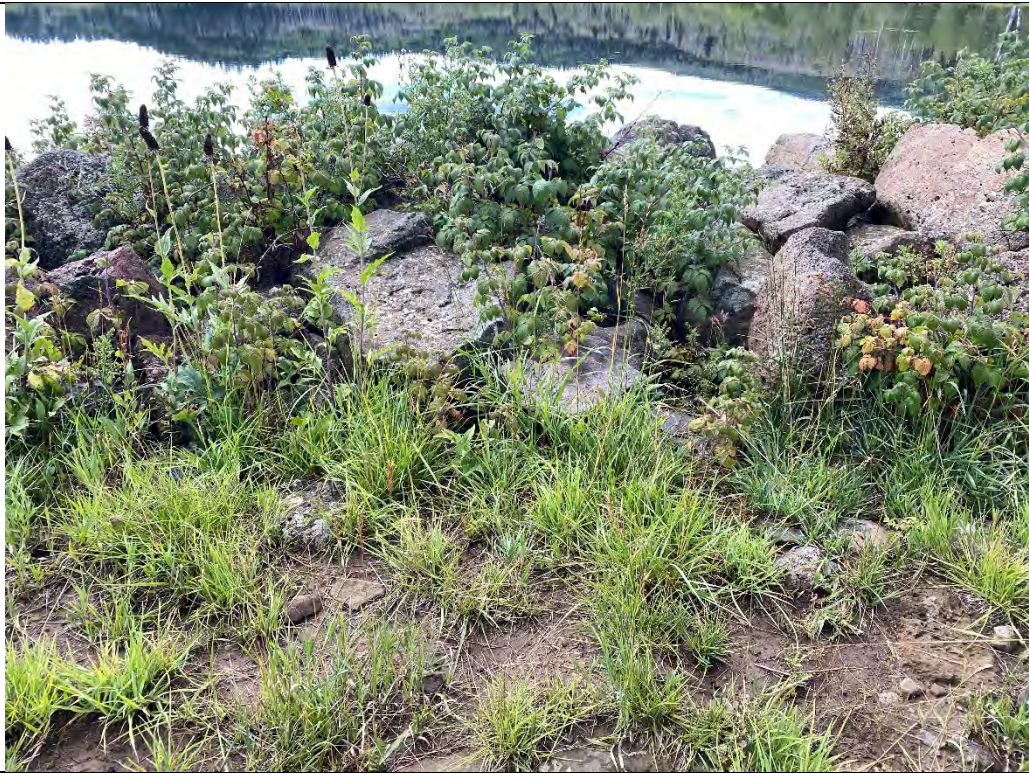
Photo 3. Close up view of the large riprap along the upstream slope with vegetation growing between the riprap.

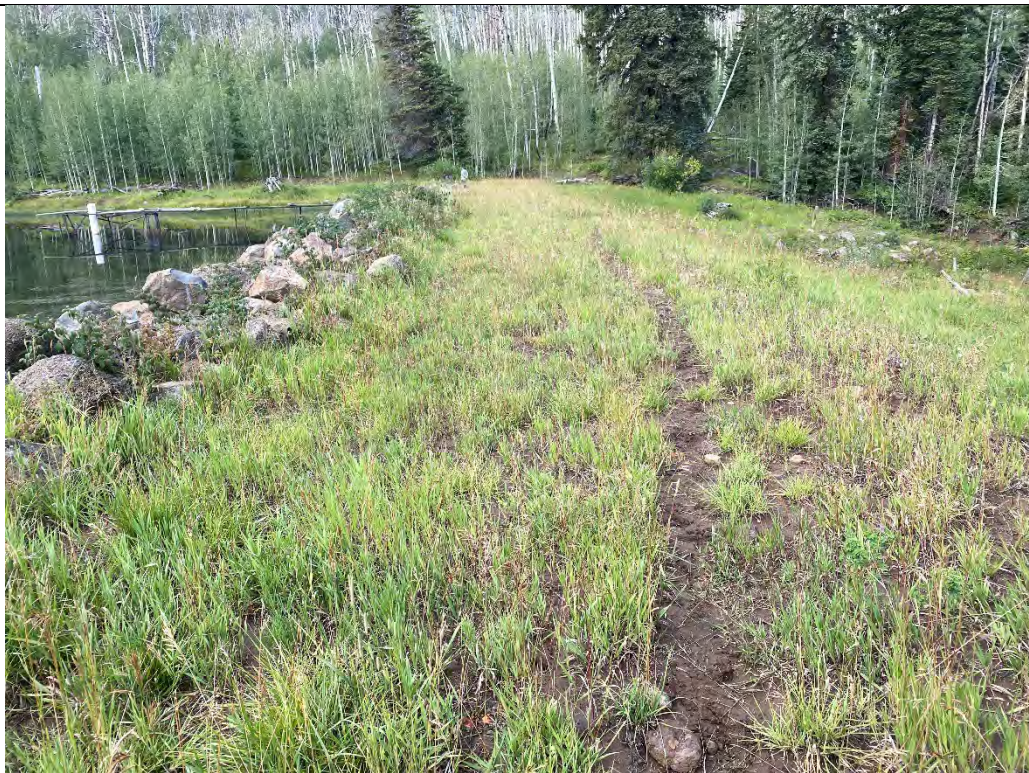
Photo 5. View of the dam crest looking left from the right abutment. Note the animal trail along the crest.

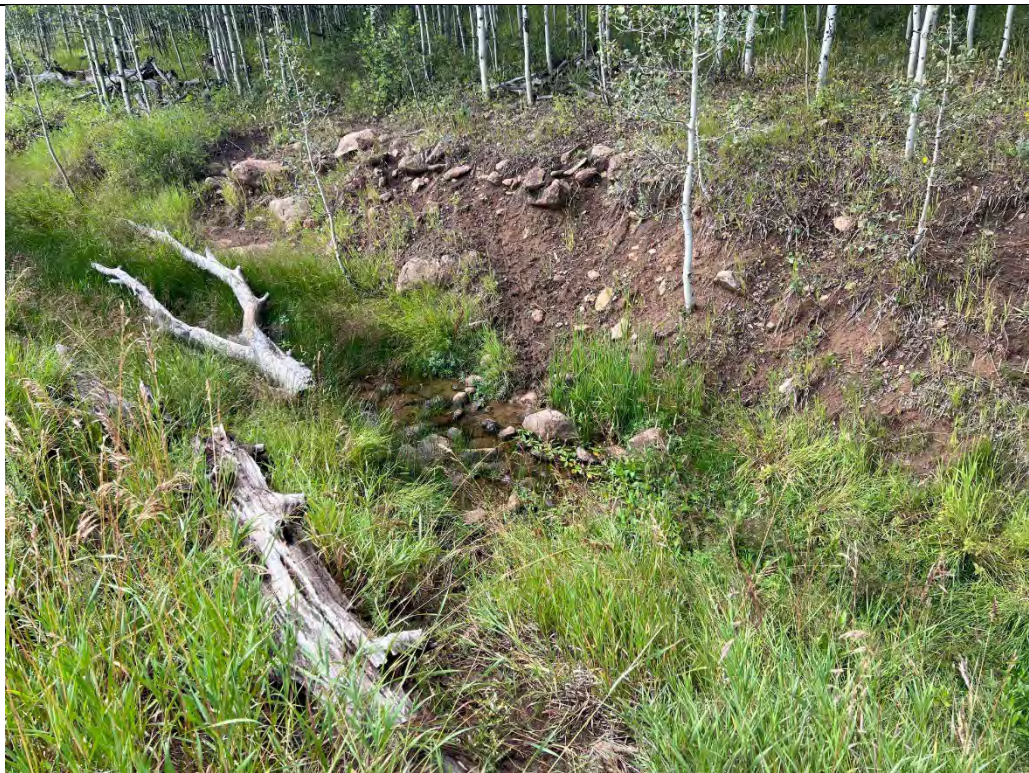
The primary spillway, located in the left abutment and has an earth cut (no formal control) invert approximately 3.5 feet below the dam crest (8361.5). This spillway is a trapezoidal earth cut with an average bottom width of 5-feet and nearly vertical side slopes (less than 1.5:1). The spillway channel was observed to be full of woody vegetation and debris that should be cleared to allow for maximum capacity. The secondary spillway, located in the right abutment, is an earth cut spillway (no formal control) that is approximately 5-feet wide and has a crest elevation of 8364. The secondary spillway was dry. Debris and dense vegetation were observed in the spillway.

Photo 7. View of the apparent control section of the primary spillway located near the left abutment. Note the woody debris and vegetation in the spillway.

6. Install a 2-foot-deep concrete control sill in the left spillway. This is the primary spillway for the dam, and installation of a cutoff wall will reduce erosion potential. Consideration

7. Provide positive drainage in the outlet works discharge channel.
8. Remove the rock in the siphon flume.
9. Continue to remove vegetation and debris on an annual basis from the dam as well as in the left and right spillways.

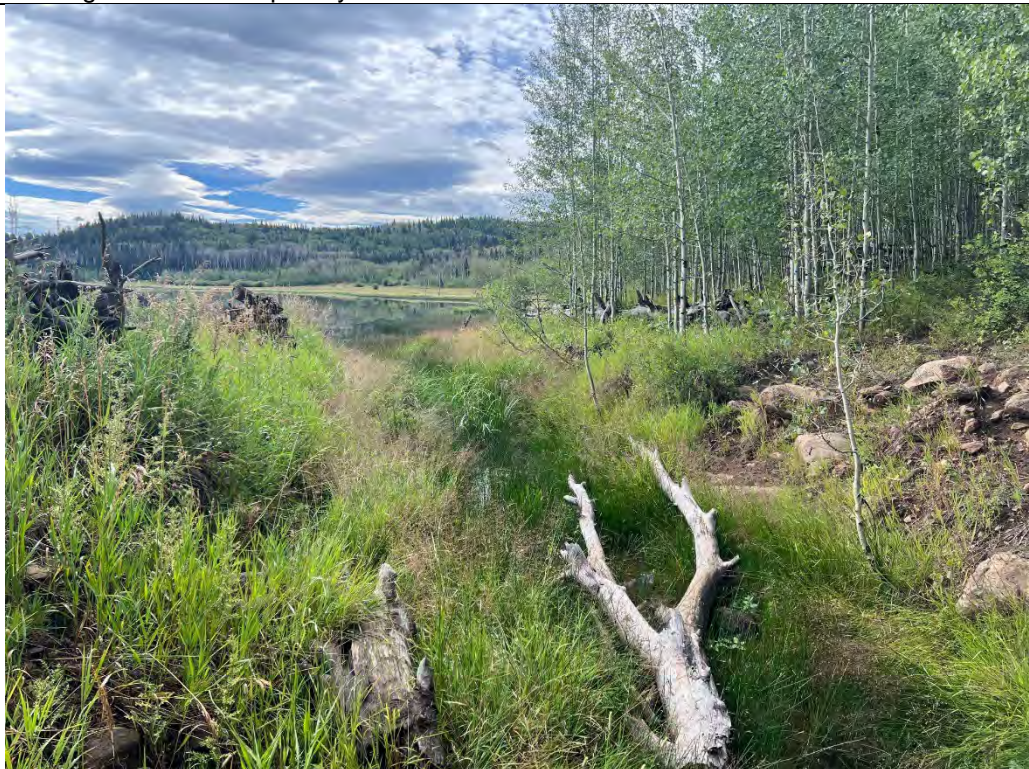
Photo 8. View looking upstream at the approach channel of the primary spillway. Again note the vegetation and debris in the spillway.

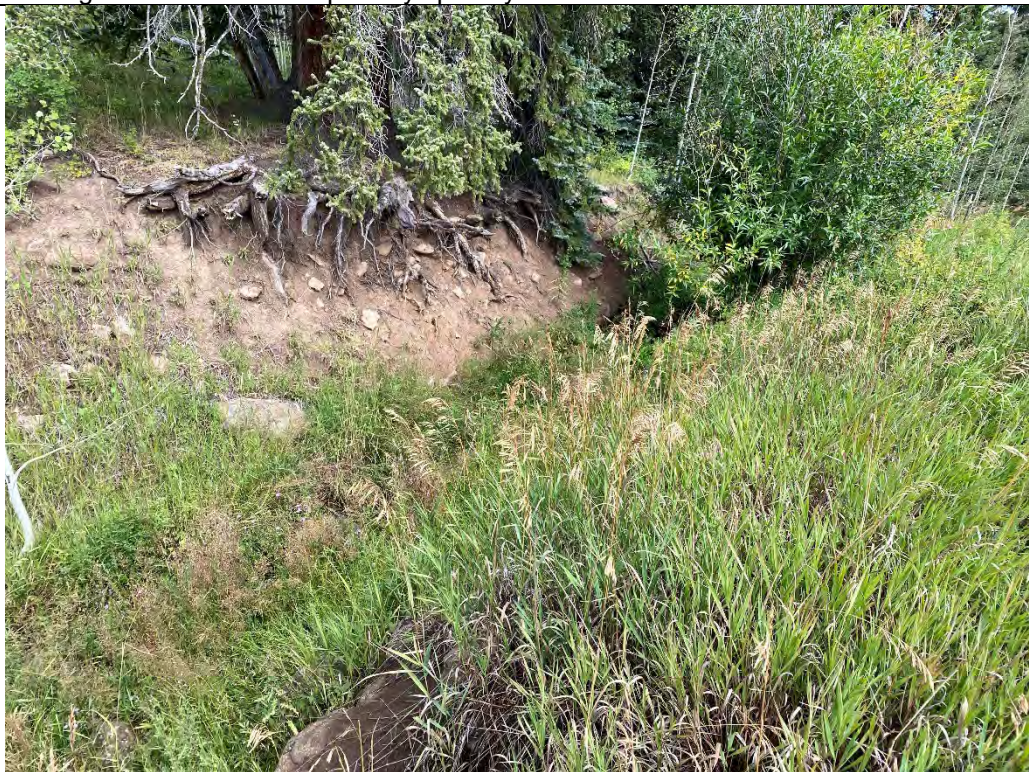
Photo 10. View of the primary spillway bank erosion. This erosion is downstream of the dam but should potentially be armored with riprap to reduce erosion over time.

should be given to grading the downstream channel and armoring the slopes in areas where erosion is evident.

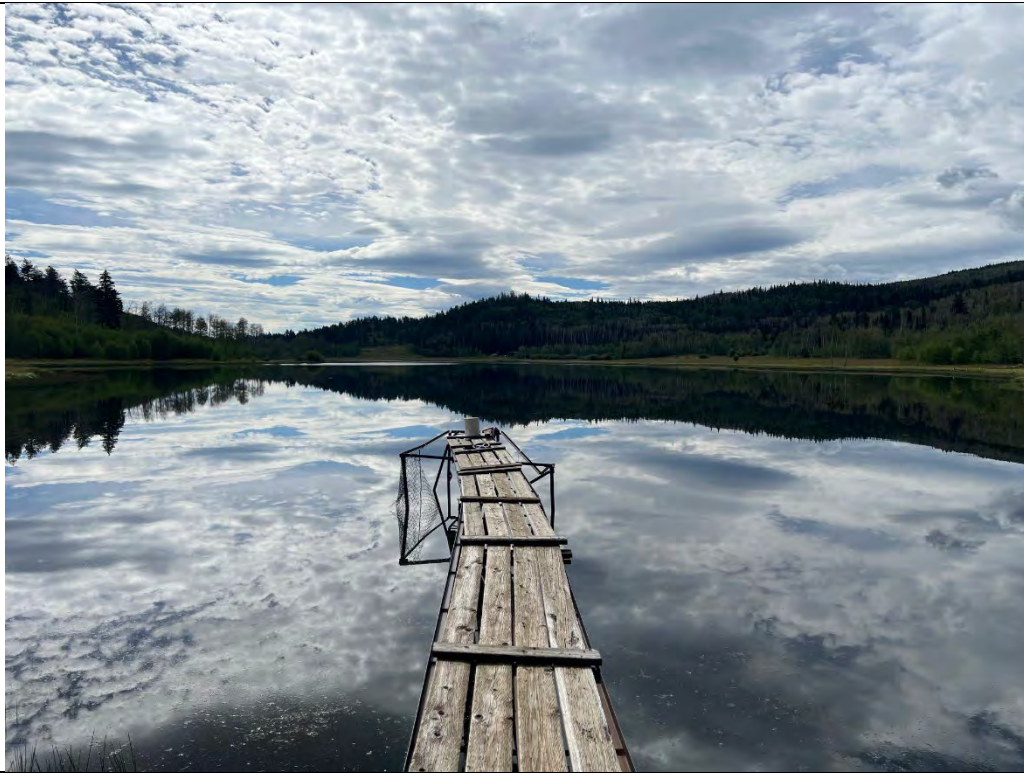
Photo 13. View of the outlet control gate and siphon system access walkway. Note that walkway should be repaired and stabilized for a safe access to operate the gate.

4. Replace the existing outlet works catwalk with a new stable catwalk with appropriate handrailing.
5. Install a reservoir staff gage. Per DWR Rule 7.7.2.2, all dams should have a staff gage.

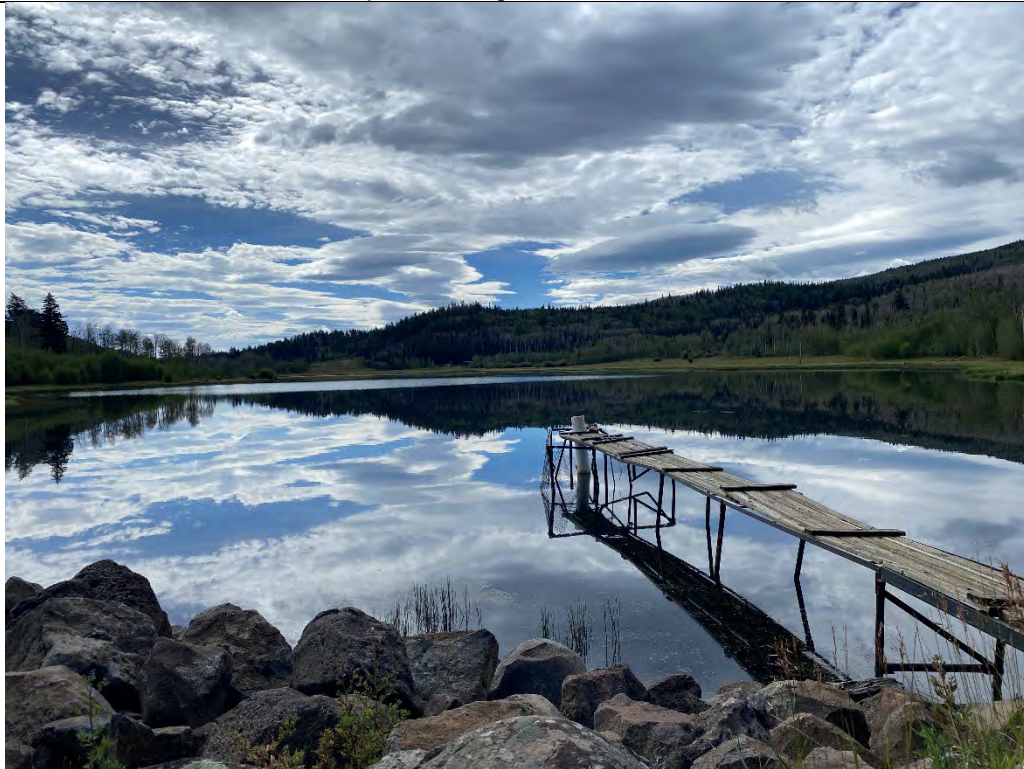
Photo 14. Another view of the outlet gate and siphon valve access walkway.

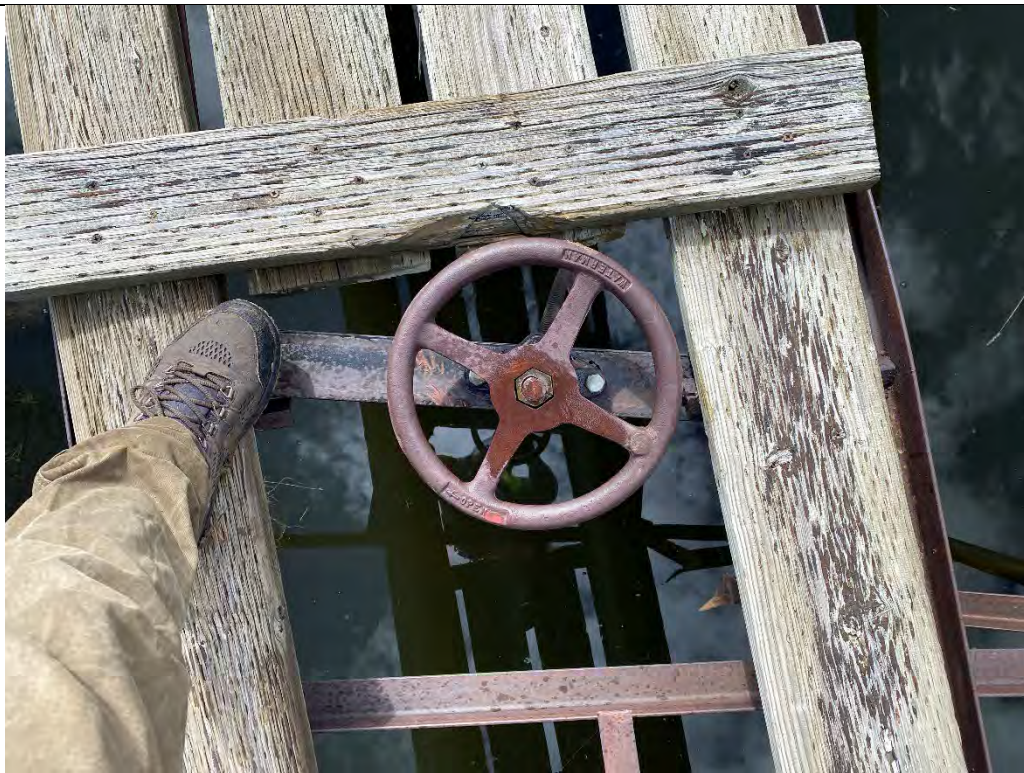
The outlet consists of a 24-inch-diameter CMP pipe that is approximately 120 feet in length. There appears to be a 24-inch slide gate submerged in the reservoir that controls the outlet discharge. The outlet was operated by the Owner during the investigation and is in considered to be in satisfactory condition. The gate stem and bracing appear to be bent and starting to corrode which could be the reason for stiffer operation. The 24-inch diameter CMP pipe is 30

Photo 15. Close up of the existing outlet works gate operator. Note that gate is fully exposed in reservoir and appears to be slightly bent and showing signs of corrosion.

3. The outlet gate appeared to be corroding and bent, thus making operation more difficult. It is our consideration that the outlet gate should be replaced with a new 12-inch slide gate mounted inside a concrete vault. The concrete vault will provide winter and weather protection for the gate. Our recommendation would include the installation of a precast manhole vault that could be brought up in smaller pieces. The vault would then be installed to protect the new outlet gate as well as the siphon valve. This recommendation would require an engineered design and submittal to DWR.

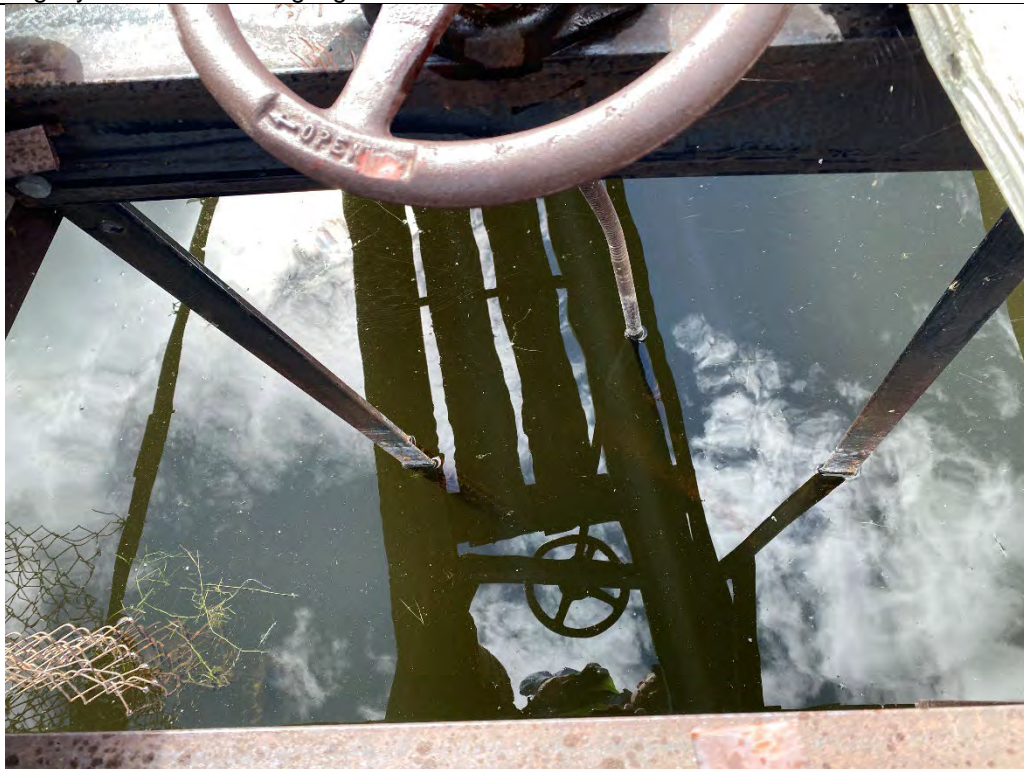
Photo 16. View looking down into the reservoir at the outlet gate. Notice the bend in the gate frame, indicating the gate is likely bent as well.

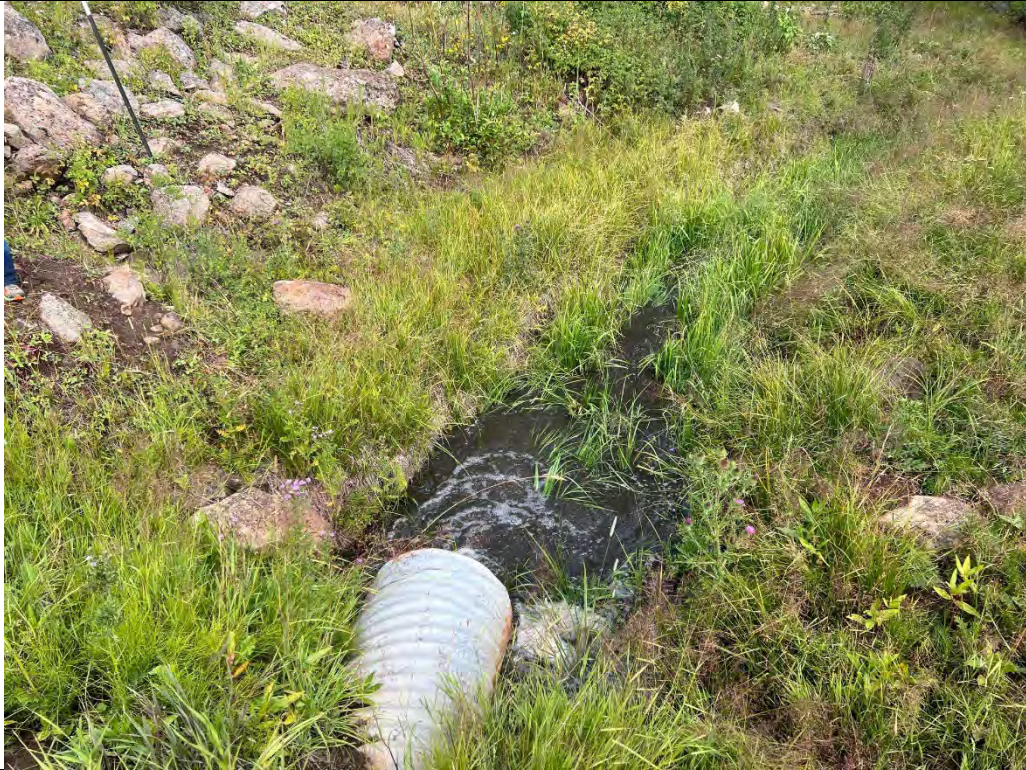
years old and corrosion and deterioration of the bottom of the pipe is likely. The discharge channel should be graded to show positive drainage away from the outlet. There is a 12-inch diameter siphon system that consists of an upstream valve in the reservoir and a downstream control valve. The upstream valve was submerged but was open. This valve was not operated during the inspection. The downstream valve is typically cracked to keep the siphon operational. The Owner operated the downstream valve during the inspection. There is a measurement flume downstream of the siphon system that has a large boulder in the upstream portion of the flume, thus preventing proper operation of the flume.

Photo 17. View of the 24-inch CMP outlet discharge conduit.

2. The 24-inch diameter CMP is over 30 years old. It is recommended that the outlet pipe should be lined with a smaller HDPE pipe and the annular space be grouted. Installation of a CIPP liner could be difficult due to access issues. Our recommendation would be to line the outlet with a 12-inch diameter pipe and grout the annular space. The liner pipe material could be PVC pipe that can snap together, thus allowing for smaller pieces to be transported to the site and inserted into the host pipe. Grout can be mixed on-site and pumped around the annular space. Based on DWR Rule 4.14, outlet drawdown of 5 reservoir feet in 5 days, reducing the outlet will still meet this DWR requirements. This recommendation would require an engineered design and submittal to DWR.

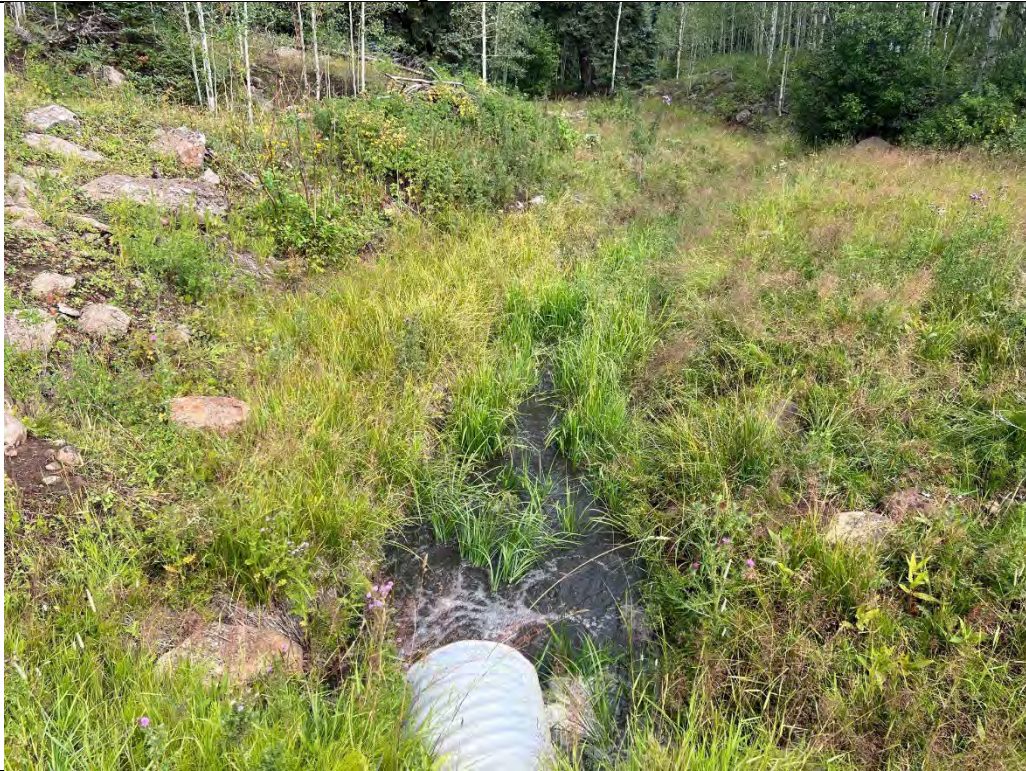
Photo 18. View of the outlet discharge channel looking downstream.

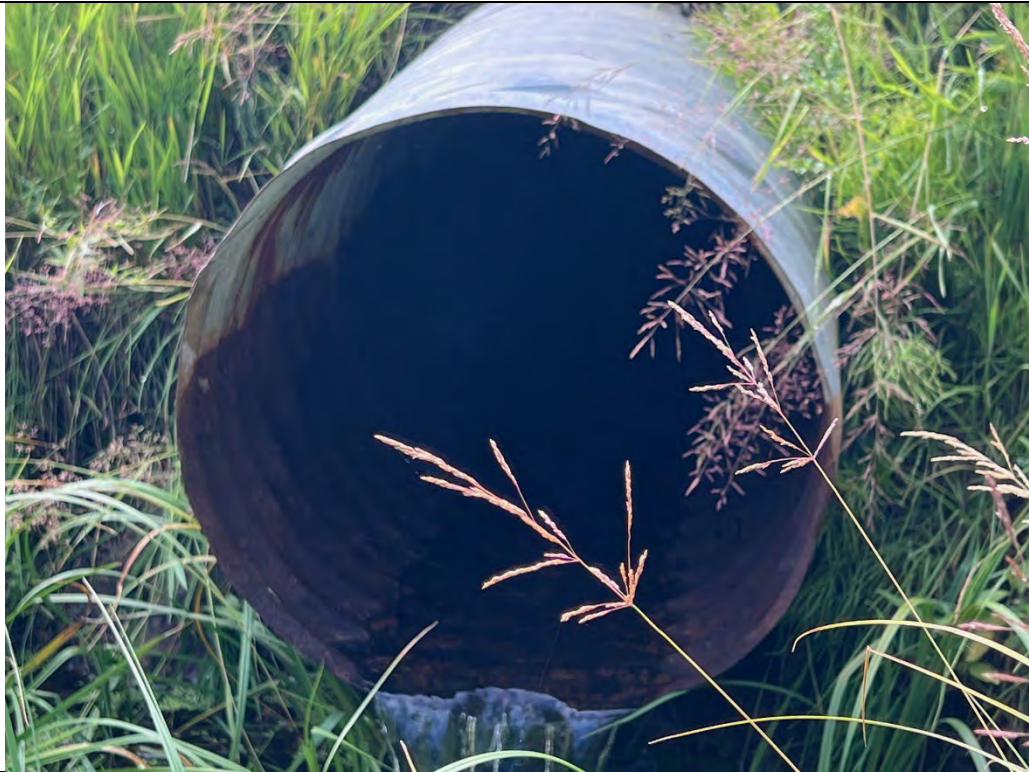
Photo 19. Close up view of the 24-inch CMP Outlet Pipe. The invert of the pipe appears to be eroding.

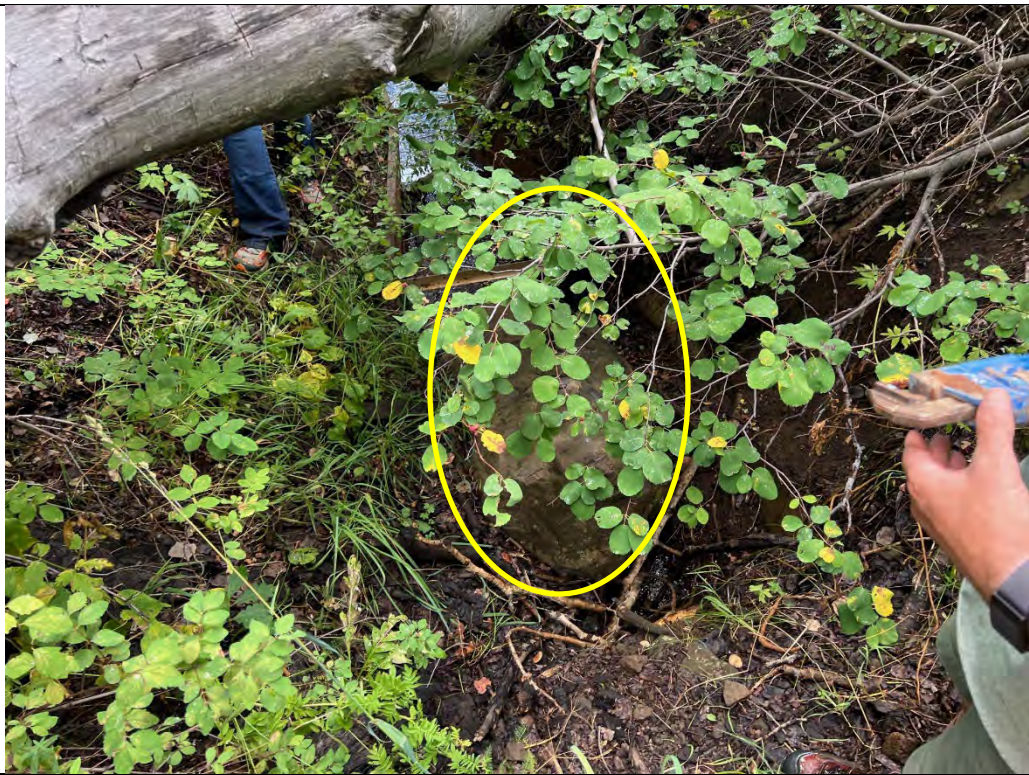
Photo 25. View of the large boulder located in the downstream measuring flume.
