February 28, 2024

Reference: Technical Solutions Memo for the Silver Lake Ditch Tunnel
Tunnel Rehabilitation
Boulder County, CO

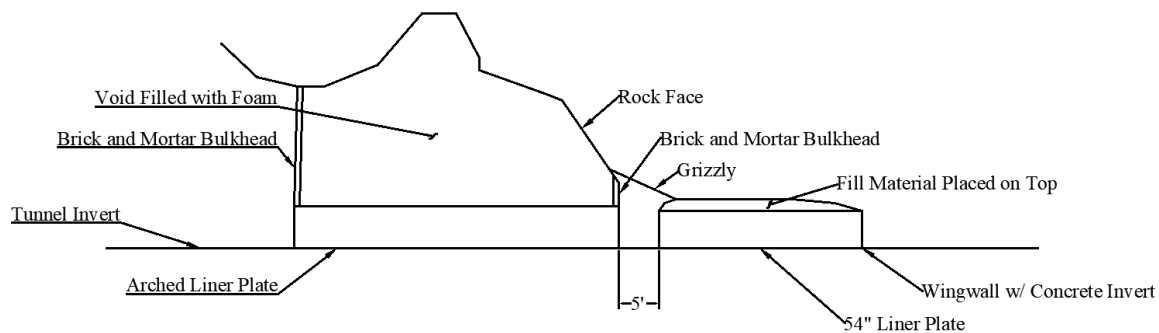
The existing tunnel consists of a 24" diameter pipe that is hung from the adjacent rock slope outside the tunnel that daylight into the West portal entry of the tunnel. The existing West portal headwall has concrete delamination occurring which ultimately results in an amount of water bypassing the West tunnel portal entry causing further erosion at this location as well as water loss. In addition, there are several boulders above the West tunnel portal that pose a safety risk as well as have the potential to impact water flow if they become dislodged. The tunnel varies in width and height, with some locations approximately shoulder width, and with heights ranging from 5' to 12'. Timber cribbing is present inside of the tunnel and supports sections of decomposing rock that are shearing from the tunnel ribs and back. This poses a safety risk when accessing the tunnel as well as a risk of further obstructing water flow. The Eastern portal of the tunnel daylight into an existing 36" corrugated metal pipe, which is buried underneath rockfall debris and is understood to be out of round due to this undesirable loading and is separated in several locations.

HW proposes multiple improvements to the Eastern portal of the tunnel so that there is less risk of loose, falling material impacting water flows. In the tunnel, 31 LF of a 48" wide x 61-11/16"

tall arched liner plate system with brick and mortar bulkheads will be installed at each end. Following liner plate and brick and mortar bulkhead installation, HW will backfill the existing void space surrounding the liner plate in multiple lifts with an expansive geotechnical foam to serve as lightweight backfill. This is intended to prevent any damage to the liner plate via rockfall. The existing gate on the Eastern portal will be reinforced to serve as a grizzly to deflect rockfall away from the tunnel portal, and to aide in the prevention of unauthorized access into the East portal.

Outside of the East portal, HW will remove the existing corrugated metal pipe on the exterior of the tunnel and replace with a new 54" outside diameter (48" inner diameter) liner plate that is then buried with compacted in-situ material and reinforcing fabric. A cast-in-place headwall and concrete invert will be placed on the in-by and out-by sections of the liner plate to create a smooth entrance and exit for water to flow. The reinforced in-situ material will serve as a barrier to future rock fall and prevent damaging of the pipe which has been observed on the existing 36" pipe. A sketch of the East portal repair is presented below.
