Spring Creek Fire Remediation Project
CWCB Grant Contract CTGG1 PDAA 202100002486

FINAL REPORT

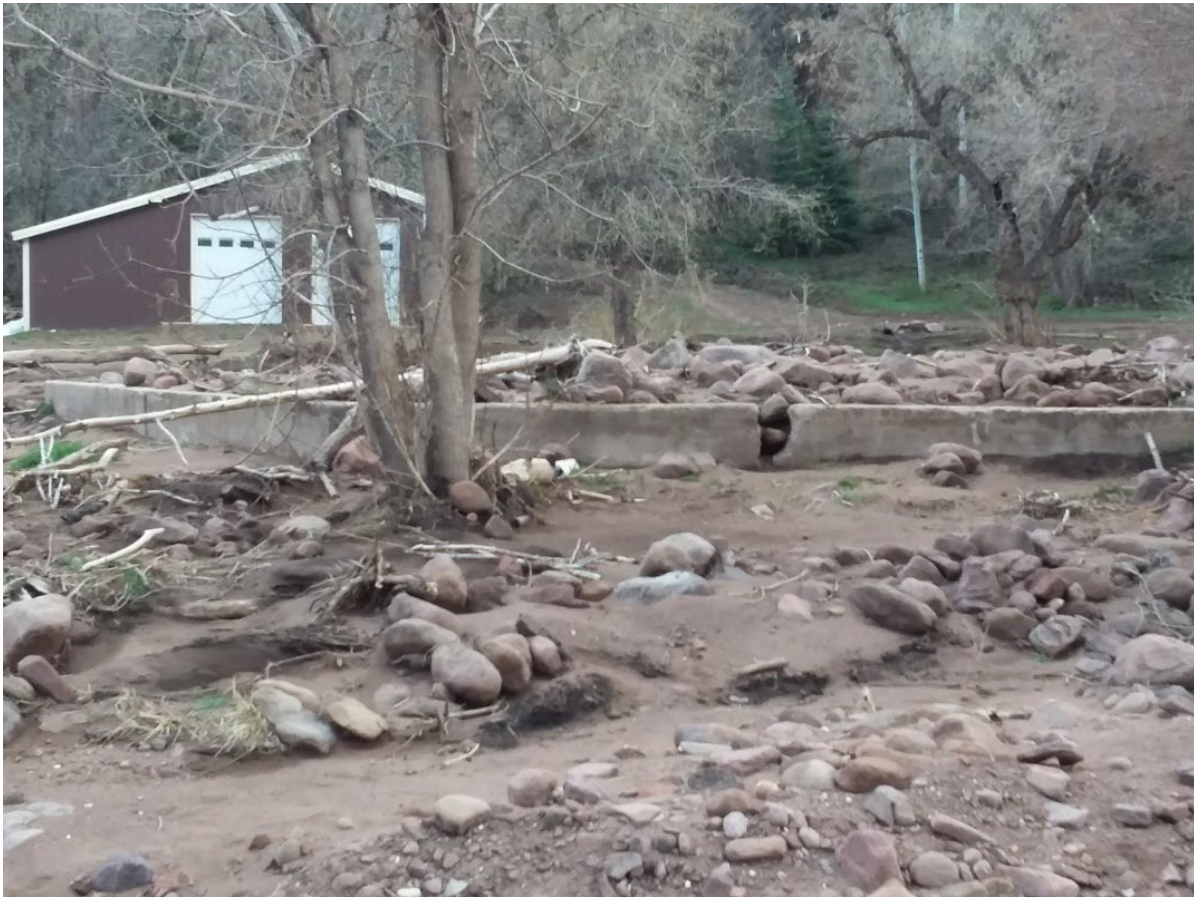
The Sulphur Springs property, particularly the swimming pool, was overwhelmed by rock and sediment runoff and sustained damage. It was decided to utilize the swimming pool as a detention basin.

Sulphur Springs pool (center) filled with sediment and rocks

- Clean the swimming pool and surrounding area of rock and sand.
- Sort the rock by size and type.
- Decommission the driveway to the Sulfur Springs garage.
- Create a layered system of gabion baskets, mining cribwalls and sill logs to fill the driveway cut, along with rock and dirt.
- Install rock vanes down the channel, now referred to as the low flow channel.
- Create a high flow channel, keeping the swimming pool as a detention basin and sheeting the flood water across the old Sulfur Springs building site.
- Create a diversion wall for low and high flows.
- Install a low water crossing by the Sulfur Springs caretaker's house.

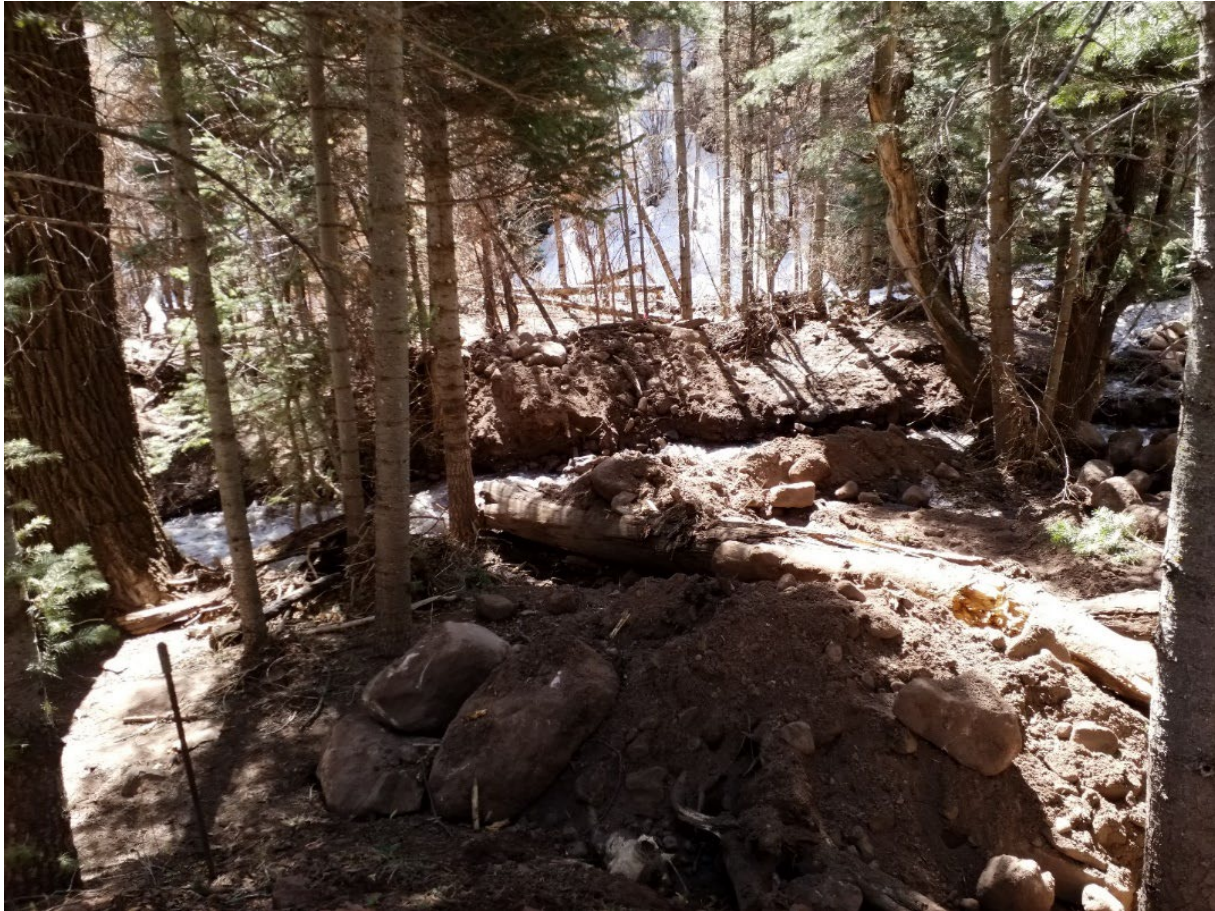
Storm damage in the area of Sulphur Springs, June 2021

Due to a storm event changing parameters, the scope of channel work had to be revised.

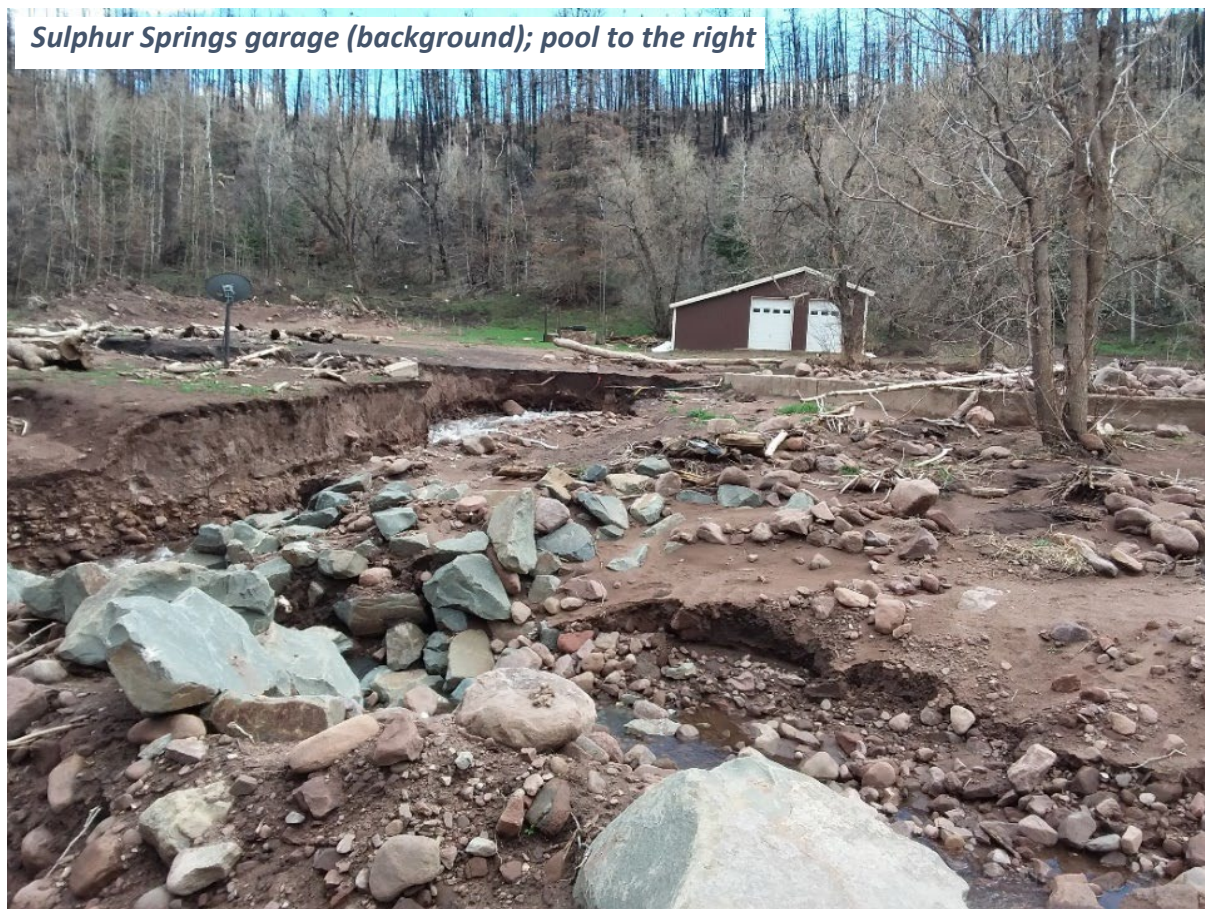
The recent task to clear the Sulphur Springs pool of sediment and rock was timely, and the project was largely successful. The pool held up to the surge and was filled to capacity with sediment and rock again, as it was designed to do.

Unfortunately, the sheer volume of water incised the stream channel, and the low water crossing access to the project area that had previously been installed was lost. Although

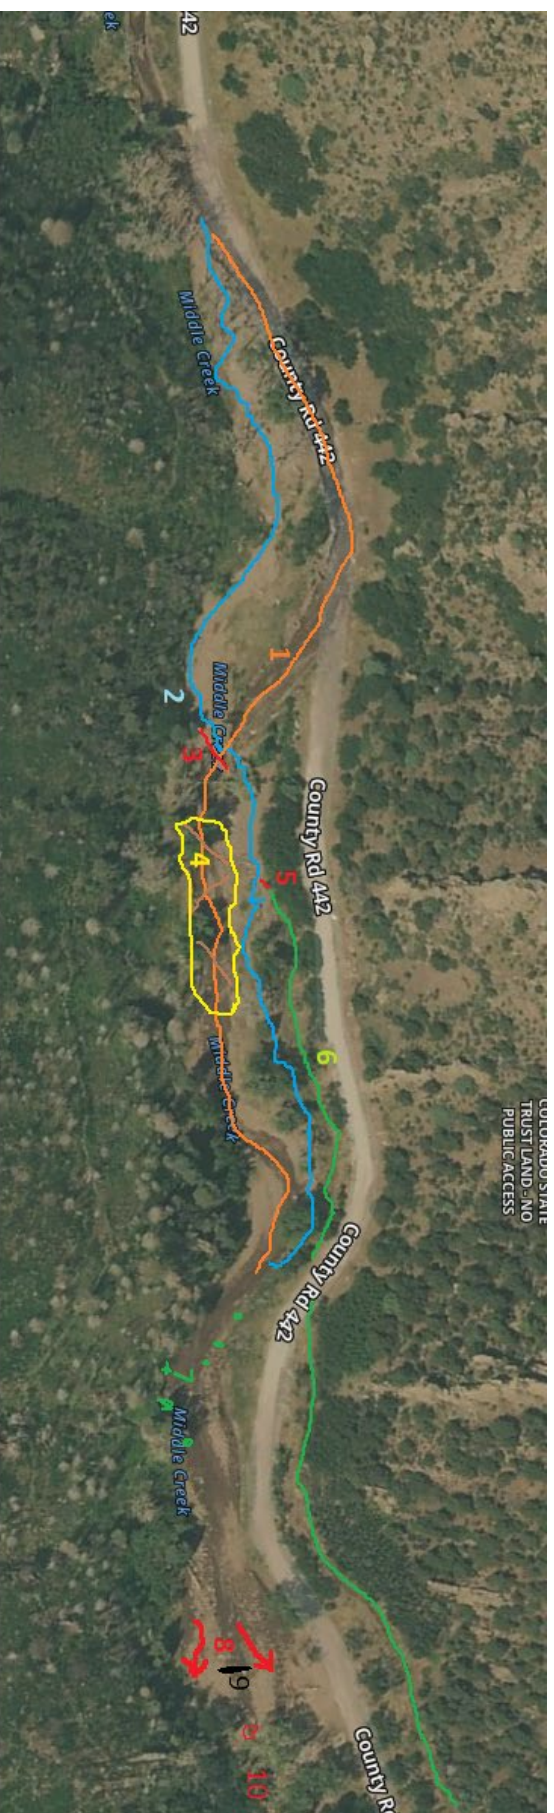
1. Current(unstable) flood channel.
2. Former (stable) creek channel.
3. Cutoff dam.
4. Flood plain restoration area with three permeable sills.
5. Diversion to Toll Gate Ditch headgate.
6. Toll Gate Ditch.
7. Revegetation Area.
8. Rocky debris to be graded to restore stream gauge function.
9. Stream Gauge.
10. Woody debris to be removed to provide clear outflow below gauge.

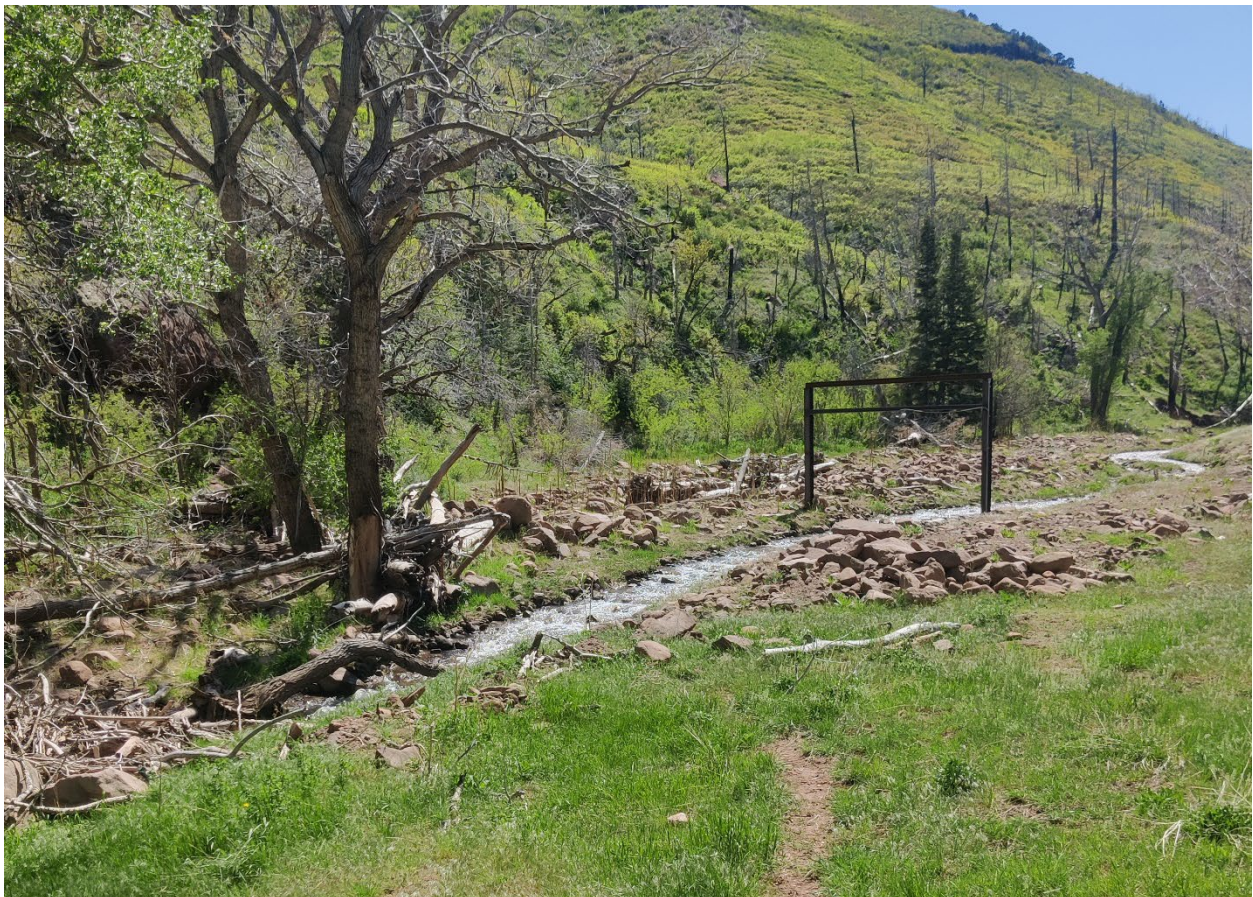
Completed Middle Creek flood warning gage site; gage mounted on metal frame shown (center right)

In Fall 2023, the planned maintenance was completed at the existing Middle Creek flood emergency warning gage. Debris was cleared by pushing the rocky boulder and sediment deposits to the north wall, forcing the water course back across the center of the vortex and over it. Limited upstream channel establishment was performed, and trees and woody debris were placed downstream of the gage with a limited amount hauled away. The integrity of the existing gage facility was maintained.

In Summer 2024, final work was completed to stabilize the gage location and reestablish the stream channel. After work on the stream gage site was finished, the intention was to move directly to the diversion project without interruption or the need to remobilize equipment. The time frame of early Summer 2024 resulted in completion of the work after spring runoff and before the summer monsoons.

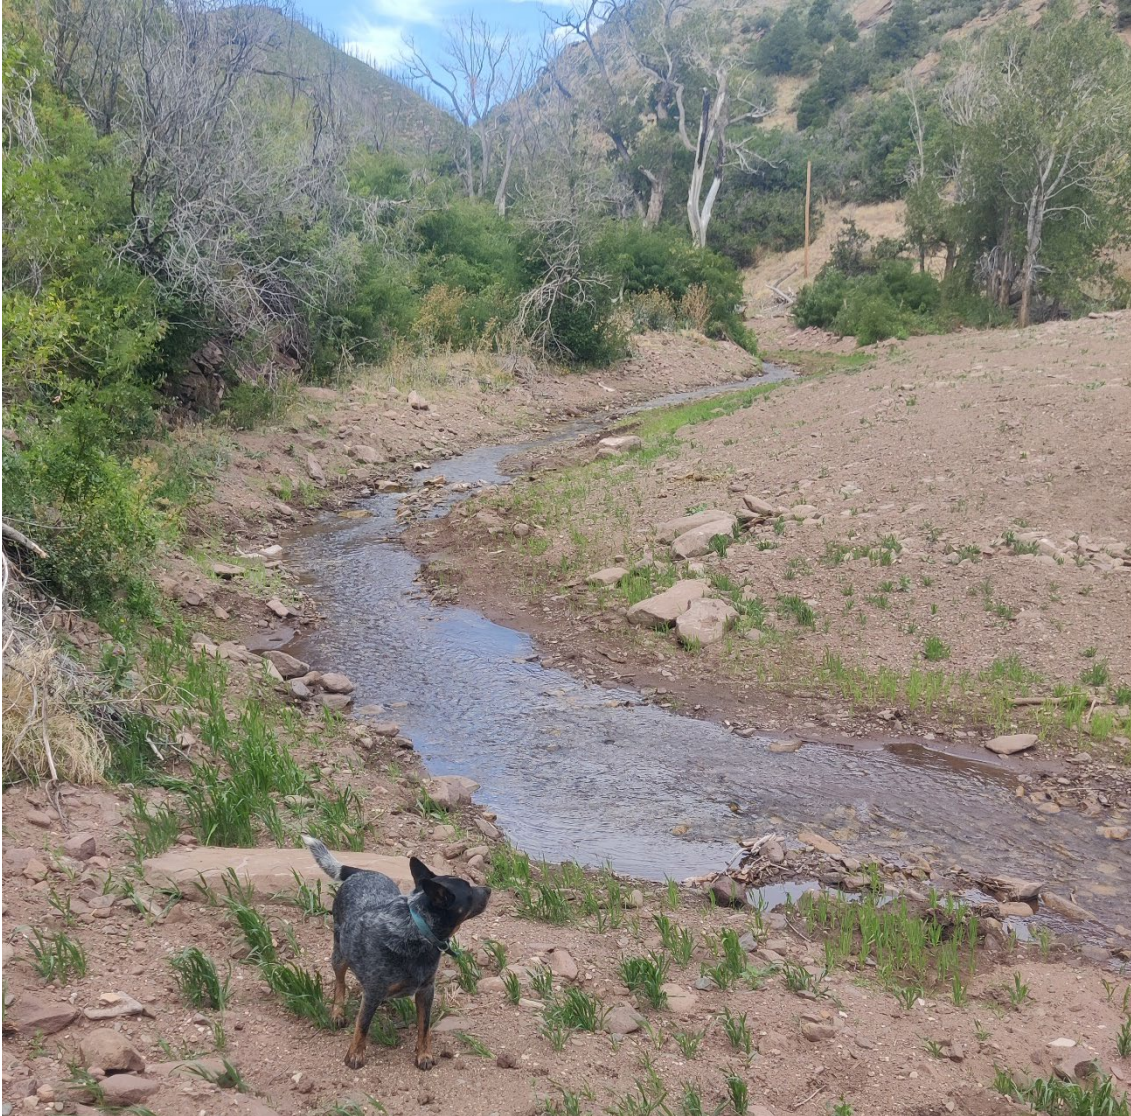
Channel restoration above dam site

Restoration of the diversion for the Toll Gate Ditch was a component of restoring the stream channel. The headgate was dug out, elevations were established for the dam and raceway, then the grade of the surface was established. Large boulders were stockpiled for use in the dam and the sediment capture structures. The channel was restored above the dam site. The stream was temporarily diverted to bypass both it and the area where the sediment capture structures would be. This unstable wide flood channel needed to be rebuilt, as recommended by Burr, so flood stages over about 280 cfs will overtop the dam and sheet out across the structures, depositing and capturing sediment.

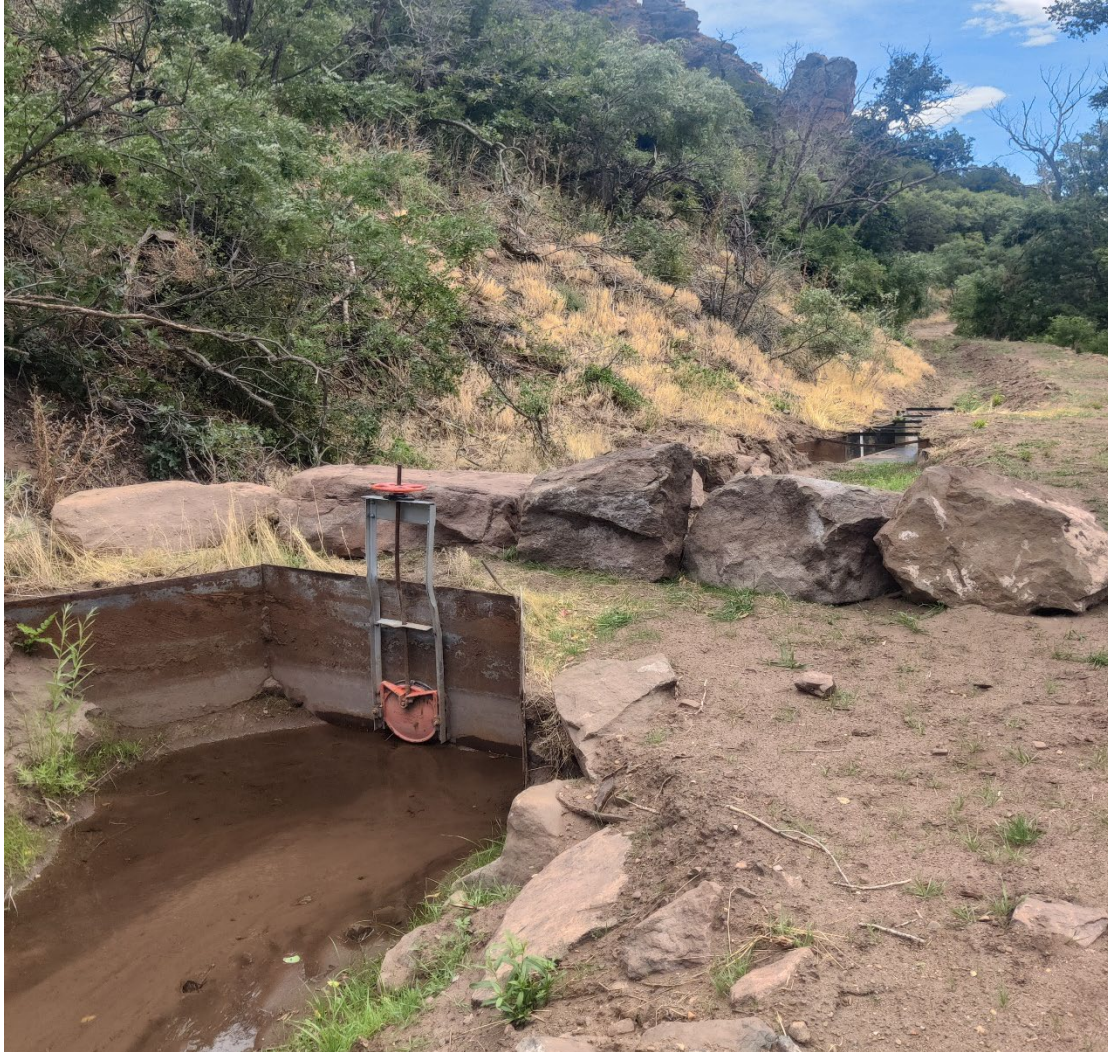
Diversion (background) and headgate with boulders to mitigate flood surges

The dam was tied into the rock cliff that previously bounced the creek into a wide meander. Lined with geotextile fabric, the dam was built up with boulders and grouted. On its lower side, four- to six-foot rectangular boulders were tightly fitted and grouted. The cutoff dam surface forms a ten-foot wide swale, with the lower side several feet taller. The raceway to the diversion begins at the lower end of the dam and continues about one hundred feet to the diversion. The diversion itself was topped by a row of three-foot boulders to prevent any flood stage from trying to follow the ditch.

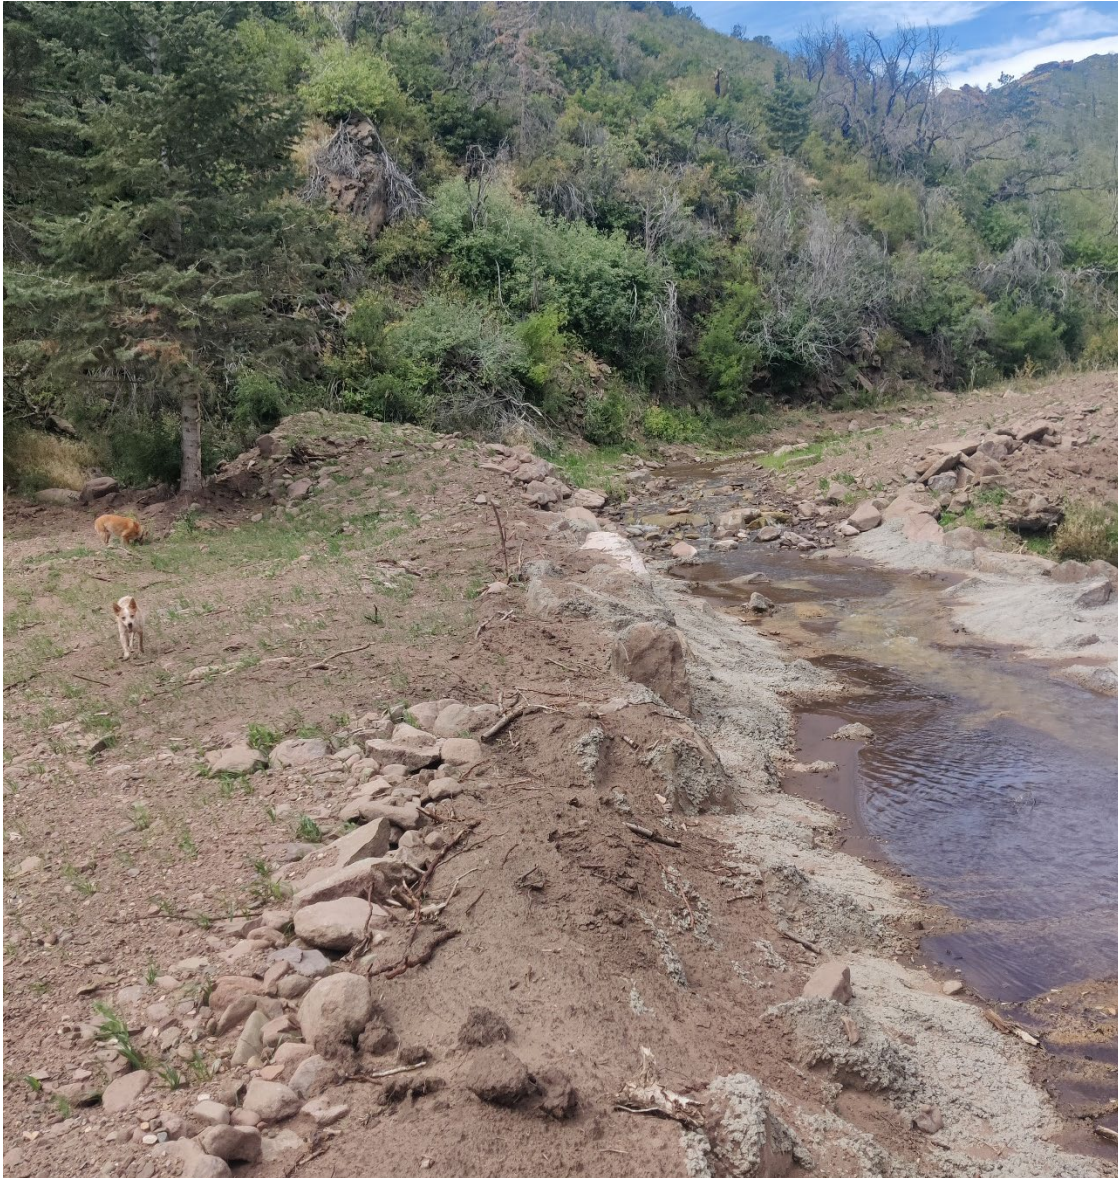
Restored Middle Creek stream channel

The remediation work on Middle Creek restored its flow to the stable original stream channel. In doing so, it may enable eventual reconstruction of County Road 442. CR442 had been rendered unusable by post-fire flooding damage, which turned the roadway into the stream channel and added large amounts of sandy loam into the stream system.

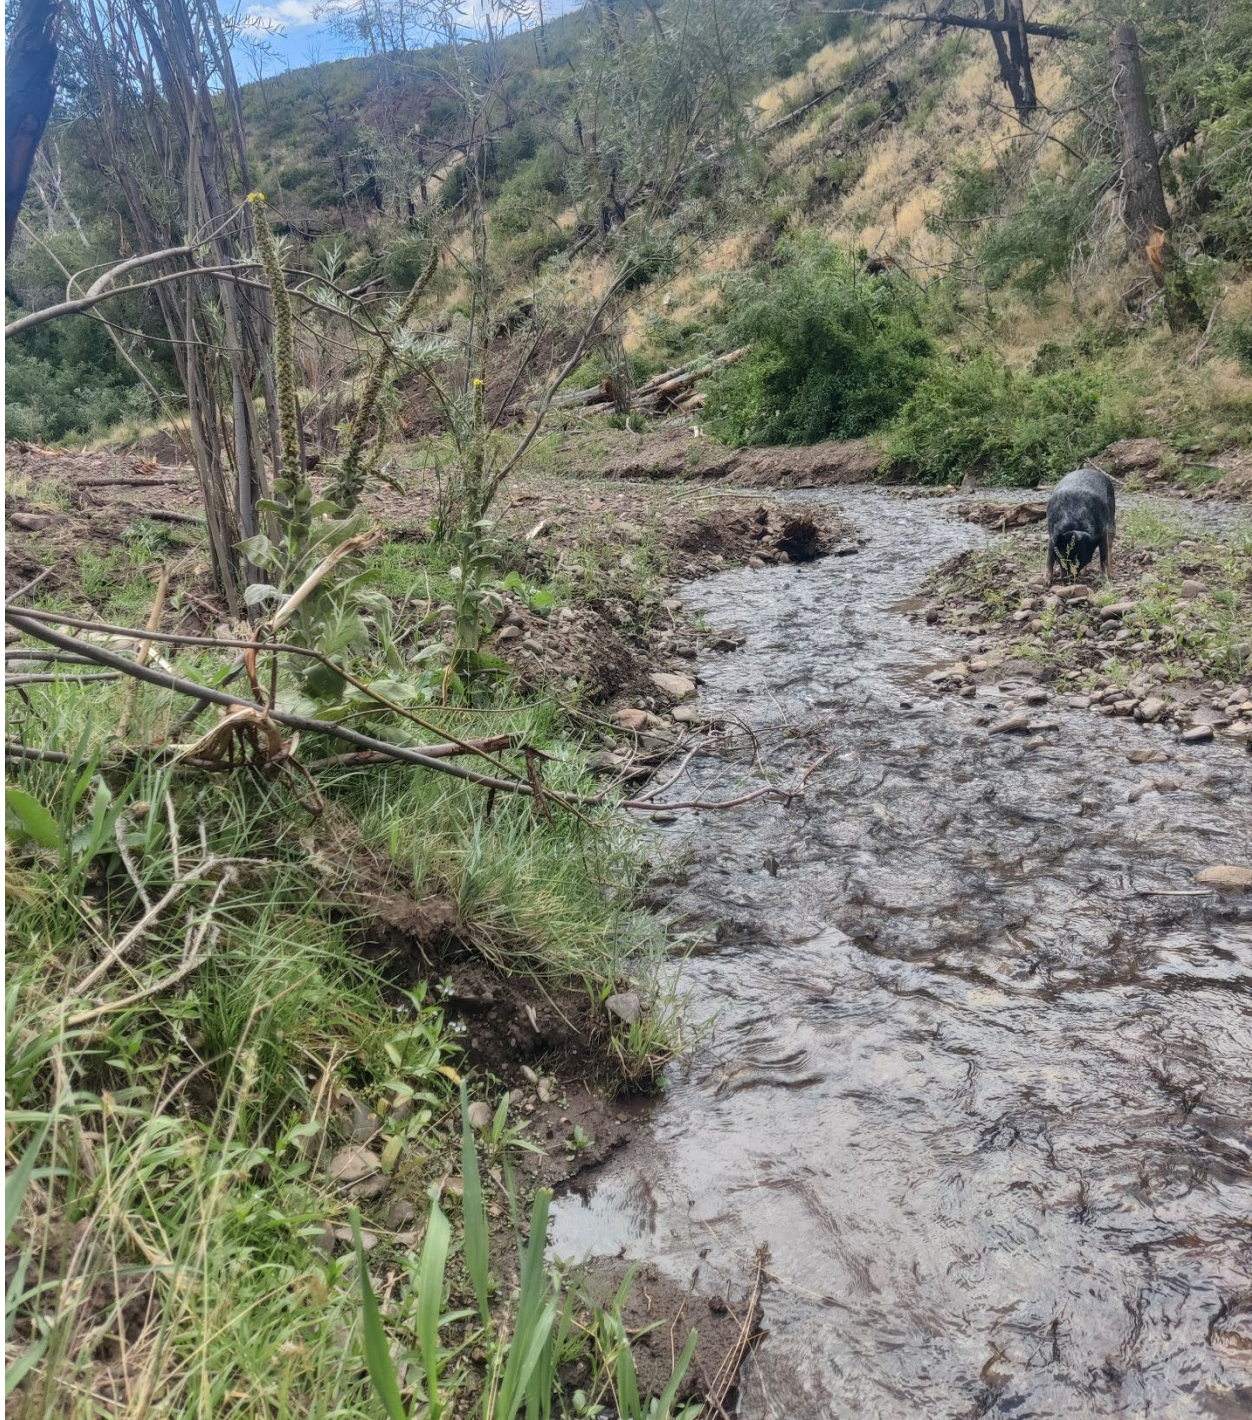
Revegetated streambanks with alders and willow clumps (left and far right)

Steffan advised in September 2024, if more is to be done with remediation, it should include bank stabilization, which seems to be the most pressing issue on and below the burn scar.

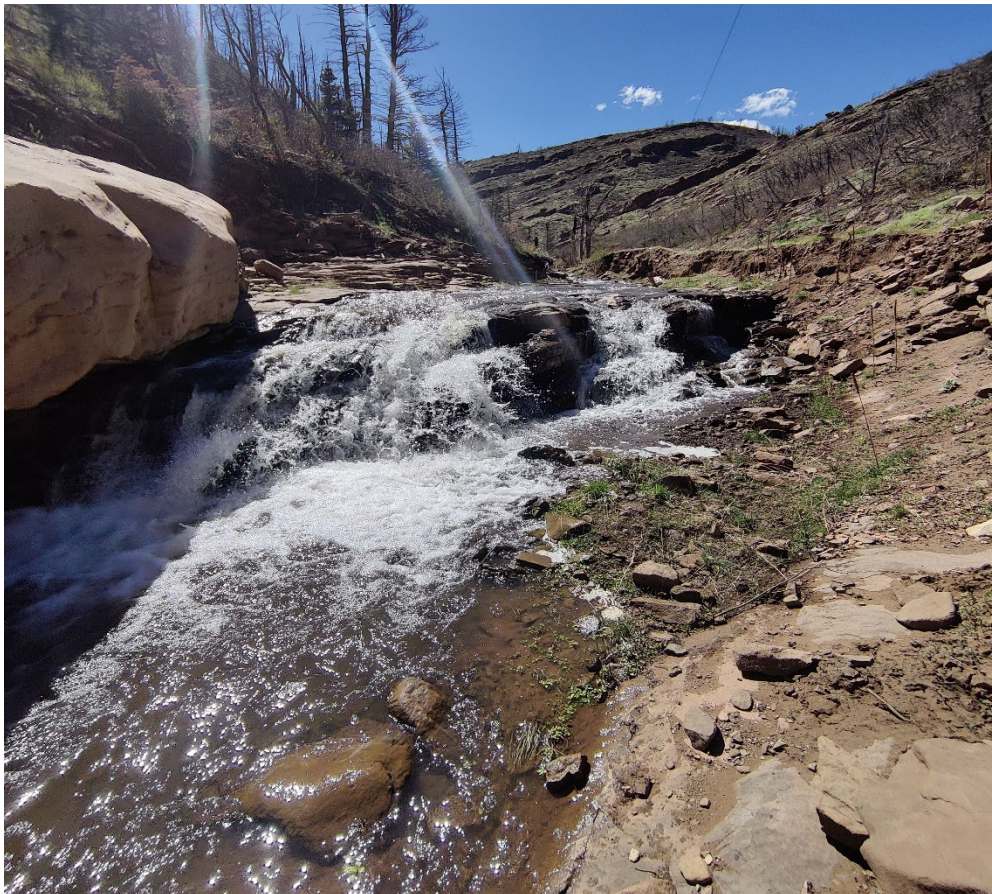
Fish barrier, Middle Creek
