October 28, 2024

**Re: FINAL REPORT**  
**Lower Beaver Brook Dam, Upper Beaver Brook Outlet Works and SCADA System**  
**CT2021-3115, WSRF Grant POGG1 2021-2565**

Attachments: pdf photos

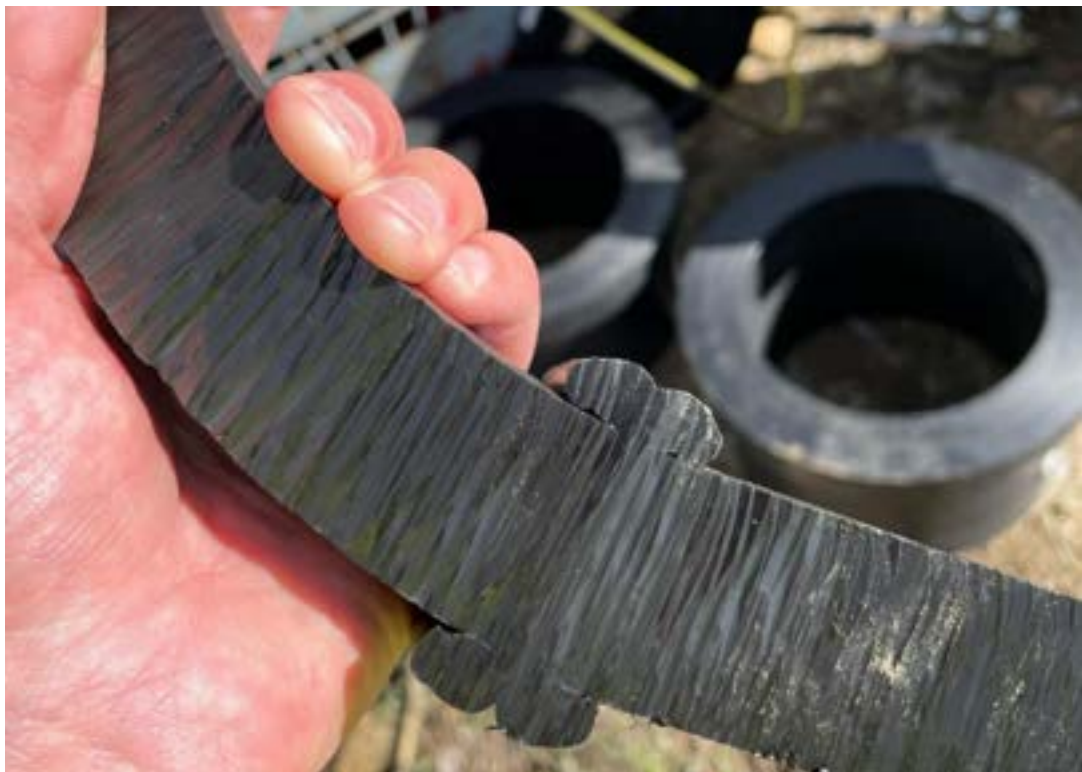
Photo 17: Result of reverse back bend test. Weld is shown to be intact and free of defects. Test was performed on four separate test sections with same result.

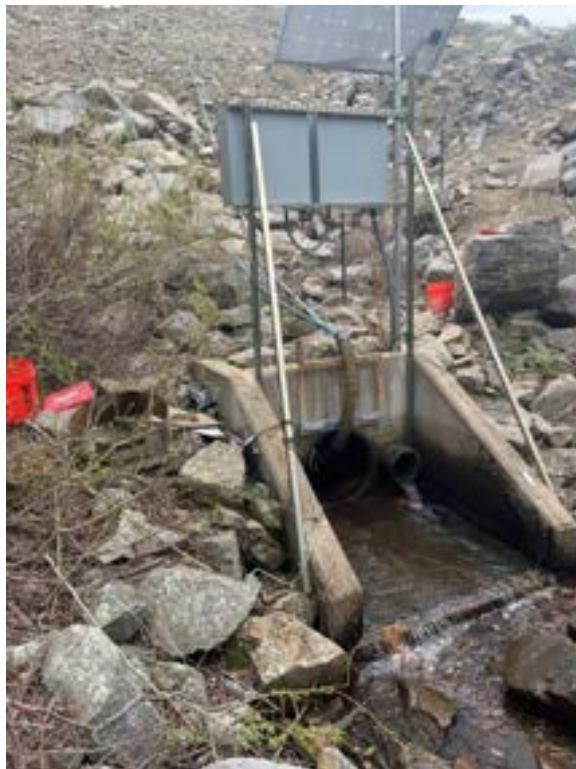
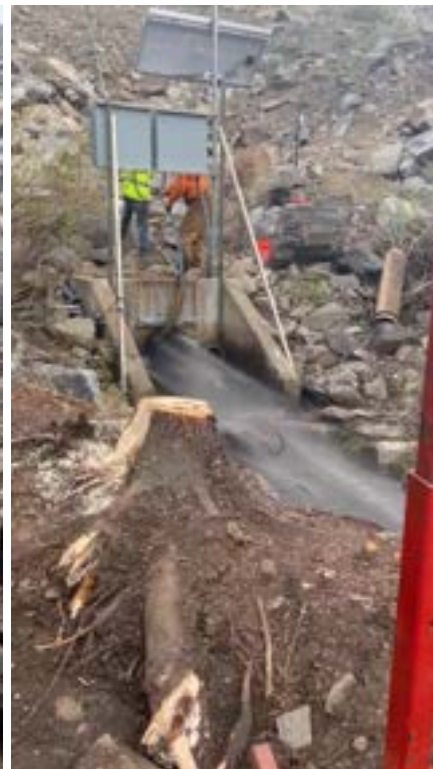
Photos 25 & 26: Jetting outlet works conduit. Multiple passes were made until debris and dirty water were no longer observed to be discharging from conduit.

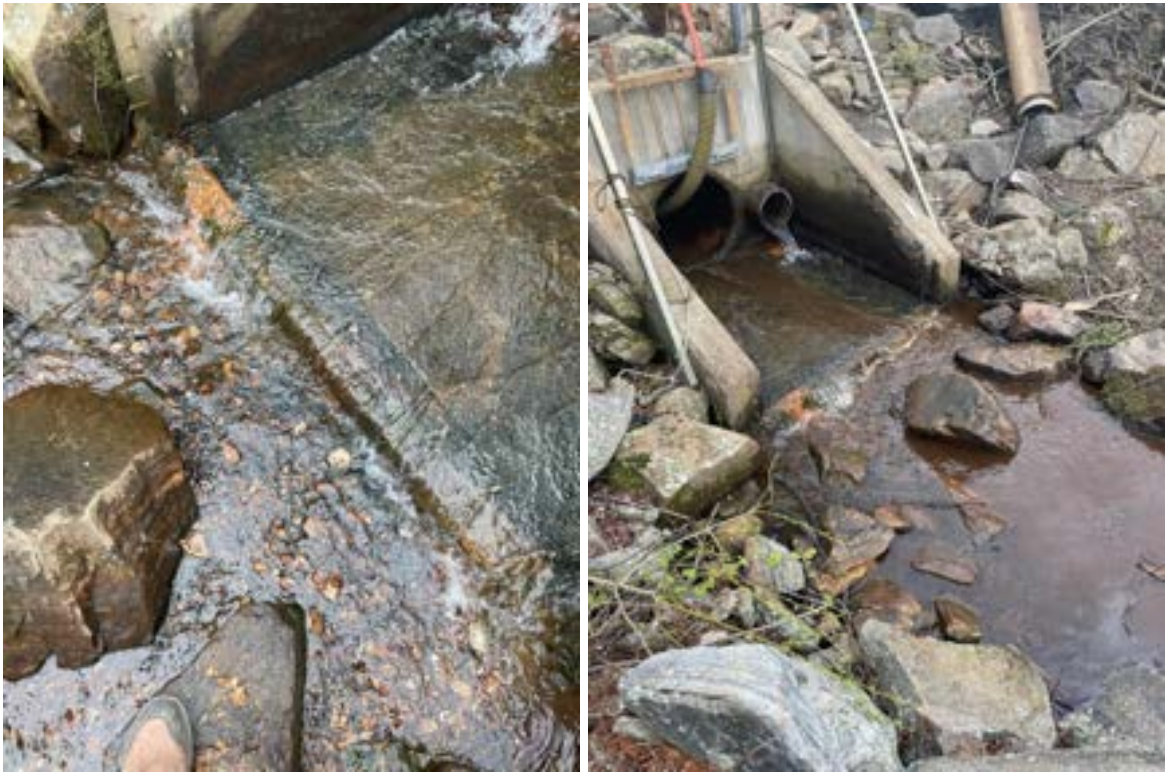
Photos 27 & 28: Lime scaling, corroded iron, and water with high suspended solids observed during jetting.

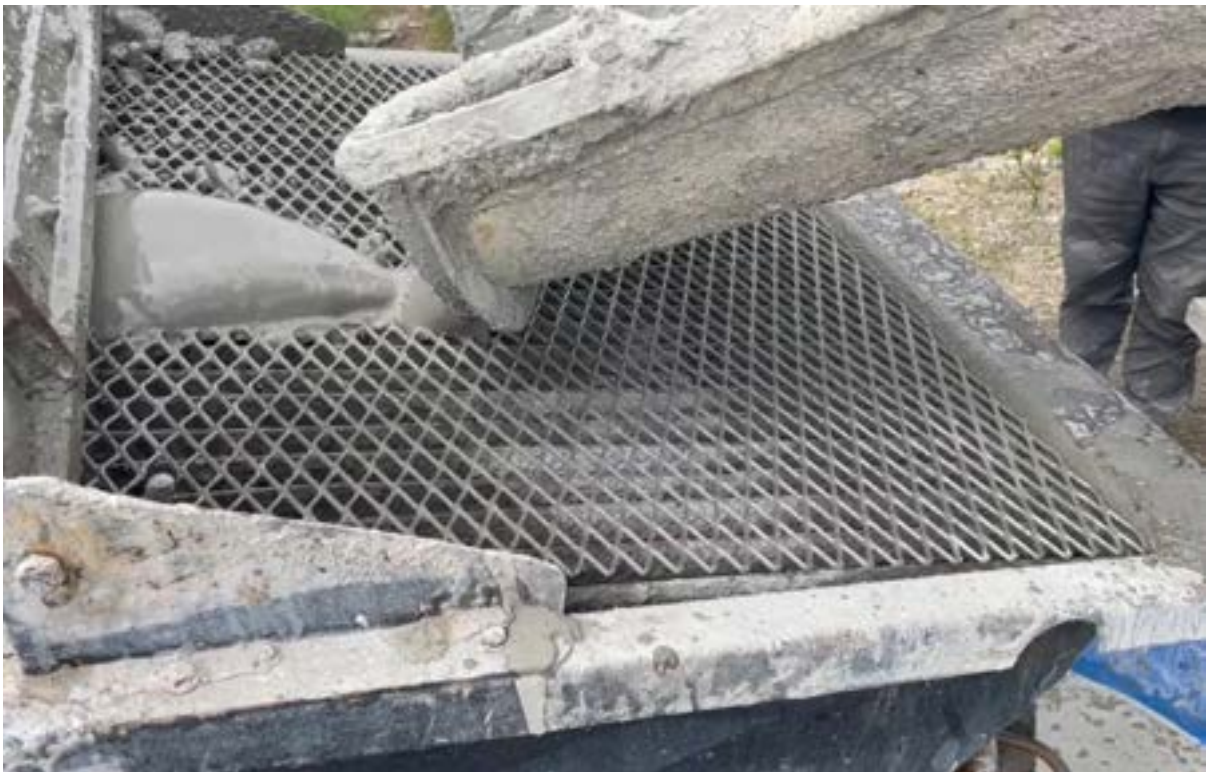
Photo 12: Grout pour into concrete hopper. Some doughballs observed in mix, as shown on strainer.

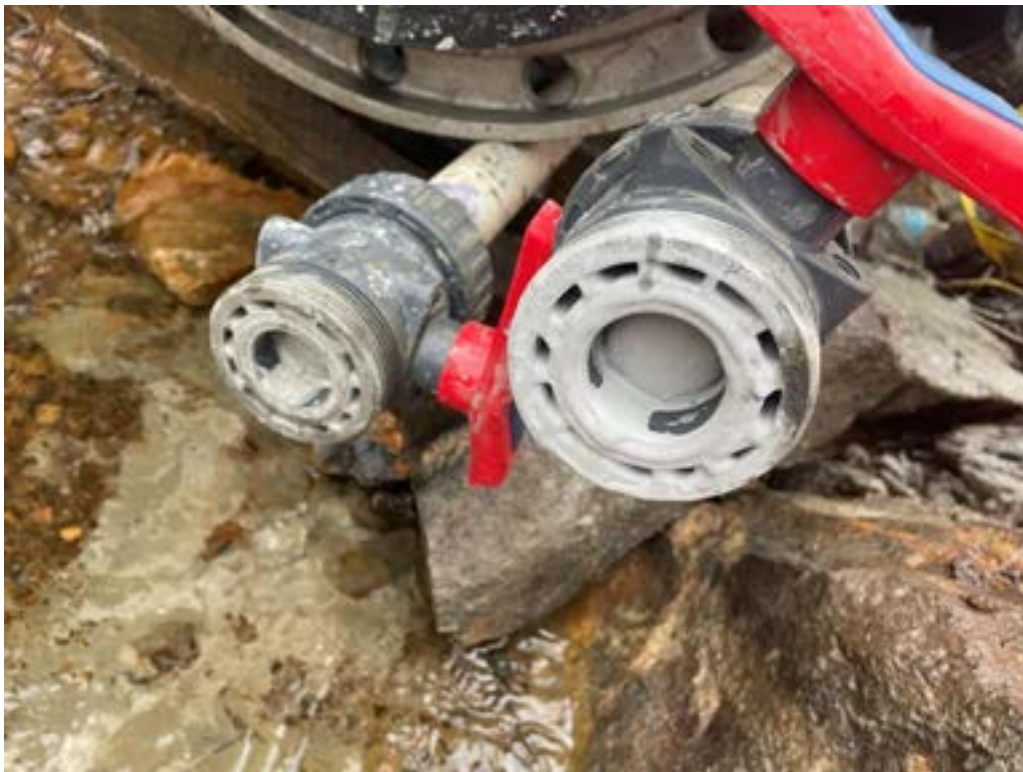
Photo 14: Grout return observed at 25% and 50% pipe lengths. Grout return also observed at 75% pipe length (not shown).

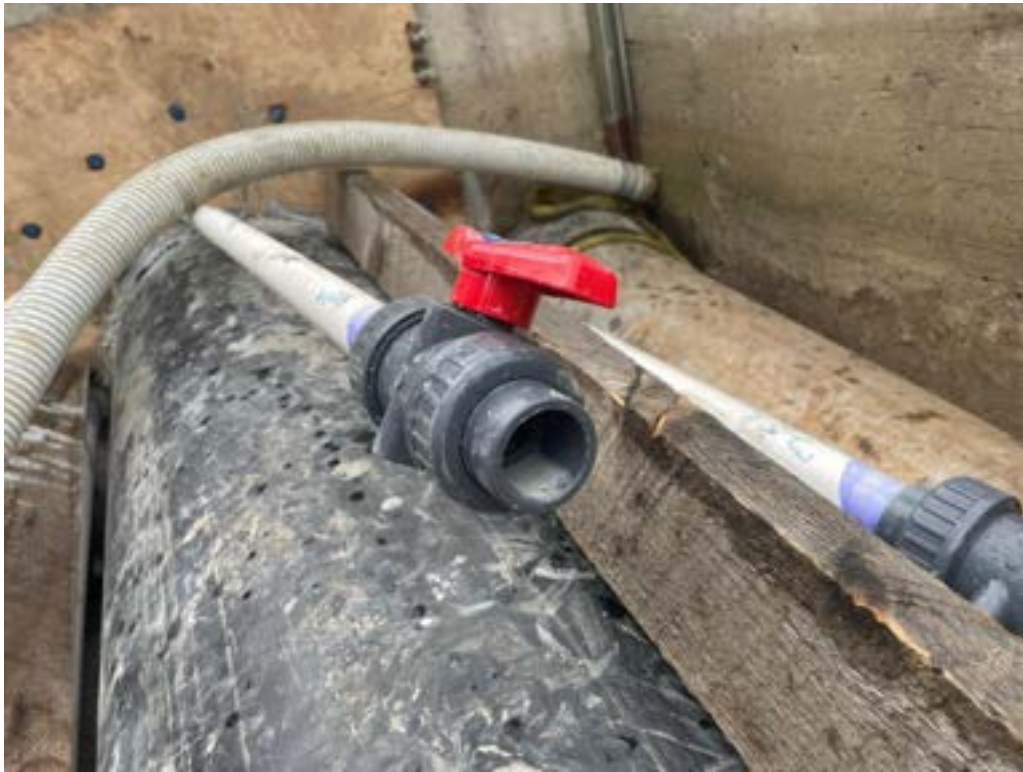
Photo 15: Partial grout return observed at 100% vent pipe lengths, as indicated by dried grout collected in pipe valve.

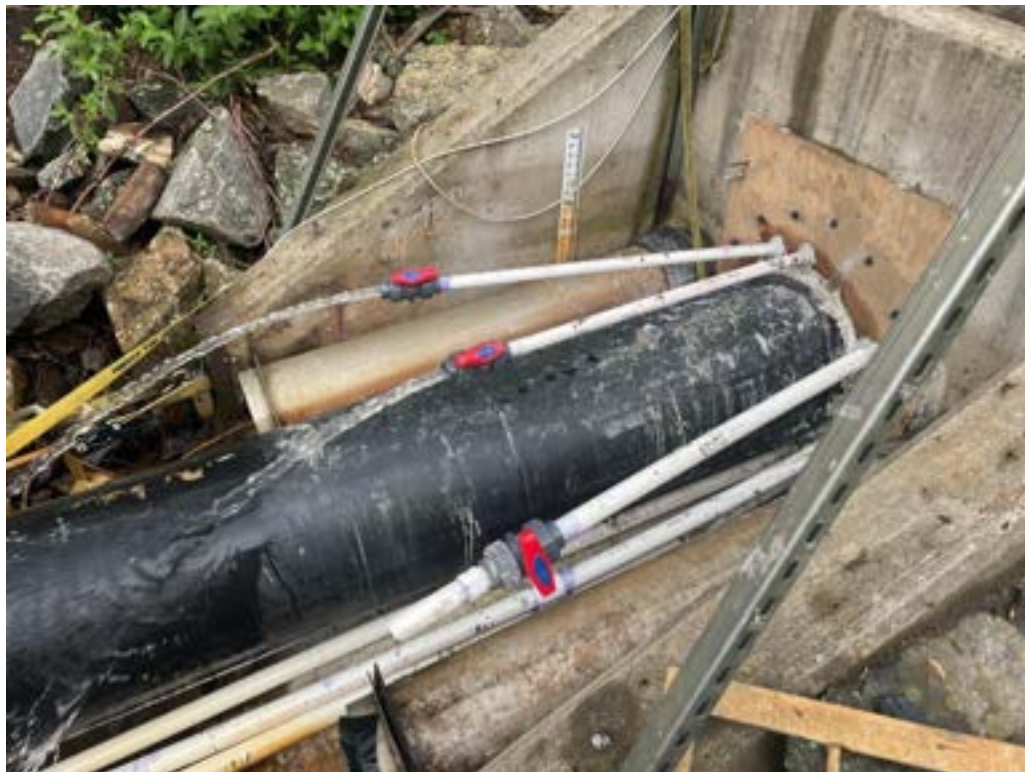
Photo 5: Water free flowing through grout vent pipes (approx 95% of pipe length) indicating grout is not placed up to the crown of the pipe at the full length.

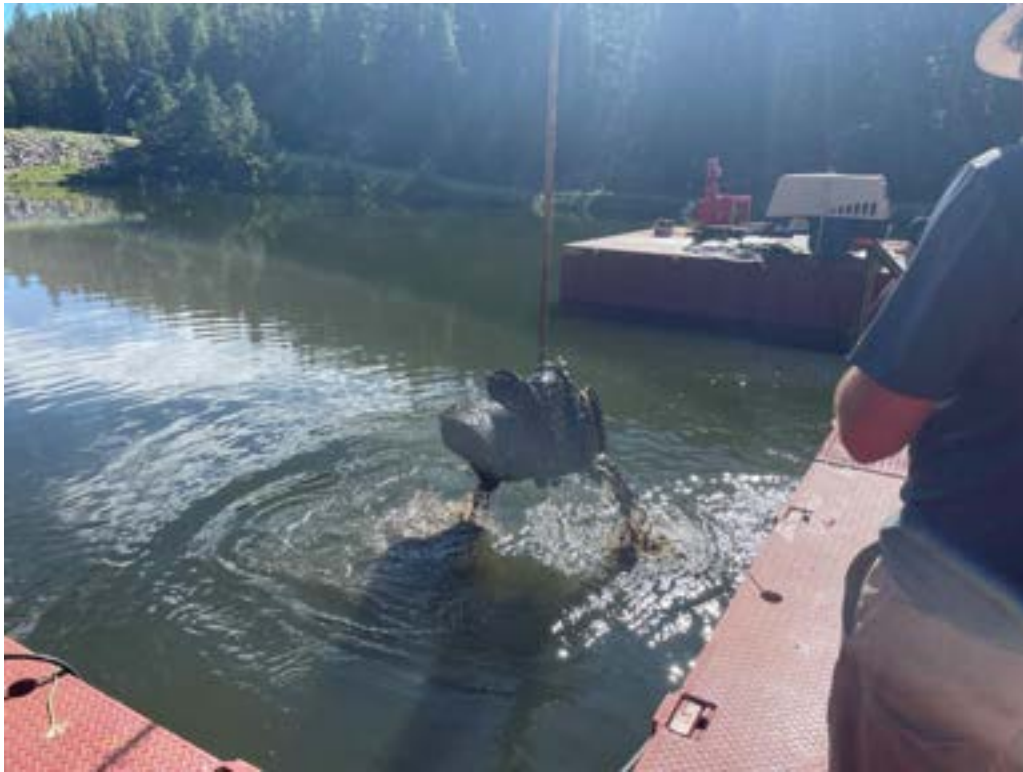
Photo 8: Left side of tee broken off and removed from structure.

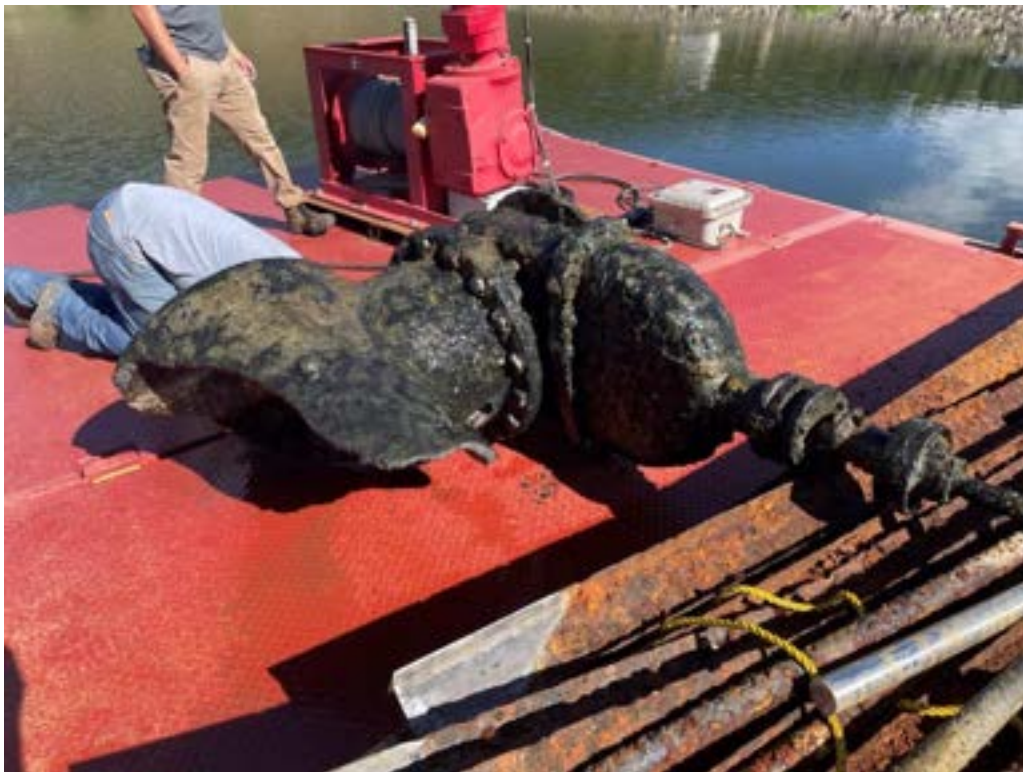
Photo 9: Left side of tee broken off and removed from structure.

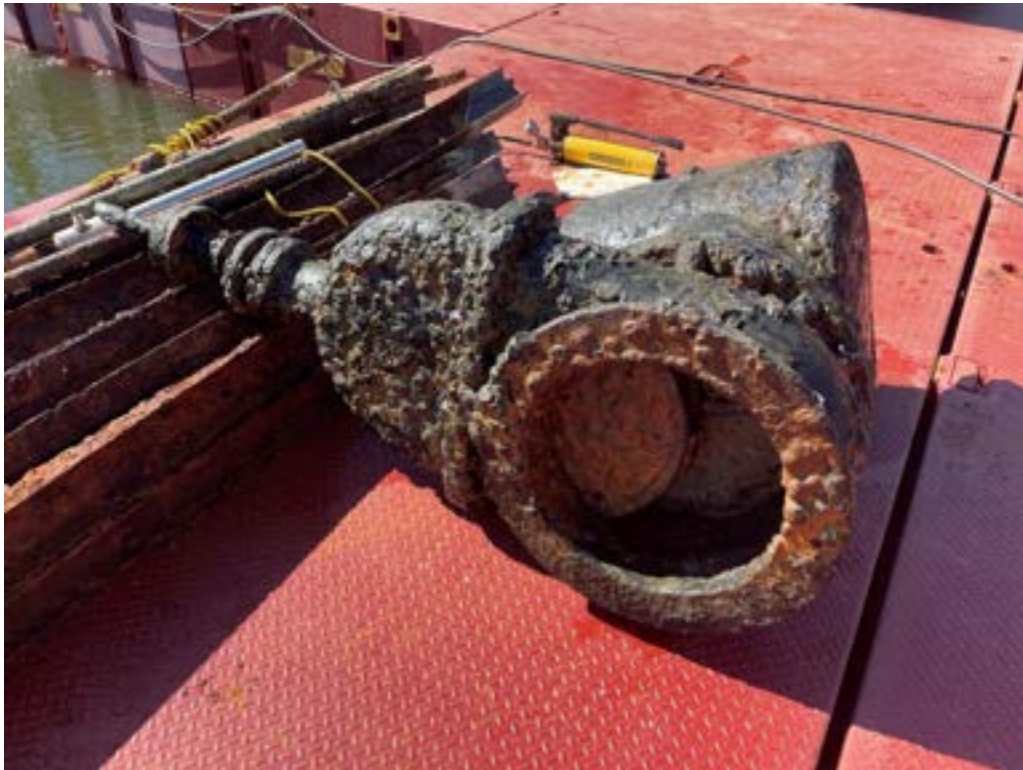
Photo 10: Condition of left-side gate.

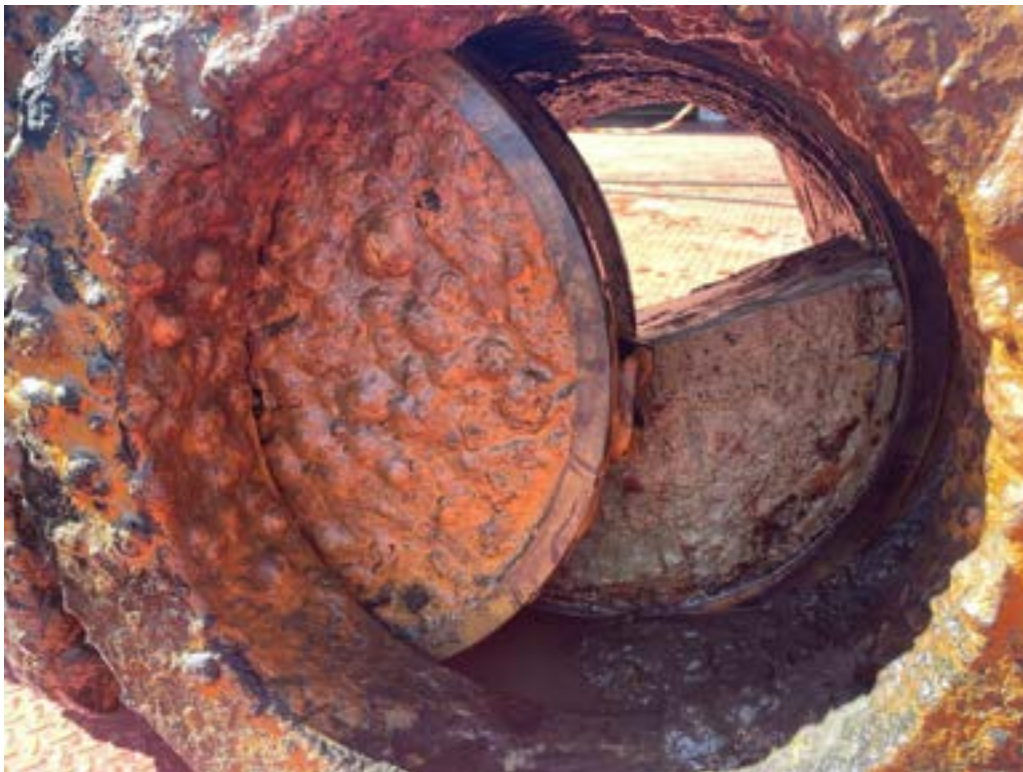
Photo 11: Grout placement within tee (approximately 50% full).

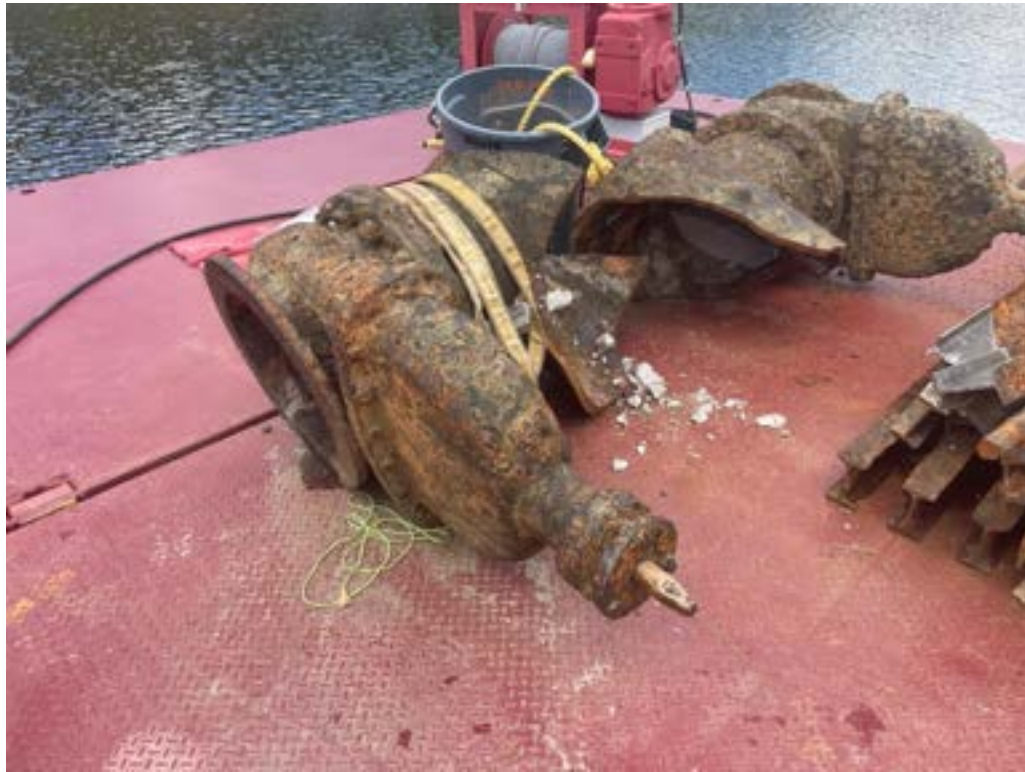
Photo 12: Right side of tee and gate broken off and removed from structure.
