OWL MOUNTAIN PARTNERSHIP

Final Report: Purchase Order: CTGG1 2022-2388

The WSRF Grant, Jackson County Irrigation Infrastructure Improvement Project, is complete. The project focused on replacing old structures as well as installing new structures to improve water control on numerous ditches in Jackson County. The replaced structures were old, dilapidated, often wooden, and non-functional. Each new structure was designed and engineered by NRCS and meets their standards and specifications. The new structures improve irrigation water control, thus improving irrigation water efficiency, reducing erosion, and limiting sediment movement.

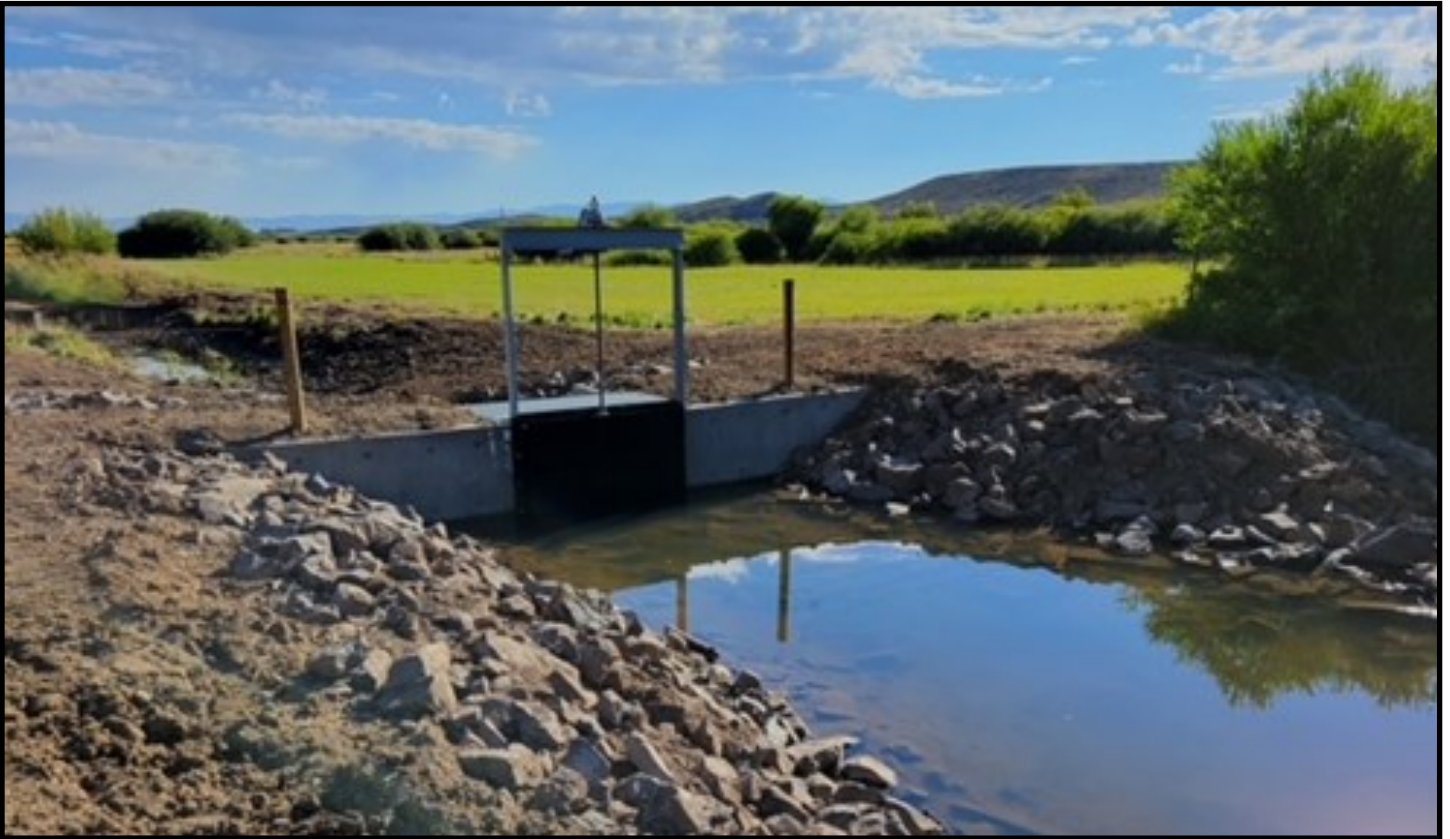
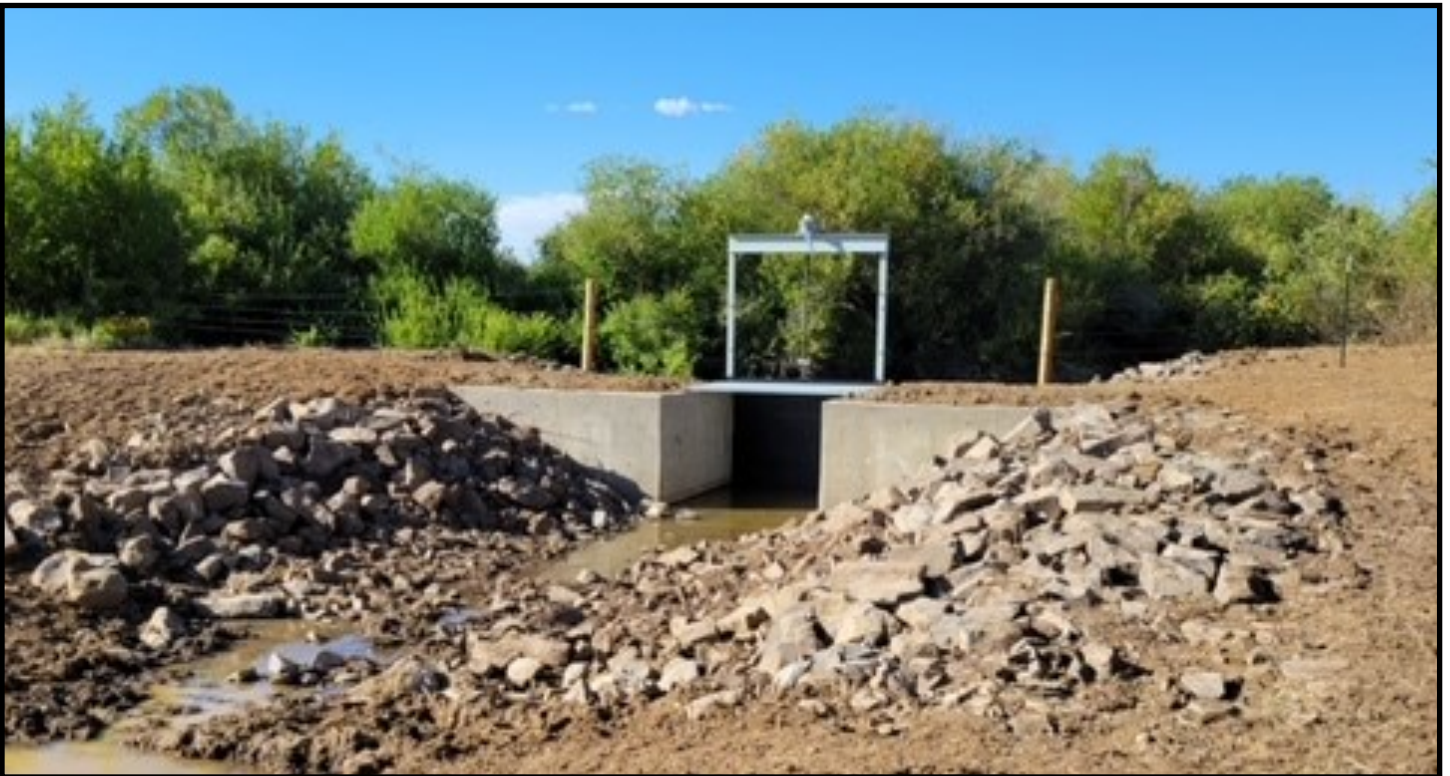
Task 1 – 969 Ditch: Replaced Headgate Structure

Front and rear views of the new concrete structure that replaces the old, dilapidated wooden structure located on the 969 ditch. The 5 x 6 foot steel gate allows the water user to not only regulate and manage the irrigation water, but it also provides a positive shut-off at the water source. The concrete headwalls extending outward into the banks and footer under the structure prevent seepage around and under the structure.

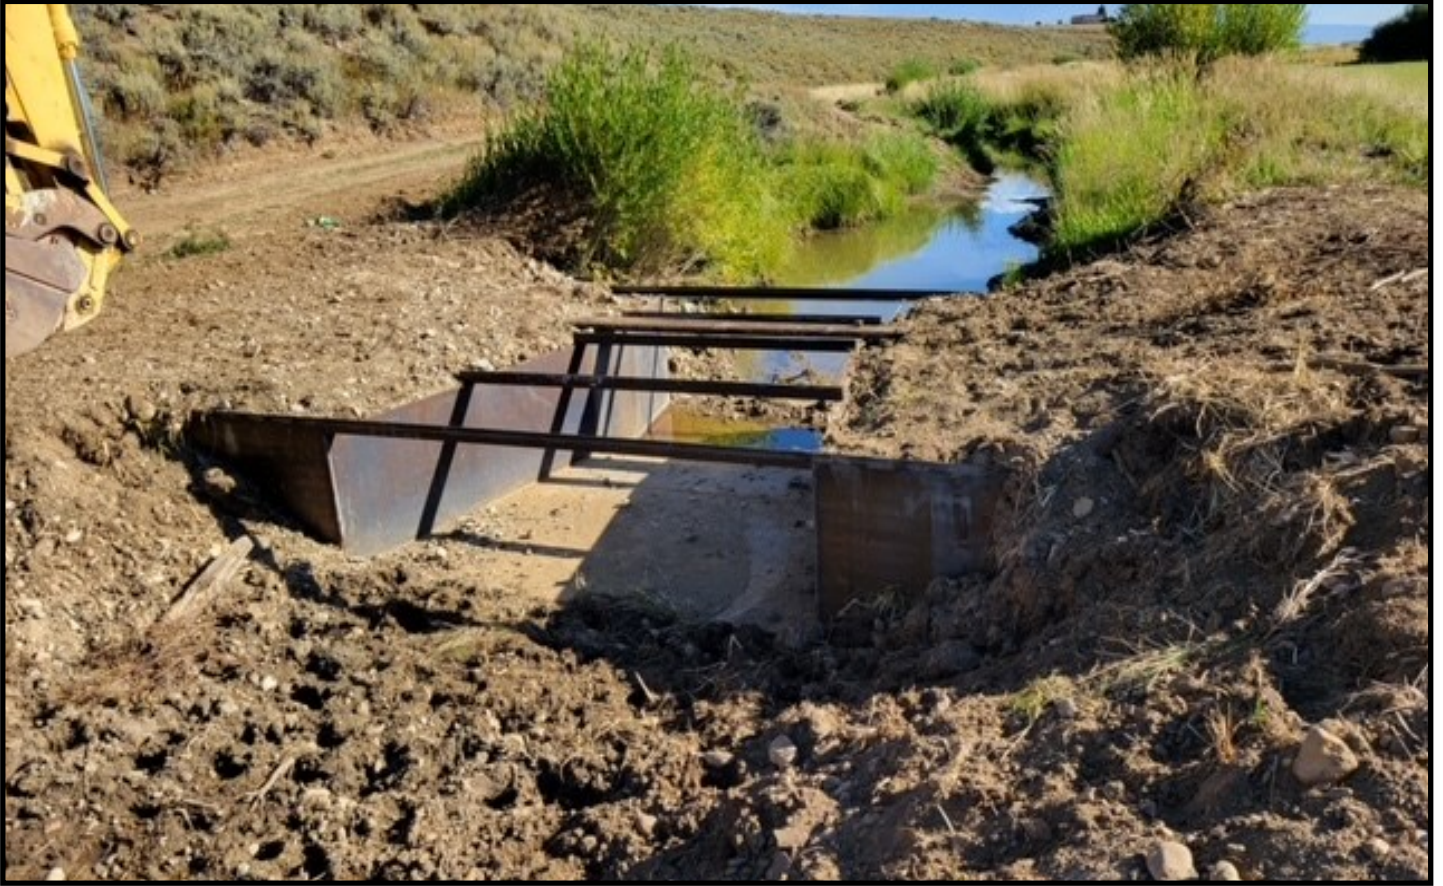
Task 1 – 969 Ditch: Replaced Measuring Device

This 6 foot wide steel measuring device replaces the old wooden structure on the 969 ditch. Located just below the new headgate, it allows the water user to properly measure the amount of water in the 969 ditch.

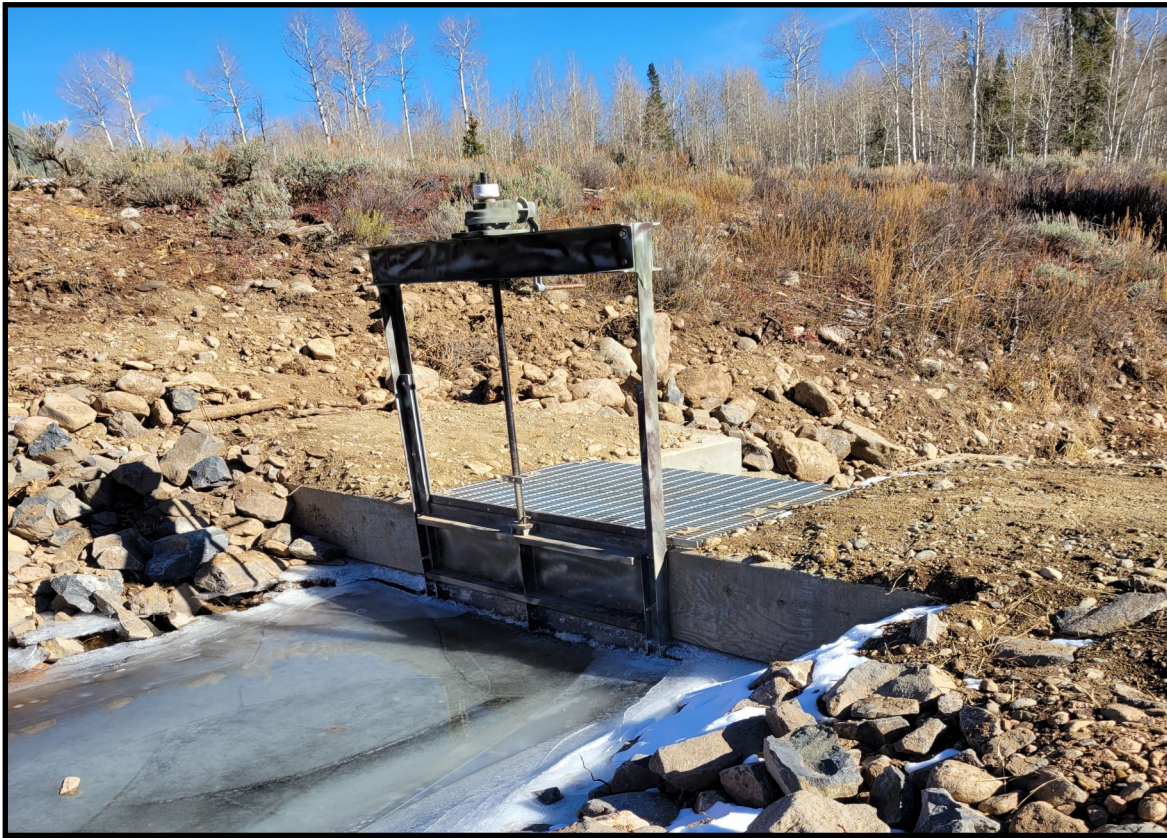
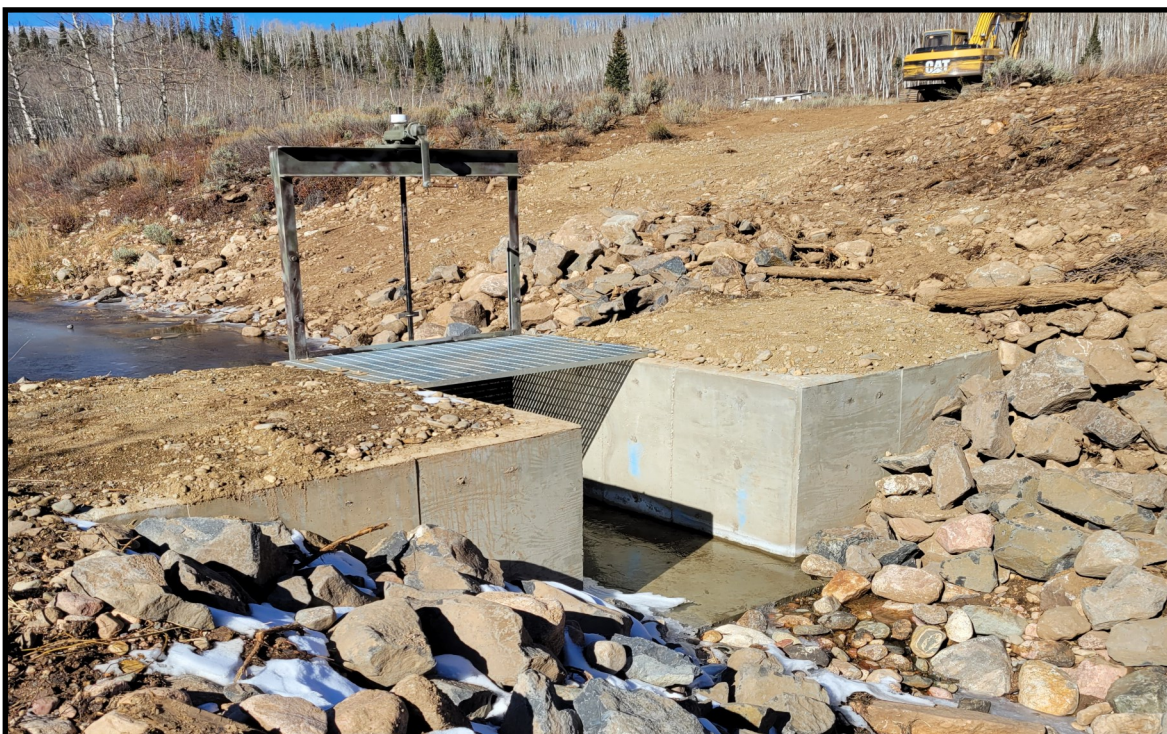
Task 2 – Chapman Ditch: Replaced Headgate Structure

Front and rear views of the new concrete structure that replaces the old, dilapidated wooden structure located the Chapman ditch. The 4 x 5 foot steel gate allows the water user to regulate and manage the irrigation water, as well as provides a positive shut-off at the water source. Extra rip-rap in soils with a greater erosion risk reduces soil movement in the water and stabilizes the banks adjacent to the structure.

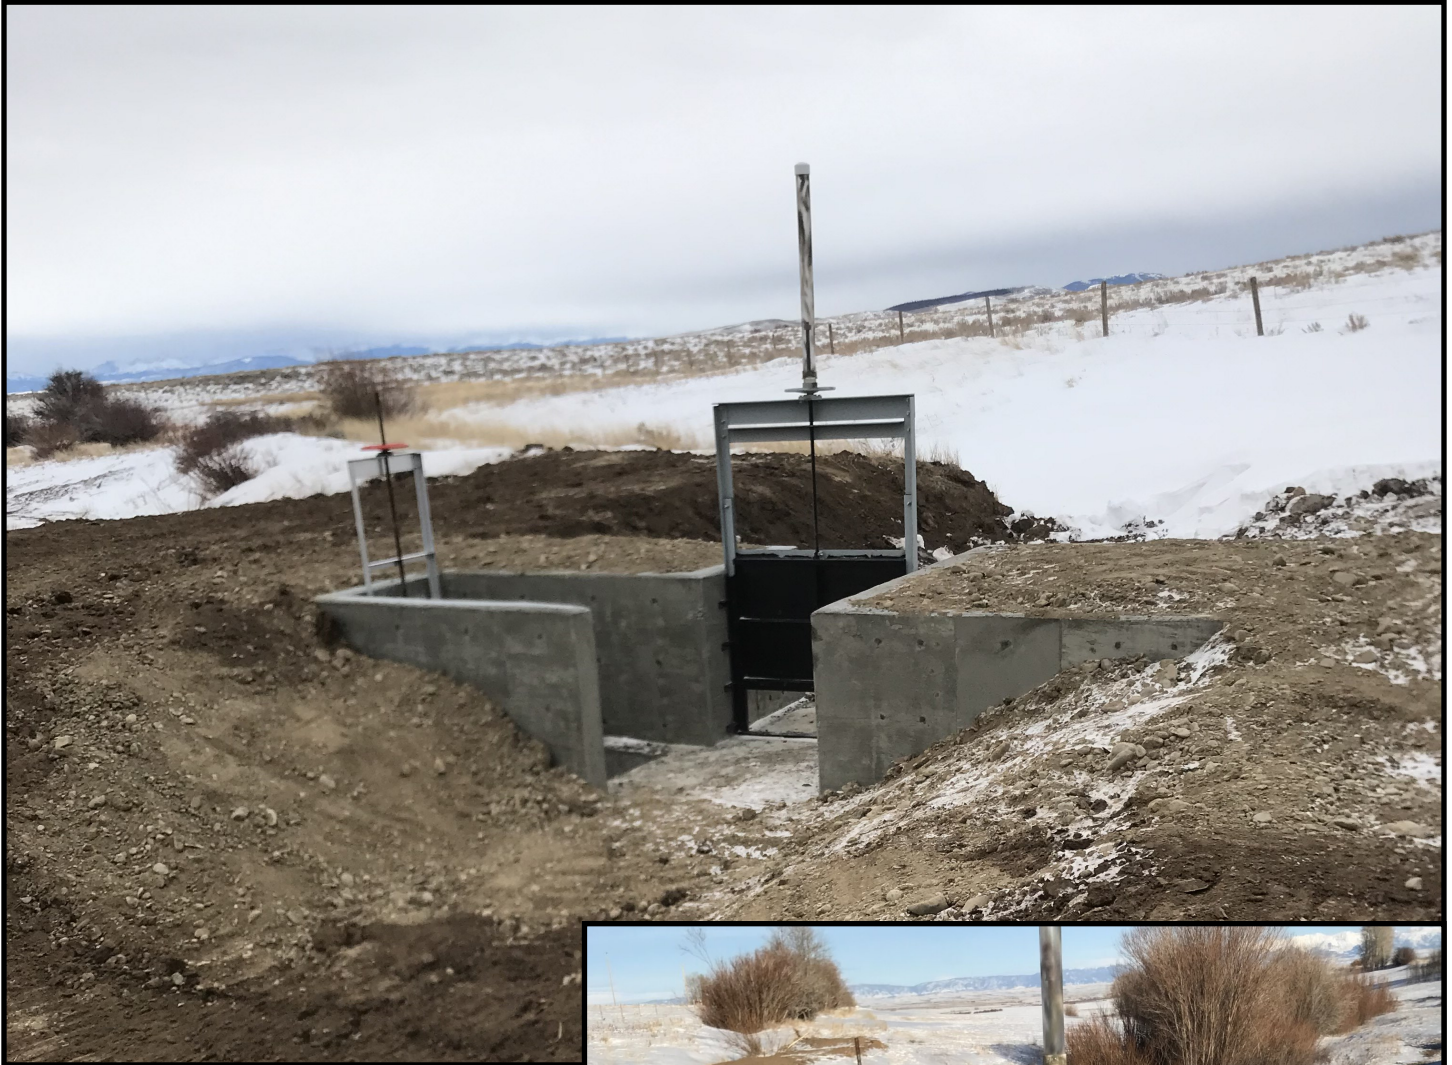
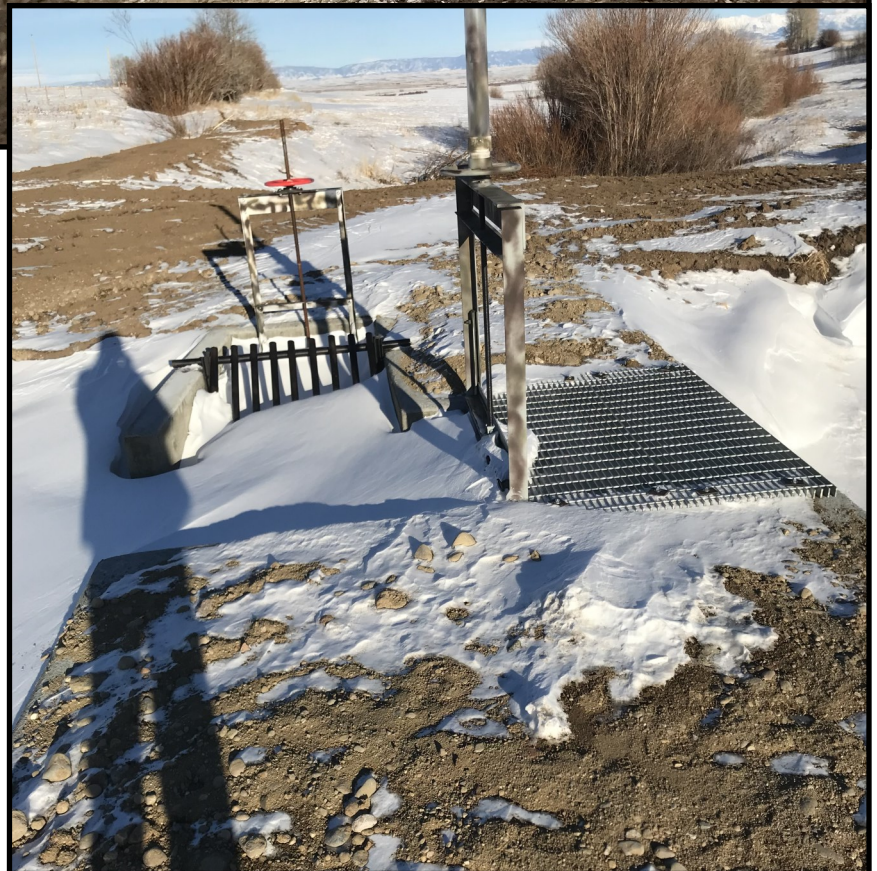
Task 3 – Chapman Ditch: Replaced Check/Turnout Structure

This combined, concrete, check and turnout structure replaces the former, dilapidated, “pieced together” structures on the Chapman ditch. The 4 x 5 foot steel gate check in the ditch allows the water user to apply positive pressure on the turnout structure when needed. The turnout is a 36” x 40’ short, ADS, pipeline, complete with a steel screw gate and a trash rack to prevent the pipe from obstruction. The pipeline is attached to the structure using a steel starter boot bolted to the concrete and inserted into the ADS pipe. The catwalk grate provides a safe location to set the level of flow in the ditch and pressure on the turnout.

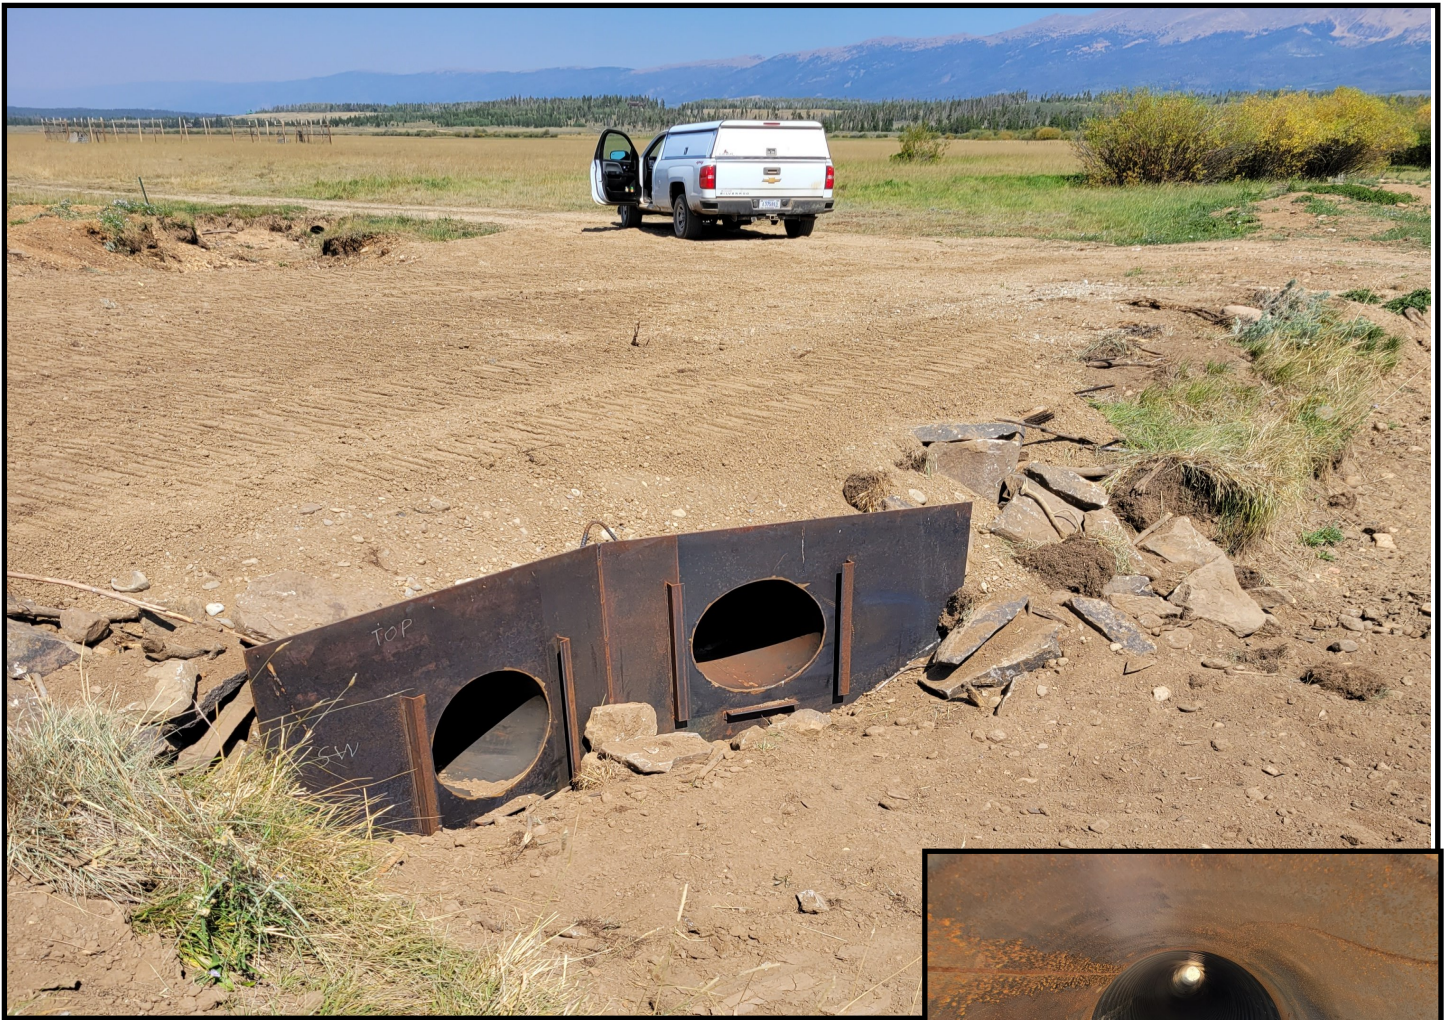
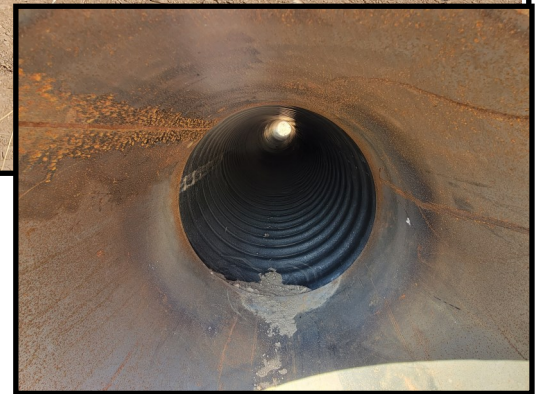
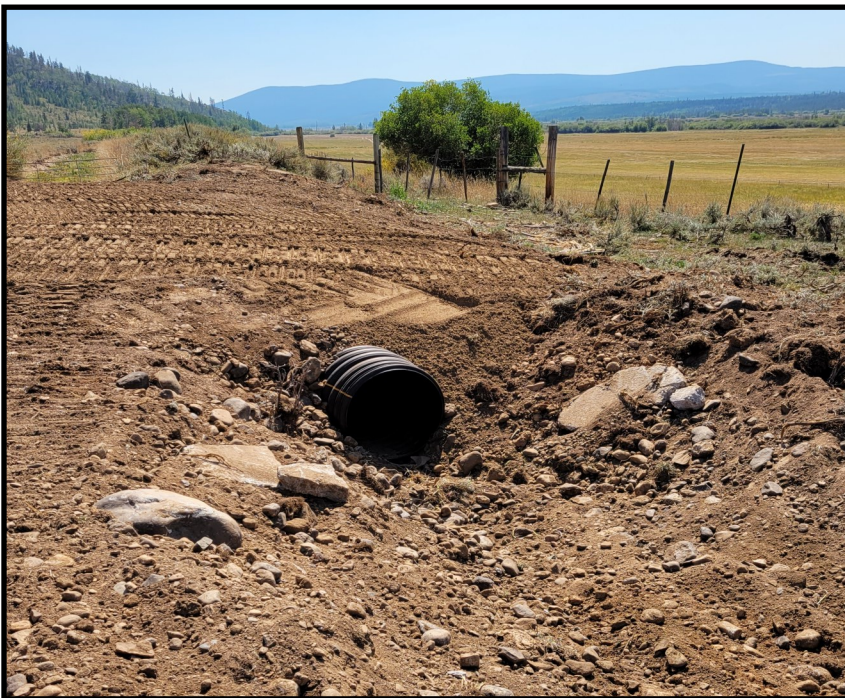
Task 4 – Squibbob Ditch: Replaced Water Division Structure

This steel headwall, with attached dual 24" x 40' ADS pipes, allows the water users to split the irrigation water and send it to two separate locations. The flow in each 24" pipe is controlled by checkboards inserted into the jointed 4 x 5 foot steel headwalls. Each pipe is attached to the headwall with a steel starter boot which prevents movement of the pipe, while the headwall controls seepage along the pipe.

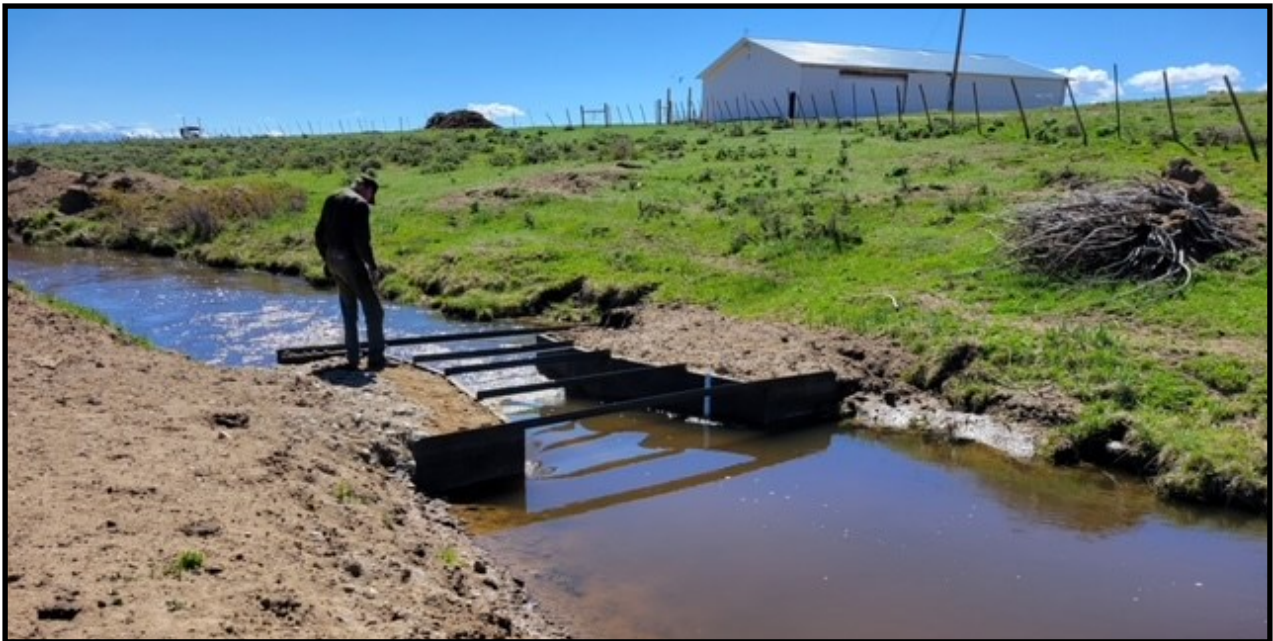
Task 6 – Antelope Ditch: Replaced Measuring Device

This 6 foot wide steel measuring device replaces the old rusted out structure on the Antelope ditch. Located less than 400 feet below the headgate, it allows the water user to properly measure the amount of water in the ditch.

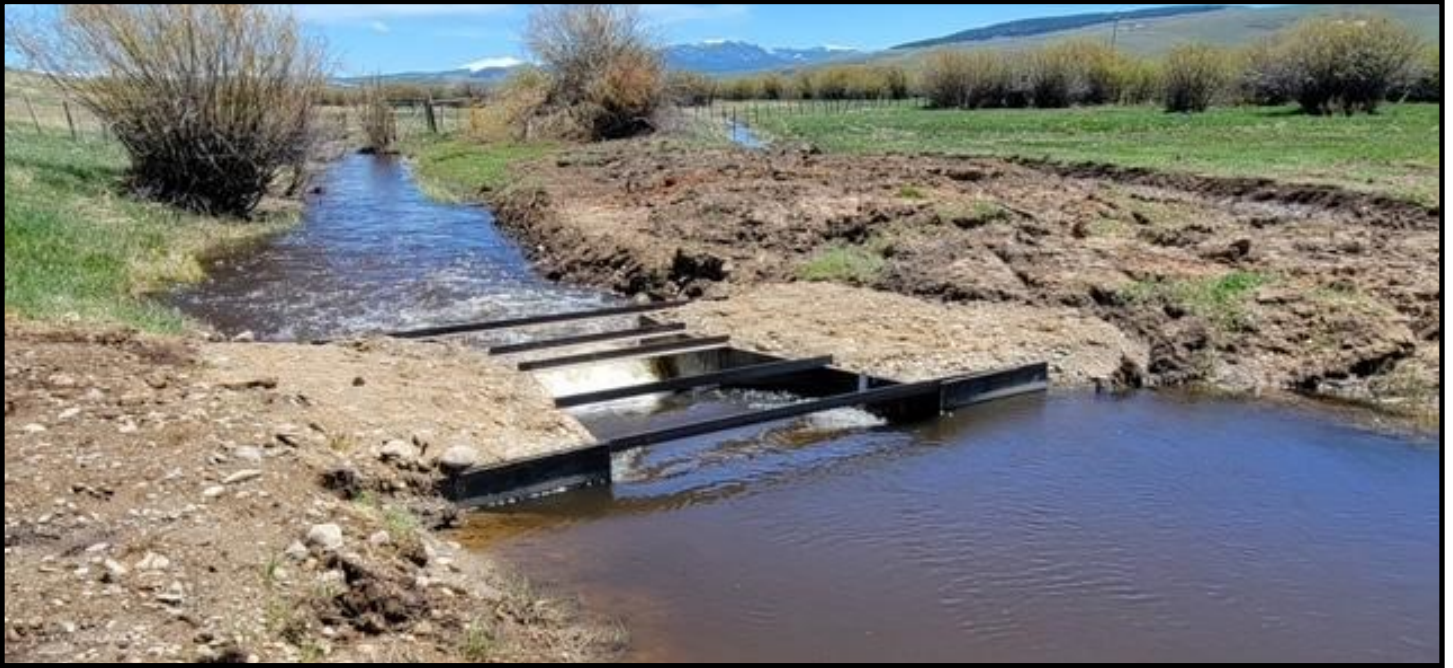
Task 7 – Nairin Ditch: Replaced Measuring Device

This 5 foot wide steel measuring device replaces the old rusted out structure on the Nairin ditch. Located directly the headgate, it allows the water user to properly measure the amount of water in the ditch.

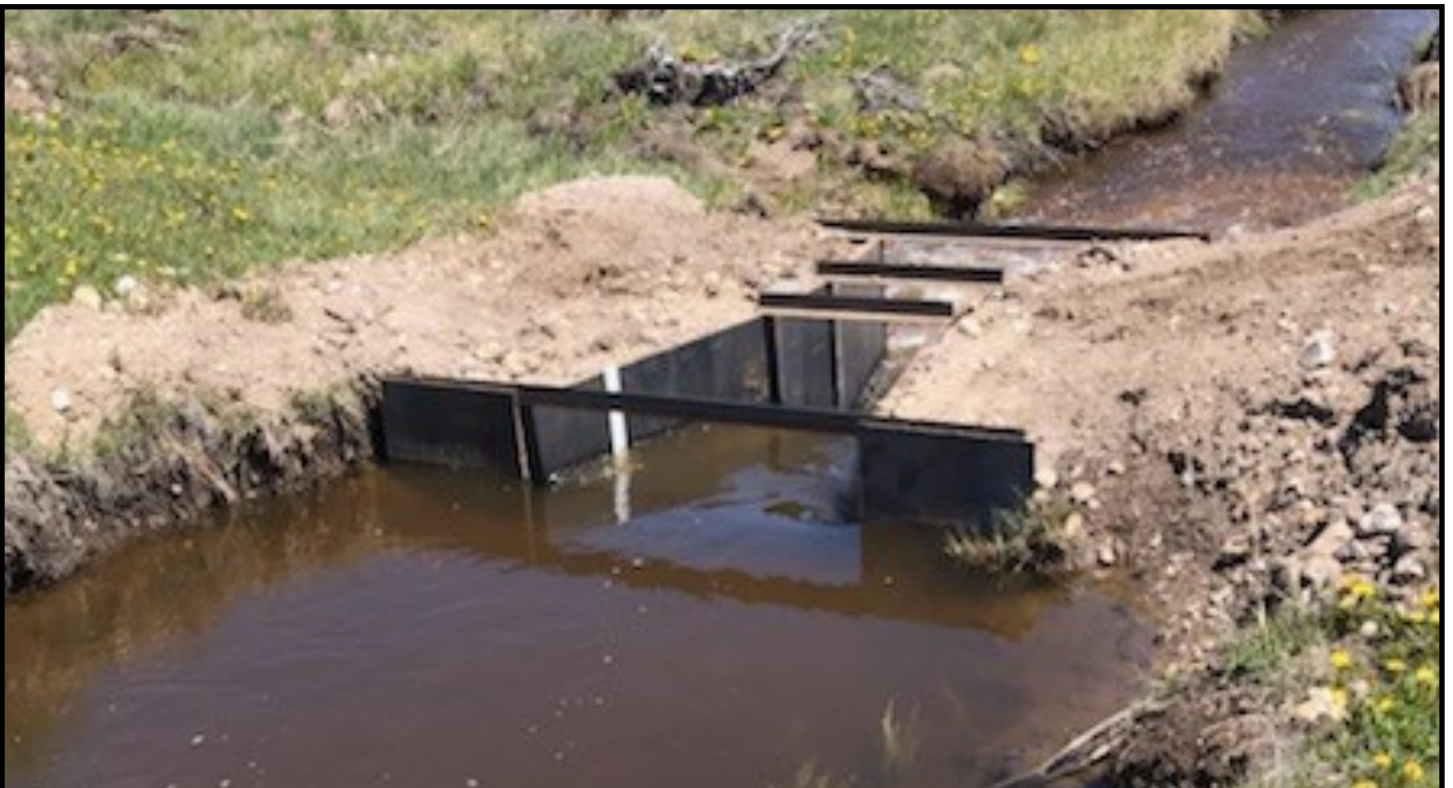
Task 8 – Darling Ditch: Replaced Measuring Device

This 30 inch wide steel measuring device replaces the old rusted out structure on the Darling ditch and allows the water user to properly measure the amount of water in the ditch.

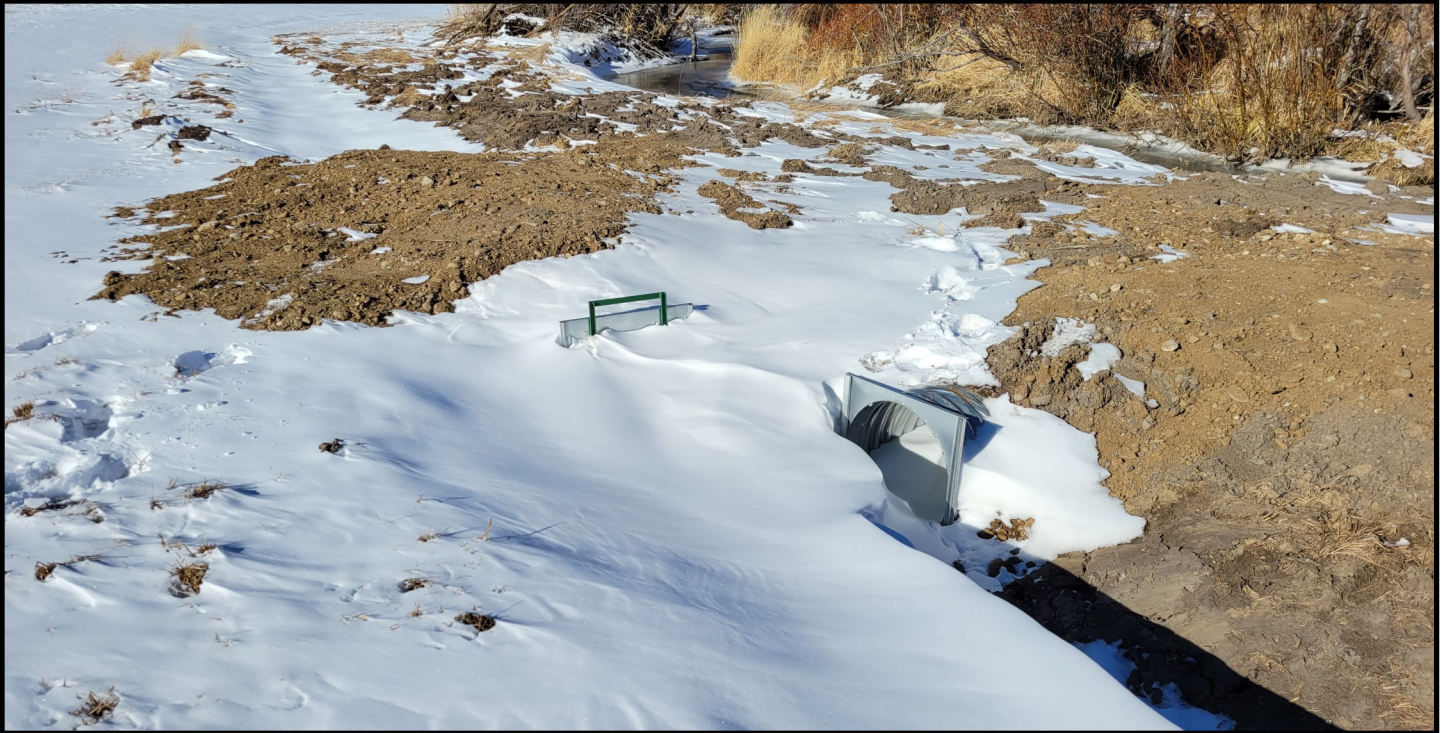
Task 9 – Willow Ditch: Replaced Check and Turnout Structures

This 24' x 20' new check and turnout pair, with aluminum slide gates, simplifies the water users effort to check and utilize the water in the Willow ditch more efficiently.

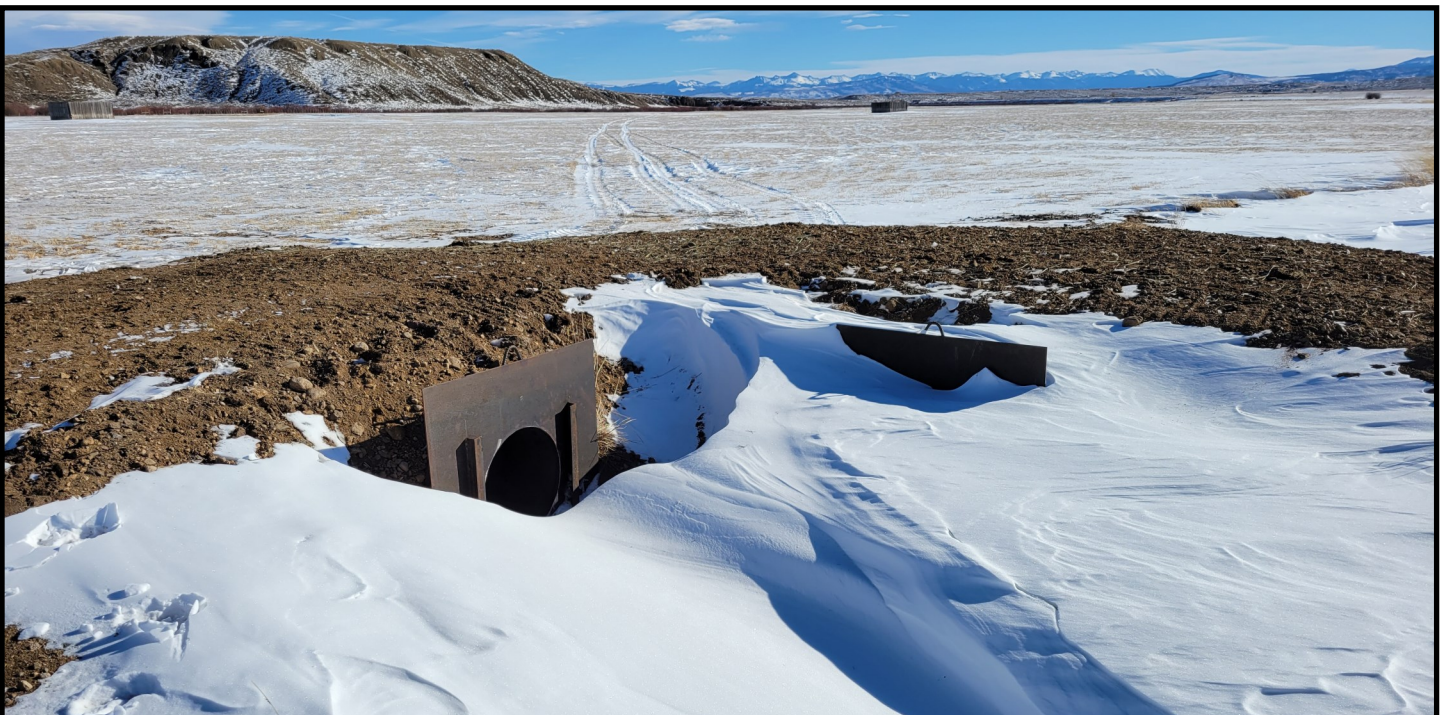
Task 10 – Staples Ditch: Replaced Check and Turnout Structures

This 24' x 20' new check and turnout pair, with 4 x 4 steel headwall for check boards, simplifies the water users effort to check and utilize the water in the staples ditch more efficiently.
