COLORADO DIVISION OF RECLAMATION, MINING AND SAFETY COAL PROGRAM INSPECTION REPORT

Permit Number: C-1981-022 Mine Name: Elk Creek Mine Operator: Oxbow Mining, LLC Operator Address: Mr. Jim Kiger P.O. Box 535 3737 Highway 133 Somerset, CO 81434	County: Delta, Gunnison Operation Type: Underground Permit Status: Active Ownership: Federal
	Operator Representative Present: Jim Kiger
Operator Representative Signature: (Field Issuance Only)

Inspection Start Date: September 4, 2013 Inspection Start Time: 08:30 Inspection End Date: September 4, 2013 Inspection End Time: 14:30		Inspection Type: Coal Partial Inspection Inspection Reason: Normal I&E Program Weather: Clear	
Joint Inspection Agency: None		Joint Inspection Contacts:	
Post Inspection Agency: None		Post Inspection Contacts:	
Inspector(s): Brock F. Bowles	Inspector's Signature:

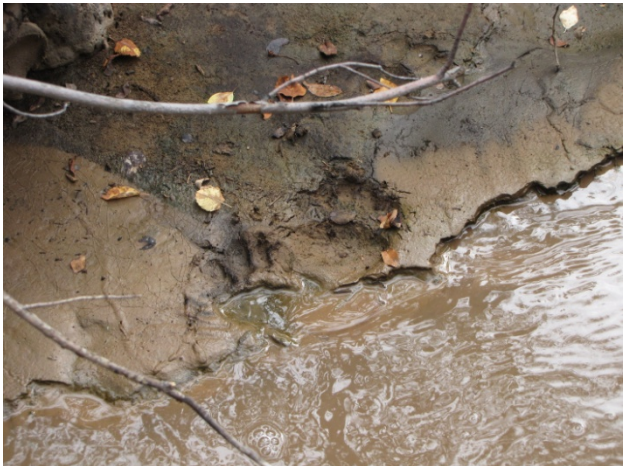
There are many wildlife tracks in the mud around the shallow pond at the discharge point. Bear prints were in the muddy banks of Elk Creek about two miles above the Elk Creek facilities area (photo 1). Bear scat was also seen in the same area.

Photo 1 – Bear Tracks on Elk Creek

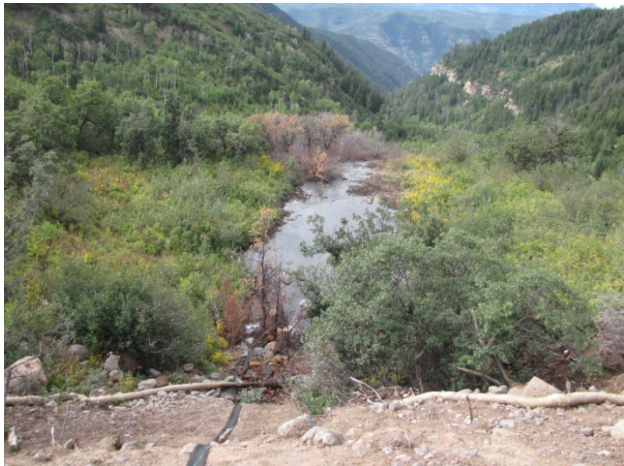
The dead vegetation around the shallow pond appears to be approximately the same extent as reported in the August 6, 2013 inspection (photo 2). The pond contains green algae and the banks are very muddy (photo 3). The soil on the hillside below the pond is saturated and has begun to slide in several areas. At the top of the slide, it appears the soil has slumped 2-3 feet (photo 4). Most of the vegetation where the soil is saturated is dead (photo 5). Water braids through the dense vegetation below the slumped area which created rills and small gullies (photo 6). There does not appear to be erosive damage to the Elk Creek tributary. In some spots of the tributary, sediment deposits were noted on the edges of the stream (photo 7). Elk Creek does not appear to have erosive damage due to the mine water discharge. The water flowing down the tributary and Elk Creek is brown in color and creates a froth in the plunge pools (photo 8). The damage caused by Outfall 015B is all on Forest Service property and is completely within the Elk Creek Mine permit boundary.

Photo 2 – Vegetation Around the Shallow Pond

The Division recognizes that this has been an emergency situation and that Oxbow is attempting to minimize the impacts. However, a repair plan for the hillside will be necessary to address any damage caused by Outfall 015B. An assessment of damage in the area will take place when the pumping of mine water is complete. The Division will continue to monitor this situation. Oxbow has been submitting discharge monitoring reports for Outfall 015B and the water quality has been within the limits of the permit. Colorado Water Quality Control Division has been notified and is also monitoring the situation.

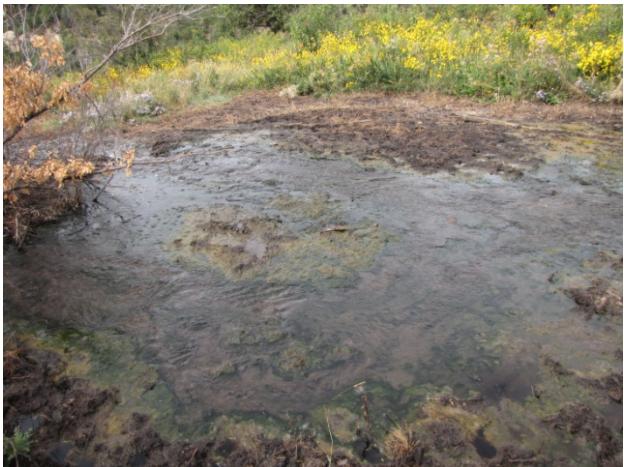
Photo 3 – Shallow Pond

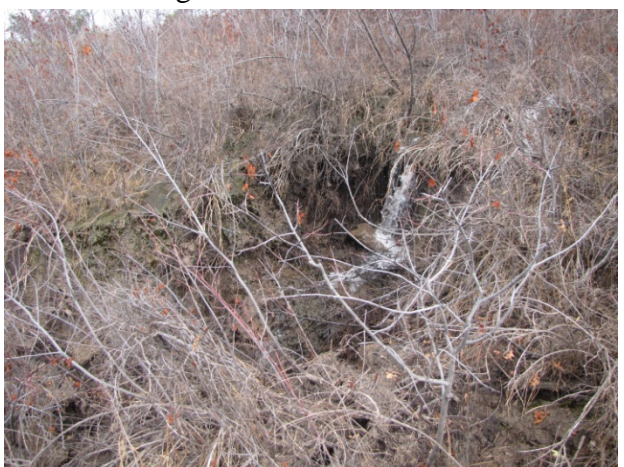
Photo 4 – Top of Slump Area

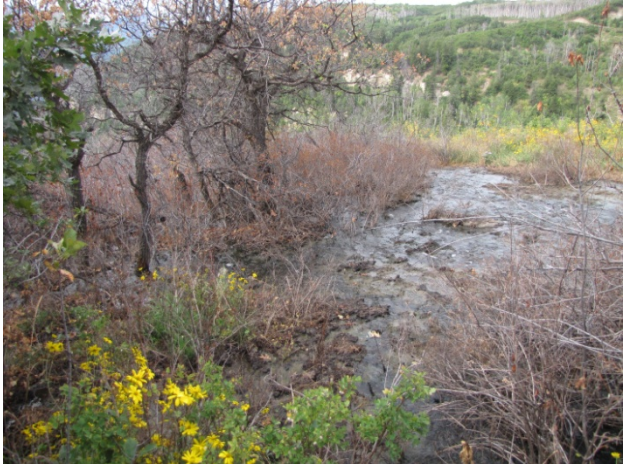
Photo 5 – Saturated Soil Below Shallow Pond

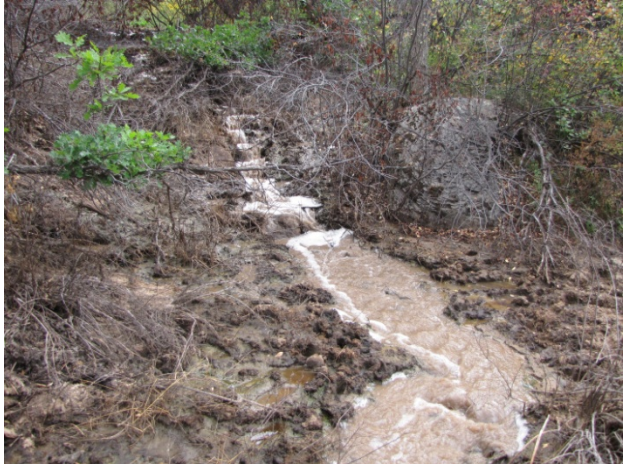
Photo 6 – Rills and Small Gullies Below Slump

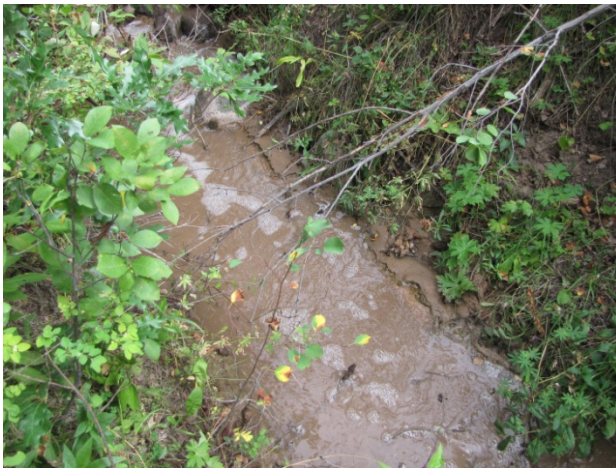
Photo 7 – Sediment Deposits

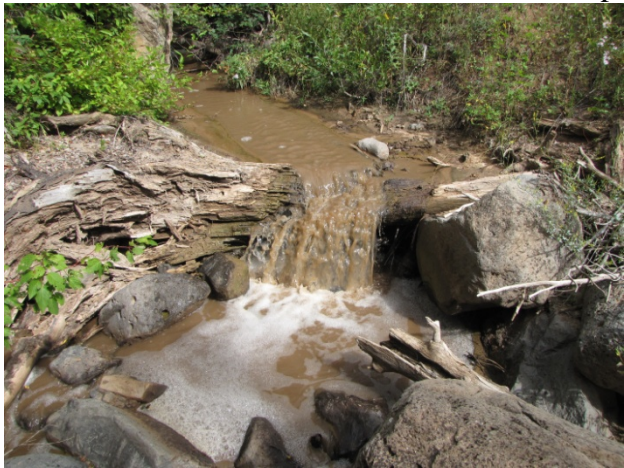
Photo 8 – Plunge Pool in Elk Creek
