COLORADO DIVISION OF RECLAMATION, MINING AND SAFETY COAL PROGRAM INSPECTION REPORT

Permit Number: C-1981-046 Mine Name: Sunlight Mine Operator: Garfield Energy Corporation Operator Address: X X, CO 11111	County: Garfield Operation Type: Underground Permit Status: Revoked Ownership: Private Operator Representative Present: None
Operator Representative Signature: (Field Issuance Only)

Inspection Start Date: July 8, 2013 Inspection Start Time: 13:00 Inspection End Date: July 8, 2013 Inspection End Time: 15:00	Inspection Type: Coal Partial Inspection Inspection Reason: Normal I&E Program Weather: Clear	
Joint Inspection Agency: None	Joint Inspection Contacts:	
Post Inspection Agency: None	Post Inspection Contacts:	
Inspector(s): Brock F. Bowles David A. Berry	Inspector's Signature:

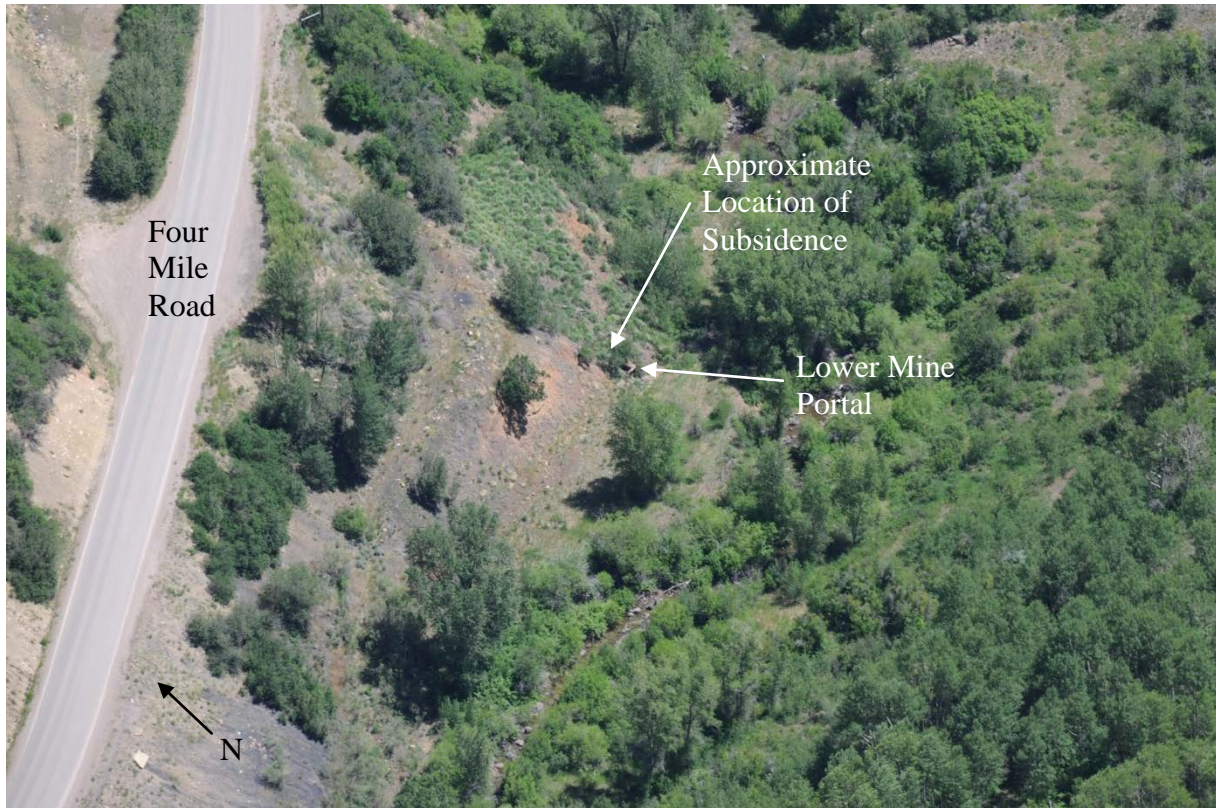
The purpose of this inspection was to evaluate the lower portal subsidence noted in previous inspection reports (June 2013, April 2013, September 2012, September 2010). The subsidence is located in the tall grass approximately 12 feet in by of the lower portal seal (photo 1). The subsidence hole is approximately 3 feet deep and 5 feet across. The hole was visually inspected to determine if the mine shaft was exposed. No openings to the mine were noted. A stick was then used to prod around the edges of the subsidence to look for any possible openings to the mine shaft. None were noted. The surface area in by of the subsidence was inspected to look for any additional signs of subsidence. None were noted.

Photo 1 – Location of Subsidence at Lower Portal

It was determined that the subsidence did not pose an immediate threat to public safety but the subsidence needed further evaluation. Steve Renner of the DRMS Abandoned Mine Lands program will be notified to further evaluate the subsidence.
