## COLORADO DIVISION OF RECLAMATION, MINING AND SAFETY COAL PROGRAM INSPECTION REPORT

<b>Permit Number:</b> C-1981-035 <b>Mine Name:</b> King Coal Mine <b>Operator:</b> GCC Energy, LLC <b>Operator Address:</b> Mr Tom Bird 6473 County Road 120 Hesperus, CO 81326	<b>County:</b> La Plata <b>Operation Type:</b> Underground <b>Permit Status:</b> Active <b>Ownership:</b> Federal
	<b>Operator Representative Present:</b>  Wade Wymore
<b>Operator Representative Signature: (Field Issuance Only)</b>  This report was issued electronically from the Division's Durango Field Office.

<b>Inspection Start Date:</b> August 28, 2013 <b>Inspection Start Time:</b> 10:35 <b>Inspection End Date:</b> August 28, 2013 <b>Inspection End Time:</b> 14:30		<b>Inspection Type:</b> Coal Complete Inspection <b>Inspection Reason:</b> Normal I&E Program <b>Weather:</b> Clear	
<b>Joint Inspection Agency:</b>  None		<b>Joint Inspection Contacts:</b>	
<b>Post Inspection Agency:</b>  None		<b>Post Inspection Contacts:</b>	
<b>Inspector(s):</b>  Marcia L. Talvitie, P.E.	<b>Inspector's Signature:</b>

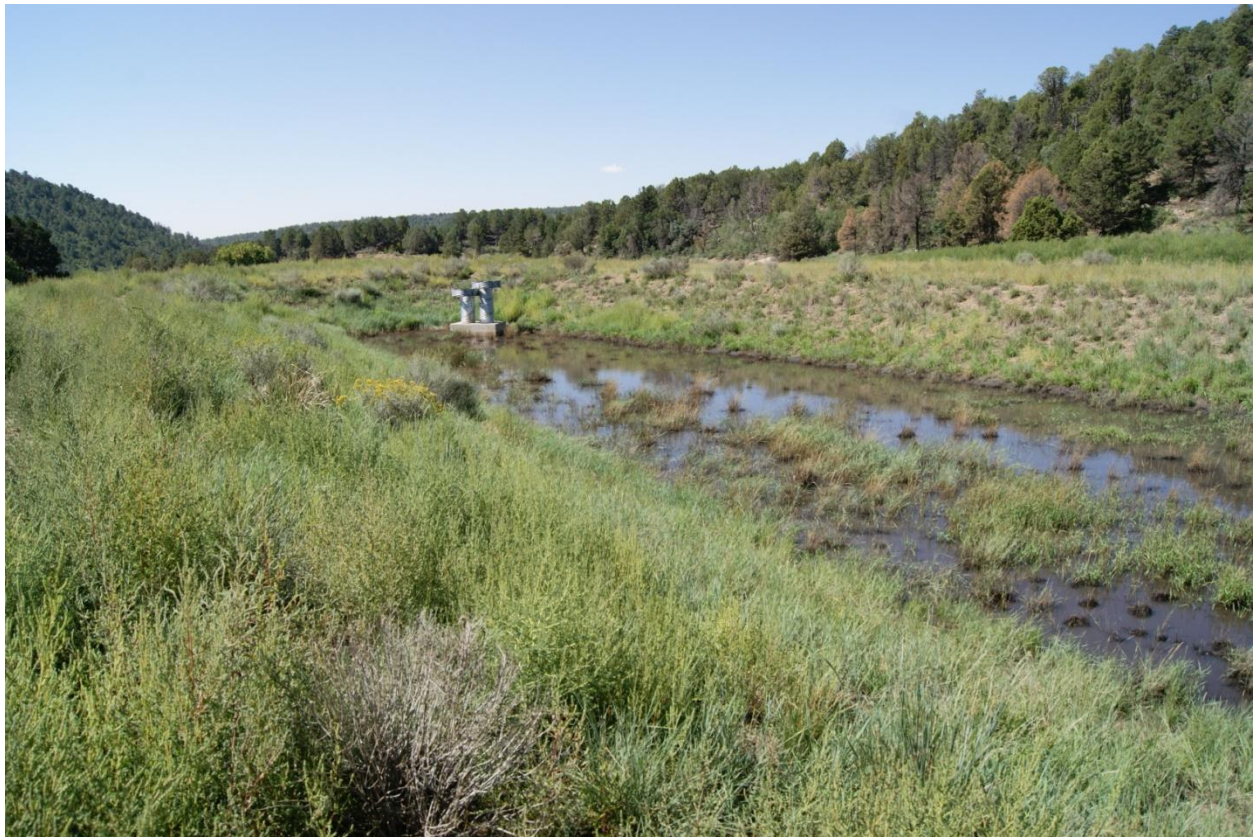
- The King II Sediment Pond floor was covered with water for approximately half its length. Pond banks were very well vegetated and stable, and no discharge was occurring.

Photo 1 – Sediment Pond at King II, looking SW

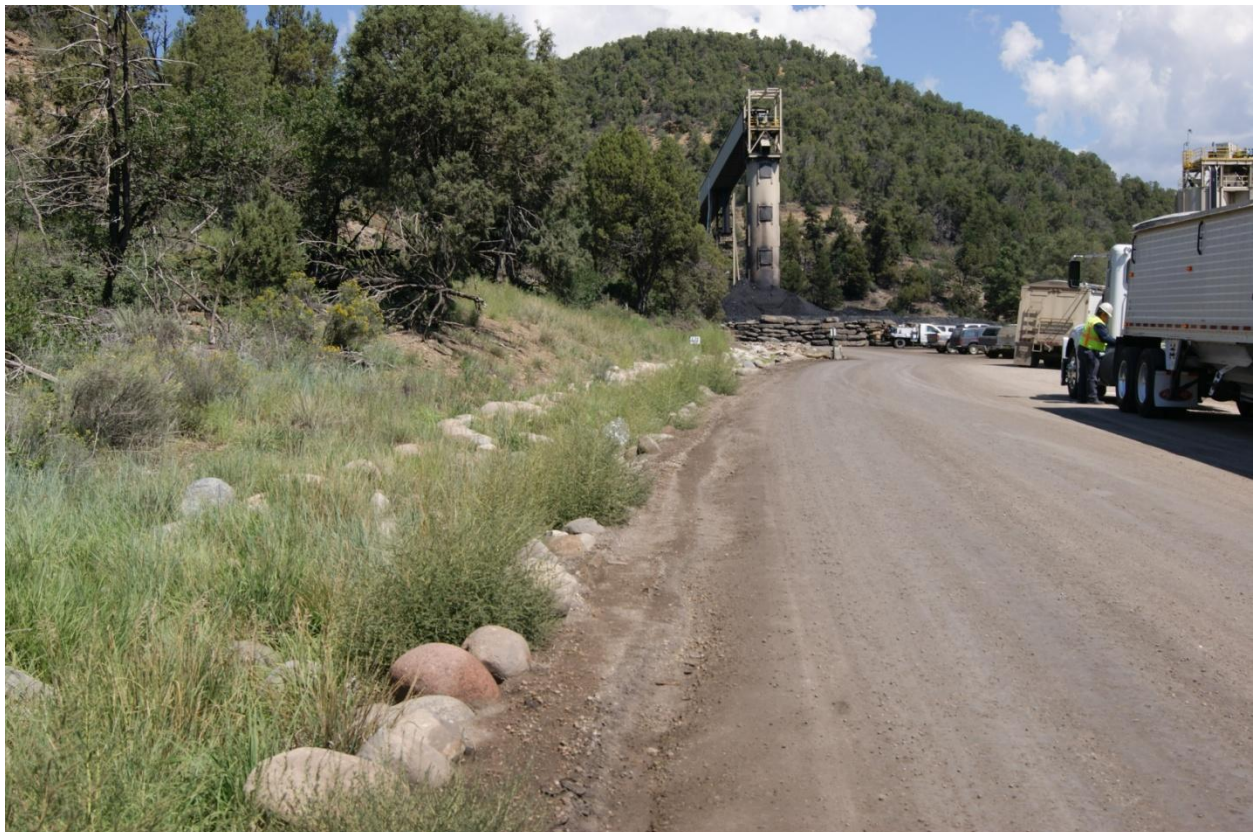
- Due to the recent rains, populations of Kochia and other annual weeds (Lambs quarters, Ragweed, Marsh elder, etc.) have overtaken most of the ground at King II which had sparse vegetation. Some ditches, and the undisturbed area to the south of the embankment, were covered with these species, which stood 3 to 6 feet in height. Mine personnel had been active in beginning to clear the weeds from the clear water diversion ditches, and Mr. Wymore said their efforts would continue.

Photo 2 – Weeds growing up in West Clean Water Diversion Ditch, looking north

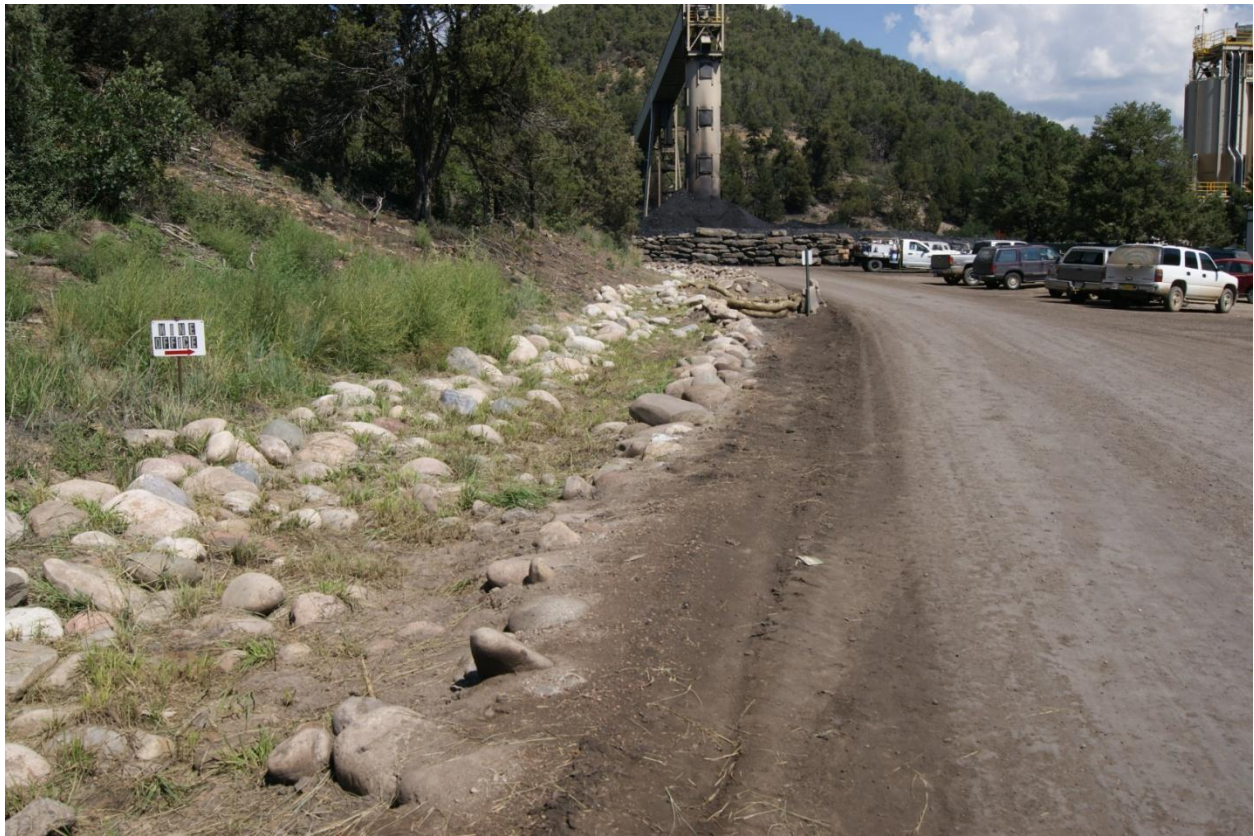
Photo 3 – Segment of West Clean Water Diversion where weeds have been removed

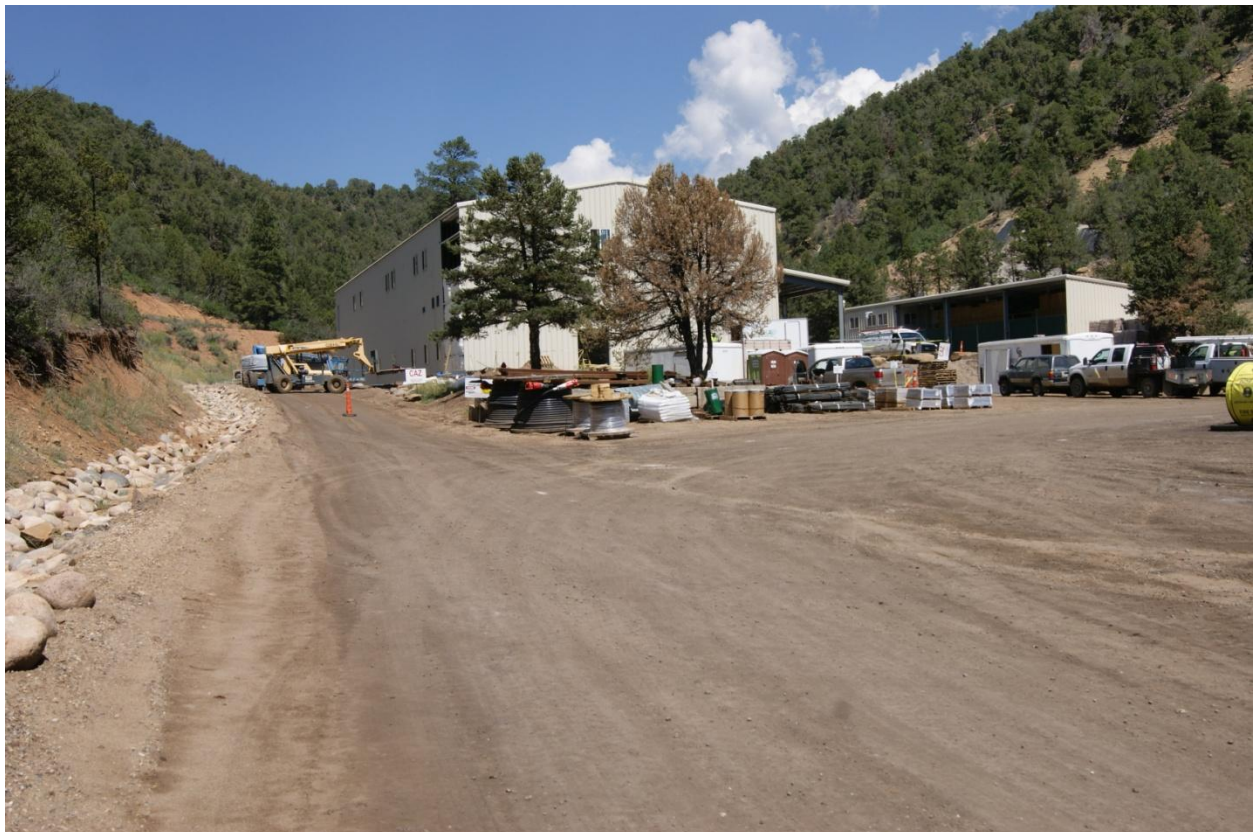
- Significant progress has been made on the two-story building being constructed at King II. The outer “skin” has been nearly all attached.
- The material storage area located at the northern tip of the western branch at King II has been cleaned up, and much of the equipment observed on earlier inspections has been removed. A chain has been installed to limit access. We noted that a few of the items now being stored there were partially covered in grease or oil. The oil storage area is the preferred location for storing equipment that may cause petroleum product contamination.

Photo 4 – Building construction at King II, looking north

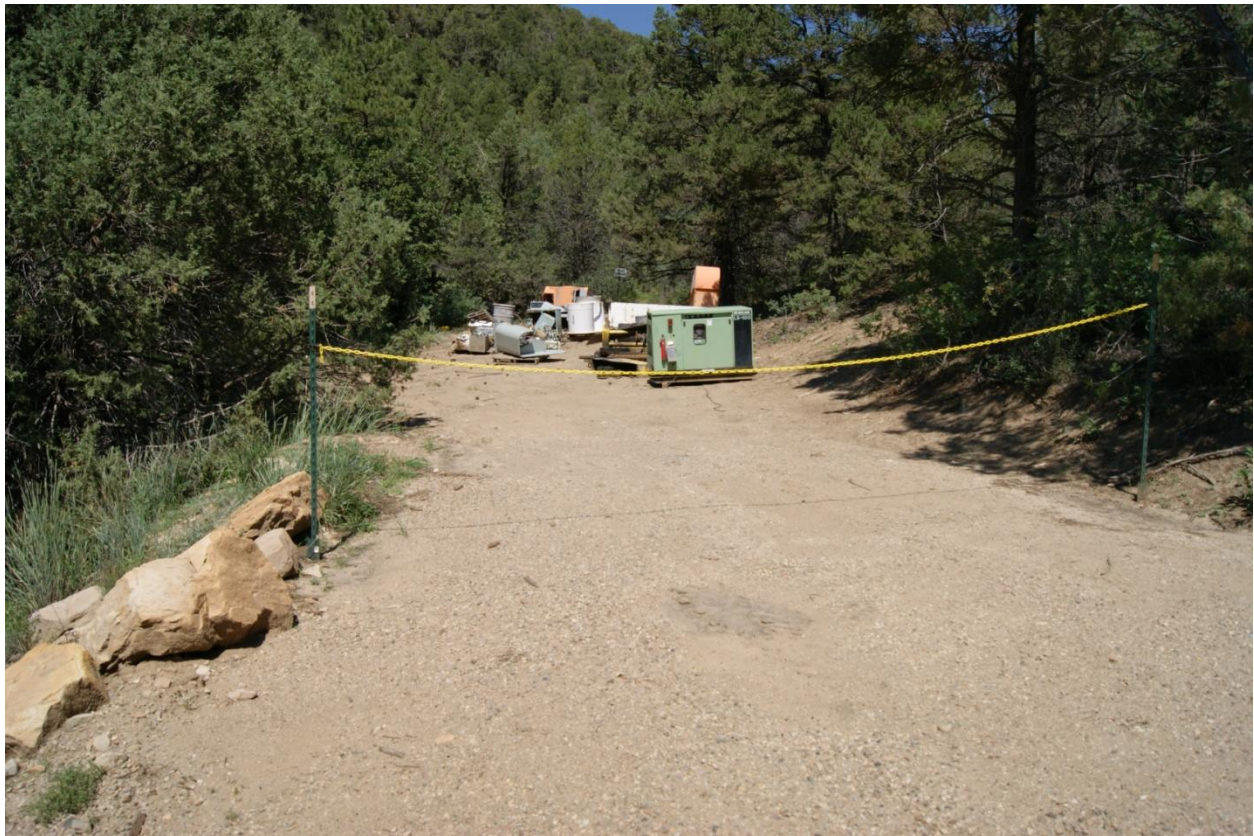
Photo 5 – Material storage area at NW end of King II

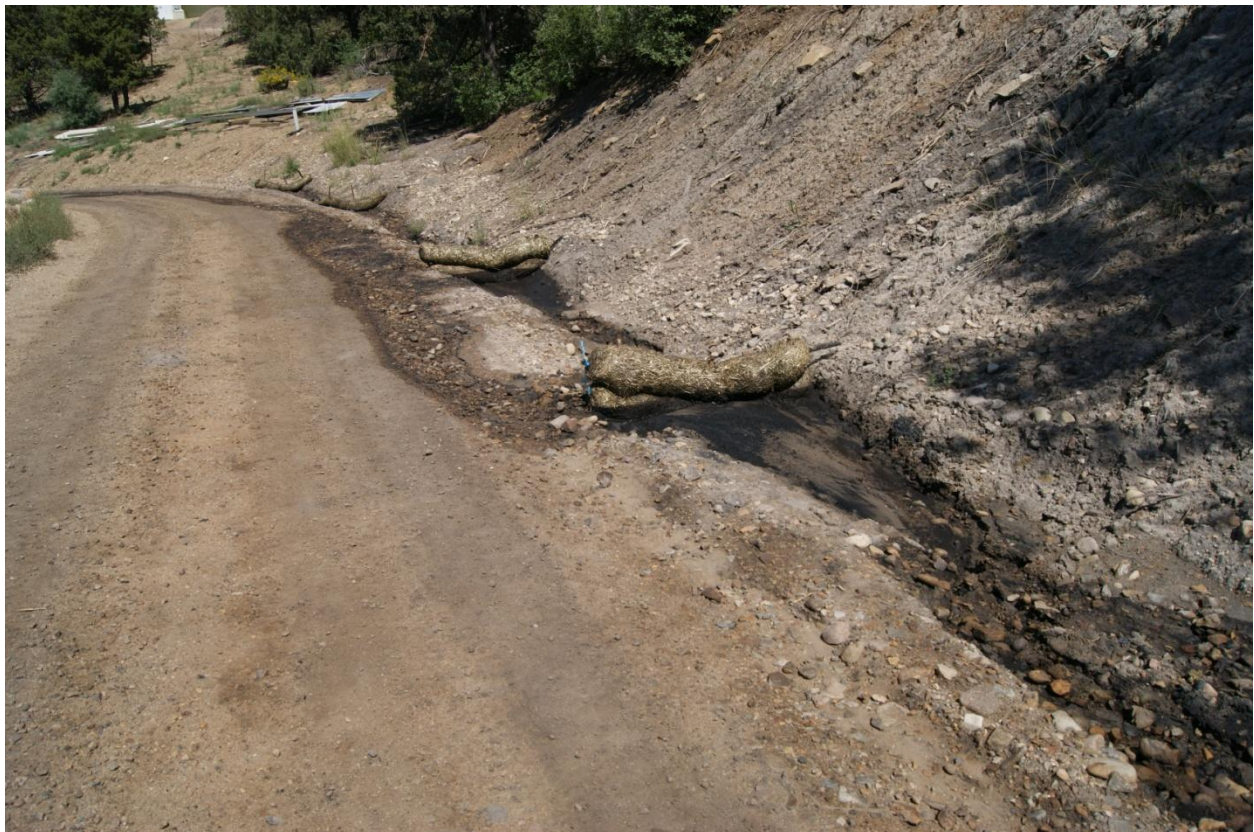
- Straw wattles are used throughout the King II area in various collection ditches to slow the velocity of the water and trap sediment before it reaches a drop inlet. Mr. Wymore said they had been changing the wattles more frequently in recent weeks, due to the amount of rain and runoff that had occurred.

Photo 6 – Straw wattles in ditch on Belt Portal Access Road

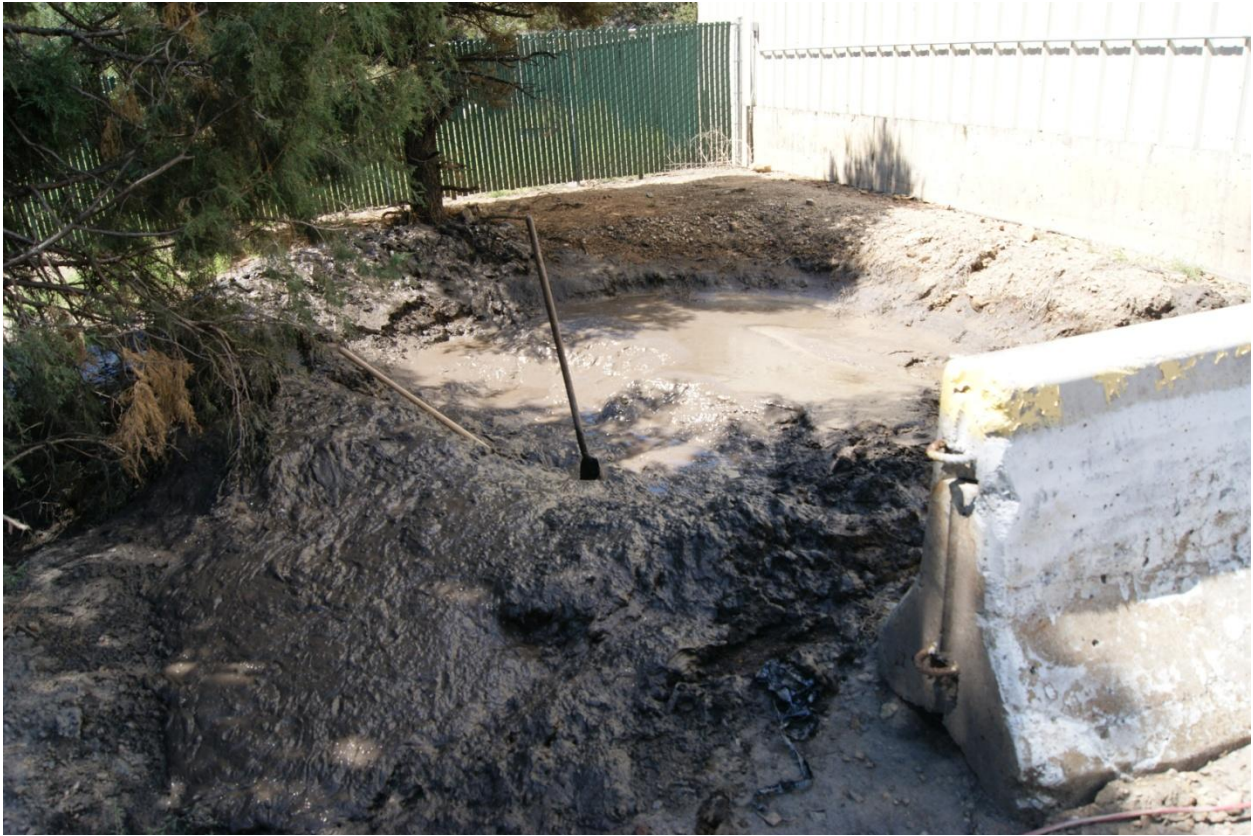
- Behind the oil storage shed is a small sump pond that collects any runoff from the shed area and allows any oily substance to be trapped before it proceeds to the sedimentation pond through the series of collection ditches. A portion of the adjacent yard and road also drains to the sump pond, and with the recent rains, the sump pond was full of muck. Shovels were on hand, indicating that mine personnel had been attempting to muck out the sump. Mr. Wymore suggested that perhaps the drainage from the road and yard could be diverted to a nearby ditch, so that it does not contribute to filling up the sump.

Photo 7 – Sump pond behind petroleum storage shed

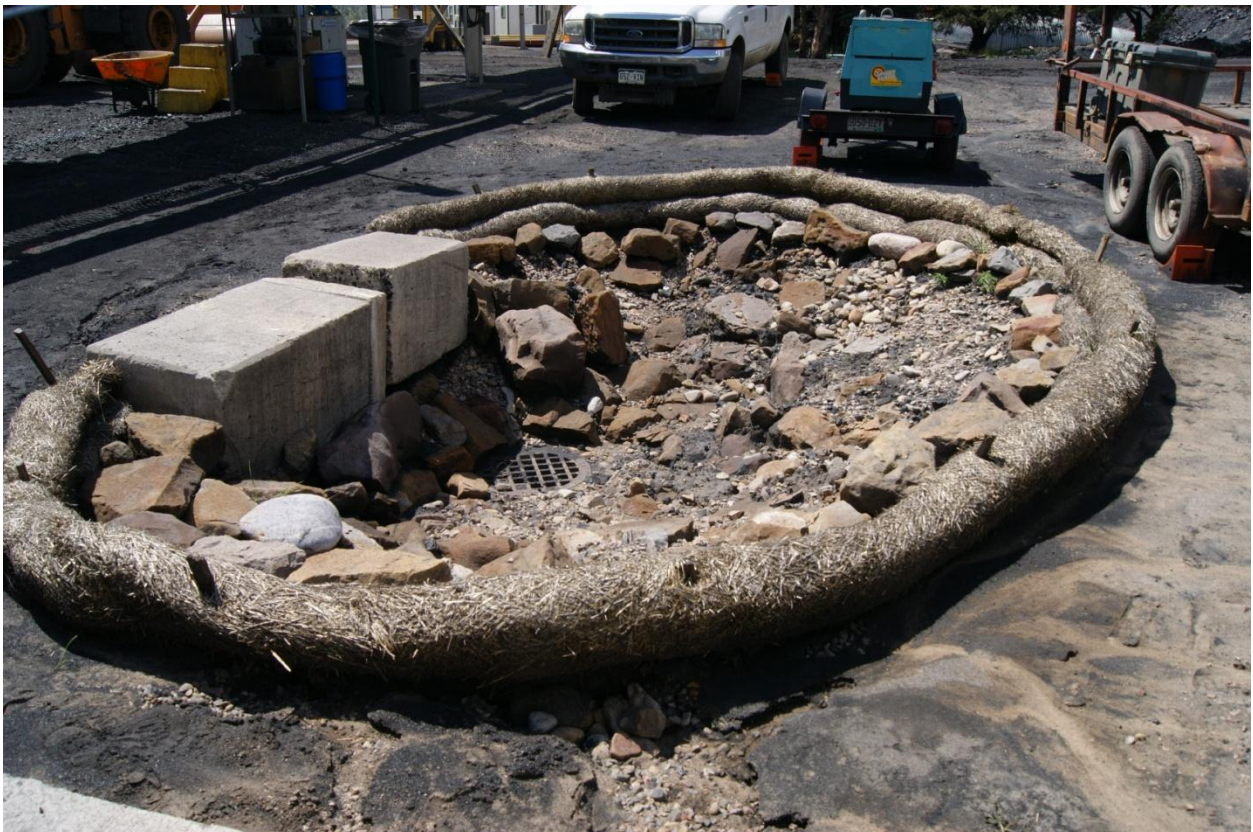
- The drop inlets at King II were all inspected, and were found to be in good condition. The inlet is covered by a grate, which is generally surrounded by coarse, angular riprap. The area is then ringed by a double layer of wattles, staked in place.

Photo 8 – Drop inlet at King II

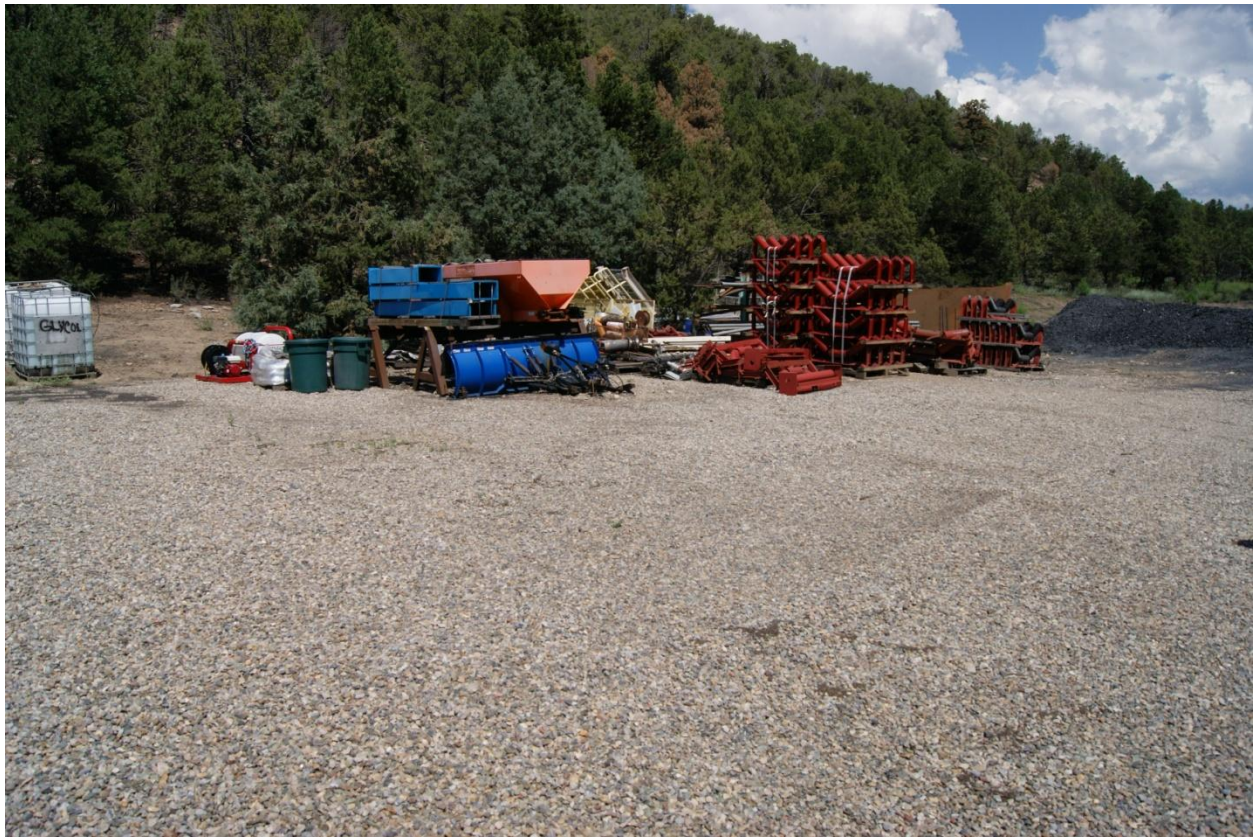
Photo 9 – Equipment storage north of King II substation

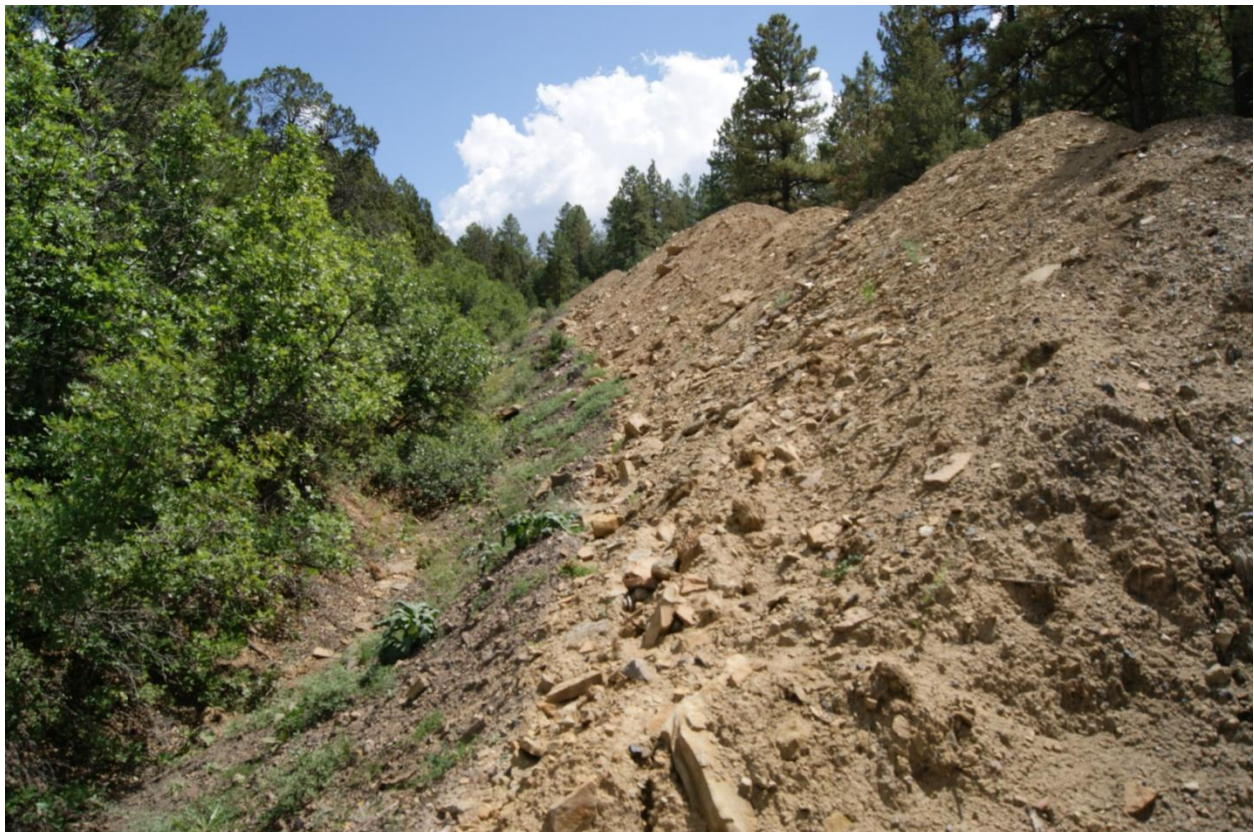
Photo 10 – Soil storage pile above Refuse Pile at King I, looking east

- The soil pile stored in the valley immediately uphill of the refuse pile needs to have a perimeter ditch and berm installed to protect the resource, and to direct any runoff away from the natural (clean water) channel and toward the collection channel along the south side of the refuse pile. This work, for which a mini-excavator could potentially be used, must be completed this season, before the snow falls.
