## COLORADO DIVISION OF RECLAMATION, MINING AND SAFETY COAL PROGRAM INSPECTION REPORT

<b>Permit Number:</b> C-1981-046 <b>Mine Name:</b> Sunlight Mine <b>Operator:</b> Garfield Energy Corporation <b>Operator Address:</b>	<b>County:</b> Garfield <b>Operation Type:</b> Underground <b>Permit Status:</b> Revoked <b>Ownership:</b> Private
	<b>Operator Representative Present:</b>  None
<b>Operator Representative Signature: (Field Issuance Only)</b>

<b>Inspection Start Date:</b> September 9, 2013 <b>Inspection Start Time:</b> 09:00 <b>Inspection End Date:</b> September 9, 2013 <b>Inspection End Time:</b> 13:30	<b>Inspection Type:</b> Coal Complete Inspection <b>Inspection Reason:</b> Normal I&E Program <b>Weather:</b> Cloudy
<b>Joint Inspection Agency:</b>  None	<b>Joint Inspection Contacts:</b>  
<b>Post Inspection Agency:</b>  None	<b>Post Inspection Contacts:</b>  
<b>Inspector(s):</b>  Brock F. Bowles  Steve Renner	<b>Inspector's Signature:</b>

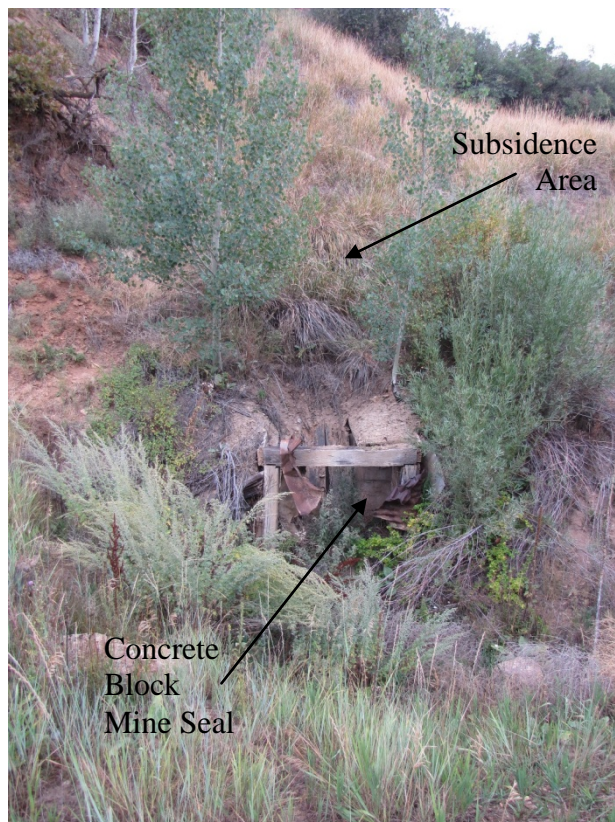
This was a complete inspection of the Sunlight Mine conducted by Brock Bowles and Steve Renner of the Colorado Division of Reclamation, Mining and Safety on September 9, 2013. Darnell Oxford of Red Dog Enterprises, was also present for the inspection. The permit for this mine was revoked and the bond was forfeited. The reclamation was completed by the Division. Weather conditions were overcast and rain started about 12:30. The purpose of this inspection was to evaluate the subsidence above the lower portal noted in previous inspection reports (June 2013, April 2013, September 2012, September 2010 and July 2013). The subsidence was located in the tall grass approximately 12 feet in by of the lower portal seal (photo 1). The subsidence hole is approximately 3 feet deep by 5 feet across.

Photo 1 – Location of Subsidence

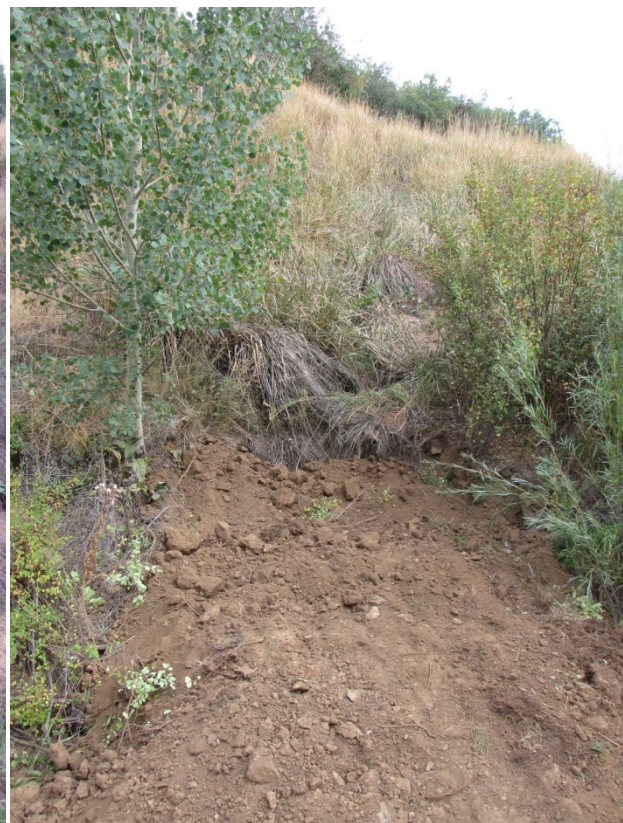
The concrete block mine portal seal was backfilled and graded to approximate original contour (photo 2). The excavated subsidence area at the lower portal was backfilled and graded to approximate original contour (photo 3). The drainage ditch in front of the mine seal was backfilled. The remainder of the ditch to the east of the portal was not backfilled.

Photo 2 – Mine Seal Backfilled with Soil

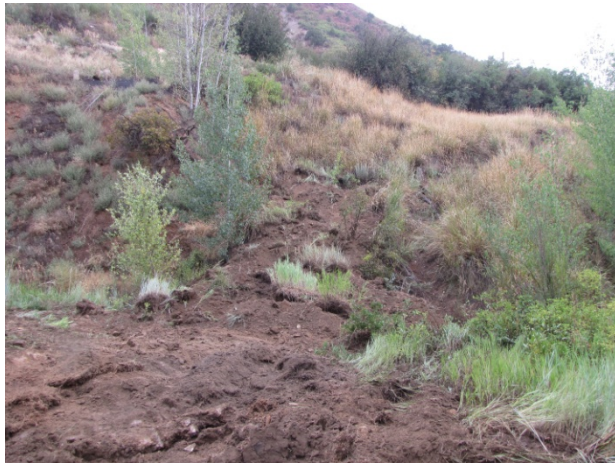
The surface of the excavated hillside was left in a rough condition and clumps of sod and shrubbery were placed randomly (photo 3). Flat areas disturbed and/or compacted by the machinery were roughened with the bucket of the loader (photo 4). Steve Renner will seed the entire disturbed area in October.

Photo 3 – Excavation Re-Contoured to AOC

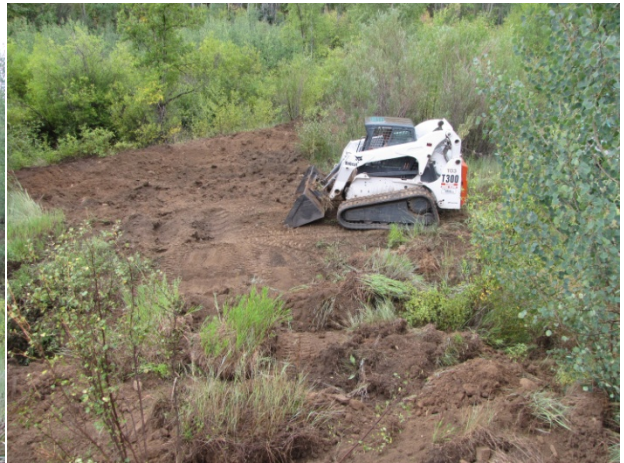
Photo 4 – Compacted Areas Roughened with Loader

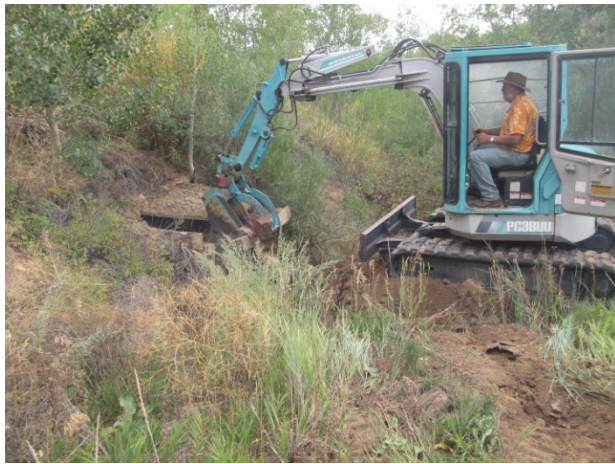
The wood cribbing around the mine seal was collapsed and removed (photo 5). The wood debris was buried in the ditch to the east of the mine seal/portal. The portal seal was not disturbed or damaged during the cribbing removal (photo 6). Steve Renner explained that the mine seal is a double wide concrete block wall reinforced with rebar. The mine seal/portal was buried with soil. The soil came from a berm located on the mine

Photo 5 – Removing Wood Cribbing

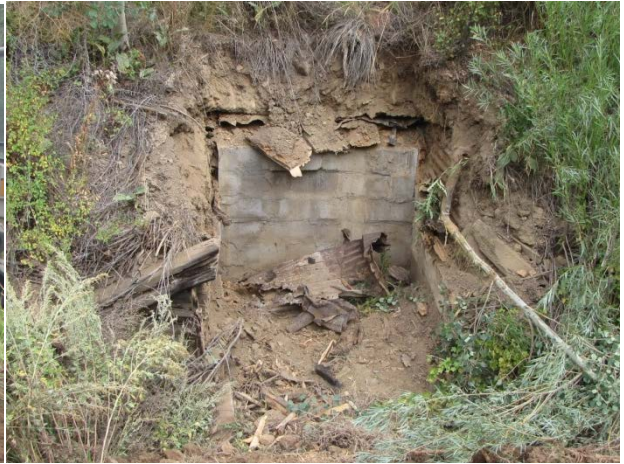
Photo 6 – Concrete Block Mine Seal

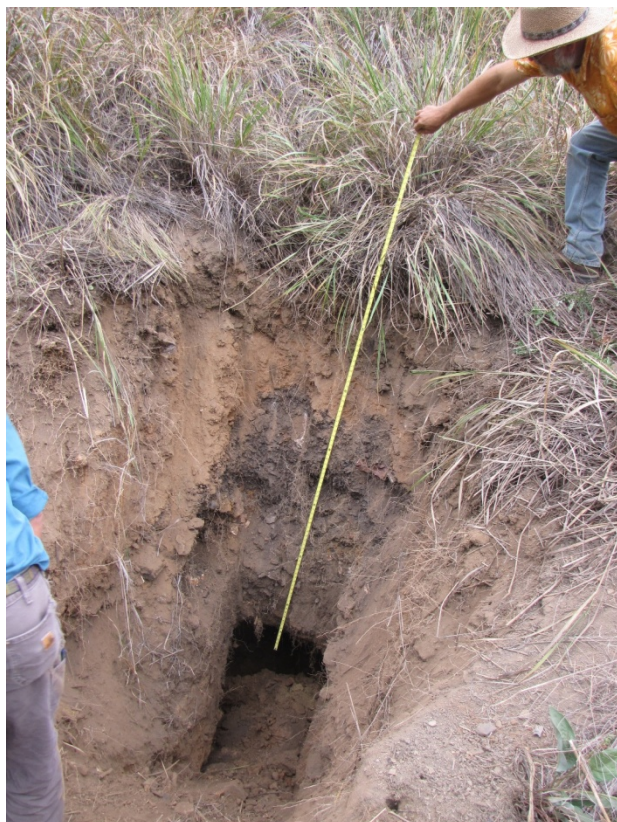
The subsidence area was excavated. The excavated soil was very soft and sandy and had little consolidation. The mine adit was found at approximately 7.5 feet below the surface (photo 7). The mine adit was approximately 4 feet in diameter. Within the adit, there was evidence of collapsing including a large rock.

Photo 7 – Mine Adit 7.5 Feet Below Surface

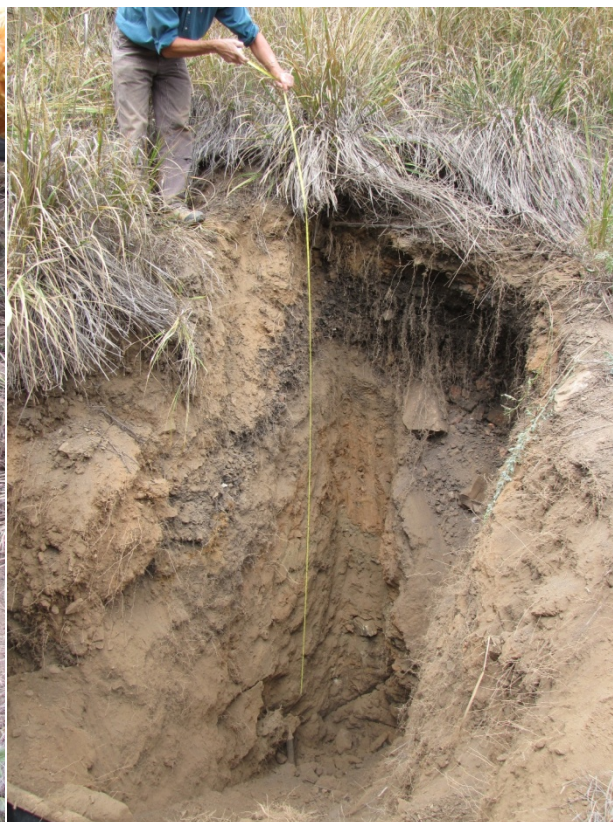
The mine adit was excavated for another 5 feet, horizontally inby. At 24 feet inby of the mine seal, the top of the mine adit was 11 feet below the surface (photo 8). At this point the adit had collapsed and only small hand-sized openings in the soil existed (photo 9). The entire length of the mine adit up to this point was collapsed.

The mine adit is approximately 4 feet in diameter and the overburden at the last excavation was 11 feet thick. The mine adit went in a northwesterly direction and appeared to be declining. The surface topography in the direction of the mine adit is inclining. It was determined that if any non-collapsed sections of the mine adit beyond this point should later collapse, it would only have a small subsidence expression on the surface and a mine adit opening is unlikely.

Photo 8 – Mine Adit 11 Feet Below Surface

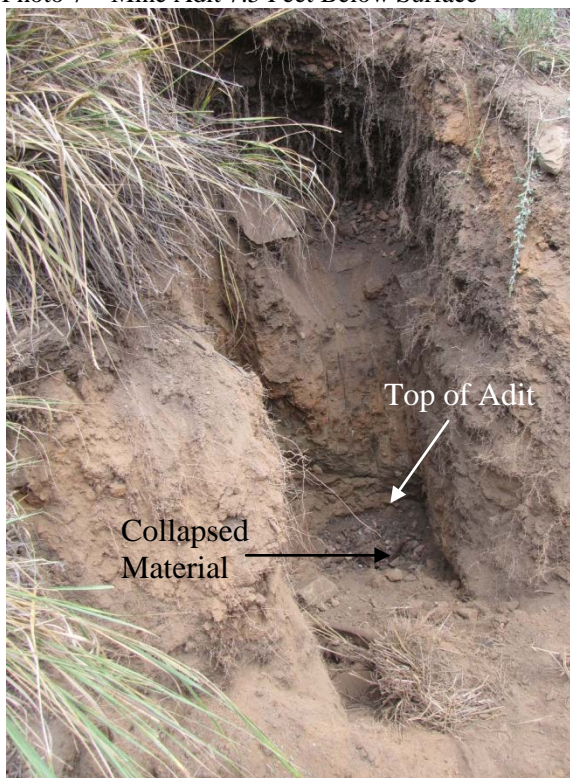
Photo 9 – Collapsed Adit
