COLORADO DIVISION OF RECLAMATION, MINING AND SAFETY COAL PROGRAM INSPECTION REPORT

Permit Number: C-1981-038 Mine Name: Bowie No. 1 Mine Operator: Bowie Resources, LLC Operator Address: Mr Basil Bear P.O. Box 1488 Paonia, CO 81428	County: Delta Operation Type: Underground Permit Status: Active Ownership: Federal
Operator Representative Present: Basil Bear	
Operator Representative Signature: (Field Issuance Only)

Inspection Start Date: September 9, 2013 Inspection Start Time: 11:50 Inspection End Date: September 9, 2013 Inspection End Time: 17:05	Inspection Type: Coal Complete Inspection Inspection Reason: Normal I&E Program Weather: Cloudy
Joint Inspection Agency: None	Joint Inspection Contacts:
Post Inspection Agency: None	Post Inspection Contacts:
Inspector(s): Susan L. Burgmaier	Inspector's Signature: <i>Susan Burgmaier</i> Signature Date: 9/12/2013

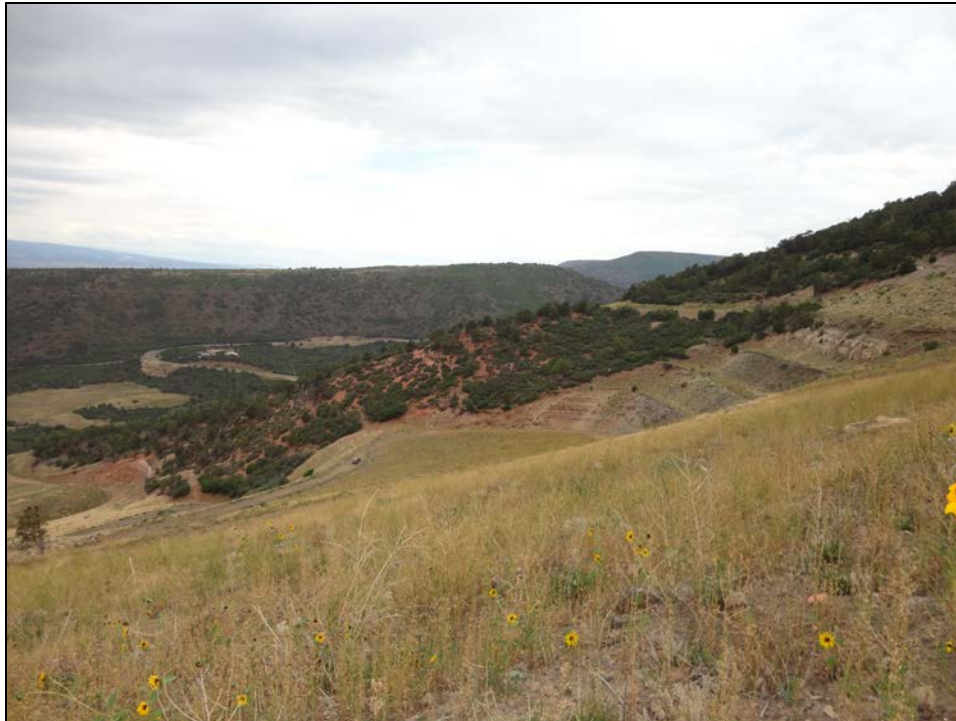
Photo 1
Fan Bench

The East Mine and ROM area were walked extensively. Vegetation in both areas is progressing well, with very few noxious weeds observed. The upper roadway on the fan bench had a patch of curly cup gumweed on it, and a few thistle plants were observed in the drainage channel to the west of the West Refuse area at the East Mine. The narrowed haul road to the East Mine has a considerable amount of cheatgrass. There is also a good sized patch of cheatgrass at the coal stockpile area of the loadout. There is still one tamerisk plant below Pond 2; the operator indicated he was aware of this plant and would eradicate it.

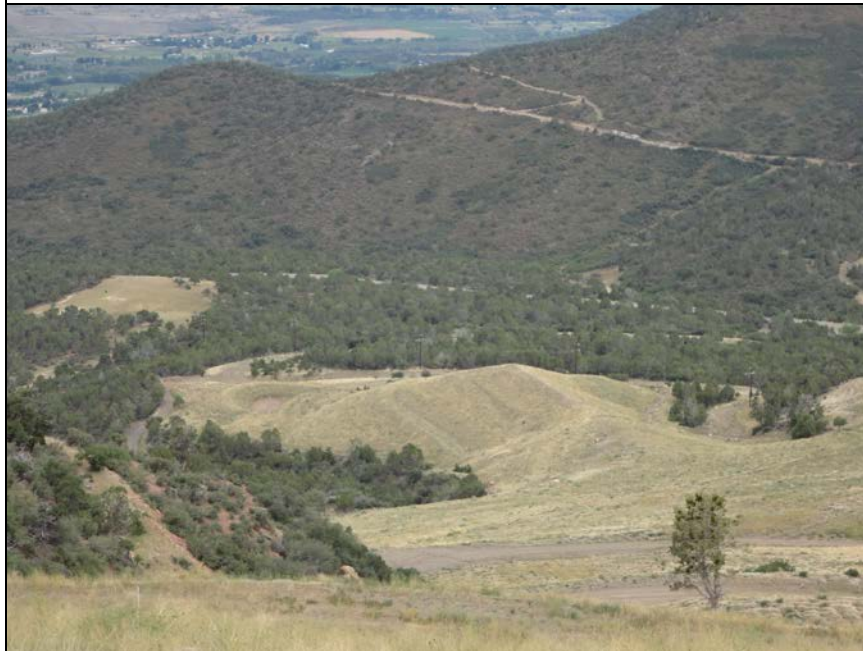
Both refuse disposal areas were stable and well vegetated.

Photo 3
Refuse disposal
area and West
Ridge pond

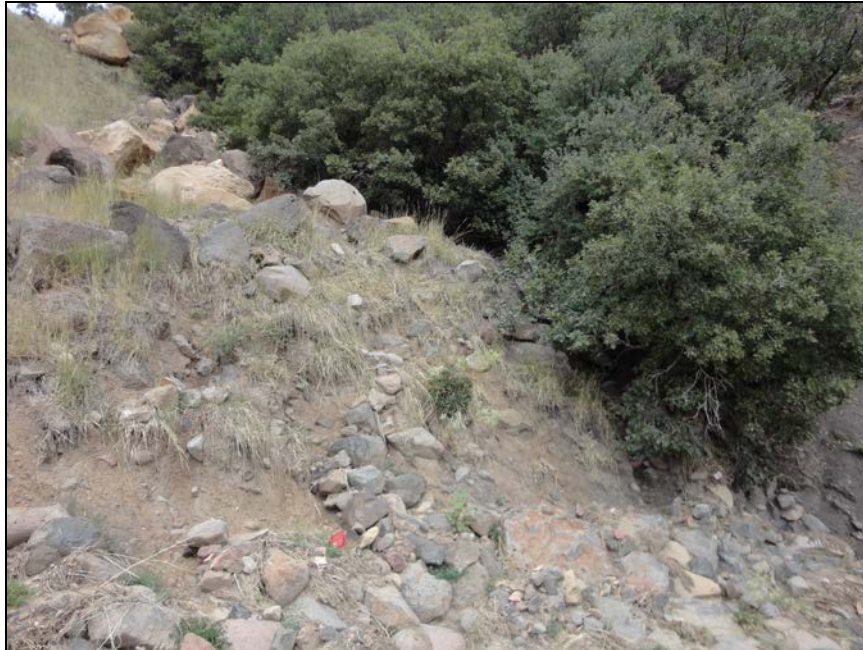
There are a few locations on the East Mine where the drainage ditches are downcutting from summer rain events: The steep lower portions of the ditches on the west and east ends of the reclaimed screening bench, the inlet to Pond 1, and the outlet of the road culvert just west of the west refuse pile. If these ditches continue to erode, repairs will be necessary.

Photo 4
Lower section of
ditch between the
screening bench
and the warehouse
bench, east side of
East Mine

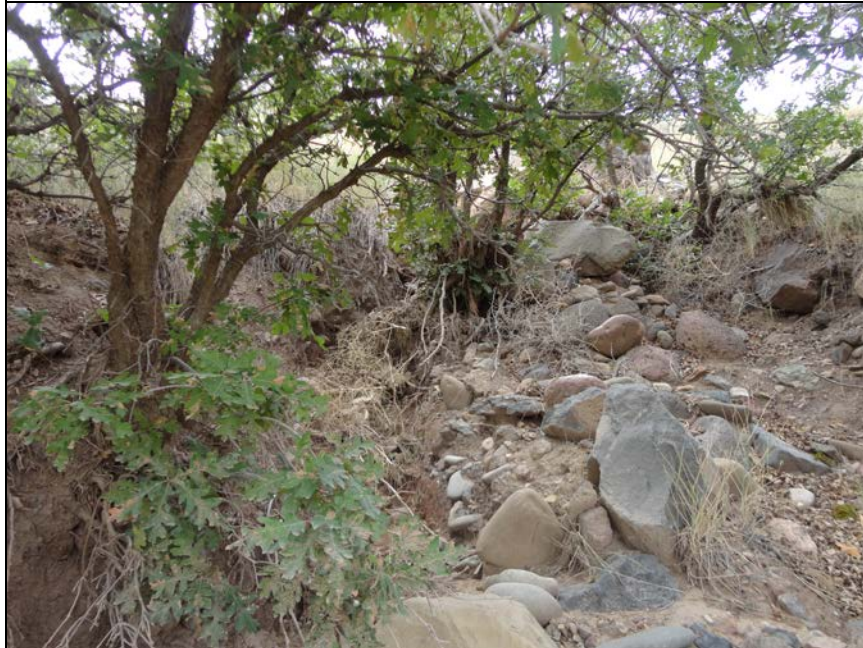
Photo 5
Culvert outlet on
east side of road

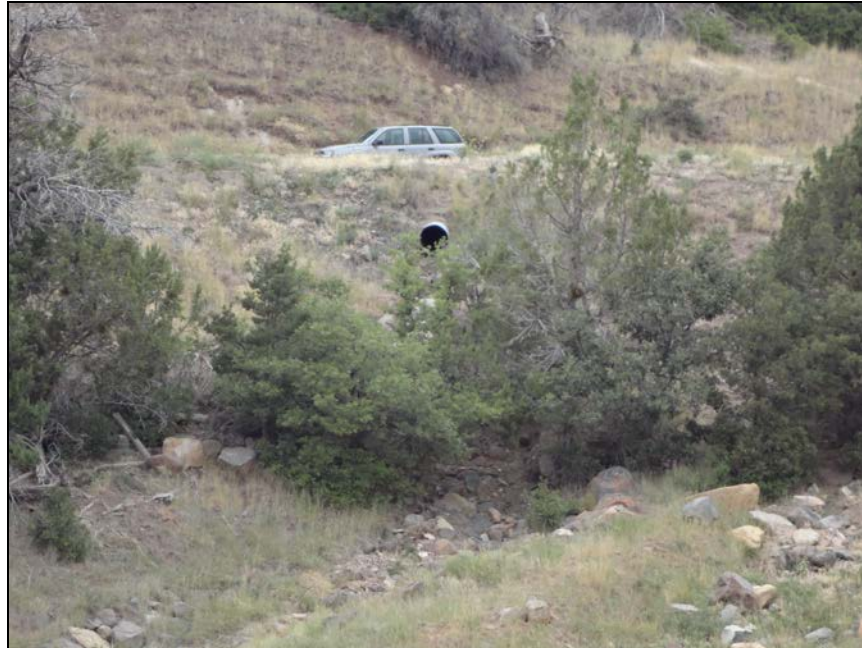
Photo 6
Culvert carrying
upper East Mine
drainage across to
West Ridge pond
(outfall shown in
Photo 5 above)

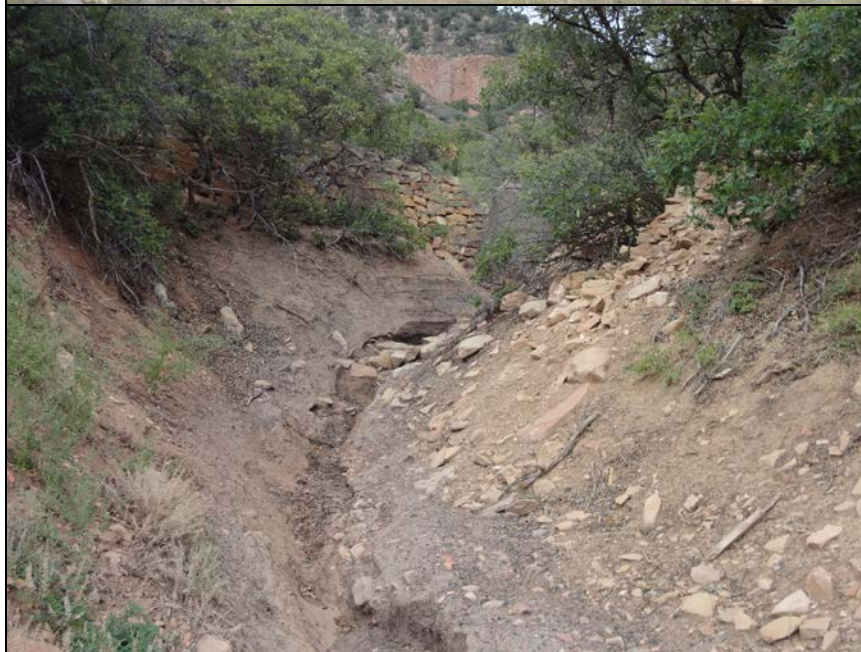
Photo 7
Pond 1 inlet
channel

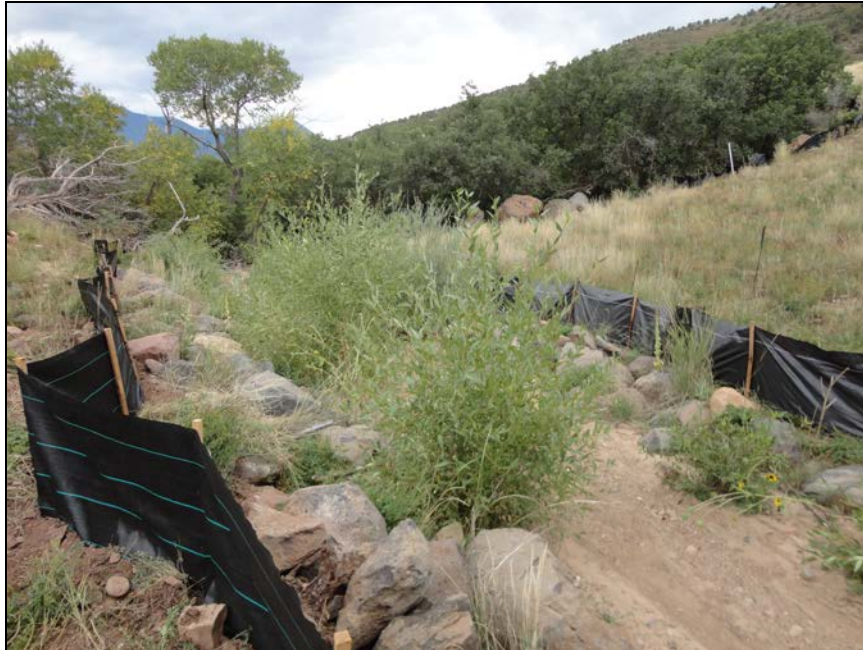
A contractor was on site replacing the silt fence along the East Mine haul road corridor reclamation. Vegetation at the Roatcap water tank SAE was in good condition. The berms along the loadout west end storage area SAE and at the east end of the loadout the berm between the sediment pond and sewage lagoon had both been repaired.

Photo 8
Silt fence replaced
at ROM area along
Stevens Gulch

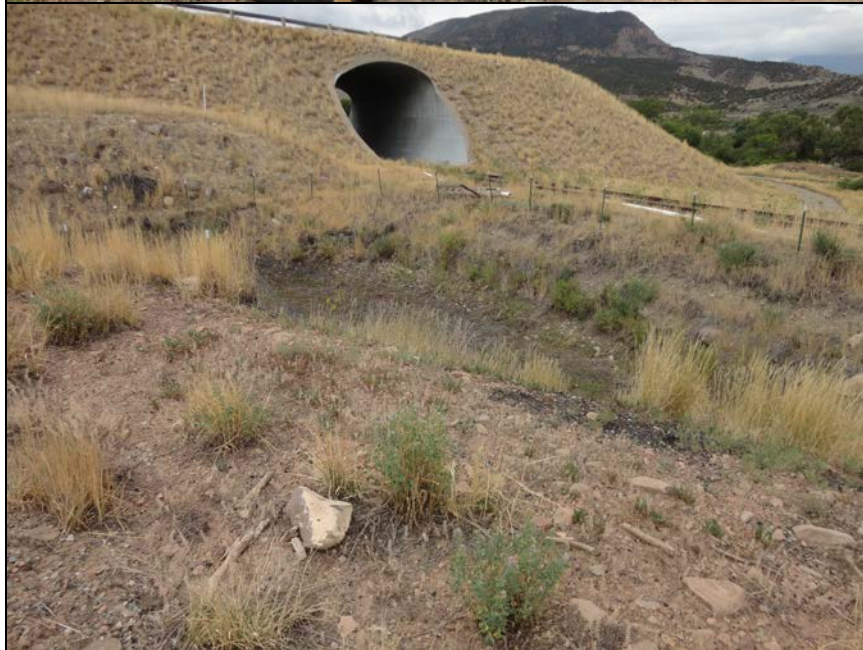
Pond 2 at the East Mine and the east loadout pond were both holding water. All other ponds were dry. No running water was observed on site.

Photo 9
Loadout stockpile
pond

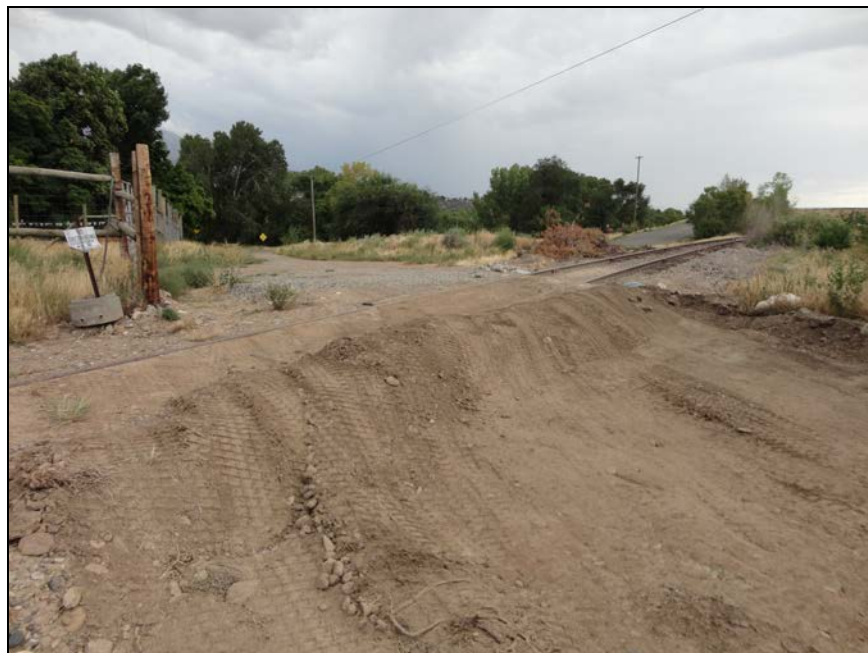
Photo 10
Berm at end of
gravel storage area
on west end of
loadout

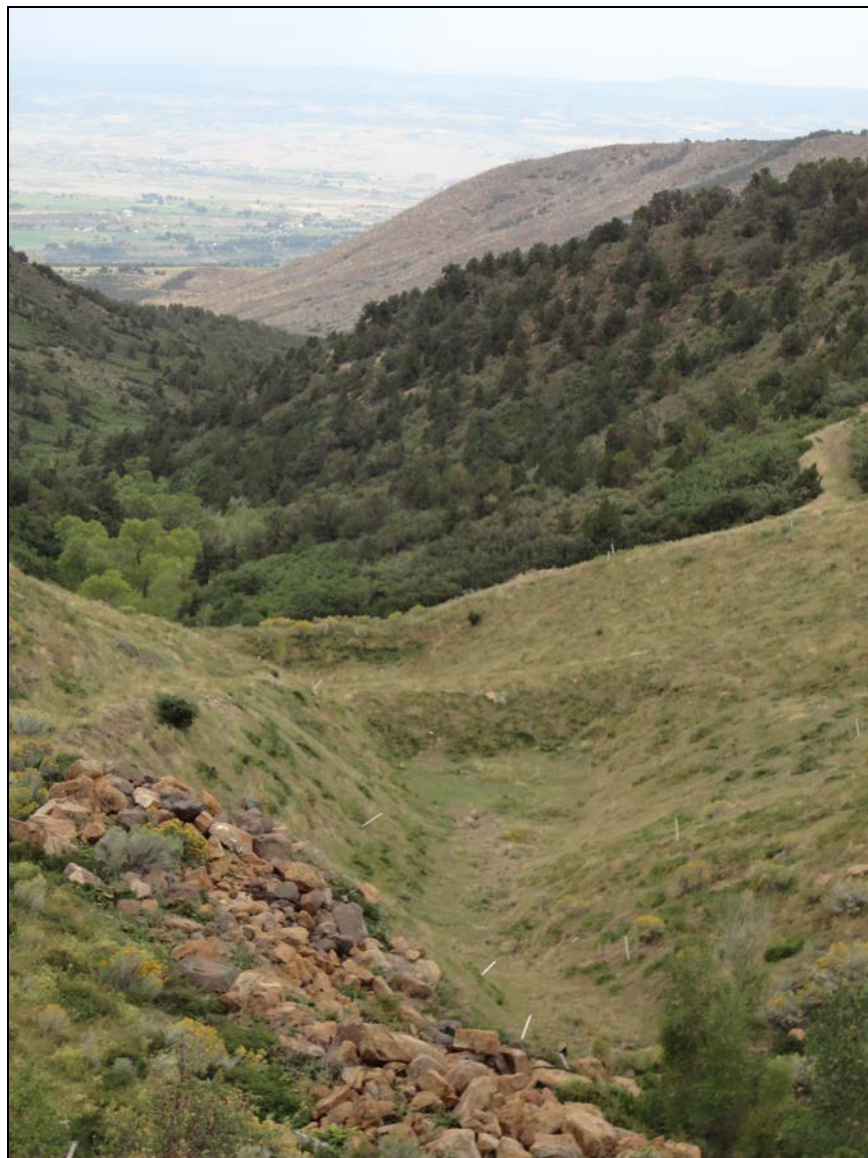
Photo 11
Sediment ponds 1
and 2 at West Mine
