COLORADO DIVISION OF RECLAMATION, MINING AND SAFETY COAL PROGRAM INSPECTION REPORT

Permit Number: C-1996-083 Mine Name: Bowie No. 2 Mine Operator: Bowie Resources, LLC Operator Address: Mr William A Bear P.O. Box 483 Paonia, CO 81428	County: Delta Operation Type: Underground Permit Status: Active Ownership: Federal and Forest
Operator Representative Present: Bill Bear	
Operator Representative Signature: (Field Issuance Only)

Inspection Start Date: September 10, 2013 Inspection Start Time: 13:30 Inspection End Date: September 11, 2013 Inspection End Time: 09:10	Inspection Type: Coal Partial Inspection Inspection Reason: Normal I&E Program Weather: Raining
Joint Inspection Agency: None	Joint Inspection Contacts:
Post Inspection Agency: None	Post Inspection Contacts:
Inspector(s): Susan L. Burgmaier Sandra L. Brown	Inspector's Signature:

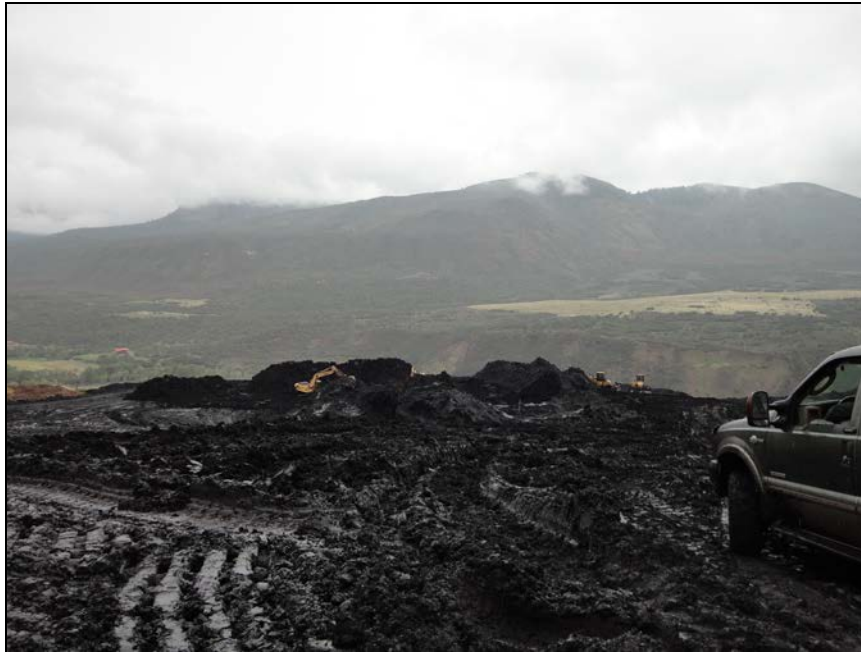
Work continues on Gob Pile #2 to grade and compact all of the end-dumped refuse material that was cited in NOV CV2013004. All of the end dumped material that was out of compliance in the Gob Pile #2 expansion area has been graded and compacted. The eastern portion of the pile, also cited in the notice of violation, is nearing completion. There is about an acre sized area of material left to grade and compact, but the vertical height of the material has decreased substantially since the last DRMS ground inspection (August 21, 2013).

Photo 1
Eastern flank of Gob Pile
#2, remaining end-
dumped material subject
to NOV CV2013004

Abatement Description: Place and compact all existing end-dumped material on Gob Pile #2 in accordance with the Rules and approved permit application package.

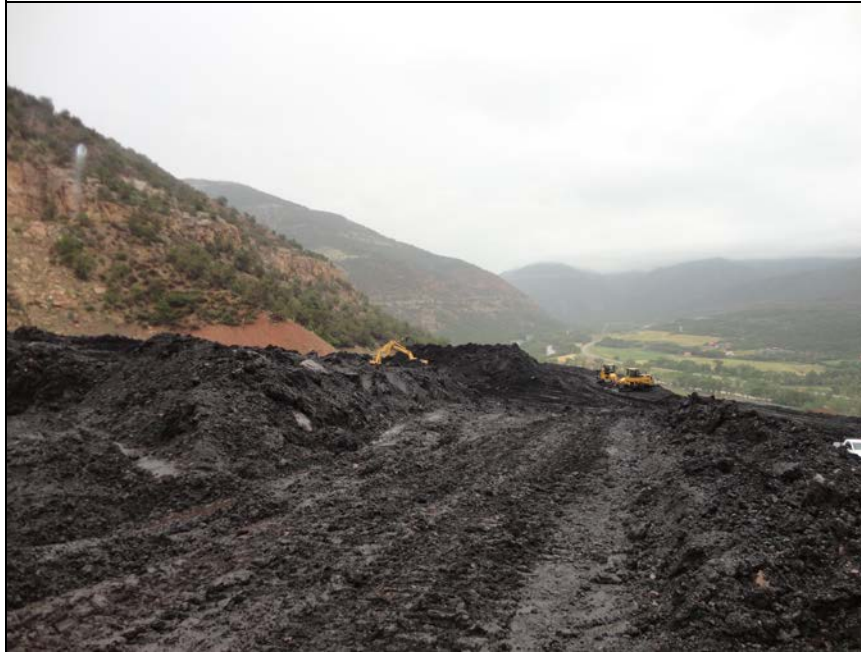
Photo 2
Central portion of Gob
Pile #2 expansion area

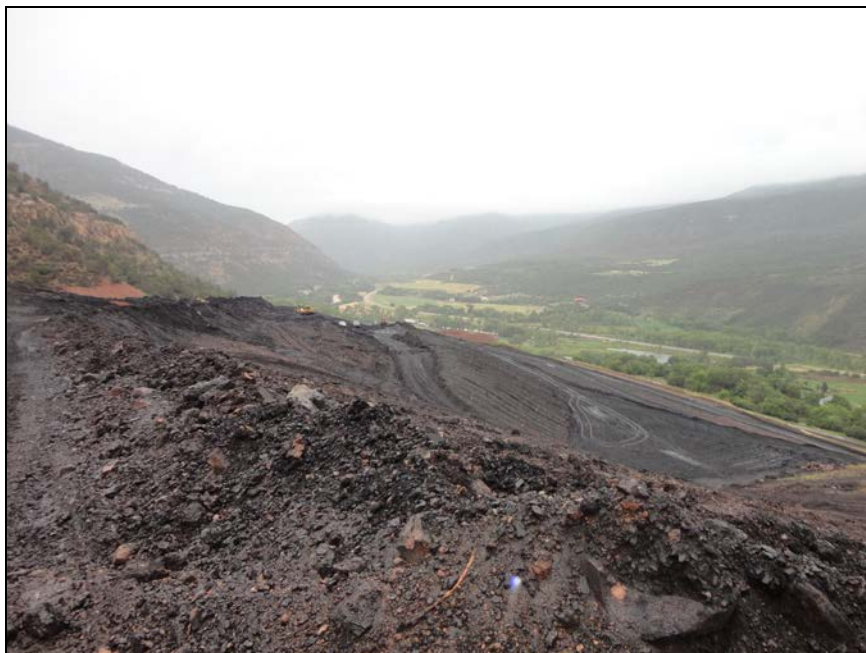
Photo 3
Lower Gob Pile #2
expansion area

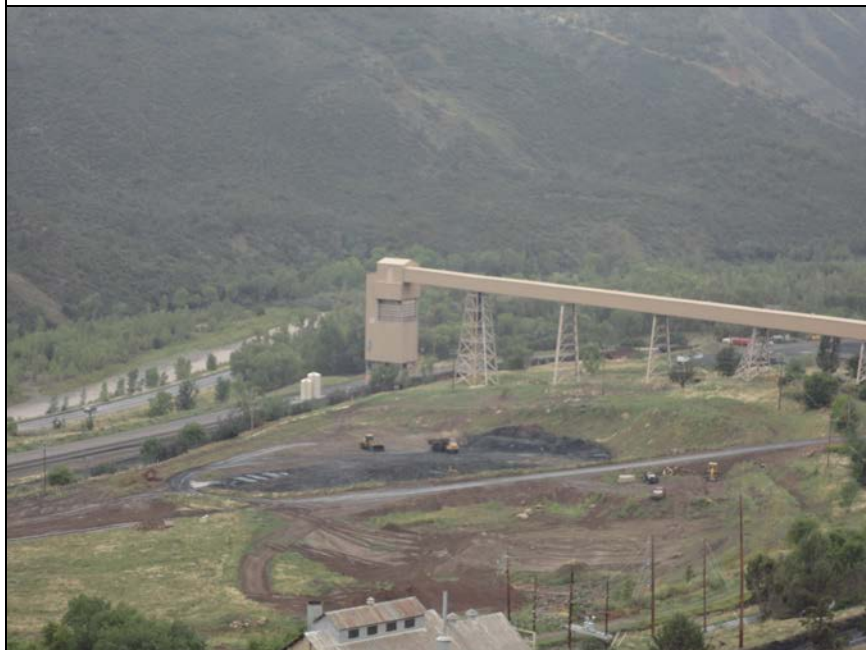
Gob was being placed in Gob Pile #3. The operator estimated that about 10-15,000 tons of gob had been placed in the new disposal area since it opened on September 7, 2013. The material was being spread for drying prior to compaction.

Photo 4
Gob Pile #3

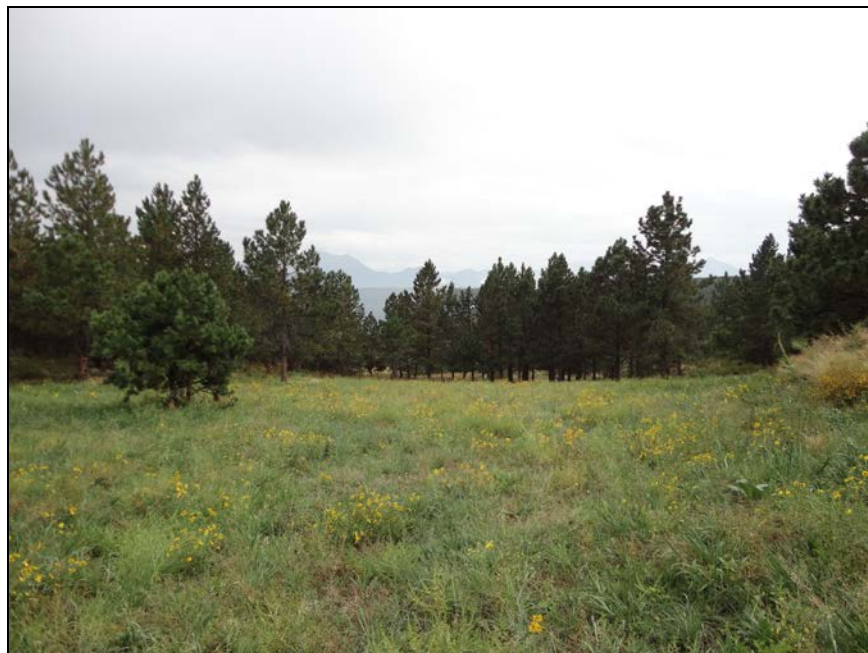
Photo 5
GVB 10D/10E

Drill pads along the Plantation Road were inspected. Revegetation on these sites has resulted in a good stand of grasses (brome, fescue, and wheatgrass) forbs (mint, milk vetch, yarrow), and a few shrubs (sage, snowberry, rose). Houndstongue and thistle will need to be treated at all of the sites visited, and cheatgrass on the road to GVB D8B as well. The operator indicated an effort would be made to treat the cheatgrass before winter sets in.

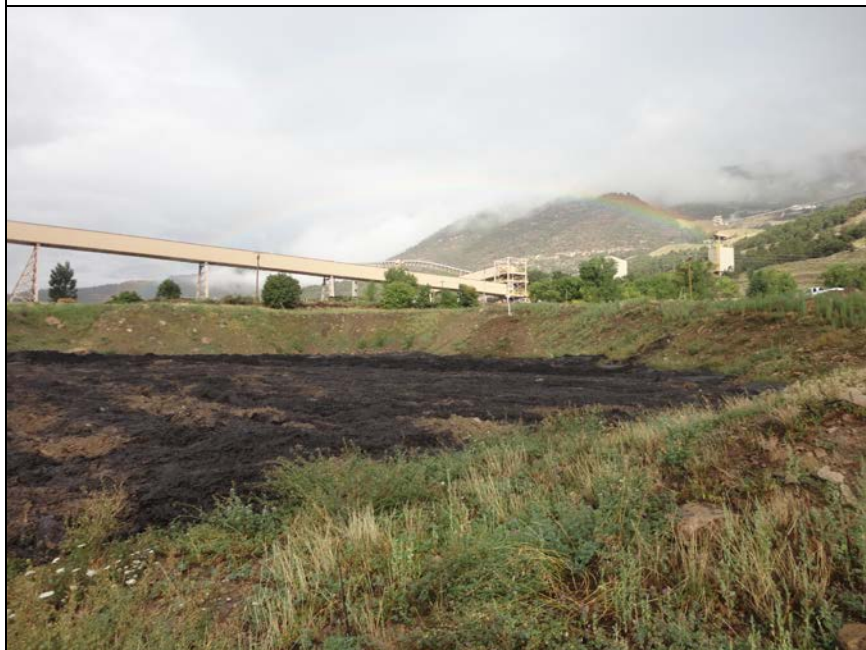
Photo 8
Gob placed in Gob Pile #3

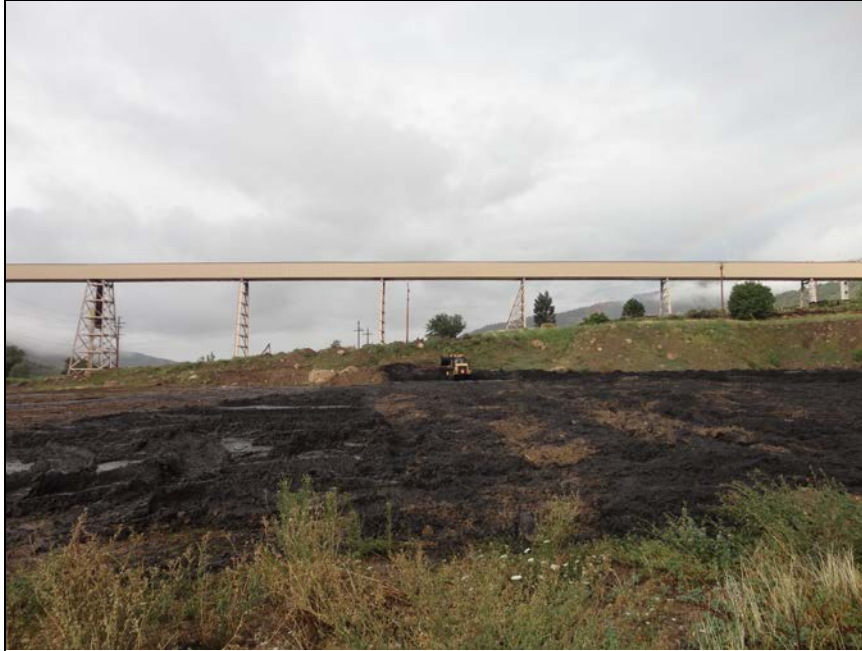
Photo 9
Gob being spread in Gob
Pile #3

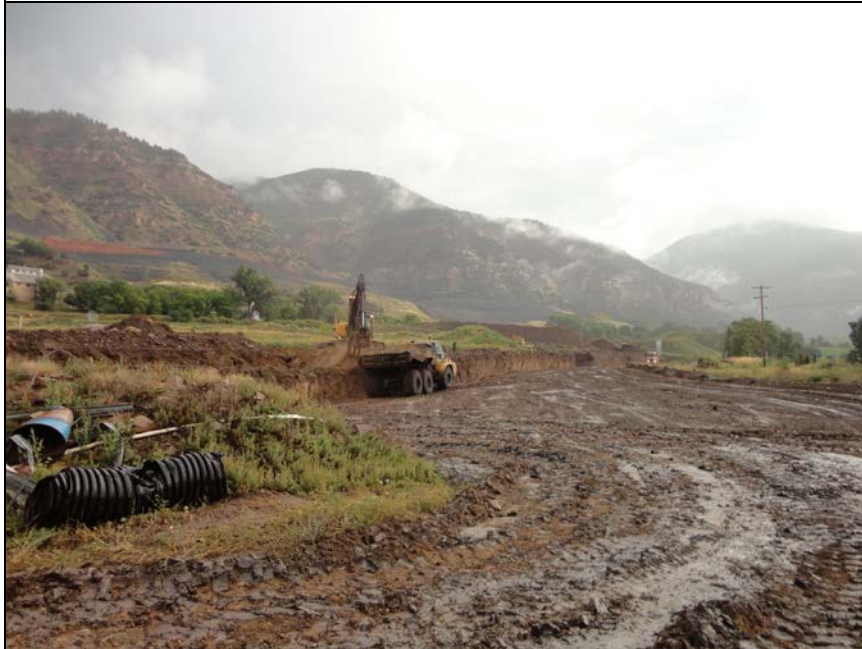
Cover material was being excavated on the east end of the Gob Pile #3 disposal area. The material was being excavated in 4' lifts and trucked to the approved cover material stockpile.

Photo 10
Cover material excavation
on east end of Gob Pile #3
disposal area

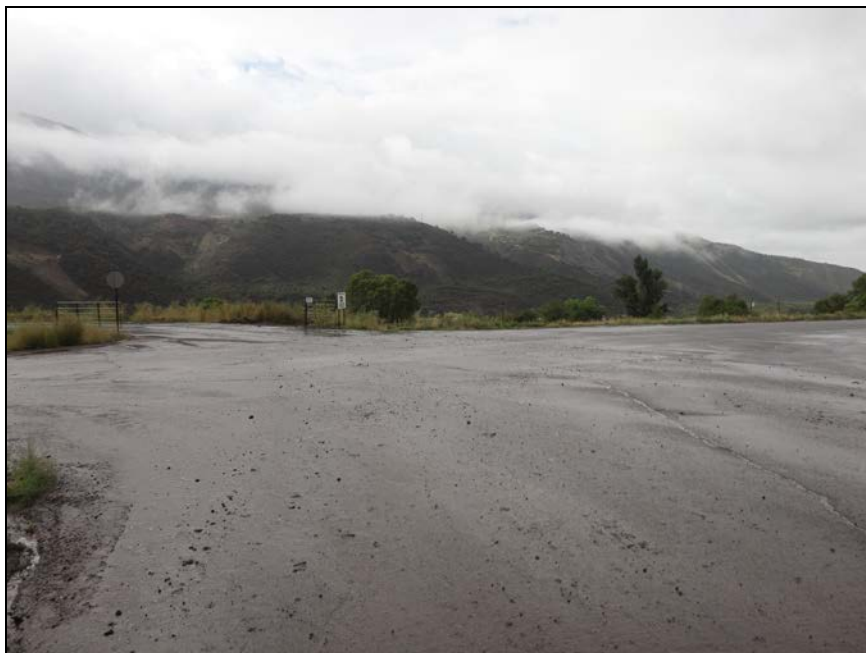
Photo 11
Crossing over Old
Highway 133 from mine
haul road to Gob Pile #3
haul road
