COLORADO DIVISION OF RECLAMATION, MINING AND SAFETY COAL PROGRAM INSPECTION REPORT

Permit Number: C-1981-033 Mine Name: Bear Mine Operator: Bear Coal Company, Inc. Operator Address: Mr Daniel Bear 1326 War Emblem Lane Rock Springs, WY 82901	County: Gunnison Operation Type: Underground Permit Status: Revoked Ownership: Federal
	Operator Representative Present: NA - Revoked Site
Operator Representative Signature: (Field Issuance Only)

Inspection Start Date: September 10, 2013 Inspection Start Time: 09:30 Inspection End Date: September 10, 2013 Inspection End Time: 13:00		Inspection Type: Coal Complete Inspection Inspection Reason: Normal I&E Program Weather: Cloudy	
Joint Inspection Agency: None		Joint Inspection Contacts:	
Post Inspection Agency: None		Post Inspection Contacts:	
Inspector(s): Susan L. Burgmaier Sandra L. Brown	Inspector's Signature:

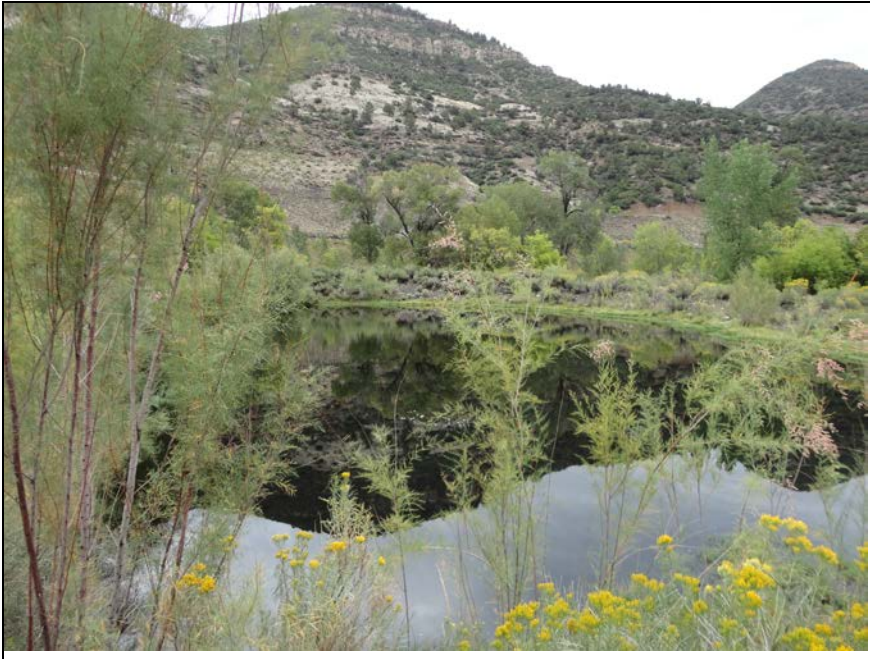
The sedimentation pond was dry. The mine spring was flowing to the treatment pond, which was discharging water to the North Fork of the Gunnison River.

<p>Photo 1 Treatment pond</p>

Reclamation requirements for hydrologic structures include removal of the sediment and treatment pond, and construction of the approved open channel to convey the portal spring water directly to the North Fork of the Gunnison River.

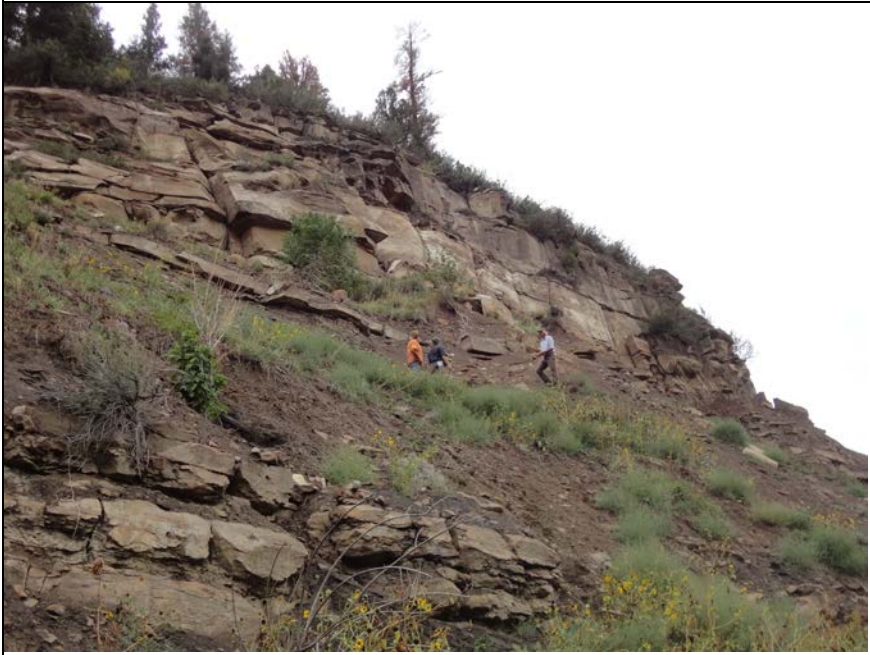
The slide on the west end of the portal slope appeared to be stable, and has not moved significantly since the initial slide occurred.

<p>Photo 2 Slide scarp</p>

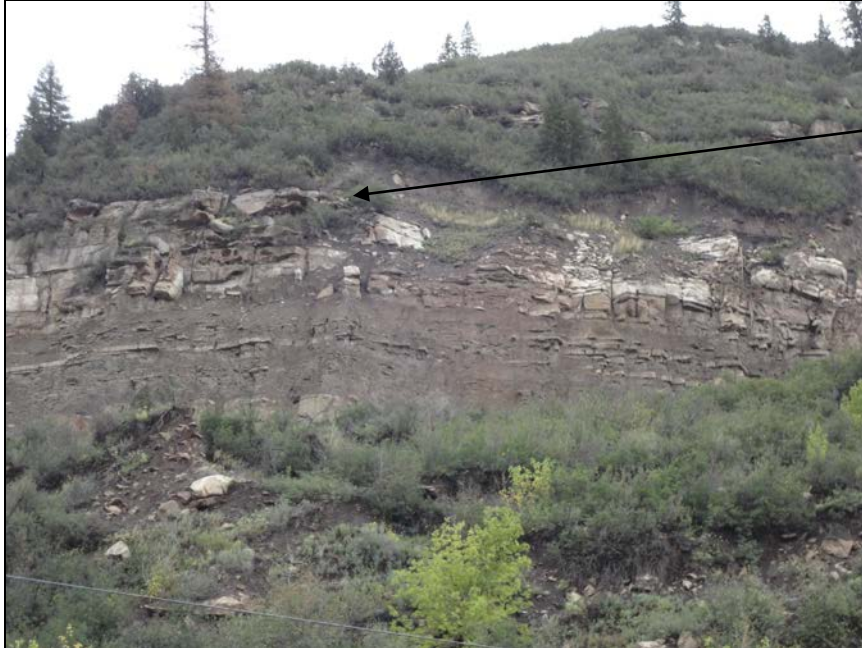
Steve Renner noticed that steam was escaping at the top of the slide scarp on the west end of the disturbance area, suggesting that the fire in the old workings was still burning. He also observed evidence of venting of heated mine air (roughly 90 degrees Fahrenheit) from the fractured sandstone on the upper portion of the slide scarp.

Photo 3
Slide scarp; steam
escaping

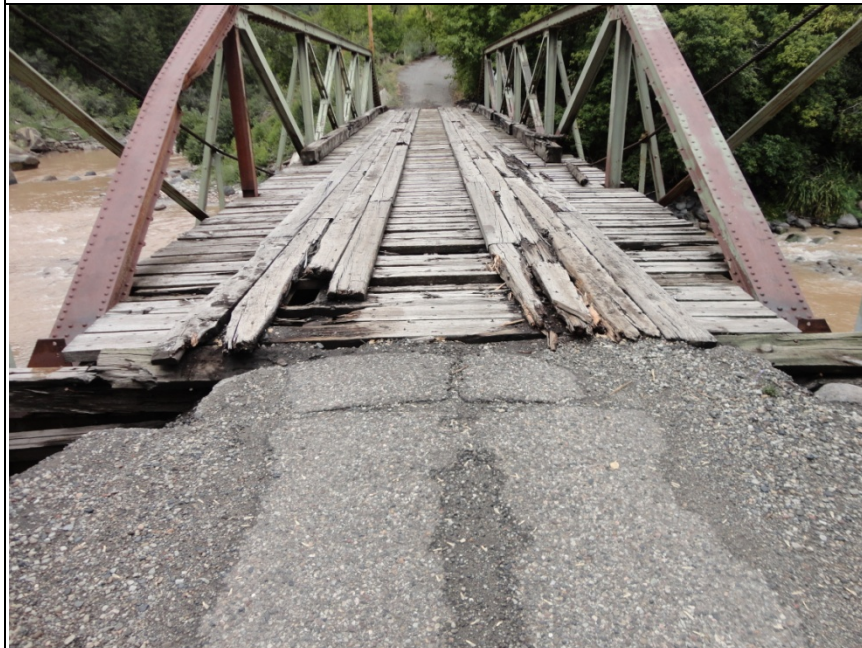
The bridge providing access to the site remains in poor condition and continues to deteriorate. Representatives from the Inactive Mine Reclamation program will arrange for appropriate barriers to vehicular access to prevent injury to persons attempting to cross the bridge.

Photo 4
Bridge over North Fork of
the Gunnison river
