COLORADO DIVISION OF RECLAMATION, MINING AND SAFETY COAL PROGRAM INSPECTION REPORT

Permit Number: C-1981-014 Mine Name: Southfield Mine Operator: Energy Fuels Coal, Inc. Operator Address: Mr George Patterson P.O. Box 459 Florence, CO 81226	County: Fremont Operation Type: Underground Permit Status: Permanent Cessation Ownership: Private Operator Representative Present: Kent Crofts
Operator Representative Signature: (Field Issuance Only)

Inspection Start Date: September 17, 2013 Inspection Start Time: 11:00 Inspection End Date: September 18, 2013 Inspection End Time: 15:30	Inspection Type: Coal Partial Inspection Inspection Reason: Normal I&E Program Weather: Clear
Joint Inspection Agency: None	Joint Inspection Contacts:
Post Inspection Agency: None	Post Inspection Contacts:
Inspector(s): Janet H. Binns Robert D. Zuber, P.E.	Inspector's Signature:

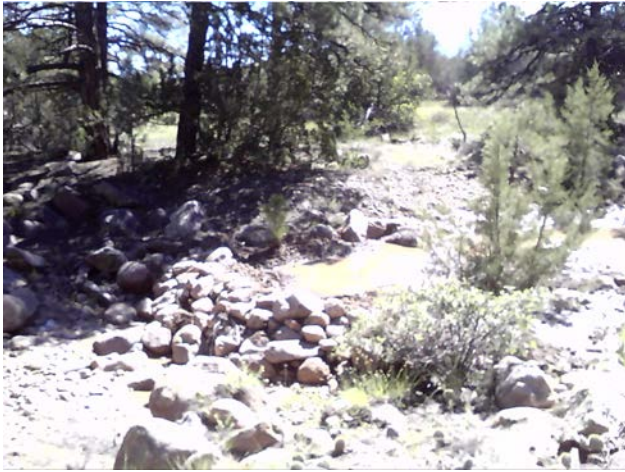
The vegetation consultant, Kent Crofts, was on the Southfield mine site conducting vegetation sampling. Mr. Crofts had informed the Division, via a telephone conversation on 9/16/2013, that he had observed significant water flow in Newlin Creek on 9/14/2013. At the time of the inspection there was insignificant flow at the Thompson driveway culvert. The inspectors walked downstream along the Newlin Creek drainage from the Thompson driveway. There was evidence that Newlin Creek had seen flows but at the time of the inspection the drainageway had a trickle of water and the banks were wet, with occasional puddles in low spots. Just upstream of a fence-line across the creek was a rock dam. This structure appeared to have been constructed by hand. There was water pooled upstream of the dam. There was also considerable deposition of organic material, pine needles, leaf mould, branches and twigs, at this location. There was also evidence in the channel that a reduced flow had continued past this location. The inspection continued past the fence-line across Newlin Creek. We walked along the drainage until we located the pink flagging tape and wooden stake previously placed by the landowner or his representative, to mark where they had observed flow to seep into the bottom of the channel. The Newlin Creek channel was damp downstream of this point, although it did not appear that a large volume of water had continued to flow. There were no surficial cracks or holes visible in this area.

Photo 1: Rock dam in Newlin Creek

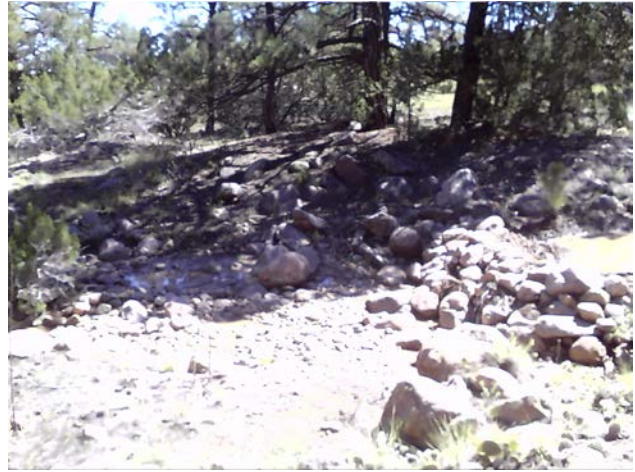
Photo 2: downstream of rock dam in Newlin Creek

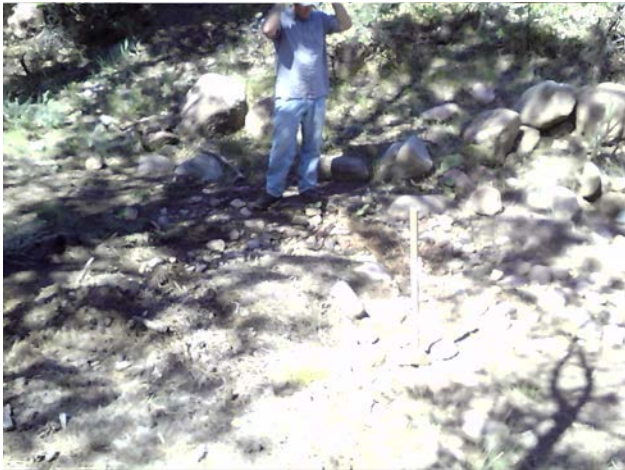
Photo 3: Landowner's stake marking point Newlin Creek flow previously infiltrated into channel

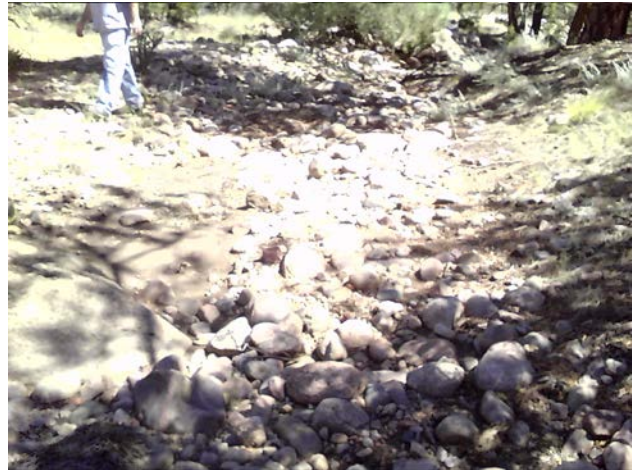
Photo 4: Flow in Newlin Creek had continued downstream of stake.

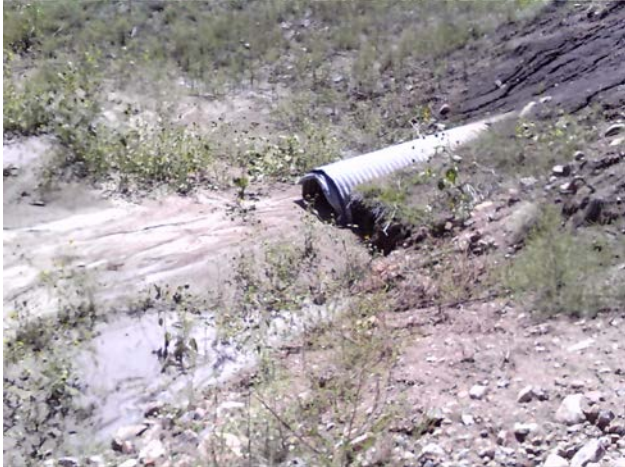
Pond 5 was holding a pool of water, a couple feet below the primary riser pipe. There was no evidence that any discharge had occurred from this pipe. Nor was there any sign based upon the inslopes of the pond that the water elevation had ever reached the discharge level prior to the inspection. The water held in the pond was muddy. Culvert 40 was clear at both the inlet and outlet. Sediment had deposited at the outlet of Culvert 39 and will require clearing. The outlet of the Pond 5 primary spillway also needs to be cleared of material.

Photo 5: Outlet of Culvert 39 into Pond 5.

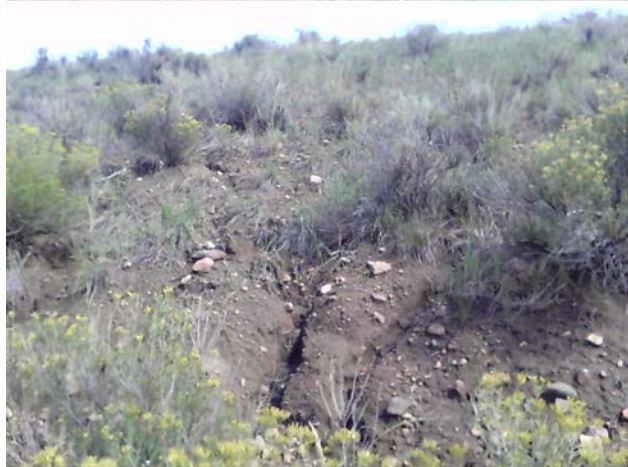
The silt fence on the north side of the truck tunnel continues to stabilize the gully adjacent to the concrete structure. EFCI had previously removed sediment from the north entrance of the truck tunnel. Additional sediment has been deposited on the concrete apron since the storm events. Stabilization of the slope immediately

north of the concrete apron is needed to prevent the formation of erosional features.

Photo 6: slope on northwest corner of truck tunnel requires stabilization.

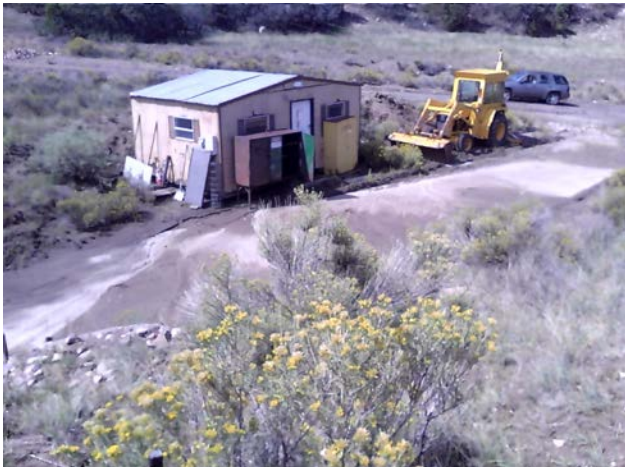
Photo 7: recent sediment deposition from slope shown in Photo 5.

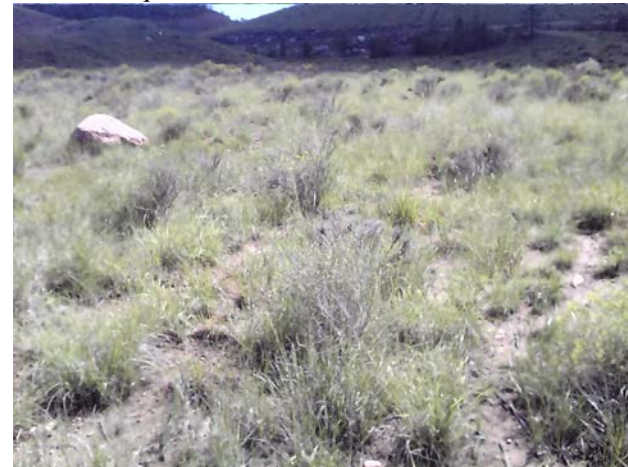
The vegetation throughout the reclaimed mine and loadout looked very healthy. Numerous warm season grasses; Blue grama, Side-oats grama, and Little bluestem were readily observed on the reclaimed areas.

Photo 8: Vegetation on reclaimed portal area

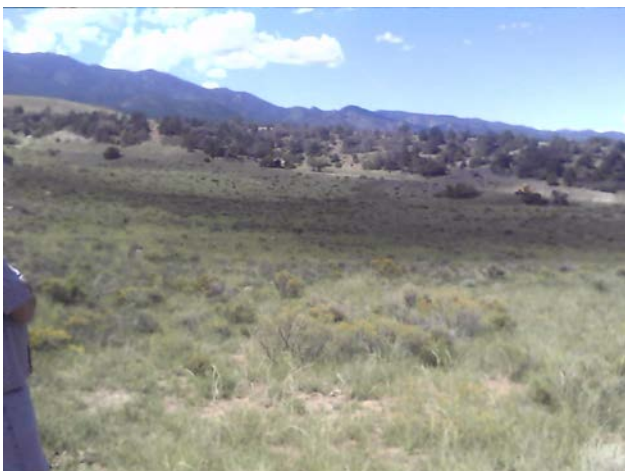
Photo 9: looking southwest across reclaimed portal area

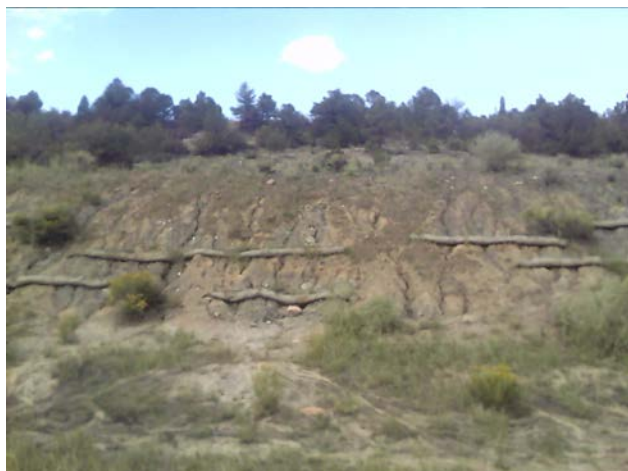
The wattled slope north of the permanent gravel parking area experienced considerable rilling under the wattles with the recent storms. In accordance with rill and gully repair rule, this slope needs to be reworked and the wattles trenched and re-anchored to the slope.

Photo 10: slope north of parking are. Slope and wattles need repair.
