**COLORADO DIVISION OF RECLAMATION, MINING AND SAFETY
COAL PROGRAM INSPECTION REPORT**

Permit Number: C-1980-007 Mine Name: West Elk Mine Operator: Mountain Coal Company, LLC Operator Address: Ms Kathleen G Welt P.O. Box 591 Somerset, CO 81434	County: Delta, Gunnison Operation Type: Underground Permit Status: Active Ownership: Federal
	Operator Representative Present: Kathy Welt and Jessica Loveland
Operator Representative Signature: (Field Issuance Only) N/A – Issued from Denver Office

Inspection Start Date: August 19, 2013 Inspection Start Time: 08:00 Inspection End Date: August 22, 2013 Inspection End Time: 19:30	Inspection Type: Coal Partial Inspection Inspection Reason: Normal I&E Program Weather: Cloudy
Joint Inspection Agency: None	Joint Inspection Contacts: None
Post Inspection Agency: None	Post Inspection Contacts: None
Inspector(s): James R. Stark	Inspector's Signature:

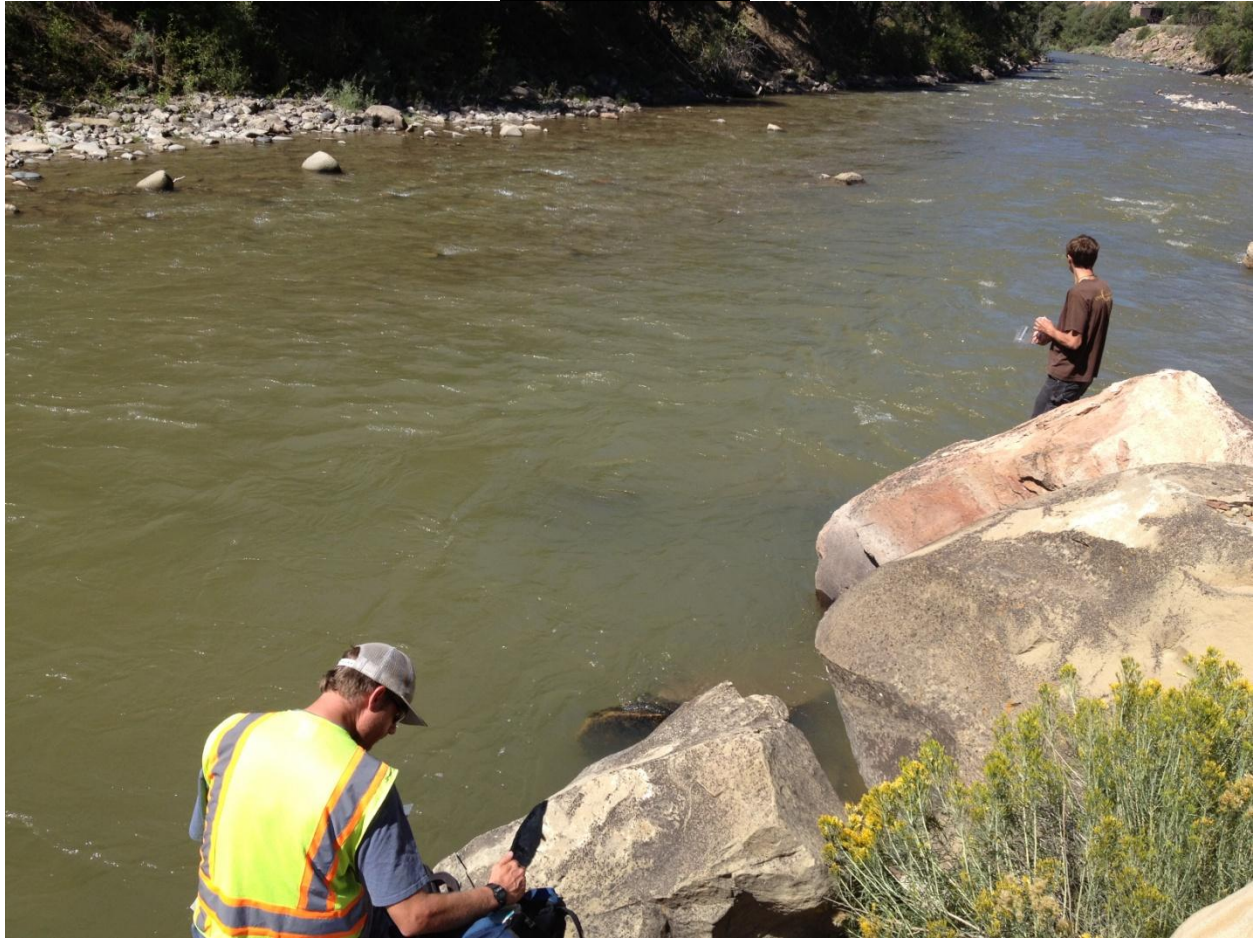
Surface water sampling – Lower North Fork

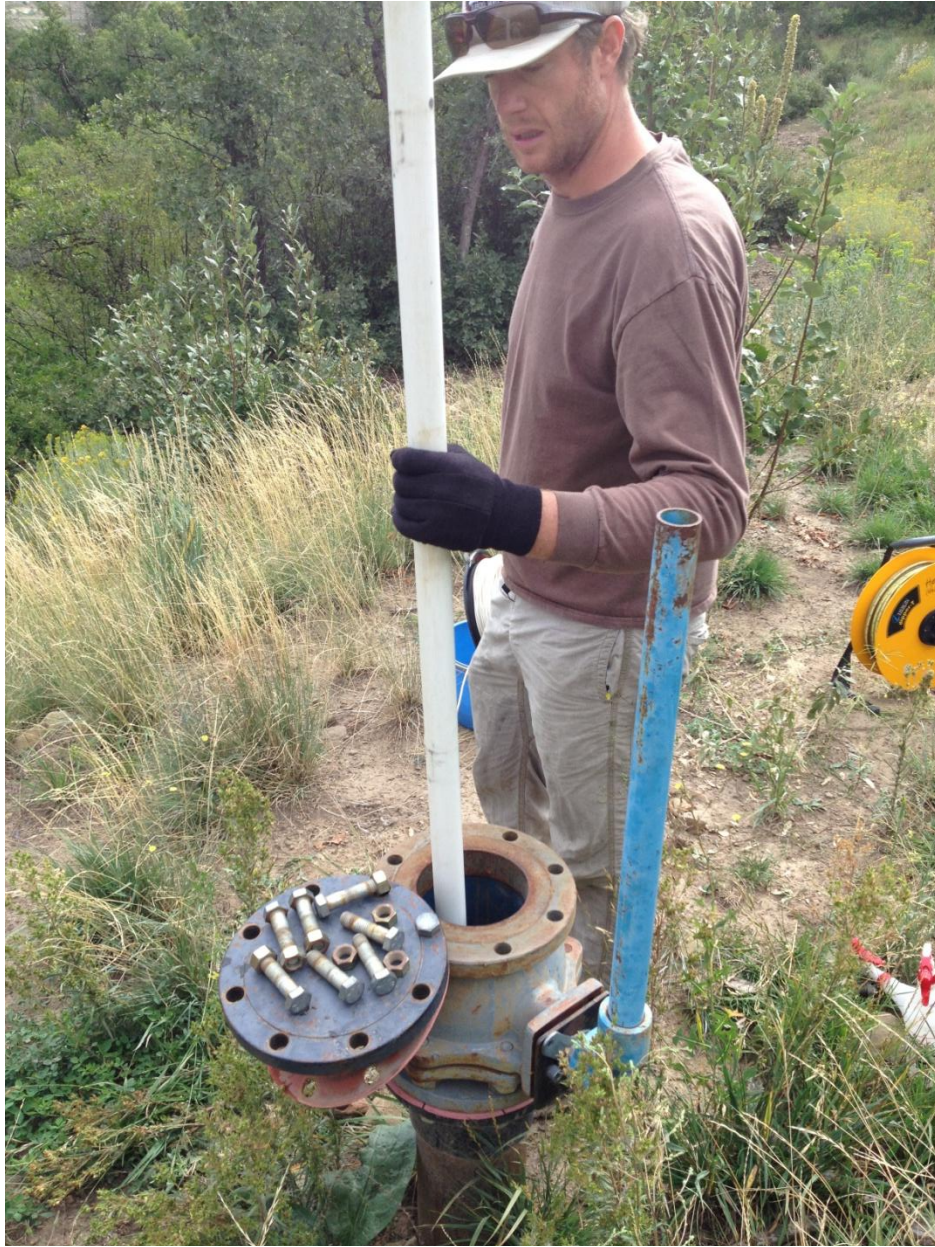
Groundwater Sampling – Well 01-11-1
