COLORADO DIVISION OF RECLAMATION, MINING AND SAFETY COAL PROGRAM INSPECTION REPORT

Permit Number: C-1983-059 Mine Name: Terror Creek Loadout Operator: Terror Creek LLC Operator Address: Mr James A Kiger P.O. Box 535 3737 Highway 133 Somerset, CO 81434	County: Delta Operation Type: Loadout Permit Status: Active Ownership: Private
	Operator Representative Present: None
Operator Representative Signature: (Field Issuance Only) N/A – Report Issued from Denver Office

Inspection Start Date: August 21, 2013 Inspection Start Time: 18:15 Inspection End Date: August 21, 2013 Inspection End Time: 19:15	Inspection Type: Coal Partial Inspection Inspection Reason: Normal I&E Program Weather: Cloudy
Joint Inspection Agency: None	Joint Inspection Contacts: None
Post Inspection Agency: None	Post Inspection Contacts: None
Inspector(s): James R. Stark	Inspector's Signature:

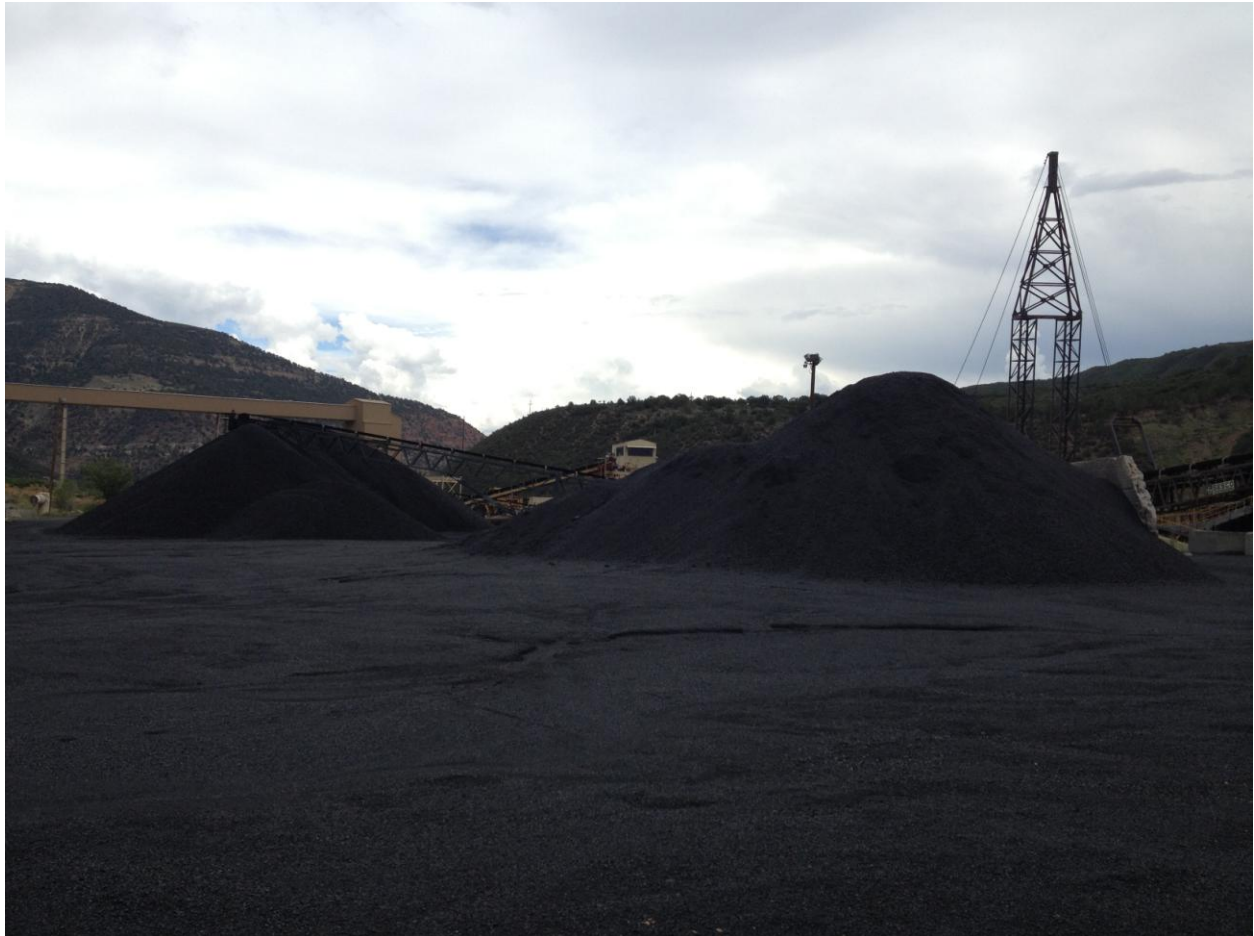
- The Terror Creek Loadout is a loadout only. Operations at the site include processing coal (sizing coal) and loading trains. The site was not operating at the time of the inspection and will only be operational when an order for coal is received. There were sizable stockpiles of lump and stoker coal and coal fines at the time of the inspection. There were no problems noted with the coal processing operations and they are consistent with what is approved in the permit.

Stoker and lump coal stockpiles at the Terror Creek Loadout
