## COLORADO DIVISION OF RECLAMATION, MINING AND SAFETY COAL PROGRAM INSPECTION REPORT

<b>Permit Number:</b> C-1981-028 <b>Mine Name:</b> Keenesburg Strip Mine <b>Operator:</b> Coors Energy Company <b>Operator Address:</b> Mr. Benjamin Moline P.O. Box 4030 Suite 400 Golden, CO 80401	<b>County:</b> Weld <b>Operation Type:</b> Surface <b>Permit Status:</b> Active <b>Ownership:</b> Private
	<b>Operator Representative Present:</b>  Danny Kipp
<b>Operator Representative Signature:</b> (Field Issuance Only)

<b>Inspection Start Date:</b> September 19, 2013 <b>Inspection Start Time:</b> 09:45 <b>Inspection End Date:</b> September 19, 2013 <b>Inspection End Time:</b> 10:45	<b>Inspection Type:</b> Coal Partial Inspection <b>Inspection Reason:</b> Normal I&E Program <b>Weather:</b> Clear
<b>Joint Inspection Agency:</b>  None	<b>Joint Inspection Contacts:</b>
<b>Post Inspection Agency:</b>  None	<b>Post Inspection Contacts:</b>
<b>Inspector(s):</b>  Brock F. Bowles	<b>Inspector's Signature:</b>

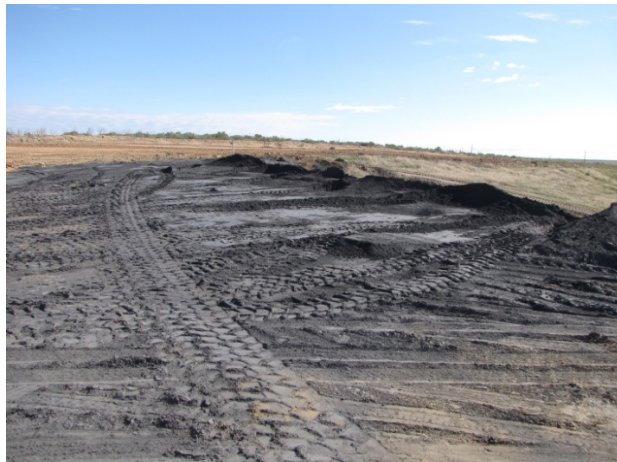
Photo 1 – Coal Ash Backfilled

Coal ash continues to be stacked and buried in B-Pit (photo 1). Coverfill material is finished being stacked on the south end of the active B-pit area (photo 2). The area had some very small rills from the recent rains but overall was in very good condition (photo 3). Top sand soil is scheduled to be placed on the coverfill material next spring. The long-term spoil area has some minor rills from the recent rains but was also in very good condition (photo 4).

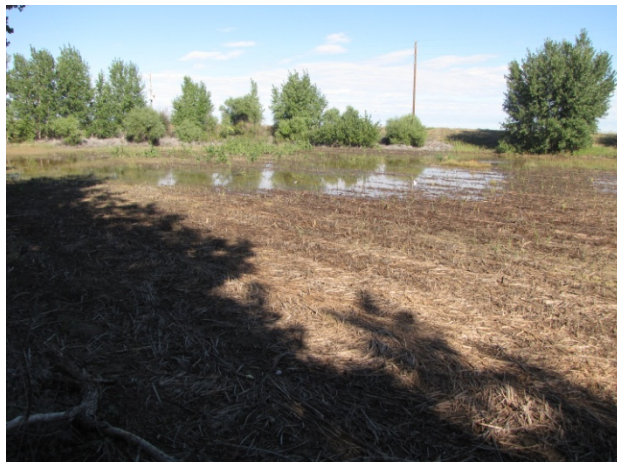
Photo 5 – Sediment Pond 2

The dugout pond had some water in it during the rain last week but was dry during the inspection. Sediment pond 2 had about a foot of water during the rains but only the west end of the pond contained some water during the inspection (photo 5). The road ditch by sediment pond 2 is free of debris and well maintained (photo 6).

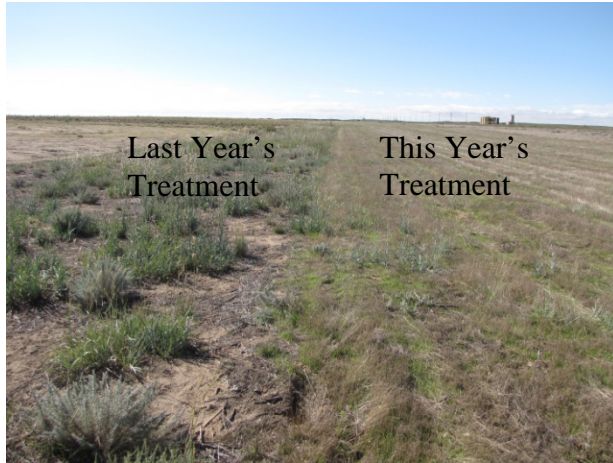
Photo 7 – Cheatgrass Treated with Panoramic

Cheatgrass is starting to germinate in all areas of the mine. The pre-emergent herbicide Panoramic was applied last month to control and buffer the cheatgrass invasion of reclaimed areas. At this time it is unclear the effectiveness of the application. Mr. Kipp speculates the heavy rains received by the mine last week may have diluted the herbicide making it ineffective. Very little cheatgrass is germinating in the areas treated with Panoramic last summer (photo 7).
