**COLORADO DIVISION OF RECLAMATION, MINING AND SAFETY  
COAL PROGRAM INSPECTION REPORT**

<b>Permit Number:</b> C-1982-056 <b>Mine Name:</b> Foidel Creek Mine <b>Operator:</b> Twentymile Coal, LLC <b>Operator Address:</b> Mr Jerry Nettleton 29515 Routt County Road No. 27 Oak Creek, CO 80467	<b>County:</b> Routt <b>Operation Type:</b> Underground <b>Permit Status:</b> Active <b>Ownership:</b> Federal
	<b>Operator Representative Present:</b>  Brian Watterson
<b>Operator Representative Signature: (Field Issuance Only)</b>

<b>Inspection Start Date:</b> September 18, 2013 <b>Inspection Start Time:</b> 13:00 <b>Inspection End Date:</b> September 18, 2013 <b>Inspection End Time:</b> 16:00		<b>Inspection Type:</b> Coal Partial Inspection <b>Inspection Reason:</b> Normal I&E Program <b>Weather:</b> Cloudy	
<b>Joint Inspection Agency:</b>  None		<b>Joint Inspection Contacts:</b>	
<b>Post Inspection Agency:</b>  None		<b>Post Inspection Contacts:</b>	
<b>Inspector(s):</b>  Jason D. Musick	<b>Inspector's Signature:</b>

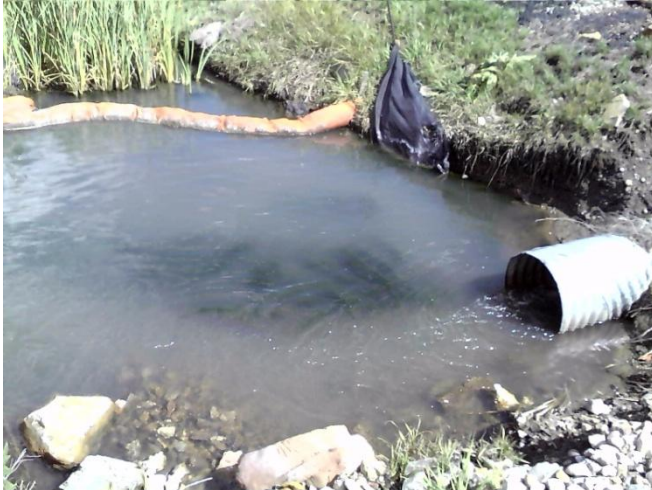
Pond D Outlet

Pond D was holding water and discharging at ~.39 through the 1' flume. The discharged water appeared cloudy at the time of the inspection. The primary and emergency spillways were stable with the primary outlet functioning as designed. The sediment delta at the inlet from the area of the RDA has been cleared. The embankments were stable and well vegetated and no problems were noted, with the exception of the following:

- The silt fence between the conveyor and the Pond D discharge is damaged. Re-establishment of the silt fence will be required to ensure the function of the fence.
- Heavy erosion from the Haul Road between the Pit and Pond D into Pond D was observed. This area will require maintenance.

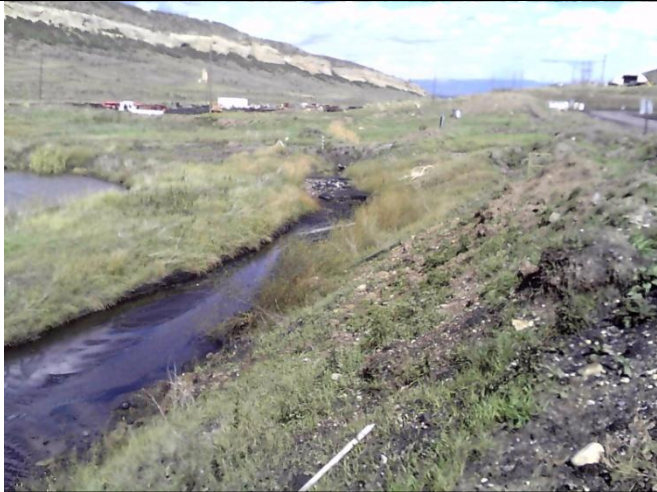
Pond E Inlet

Pond E was holding water with clear discharge at the time of the inspection. The large sediment delta observed during the August 2013 inspection has been addressed. A small amount of sediment remains along the banks of the eastern cell and around the inlet. The inlet culvert is functioning, but is damaged at the outlet going into the pond. The embankments were stable and well vegetated at the time of the inspection. The primary outlet and emergency spillway were stable with no problems noted.

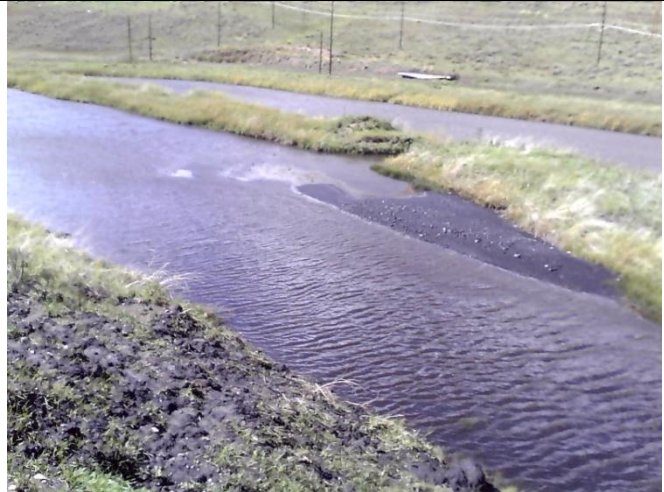
Pond E remaining sediment

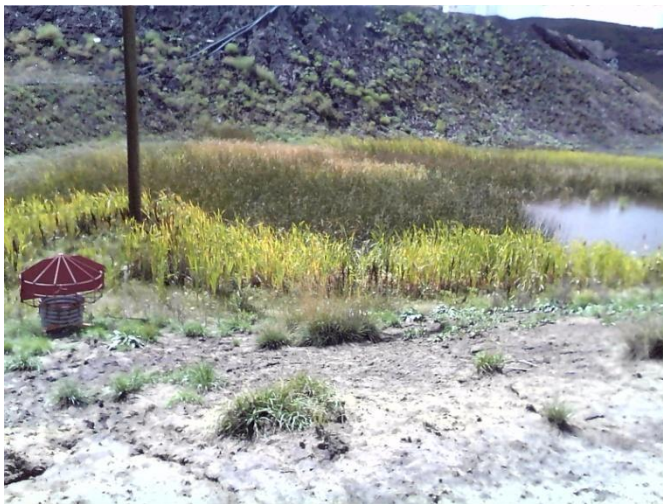
Pond C was holding a small pool of water with no discharge. Embankments were stable and well vegetated. The primary and emergency spillways were stable with no problems noted. No issues were identified with Pond C and the surrounding area with the exception of the following:

- The truck load out pad outslope above Pond C has developed a large slump. The identified slump is above Pond C and wasn't currently at risk to generate off-site impacts. The stability of the pad will need to be assessed and

repaired as needed.

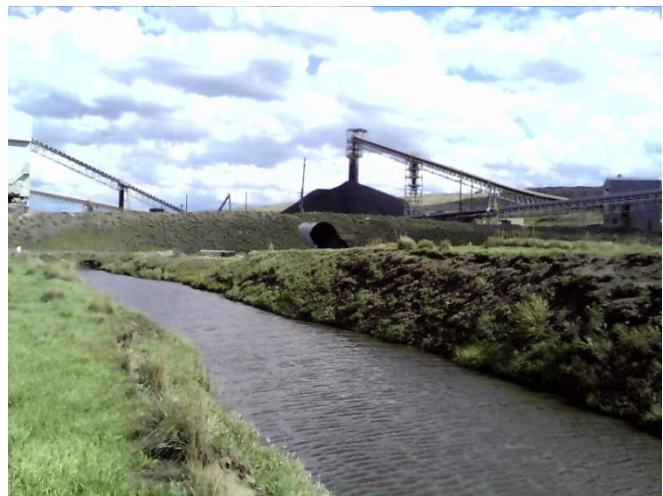
Pond B was holding water with a slight discharge through the 6" flume. The embankments were stable and well vegetated at the time of the inspection. The southeast sediment basin was recently cleaned out. No issues were identified with Pond B or the surrounding area, with the exception of the following:

- The access road to Pond B displayed heavy erosion due to recent precipitation events. No evidence of run-off to Foidel Creek was noted as the run-off was flowing into the Northwest sediment basin. However, this road will require maintenance.
- The ditch east of the railway requires maintenance to remove excess sediment and flow to Pond B.
- The lower end of the ditch and associated rock check dams west of the BOB Pile has failed. The coal fines were contained in the area by the Southeast sediment basin and the ditch along the railway; however this area will require maintenance to clear coal fines that have built up and to re-establish the ditch.

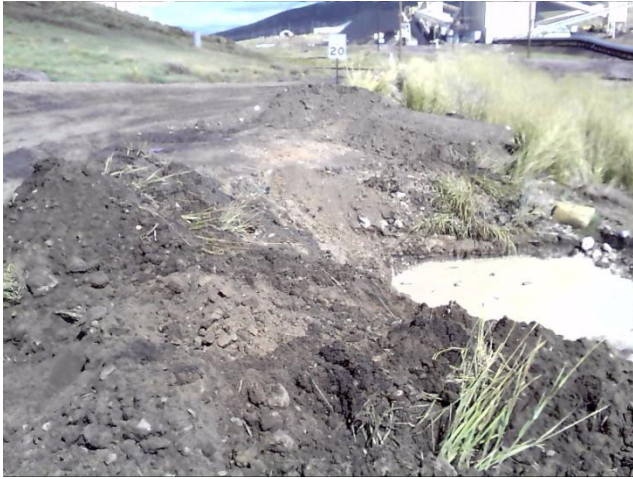
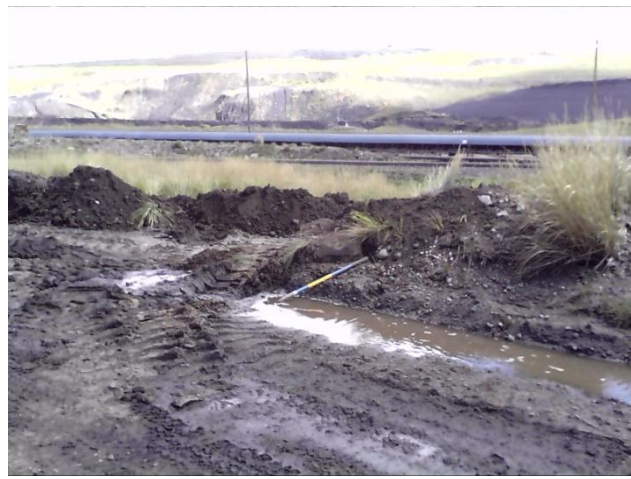
Culvert Cleanout

Maintenance work was being conducted along Haul Road C and the Brown Palace access road to clear the roadside runoff culvert and small sediment sump. The work generated heavy disturbance along the road side. The

Division understands the there is a buffer from the approved disturbance and actual disturbance associated with the roads.

- Ongoing maintenance issues should be monitored to ensure that additional or unapproved disturbance is not conducted.
