**COLORADO DIVISION OF RECLAMATION, MINING AND SAFETY  
COAL PROGRAM INSPECTION REPORT**

| <b>Permit Number:</b> C-2010-089<br><b>Mine Name:</b> New Horizon North Mine<br><b>Operator:</b> Western Fuels-Colorado, LLC<br><b>Operator Address:</b><br>Mr David G Anderson<br>12050 N. Pecos St., Suite 100<br>Westminster, CO 80234 | <b>County:</b> Montrose<br><b>Operation Type:</b> Surface<br><b>Permit Status:</b> Active<br><b>Ownership:</b> Private |

| <b>Inspection Start Date:</b> September 16, 2013<br><b>Inspection Start Time:</b> 13:00<br><b>Inspection End Date:</b> September 16, 2013<br><b>Inspection End Time:</b> 17:00 | | <b>Inspection Type:</b> Coal Complete Inspection<br><b>Inspection Reason:</b> Normal I&E Program<br><b>Weather:</b> Clear | |

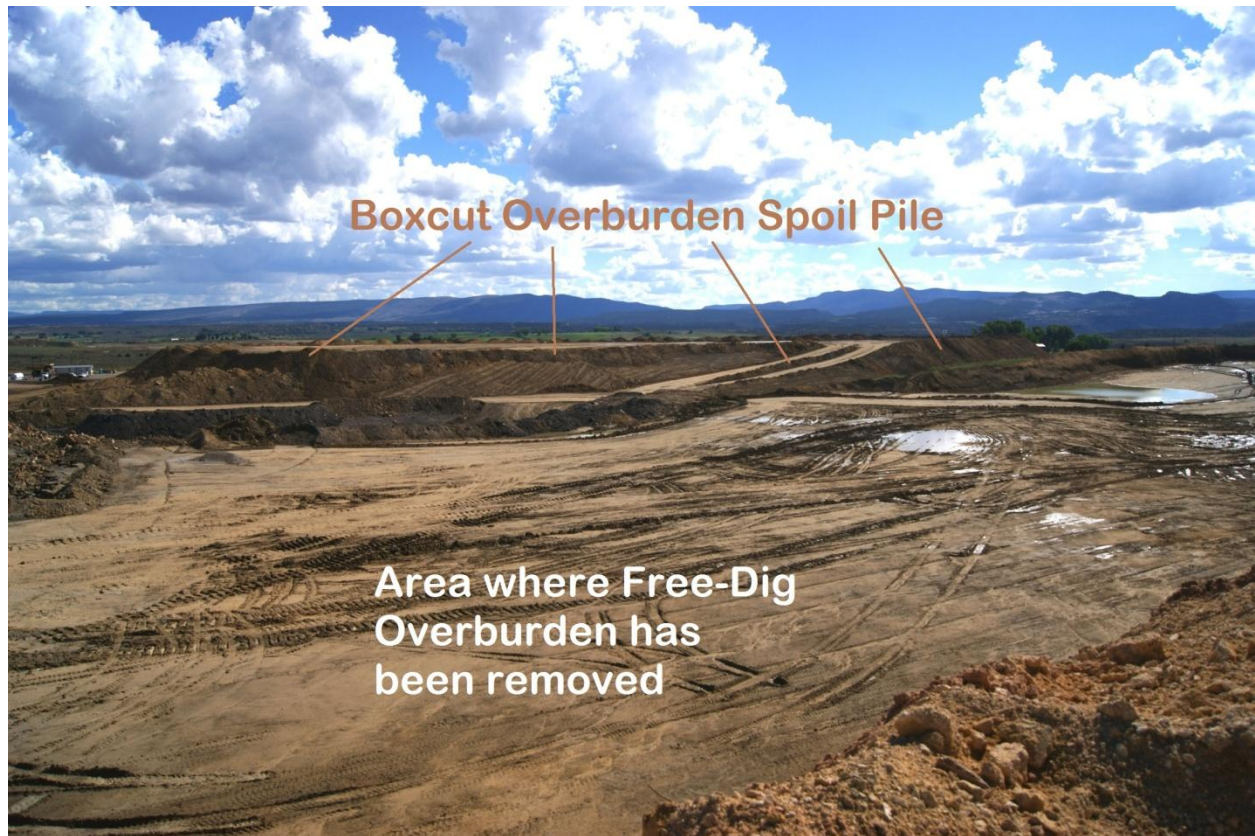
- The Boxcut Overburden Stockpile is growing in size (Photo 1). The footprint of the pile has been established, and Bench 1 “Free-Dig” material has been used to construct the lower level of the pile. Mr. Gubka said that Bench 2 overburden, which is blasted, will form the upper part of the pile.
- Material is hauled to and placed on the pile using the mine's fleet of haul trucks. The trucks are loaded by the mine's shovel.

Photo 1 – Looking SW at the overburden stockpile

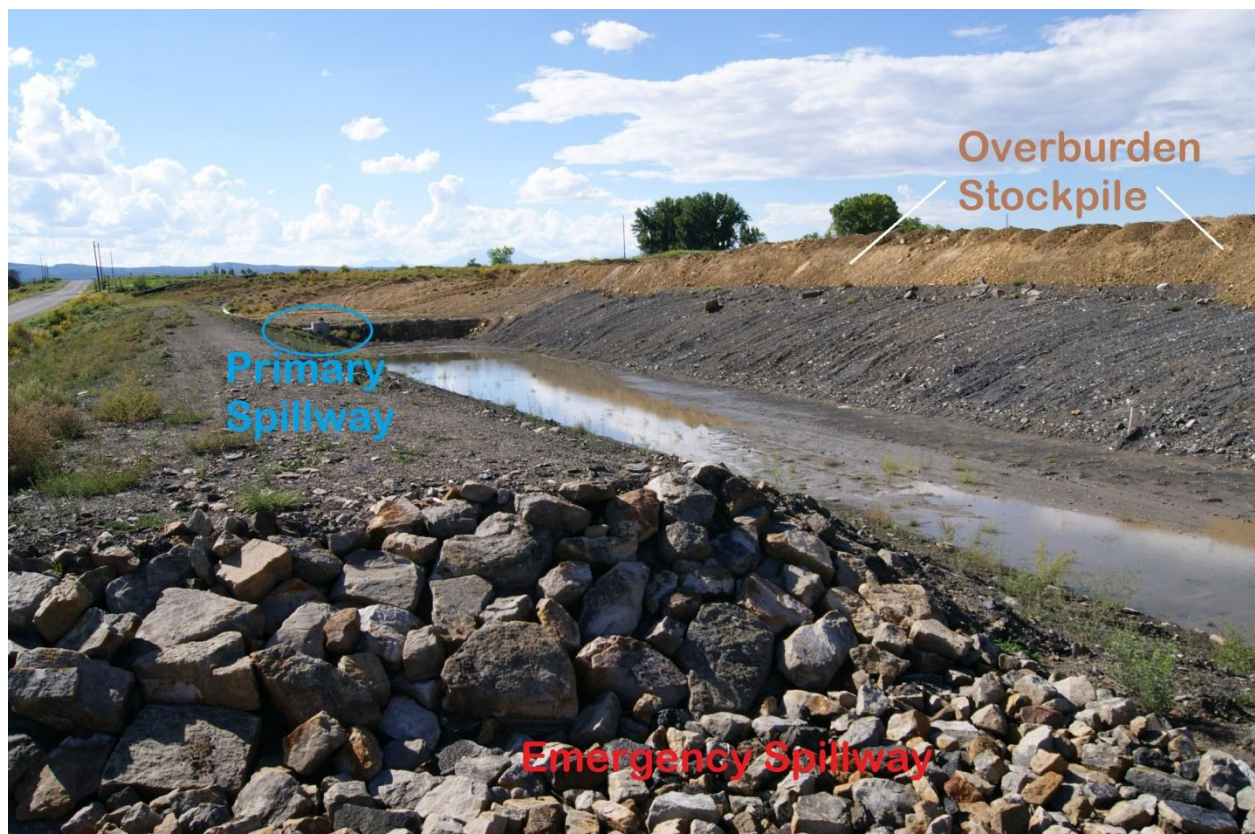
Photo 2 – Pond NHN-001, looking west

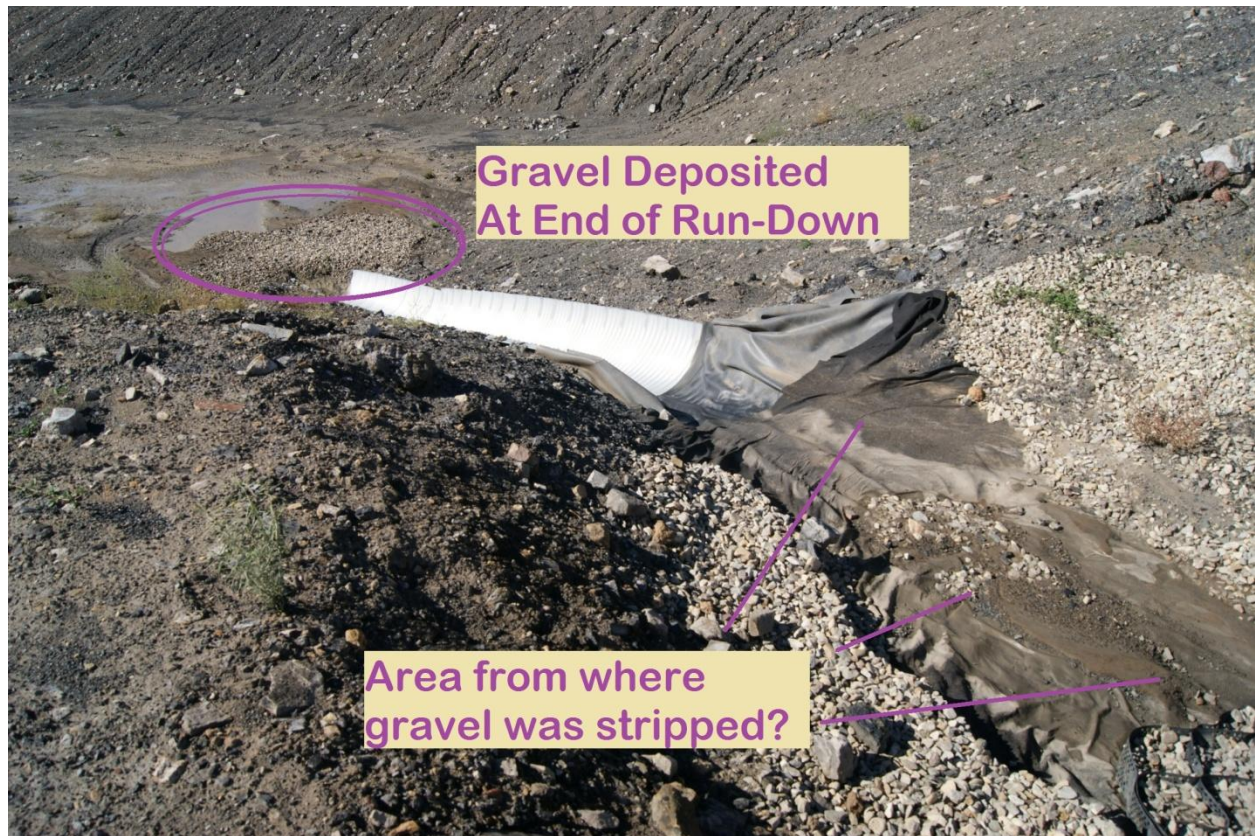
- Much of the bottom of Pond NHN-001 was covered with water (Photo 2). No discharge occurred, as the level was well below the weep holes.
- At the southeast corner of Pond NHN-001, gravel had been deposited at the bottom of the half-culvert rundown (Photo 3). It appeared that the gravel may have been washed away from the section immediately above the culvert, where the cellular lining product had not been installed.

Photo 3 – SE corner of Pond NHN-001

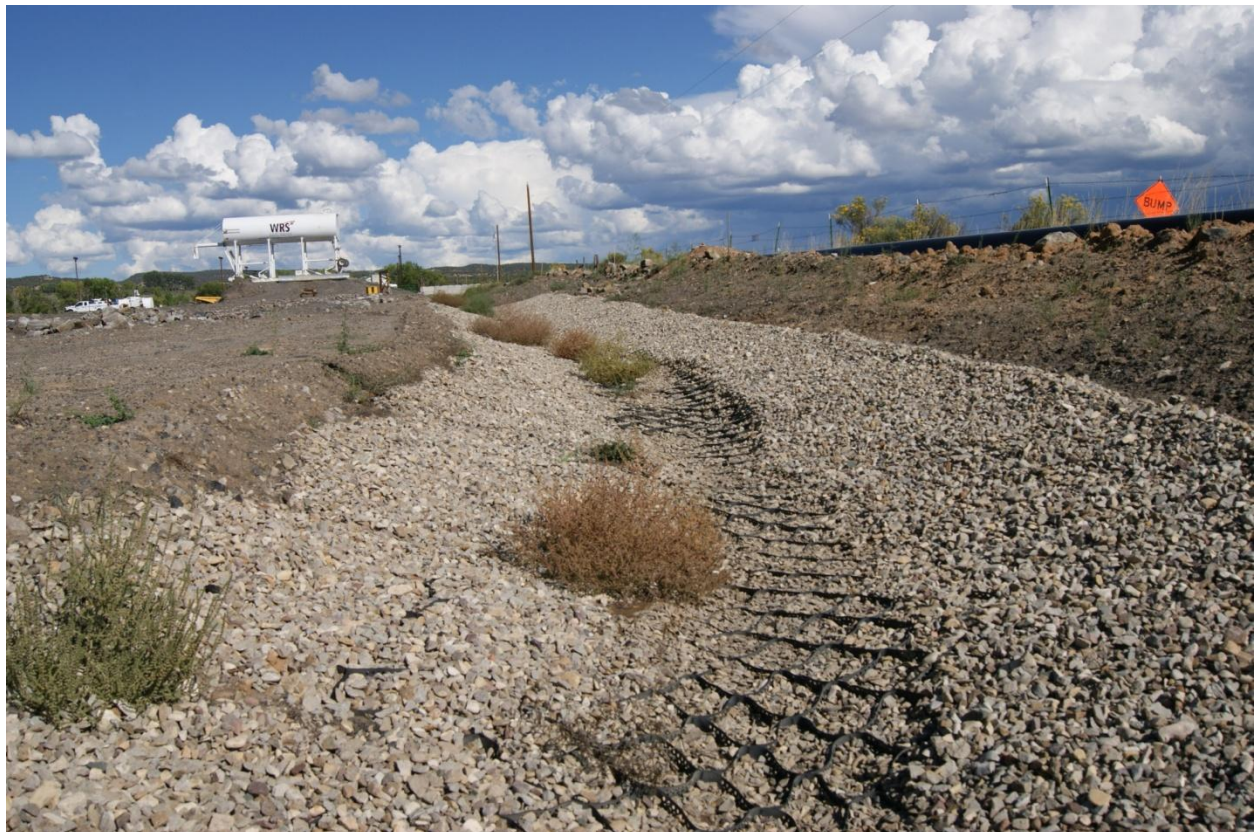
- Overall, the lined ditches appear to have performed adequately in the recent storm events (Photo 4).

Photo 4 – Lined portion of Ditch NHN-001 East, west of mine entrance

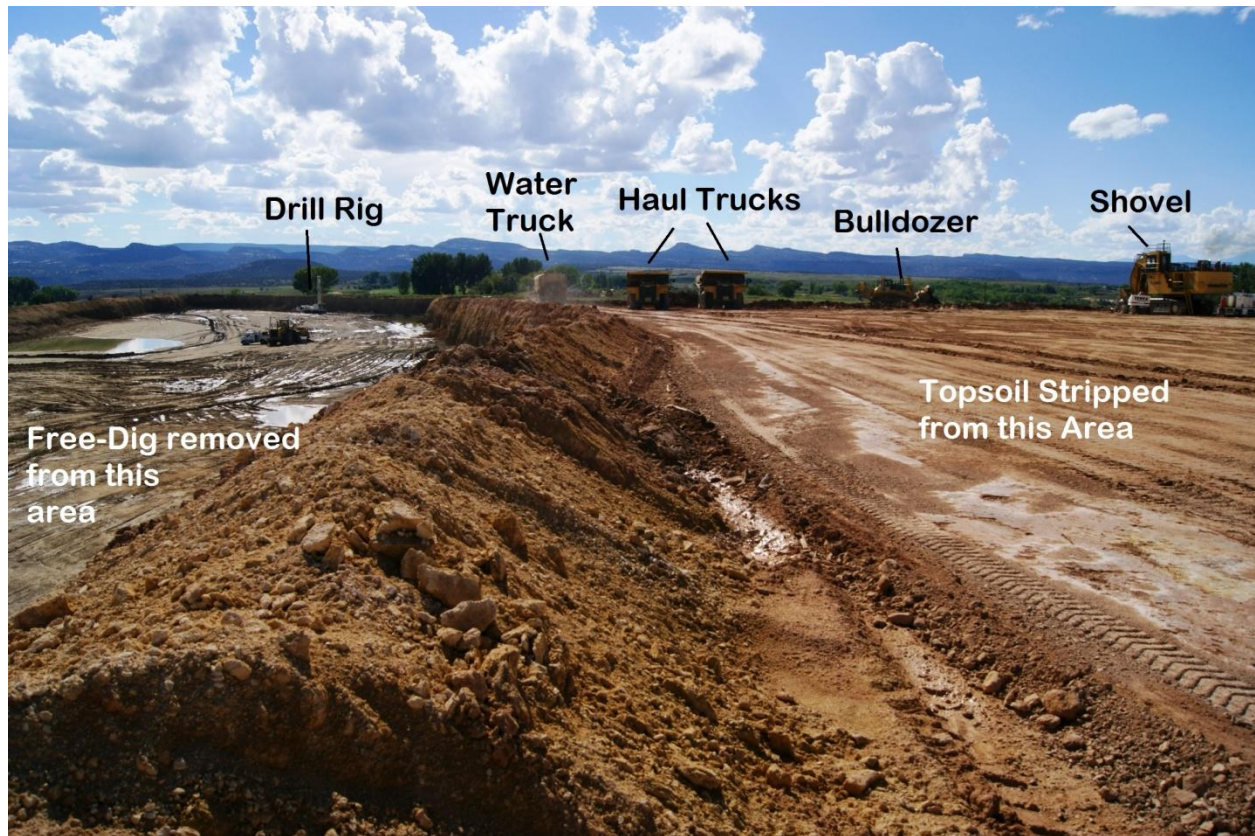
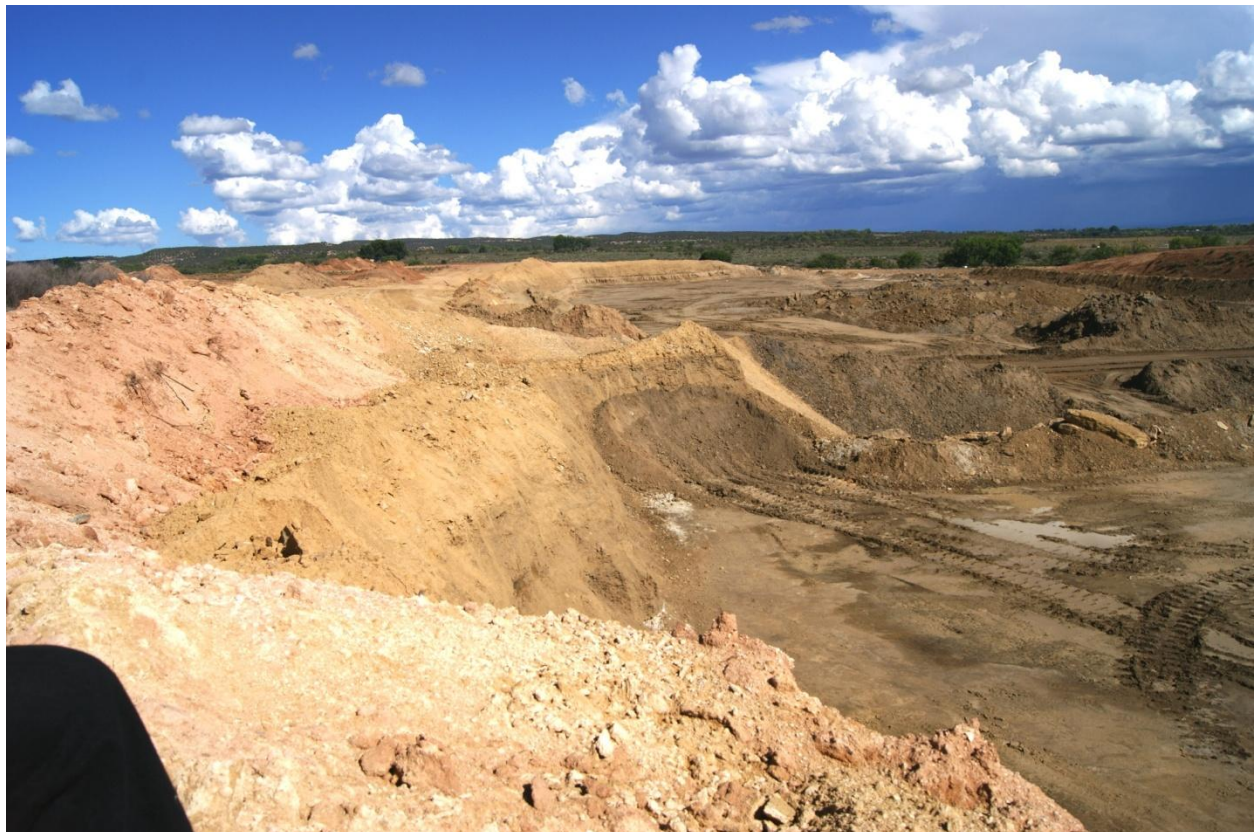
- Operations are presently somewhat modified from the east-west orientation of the cuts depicted on Map 2.05.2-1. Rick Wolney, the mine manager, explained that because of limitations imposed by the mine's emissions permit issued by the APCD, (amount of topsoil and overburden that can be handled and stockpiled), they have had to modify their operations to some degree.
- The overall sequence of topsoil removal, followed by free-dig overburden removal, and blasting to expose the coal, has not changed (Photos 5 and 6).

Photo 5 – Active operations area, looking west

Photo 6 – Highwall, looking east

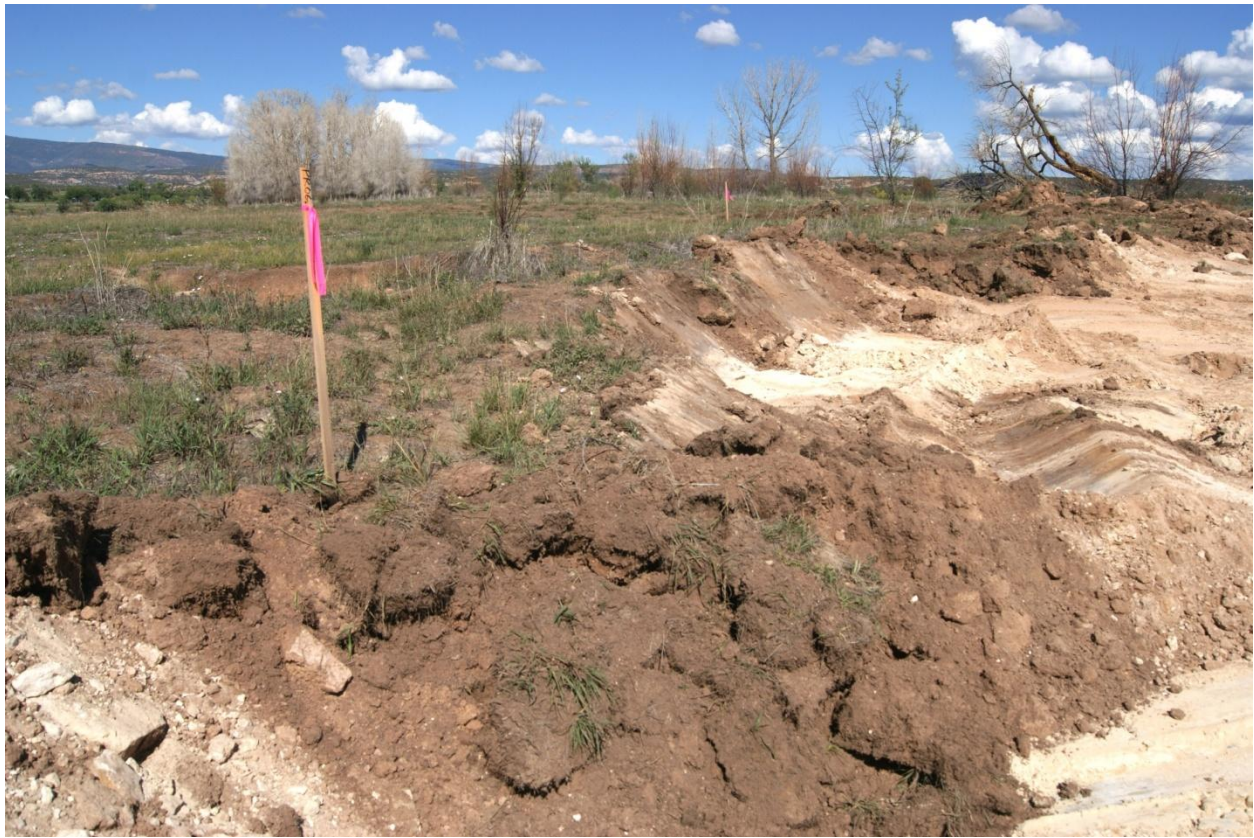
- The operator was salvaging additional Progresso (81 PRO) soil at the time of the inspection. Stakes identifying the lateral limits of the soil unit (Photo 7) had been placed in the ground, using GPS coordinates, based on the limits identified during the soil survey and shown on Permit Maps 2.04.9-2 and 2.04.9-3.
- Progresso soils continue to be stored in the designated stockpile (north), while the REC and other soils are added to the southern topsoil stockpile (Photo 8).

Photo 7 – Progresso soil unit delineated by flags

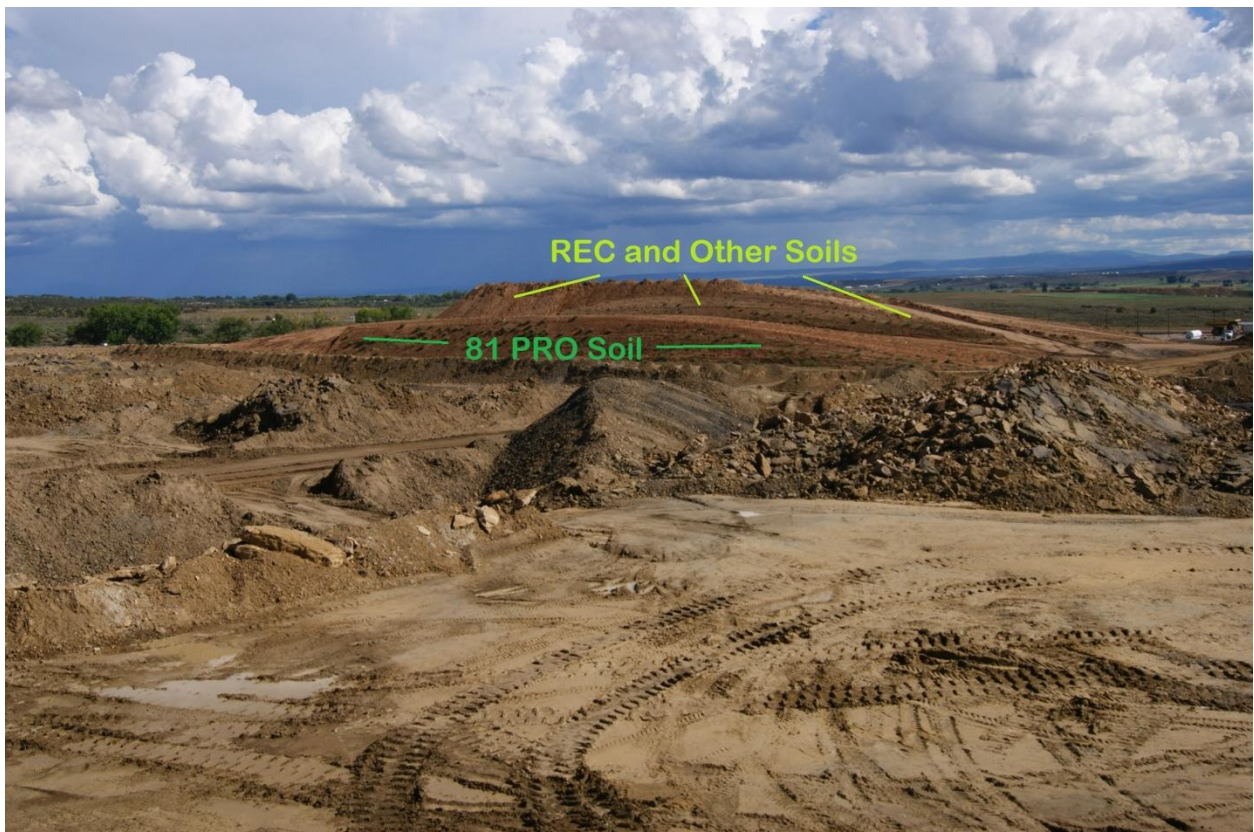
Photo 8 – Topsoil stockpiles, looking SE
