**COLORADO DIVISION OF RECLAMATION, MINING AND SAFETY
COAL PROGRAM INSPECTION REPORT**

Permit Number: C-1981-041 Mine Name: Roadside Portals Operator: Snowcap Coal Company, Inc Operator Address: Ms. Tonya Hammond P.O. Box 1430 Palisade, CO 81526	County: Mesa Operation Type: Underground Permit Status: Permanent Cessation Ownership: Federal
	Operator Representative Present: Tonya Hammond
Operator Representative Signature: (Field Issuance Only)

Inspection Start Date: September 18, 2013 Inspection Start Time: 13:00 Inspection End Date: September 18, 2013 Inspection End Time: 16:15	Inspection Type: Coal Complete Inspection Inspection Reason: Normal I&E Program Weather: Cloudy
Joint Inspection Agency: None	Joint Inspection Contacts:
Post Inspection Agency: None	Post Inspection Contacts:
Inspector(s): Michael P. Boulay	Inspector's Signature: <i>Michael P. Boulay</i>
	Signature Date: September 25, 2013

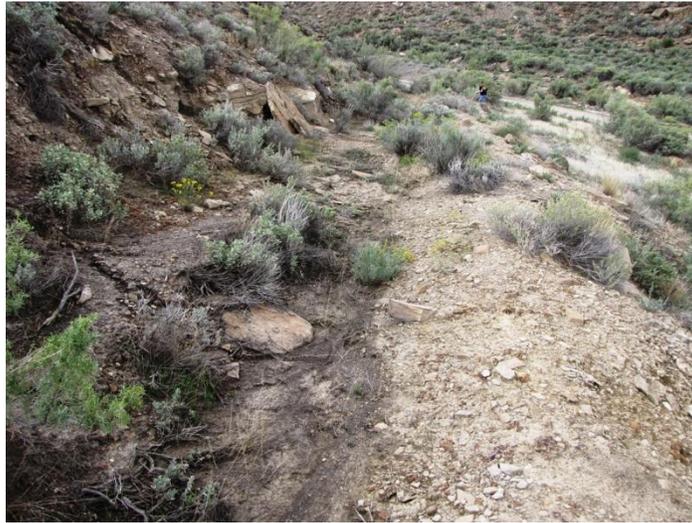
Bullet items 1 and 3 of the letter talked about repair of berms, fence lines and “pulling up” a hillside along the old fence line. These areas are the “Upper Diversion Ditches” at the North Decline which have been approved as permanent features and are not to be reclaimed. I informed Rudy that he had agreed to this back in 2011, and showed him a copy of the “Land Owner Consent” form he had signed agreeing to allow this ditch to remain as a permanent feature. Rudy had also requested that the fence and a gate be removed at this location which was recently completed by SCC. Attached Photograph No. 1 shows the East Diversion Ditch No. 1 that is the site of Rudy’s concern and this is to remain as a post-mine feature. The permanent ditch remains stable and functional and therefore, no action is required by SCC on these two issues.

Photo No. 1 - Permanent post-mine feature, East Diversion Ditch No. 1

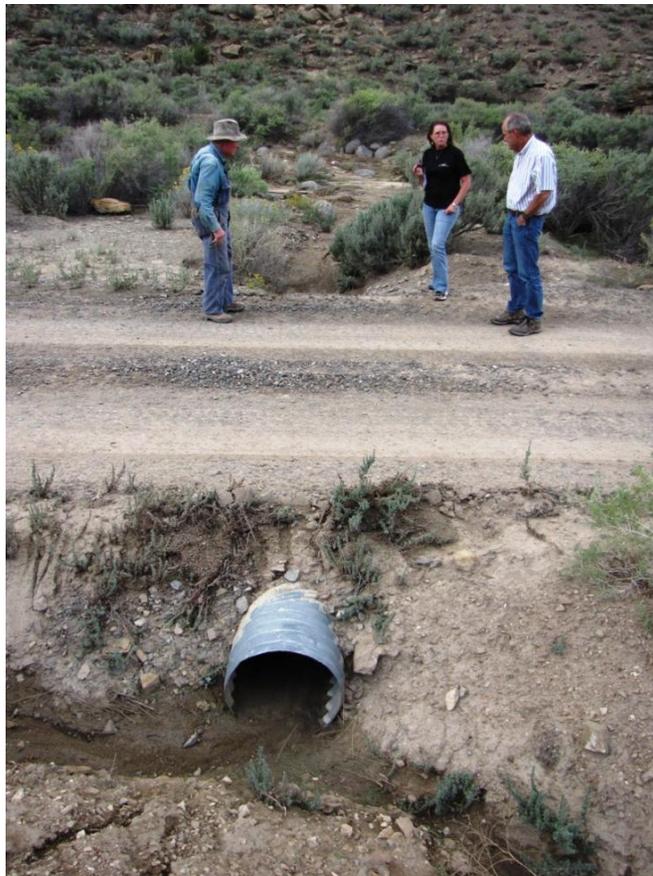
Bullet item 2 talks about installing a culvert under the existing road. There were actually two culvert issues that Mr. Fontanari wanted to talk about. The upper portion of the road at the North Decline has an existing culvert which Rudy says continually gets filled in and causes too much maintenance (see Photograph No. 2). He requested that SCC pull the culvert and install allow water crossing with a 3’ concrete bottom. We discussed alternatives for cleaning or replacing the culvert. I informed Rudy that the DRMS does not typically approve concrete to be permitted in final drainage designs, especially if there are other alternatives. This specific culvert does have a tendency to fill in and one option we considered was to raise the road where the culvert sits about a foot and reset the culvert so the outlet of the culvert is above the drainage bottom that has risen in the last several years due to sediment build up. For the time being SCC is required to clean the culvert out and is making arrangements to have this work completed. Mr. Fontanari indicated that he would like a culvert installed in the lower portion of the North Decline road. We inspected the area and found a CDOT culvert already existed. The

Photo No. 2 - Existing culvert at North Decline road requiring maintenance.

area in question is outside of the permit boundary and on CDOT property. SCC agreed to establish the road ditch better so it flows into the inlet of the culvert.

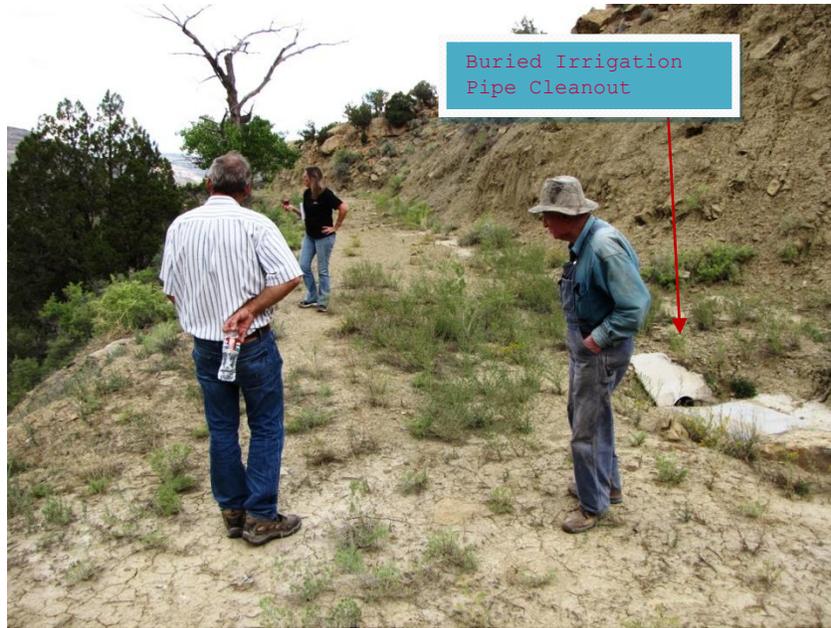
When we finished at the North Decline, Mr. Fontanari stated that he had three additional concerns on the south side of his property. We followed Rudy to a location which is now outside of the current permit area on some of his adjacent surface properties. Rudy took us to an area where he has a pipeline that runs irrigation water from Rapid Creek to his riprap gravel pit (Permit No. M-1996-076). The location of the upper irrigation pipe is shown in Photograph No. 3. Rudy indicated that he believes subsidence from the old mine works is causing his pipeline to sag, interrupting the flow and causing his "clean out areas" to fill in with sediment. He also pointed out an area on a cutslope that he believes shows some evidence of subsidence. Jim Stover and I inspected the area and did not see any evidence of subsidence in the vicinity of the buried water pipeline. The feature Rudy pointed out on the cutslope appears to be a small rockfall from the steep face of the slope (see Photograph No. 4). I did note two small cracks at the surface in the location of the buried pipeline (Photograph No. 5). It is unclear if this is related to subsidence or from slumping of the backfill material used to bury the pipeline. Rudy also commented about a lower irrigation ditch that conveys flow from Rapid Creek to what SCC refers to as the "Carey" Pond in reference to the property owner's name. This is an open irrigation ditch that he says has slumped in one area and now water backs up and overtops a culvert on one of the county roads (see Photograph No. 6). We inspected the ditch and road crossing. Based on my observations I did not see any immediate evidence that subsidence is the cause of his irrigation problems. At the lower irrigation ditch the culvert at the road crossing is silted in almost entirely on the discharge end of the culvert pipe (Photograph No. 7). Both of these areas (upper and lower irrigation ditches) were released from bond in 2007 with SL-3 and are no longer within the permit boundary.

Photo No. 3 - Location of upper irrigation pipe.

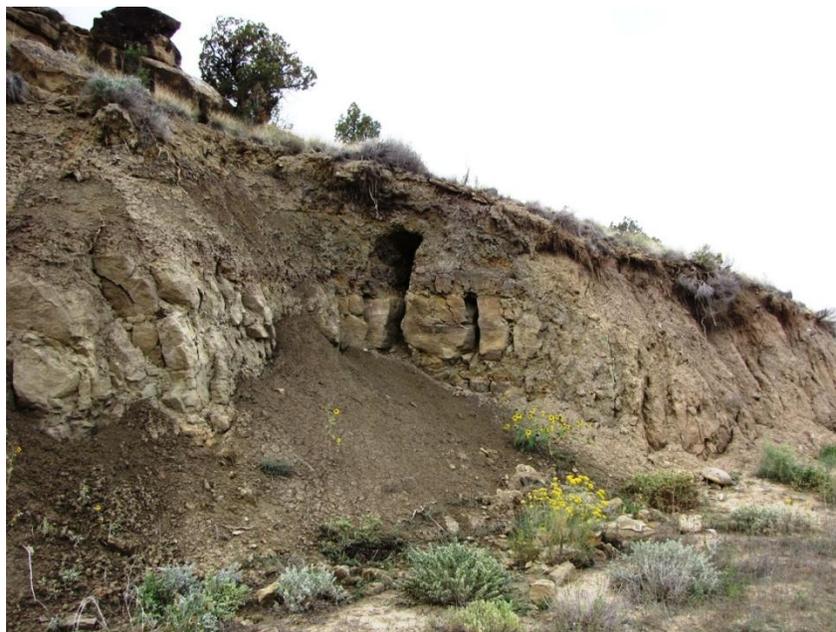
Photo No. 4 - Rockfall on cut slope above irrigation pipe location.

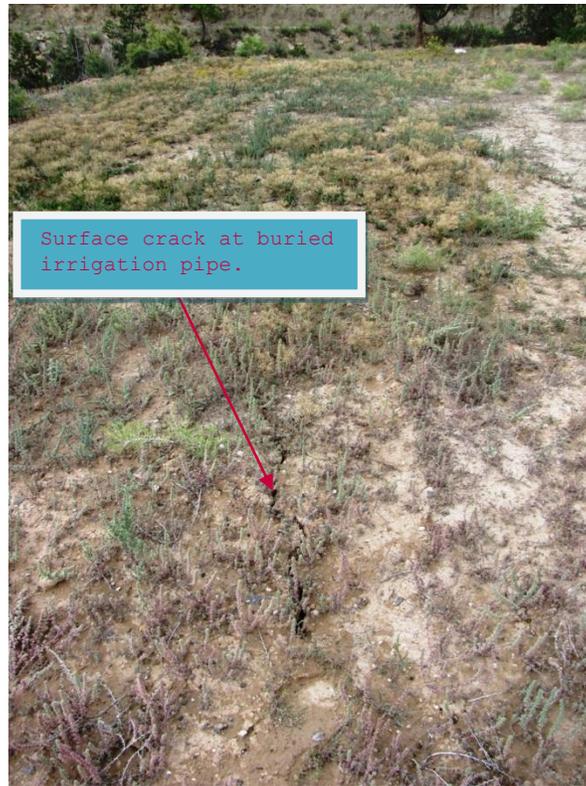
Photo No. 5 – Surface crack at location of buried irrigation pipe.

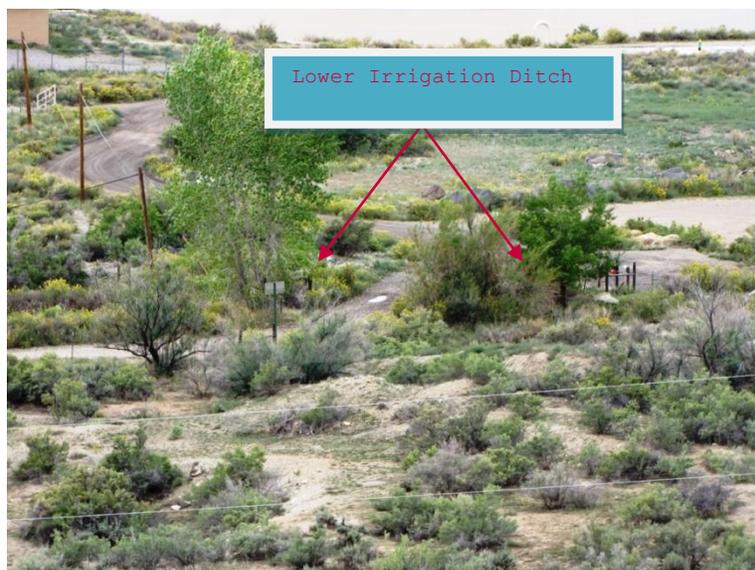
Photo No. 6 – Lower irrigation ditch located outside of current permit area.

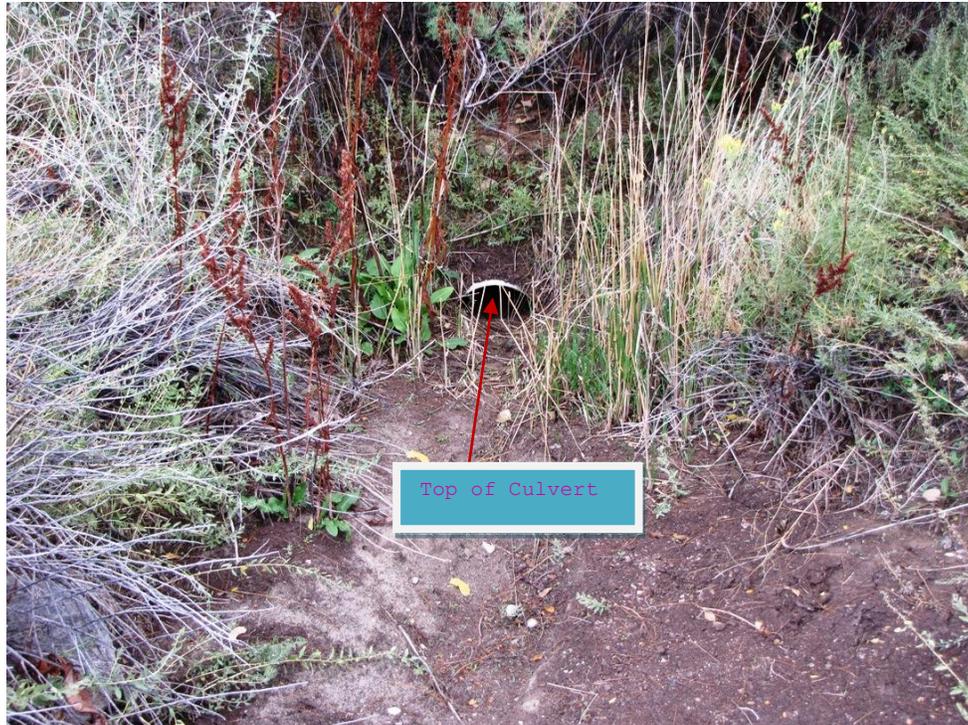
Photo No. 7 - Lower irrigation ditch culvert silted in.

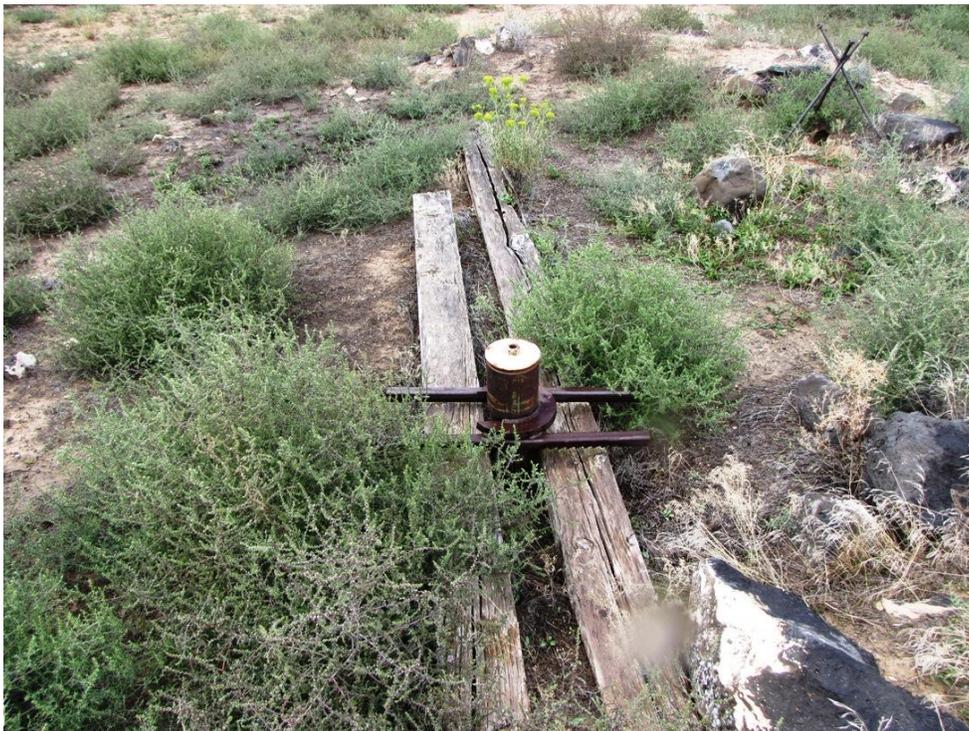
The inspection then proceeded further west to the corner of Rudy's property where it abuts with the Carey property to the west and Reams and Erickson property to the south. Rudy has discovered two old drill holes above the South Portal properties. This is the first time that he has told SCC or the DRMS about these and they do not show on any of the permit maps. One is on land owned by Rudy and is still inside the SCC permit boundary. The other is on property owned by Reams Land Trust on land that was released from bond in 2007 with SL-3. Photos of each of these existing boreholes are attached. Photograph No. 8 is the cased well located on the Fontanari property and Photograph No. 9 is an open borehole located on the Reams property. It presents a safety hazard as it covered only by an old rusty bucket. The holes should be about 100 feet deep since that is the approximate overburden depth. It is possible that these borings were exploration holes drilled Pre-Law. Even if we have no records of these, they are above old mine works and they need to be plugged and abandoned. I have subsequently met with SCC and Jim Stover to discuss plans for properly abandoning these borings. Photograph No. 10 is taken from a vantage point on the Reams property near the permit boundary looking east to the Erickson property which is located within the permit area. Mr. Fontanari indicated that subsidence effects are notable from this viewpoint.

Photo No. 8 - Cased drillhole on Fontanari property.

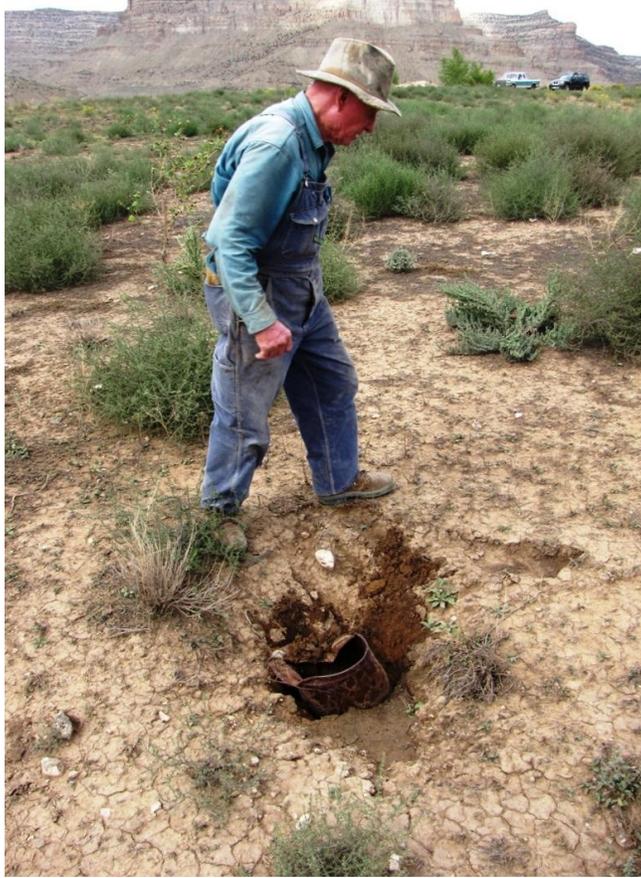
Photo No. 9 - Borehole on Reams property.

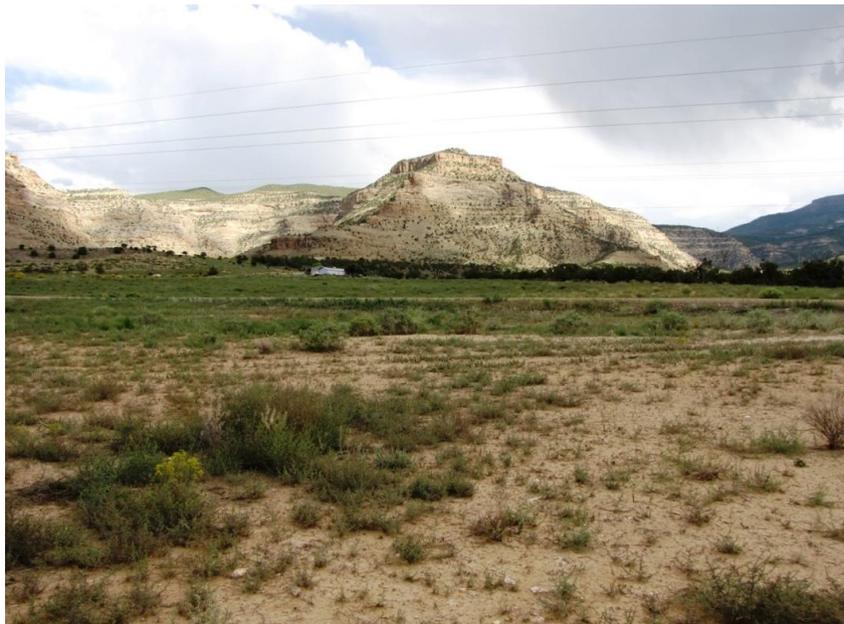
Photo No. 10 - Vantage point from Reams property looking east to Erickson property.
