# COLORADO DIVISION OF RECLAMATION, MINING AND SAFETY COAL PROGRAM INSPECTION REPORT

<b>Permit Number:</b> C-1981-037 <b>Mine Name:</b> GEC Strip Mine <b>Operator:</b> GEC Minerals, Inc. <b>Operator Address:</b> Dr W Corley 2605 Constellation Drive Colorado Springs, CO 80906	<b>County:</b> Fremont <b>Operation Type:</b> Surface <b>Permit Status:</b> Revoked <b>Ownership:</b> Private
	<b>Operator Representative Present:</b>  NA
<b>Operator Representative Signature:</b> (Field Issuance Only)

<b>Inspection Start Date:</b> September 17, 2013 <b>Inspection Start Time:</b> 15:30 <b>Inspection End Date:</b> September 17, 2013 <b>Inspection End Time:</b> 17:00	<b>Inspection Type:</b> Coal Complete Inspection <b>Inspection Reason:</b> Normal I&E Program <b>Weather:</b> Clear
<b>Joint Inspection Agency:</b>  None	<b>Joint Inspection Contacts:</b>
<b>Post Inspection Agency:</b>  None	<b>Post Inspection Contacts:</b>
<b>Inspector(s):</b>  Janet H. Binns  Robert D. Zuber, P.E.	<b>Inspector's Signature:</b>

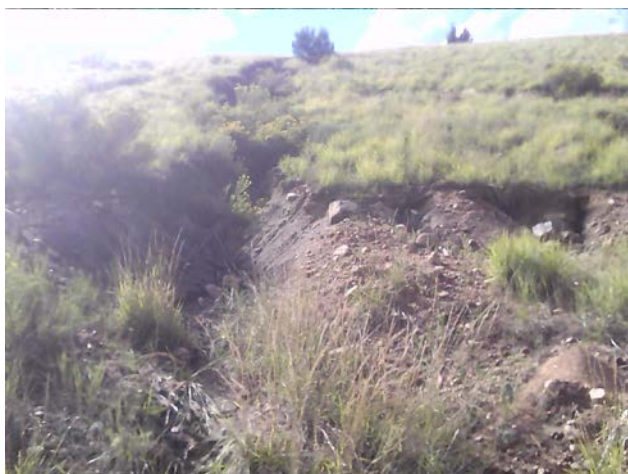
Side slopes of the reclaimed East Pit, West Pit, and Chen's Hill continue to exhibit signs of sediment movement. Sediment no longer is deposited in the remaining sediment pond adjacent to Fremont County Road No. 92, but is deposited in the ditch and on the east side of the county road. No apparent new gullies were noted, but existing large gullies show signs of additional sediment movement after the recent storms.

Photo 5: Gully at bottom of East pit slope
