**COLORADO DIVISION OF RECLAMATION, MINING AND SAFETY
COAL PROGRAM INSPECTION REPORT**

Permit Number: C-1980-004 Mine Name: McClane Canyon Mine Operator: McClane Canyon Mining, LLC Operator Address: Mr. Corey Heaps P.O. Box 98 Loma, CO 81524	County: Garfield Operation Type: Underground Permit Status: Temporary Cessation Ownership: Federal
Operator Representative Present: Jim Riddle	
Operator Representative Signature: (Field Issuance Only)

Inspection Start Date: September 20, 2013 Inspection Start Time: 10:45 Inspection End Date: September 20, 2013 Inspection End Time: 12:00	Inspection Type: Coal Complete Inspection Inspection Reason: Normal I&E Program Weather: Clear
Joint Inspection Agency: None	Joint Inspection Contacts:
Post Inspection Agency: None	Post Inspection Contacts:
Inspector(s): Michael P. Boulay	Inspector's Signature: <i>Michael P. Boulay</i> Signature Date: 9/25/13

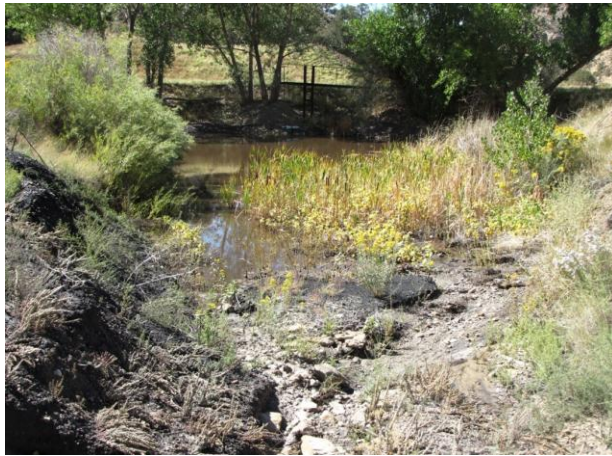
All other drainage structures and diversion culverts in the portal area were clear of debris and functional. The catchment basins for the large diversions at the upper end of the portals area were all dry and well maintained. The mine was not discharging water during the inspection. The mine discharge point to a diversion culvert is located on the north side of the portals area. The sediment pond was containing muddy water at a level of about 2-3 feet below the spillway. The silt fences located on the northeast side of the access road bridge and at the entrance to

Sediment Pond

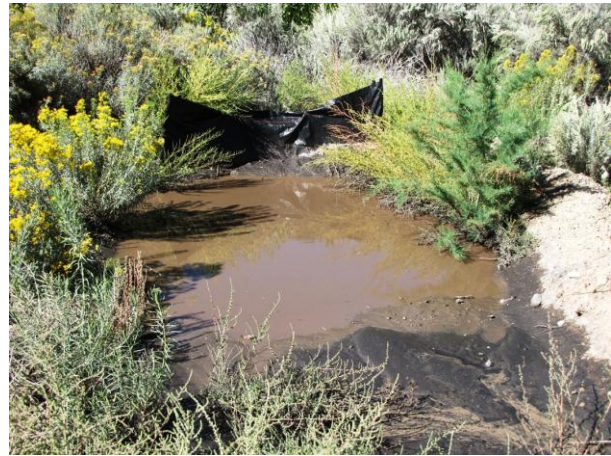
the road accessing the subsoil and topsoil pile locations were properly keyed in and appeared functional. The silt fence at the road bridge was still retaining a significant amount of water. Site sediment control features were in good working order throughout the site. Photographs of these sediment control features are attached.

Silt Fence at Road Bridge Crossing

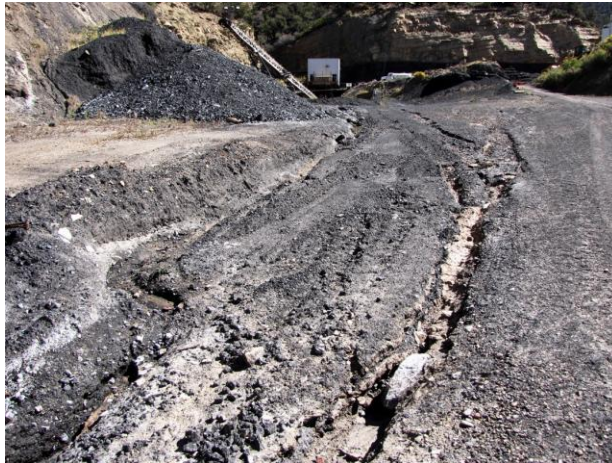
Some minor damage to the upper portion of the haul road adjacent to the coal stockpile occurred as a result of stormwater runoff. Some minor rills have formed that will need to be graded and repaired prior to the next inspection. Otherwise roads were generally well maintained and in good condition throughout the site. Ditches along the haul received significant flow and water was still retained by the larger sediment trap installed along the south side of the haul road. Culverts were clear of sediment and debris and functioning properly.

Rill Formation on Upper Portion of Haul Road

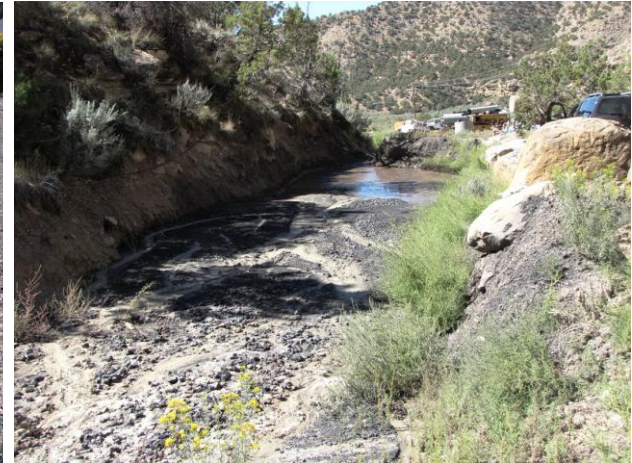
Sediment Trap on South Side of Haul Road
