**COLORADO DIVISION OF RECLAMATION, MINING AND SAFETY
COAL PROGRAM INSPECTION REPORT**

Permit Number: C-1981-014 Mine Name: Southfield Mine Operator: Energy Fuels Coal, Inc. Operator Address: Mr George Patterson P.O. Box 459 Florence, CO 81226	County: Fremont Operation Type: Underground Permit Status: Permanent Cessation Ownership: Private Operator Representative Present: Kent Crofts
Operator Representative Signature: (Field Issuance Only)

Inspection Start Date: September 17, 2013 Inspection Start Time: 11:00 Inspection End Date: September 17, 2013 Inspection End Time: 15:30		Inspection Type: Coal Partial Inspection Inspection Reason: Normal I&E Program Weather: Clear	
Joint Inspection Agency: None		Joint Inspection Contacts:	
Post Inspection Agency: None		Post Inspection Contacts:	
Inspector(s): Janet H. Binns Robert D. Zuber, P.E.		Inspector's Signature:

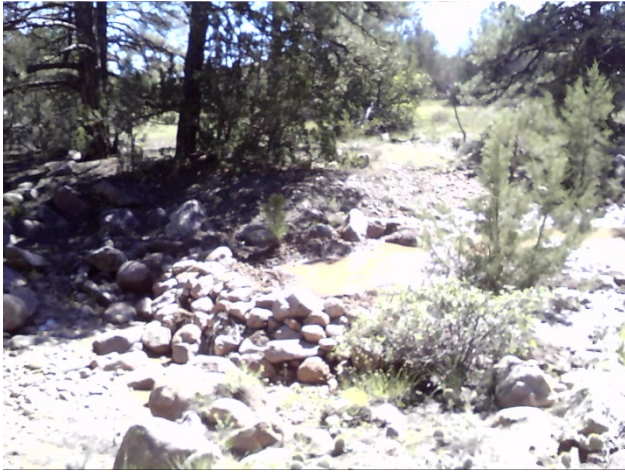
The vegetation consultant, Kent Crofts, was on the Southfield mine site conducting vegetation sampling. Mr. Crofts had informed the Division, via a telephone conversation on 9/16/2013, that he had observed significant water flow in a drainage, that crosses Fremont County Road No. 15 northeast of the permit area, on 9/14/2013. At the time of the inspection there was insignificant flow at the Thompson driveway culvert. The inspectors walked downstream along the Newlin Creek drainage from the Thompson driveway. There was evidence that Newlin Creek had seen flows but at the time of the inspection the drainageway had a trickle of water and the banks were wet, with occasional puddles in low spots. Just upstream of a fence-line across the creek was a rock dam. This structure appeared to have been constructed by hand. There was water pooled upstream of the dam. There was also considerable deposition of organic material, pine needles, leaf mould, branches and twigs, at this location. There was also evidence in the channel that a reduced flow had continued past this location. The inspection continued past the fence-line across Newlin Creek. We walked along the drainage until we located the pink flagging tape and wooden stake previously placed by the landowner or his representative, to mark where they had observed flow to seep into the bottom of the channel. The Newlin Creek channel was damp downstream of this point, although it did not appear that a large volume of water had continued to flow. There were no surficial cracks or holes visible in this area.

Photo 1: Rock dam in Newlin Creek

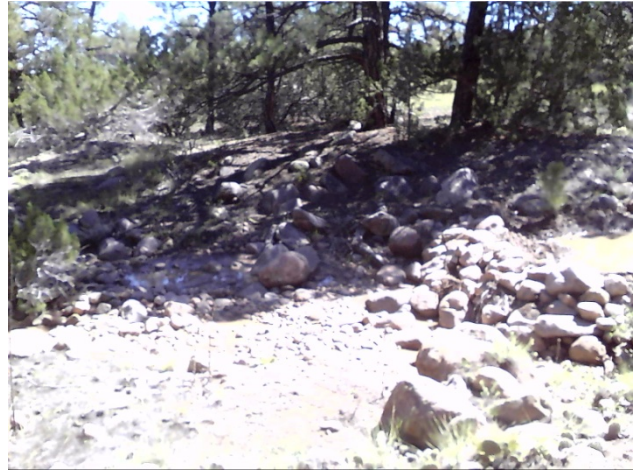
Photo 2: downstream of rock dam in Newlin Creek

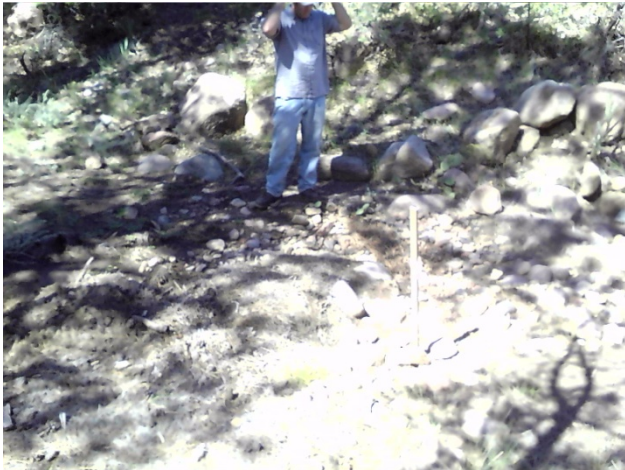
Photo 3: Landowner's stake marking point Newlin Creek flow previously infiltrated into channel

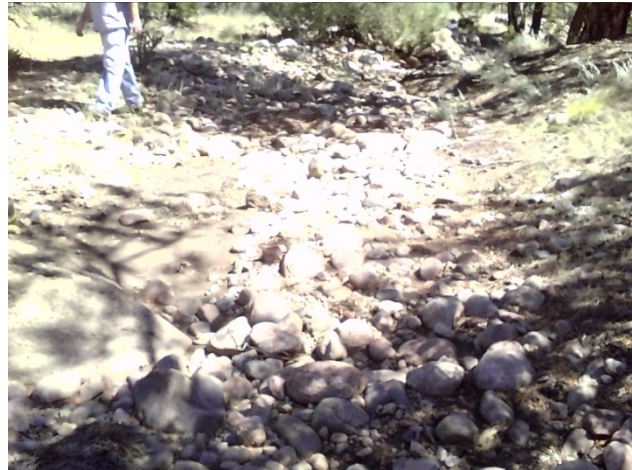
Photo 4: Flow in Newlin Creek had continued downstream of stake.

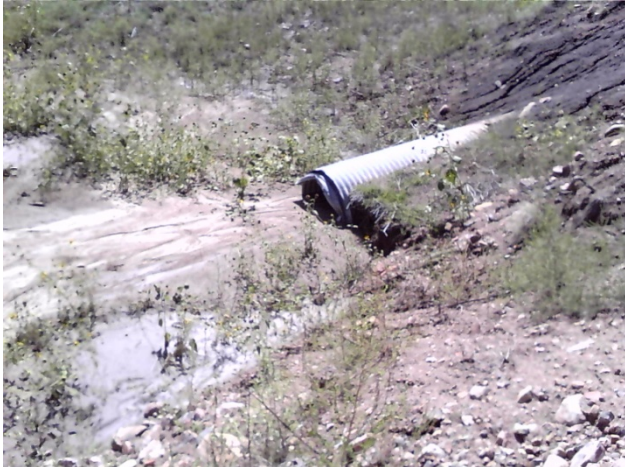
Pond 5 was holding a pool of water, a couple feet below the primary riser pipe. There was no evidence that any discharge had occurred from this pipe. Nor was there any sign based upon the inslopes of the pond that the water elevation had ever reached the discharge level prior to the inspection. The water held in the pond was muddy. Culvert 40 was clear at both the inlet and outlet. Sediment had deposited at the outlet of Culvert 39 and will require clearing. The outlet of the Pond 5 primary spillway also needs to be cleared of material.

Photo 5: Outlet of Culvert 39 into Pond 5.

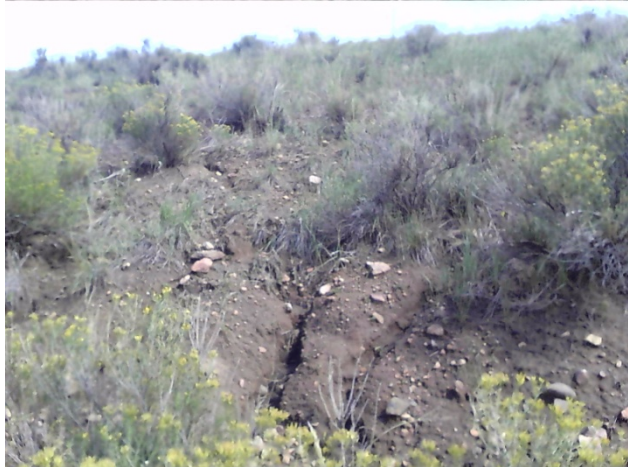
The silt fence on the north side of the truck tunnel continues to stabilize the gully adjacent to the concrete structure. EFCI had previously removed sediment from the north entrance of the truck tunnel. Additional sediment has been deposited on the concrete apron since the storm events. Stabilization of the slope immediately

north of the concrete apron is needed to prevent the formation of erosional features.

Photo 6: slope on northwest corner of truck tunnel requires stabilization.

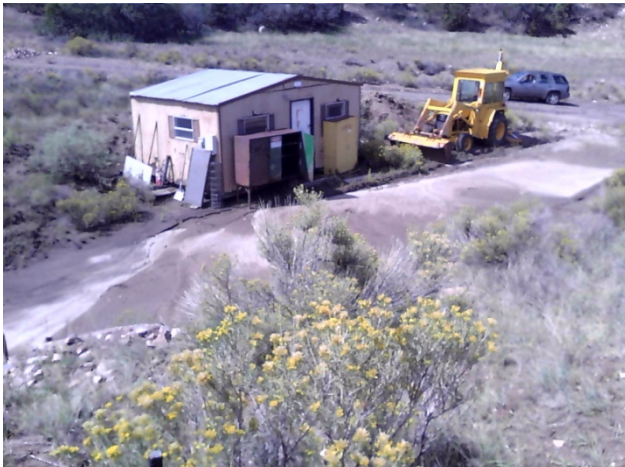
Photo 7: recent sediment deposition from slope shown in Photo 5.

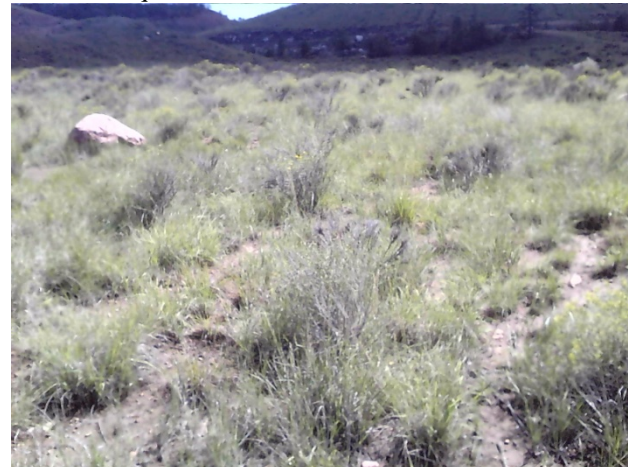
The vegetation throughout the reclaimed mine and loadout looked very healthy. Numerous warm season grasses; Blue grama, Side-oats grama, and Little bluestem were readily observed on the reclaimed areas.

Photo 8: Vegetation on reclaimed portal area

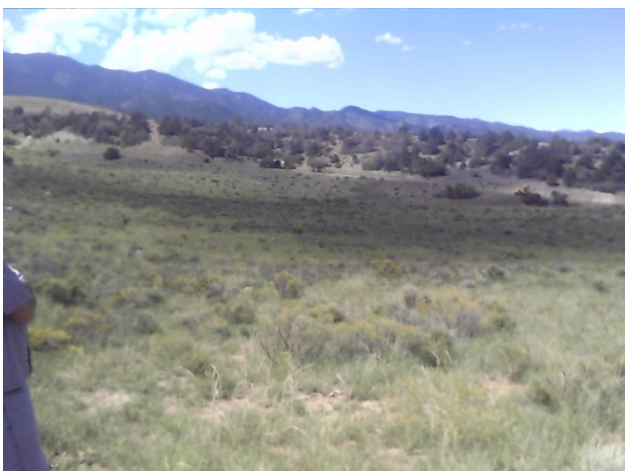
Photo 9: looking southwest across reclaimed portal area

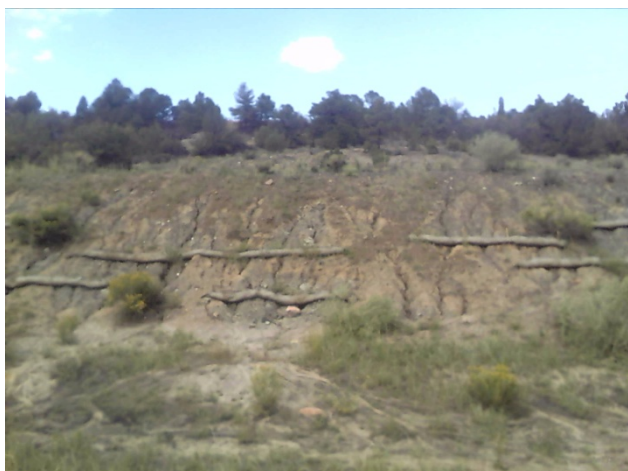
The wattled slope north of the permanent gravel parking area experienced considerable rilling under the wattles with the recent storms. In accordance with rill and gully repair rule, this slope needs to be reworked and the wattles trenched and re-anchored to the slope.

Photo 10: slope north of parking are. Slope and wattles need repair.
