COLORADO DIVISION OF RECLAMATION, MINING AND SAFETY
MINERALS PROGRAM INSPECTION REPORT
PHONE: (303) 866-3567

MINE NAME: Bachelor Mines (Syracuse Portal)	MINE/PROSPECTING ID#: M-1980-170	MINERAL: Silver	COUNTY: Ouray
INSPECTION TYPE: Monitoring	INSPECTOR(S): Wallace H. Erickson	INSP. DATE: September 20, 2013	INSP. TIME: 14:00
OPERATOR: Bachelor Silver Mines Company	OPERATOR REPRESENTATIVE: None present	TYPE OF OPERATION: 110(2) - Hard Rock Limited Impact	
REASON FOR INSPECTION: Normal I&E Program	BOND CALCULATION TYPE: Partial Bond	BOND AMOUNT: \$7,693.00	
DATE OF COMPLAINT: NA	POST INSP. CONTACTS: None	JOINT INSP. AGENCY: None	
WEATHER: Cloudy	INSPECTOR'S SIGNATURE:

Bachelor Mines
(Syracuse Portal)
M-1980-170
September 20, 2013

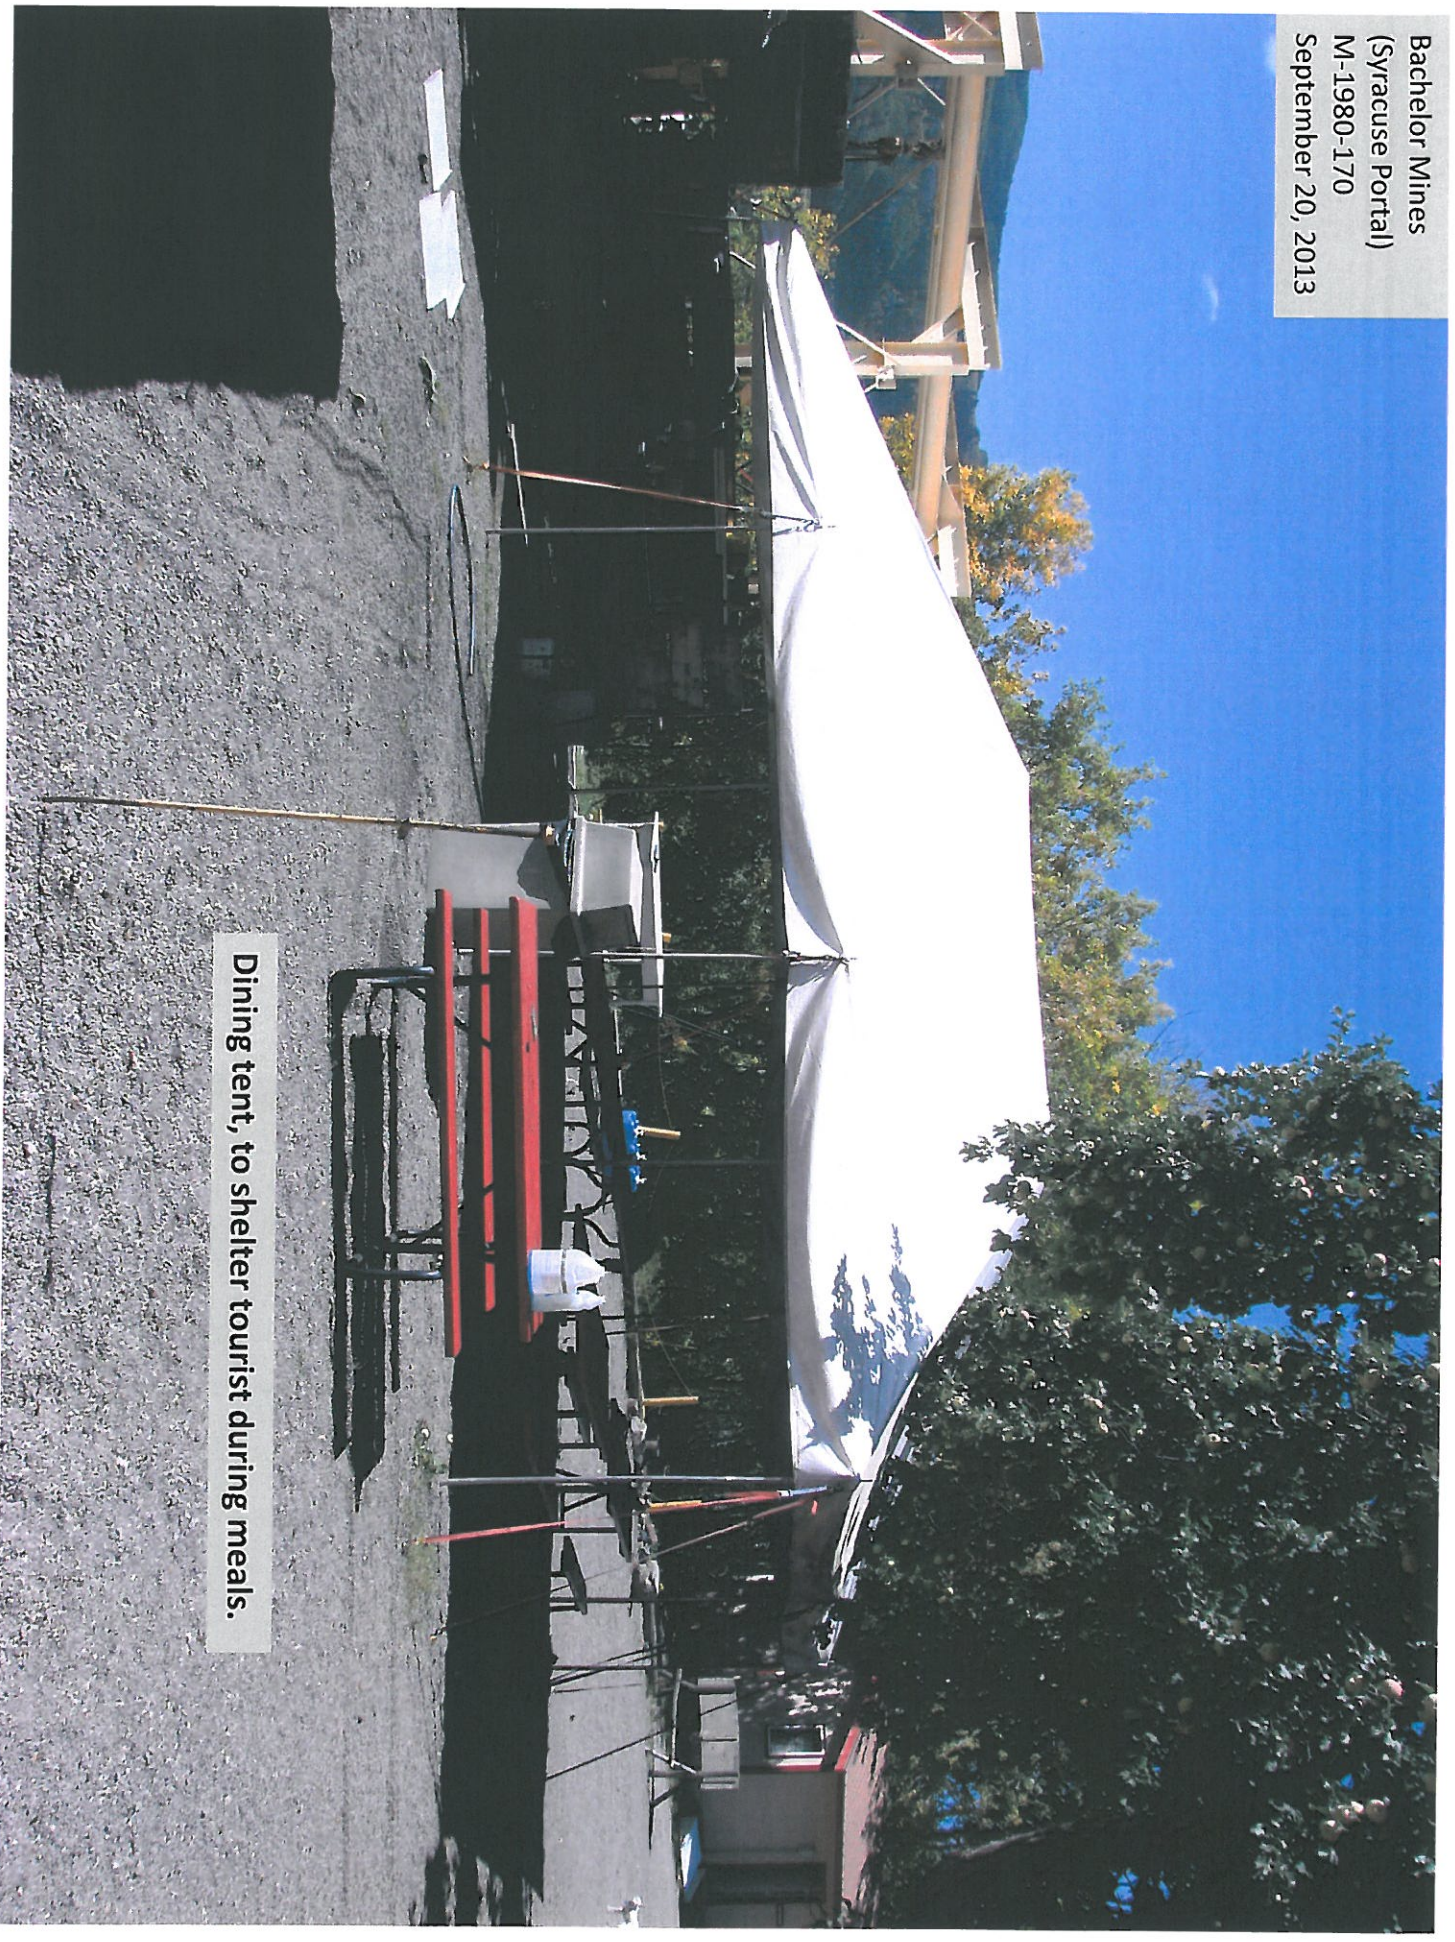
Dining tent, to shelter tourist during meals.

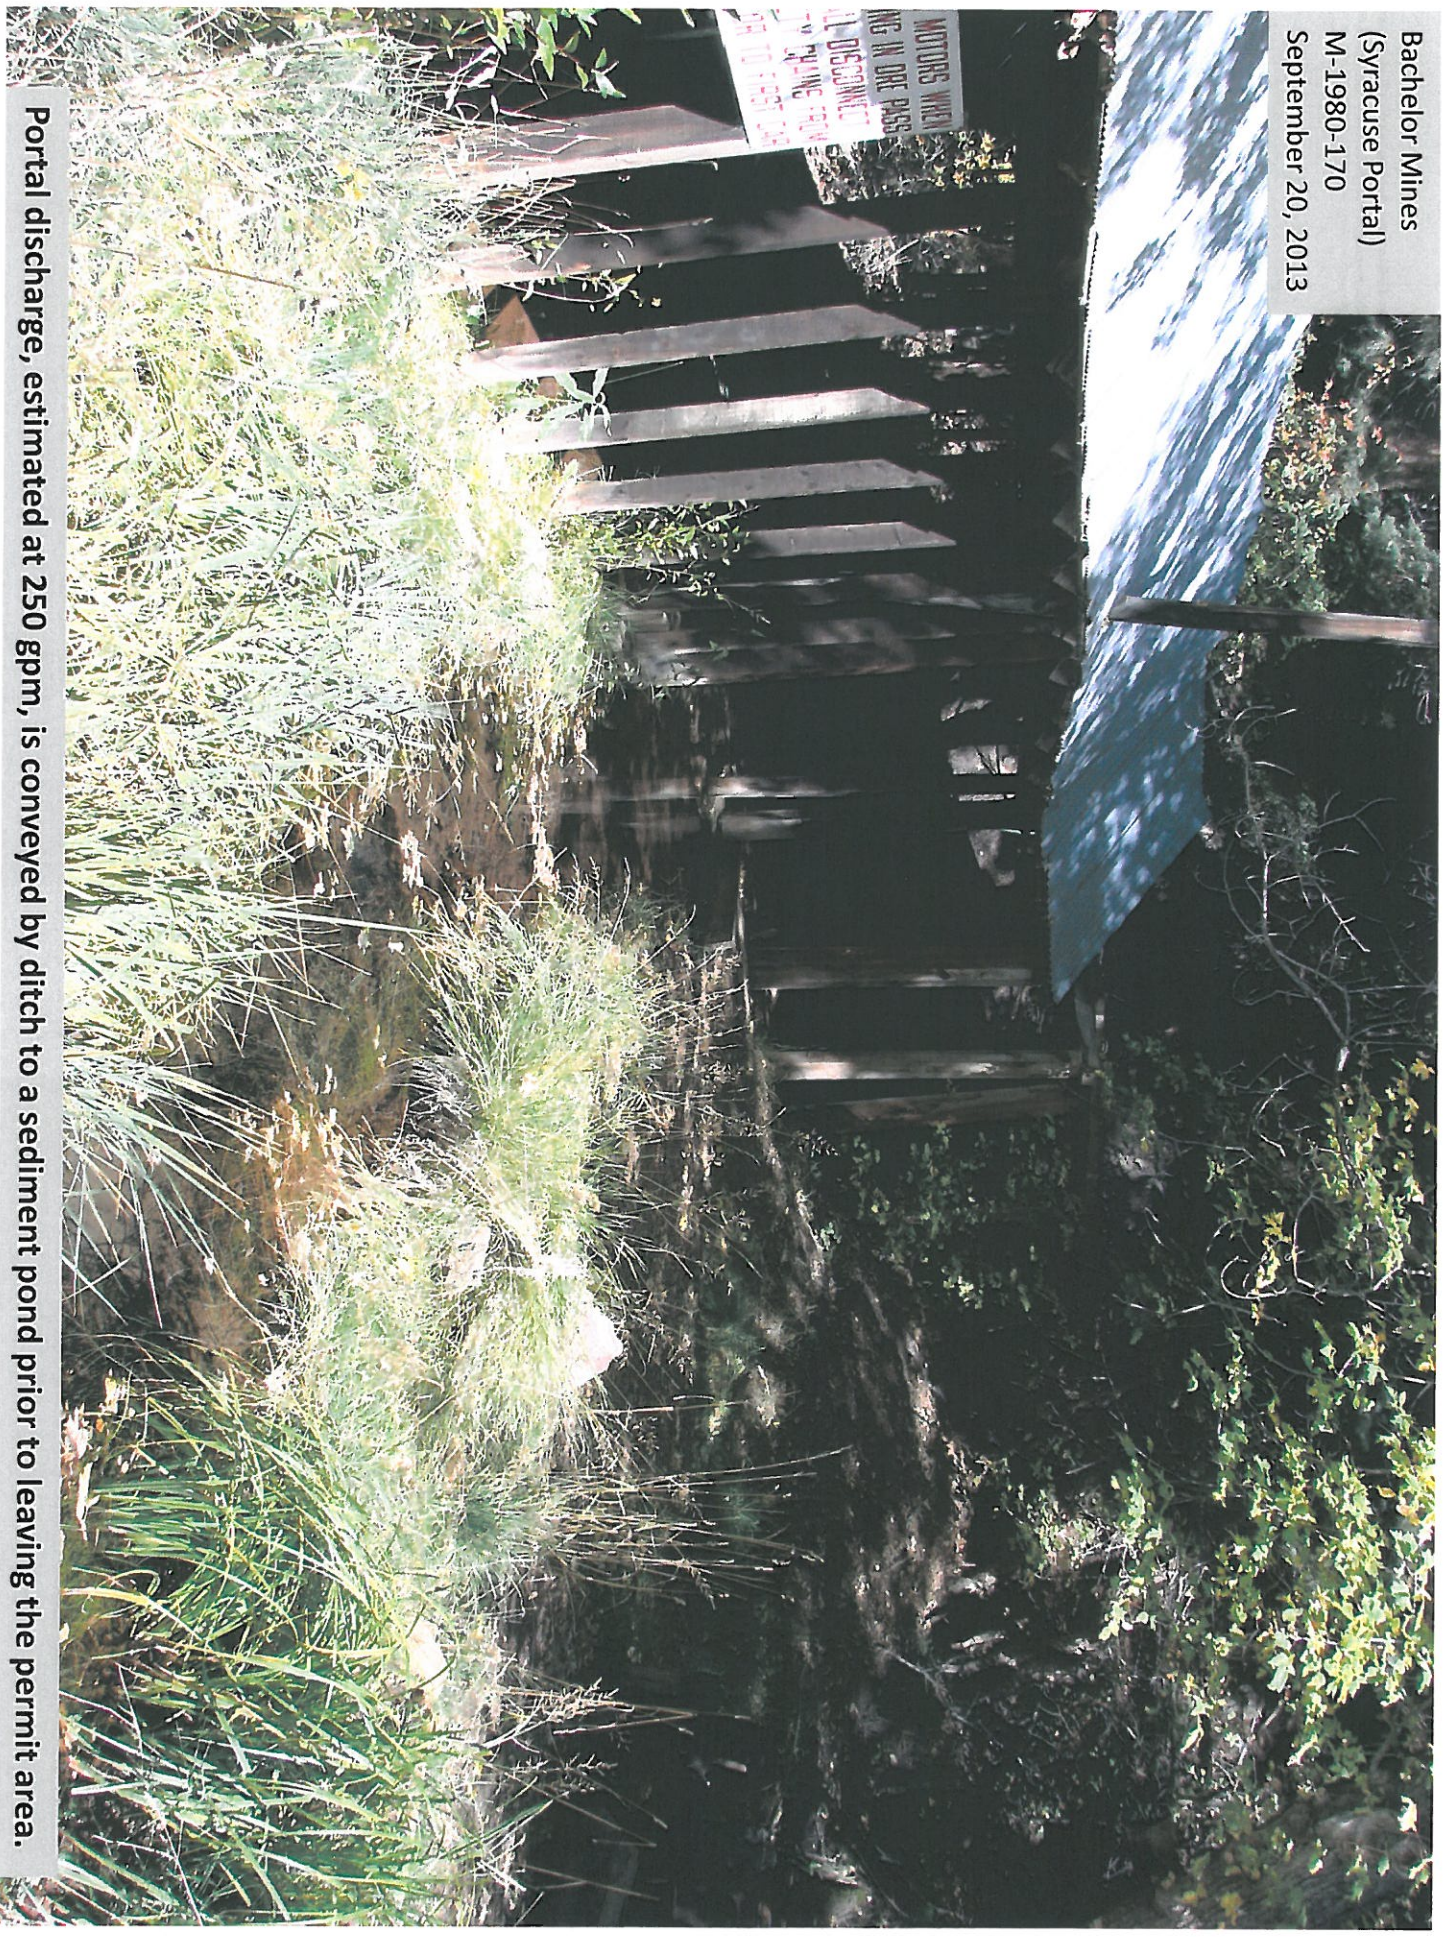
As shown in the photos, current conditions appear similar to the descriptions of the pre-permit disturbance provided in the original application documents. The portal discharge was estimated at 250-300 gallons per minute and was routed to the south end of the permit area as indicated in the application documents. Mine drainage appeared clear; no evidence of iron staining or metals precipitation was observed. Aquatic plants were thriving throughout all portions of the discharge ditch. Mine drainage ultimately reports to Lake Lenore Estates and does not discharge directly to a live stream channel.

Portal discharge, estimated at 250 gpm, is conveyed by ditch to a sediment pond prior to leaving the permit area.

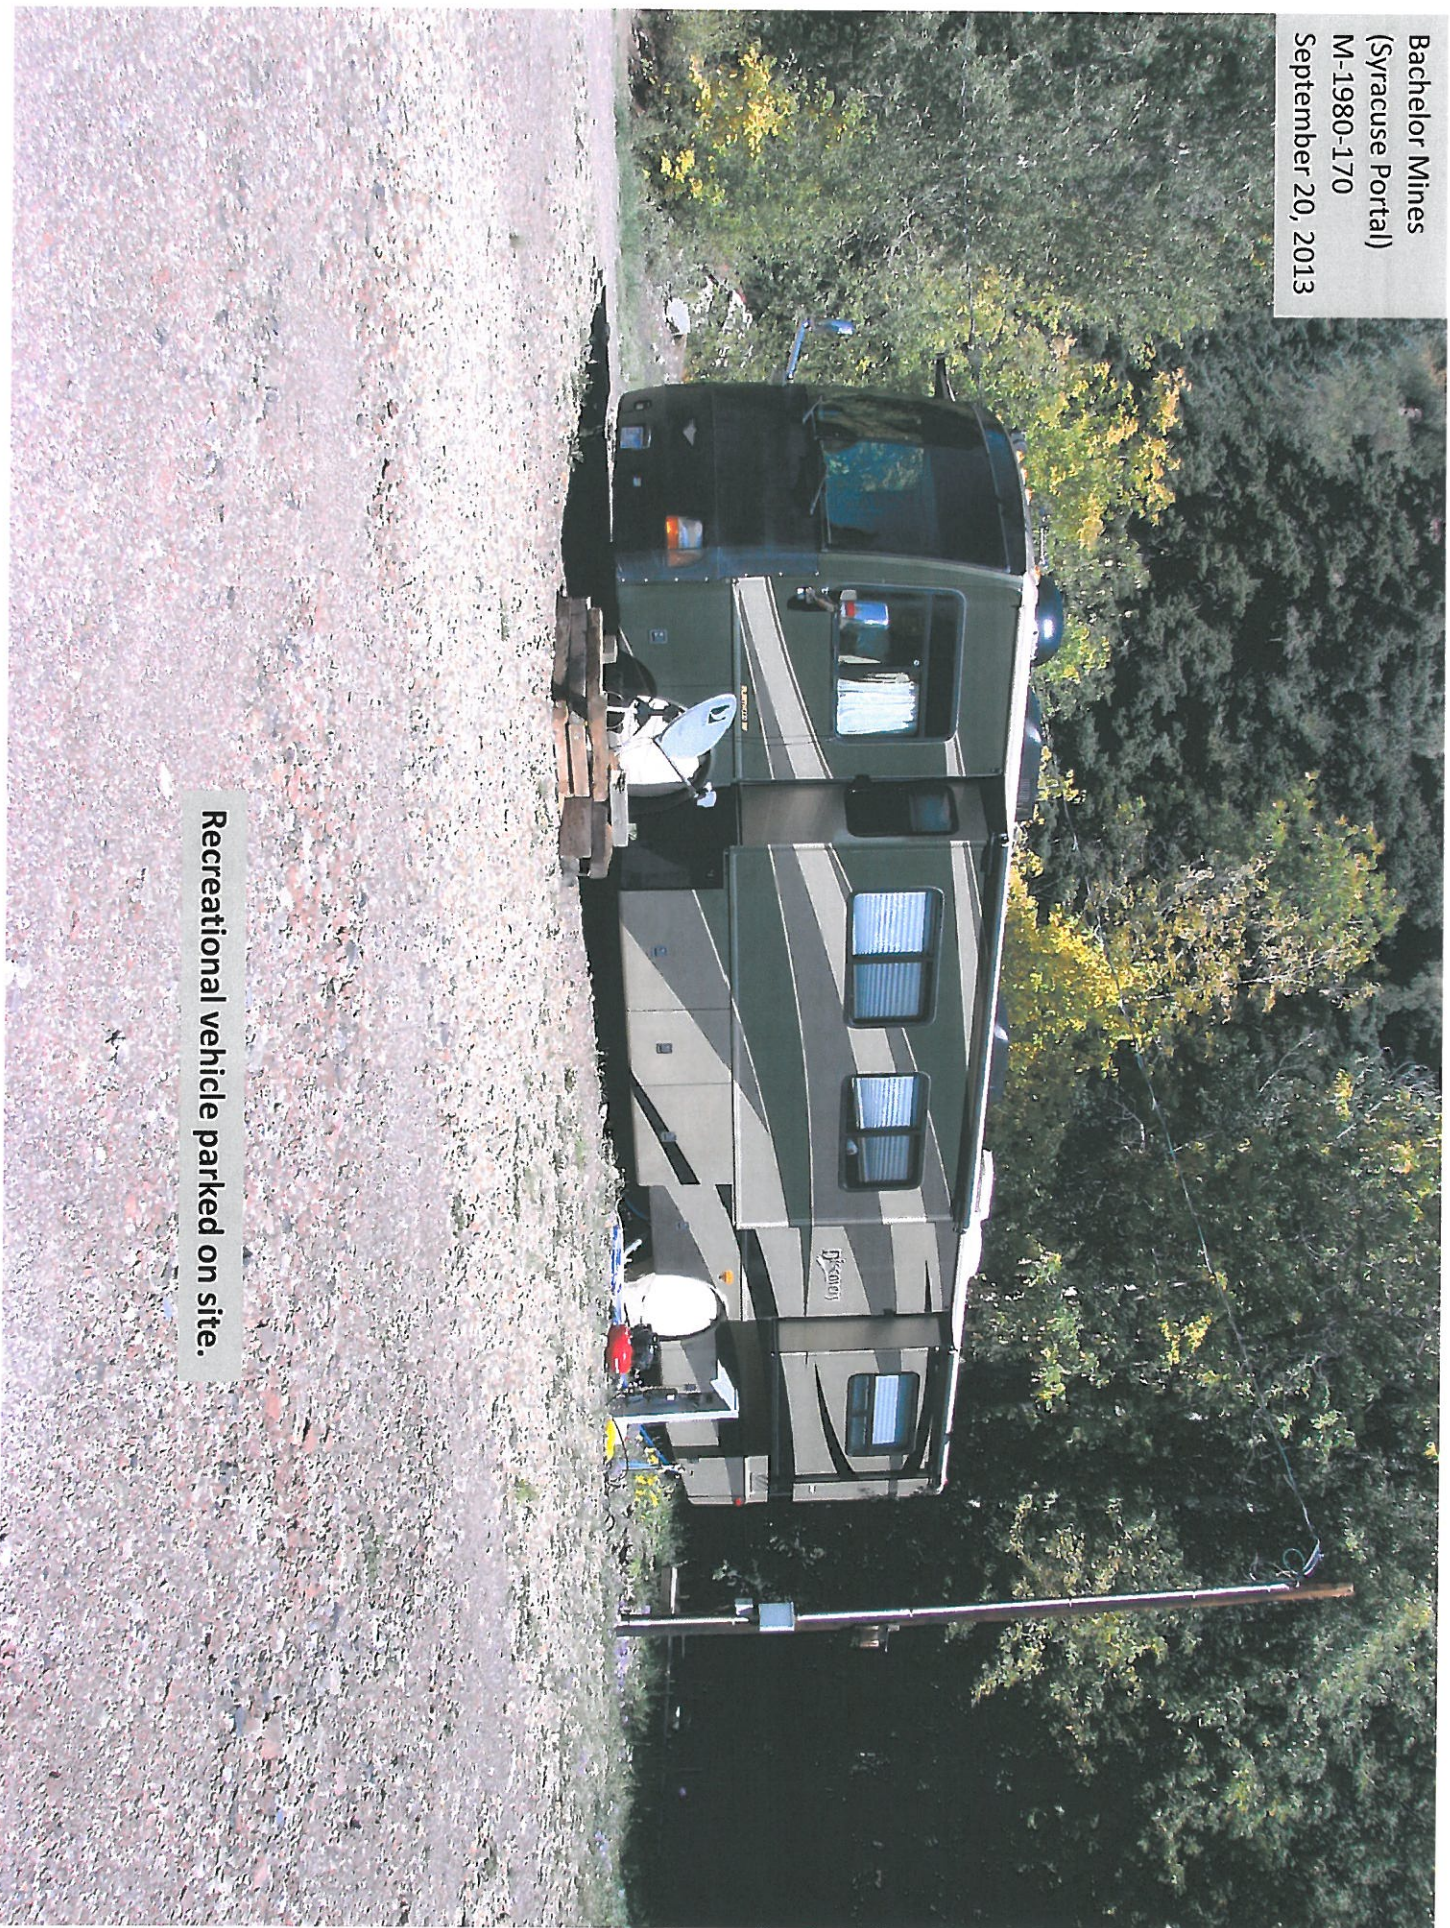
Recreational vehicle parked on site.
