COLORADO DIVISION OF RECLAMATION, MINING AND SAFETY COAL PROGRAM INSPECTION REPORT

Permit Number: C-1981-022 Mine Name: Elk Creek Mine Operator: Oxbow Mining, LLC Operator Address: Mr Jim Kiger P.O. Box 535 3737 Highway 133 Somerset, CO 81434	County: Delta, Gunnison Operation Type: Underground Permit Status: Active Ownership: Federal
	Operator Representative Present: None
Operator Representative Signature: (Field Issuance Only)

Inspection Start Date: September 25, 2013 Inspection Start Time: 11:25 Inspection End Date: September 25, 2013 Inspection End Time: 11:30	Inspection Type: Aerial Inspection Inspection Reason: Normal I&E Program Weather: Clear
Joint Inspection Agency: None	Joint Inspection Contacts:
Post Inspection Agency: None	Post Inspection Contacts:
Inspector(s): Brock F. Bowles Harry B. Ranney	Inspector's Signature:

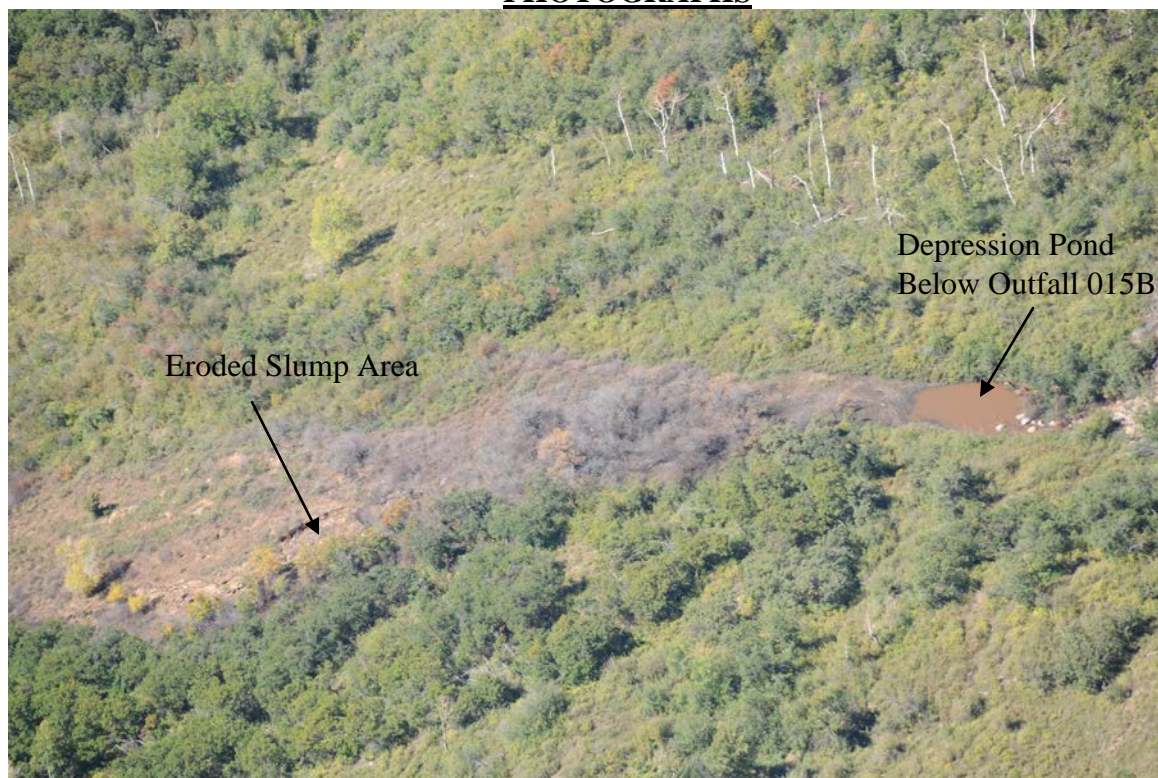
Water was standing in the small depression below the Outfall 015B well pad (photo 1). Water was not discharging from the depression indicating that water was not being pumped from the mine workings at the time of the aerial inspection. The water in the pond has a brown color which is different than the last inspection when it was clear. This may be due to the water supply being stopped and the wildlife activity of the area. The eroded slump area below the depression is evident in these aerial photographs. It does not appear that the extent of the eroded slump area has increased since that last ground inspection on September 4, 2013.

Photo 1 – Discharge Area Below Outfall 015B

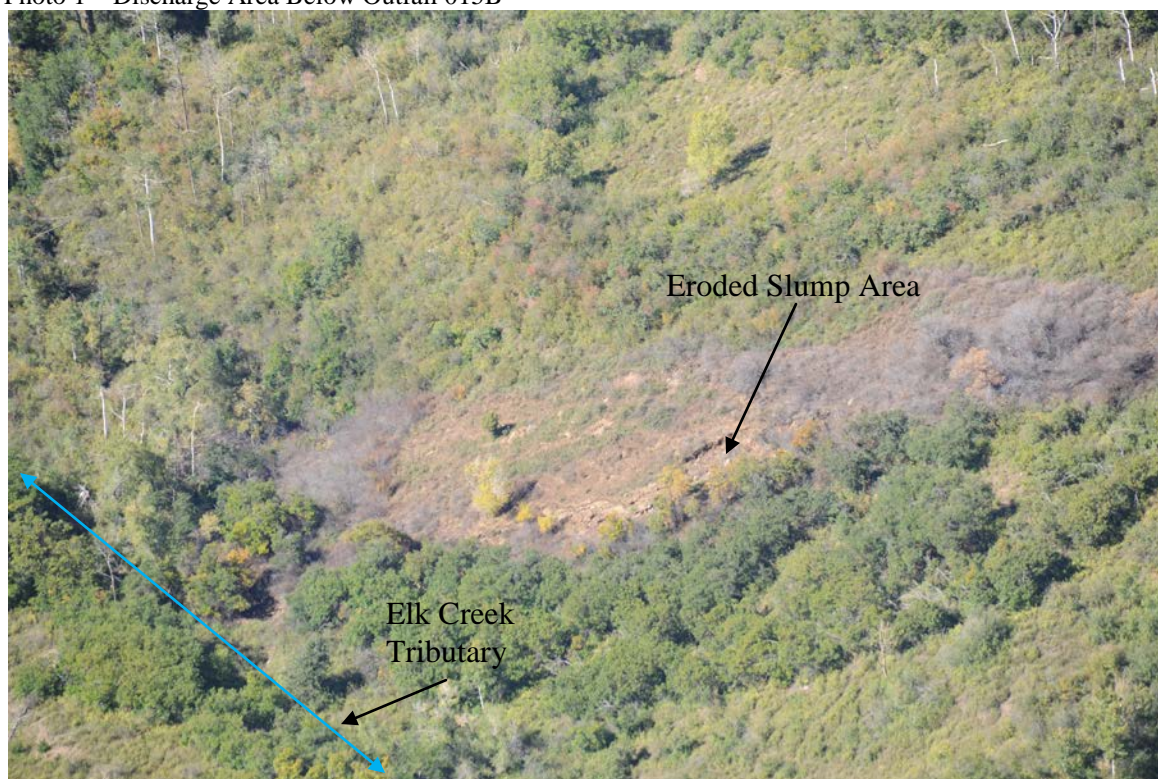
Much of the vegetation below the depression discharge point of Outfall 015B is dead (photo 2). It does not appear that the extent of the dead vegetation has increased since the last aerial inspection. The dead vegetation is located between the depression pond and the Elk Creek tributary. This is consistent with the observation of the September 4, 2013 ground inspection.

Photo 2 – Extent of Vegetation Damage Below Outfall 015B
