# COLORADO DIVISION OF RECLAMATION, MINING AND SAFETY COAL PROGRAM INSPECTION REPORT

<b>Permit Number:</b> C-1981-046 <b>Mine Name:</b> Sunlight Mine <b>Operator:</b> Garfield Energy Corporation <b>Operator Address:</b>  X X, CO 11111	<b>County:</b> Garfield <b>Operation Type:</b> Underground <b>Permit Status:</b> Revoked <b>Ownership:</b> Private  <b>Operator Representative Present:</b>  None
<b>Operator Representative Signature:</b> (Field Issuance Only)

<b>Inspection Start Date:</b> September 25, 2013 <b>Inspection Start Time:</b> 11:06 <b>Inspection End Date:</b> September 25, 2013 <b>Inspection End Time:</b> 11:06		<b>Inspection Type:</b> Aerial Inspection <b>Inspection Reason:</b> Normal I&E Program <b>Weather:</b> Clear	
<b>Joint Inspection Agency:</b>  None		<b>Joint Inspection Contacts:</b>	
<b>Post Inspection Agency:</b>  None		<b>Post Inspection Contacts:</b>	
<b>Inspector(s):</b>  Brock F. Bowles  Harry B. Ranney		<b>Inspector's Signature:</b>

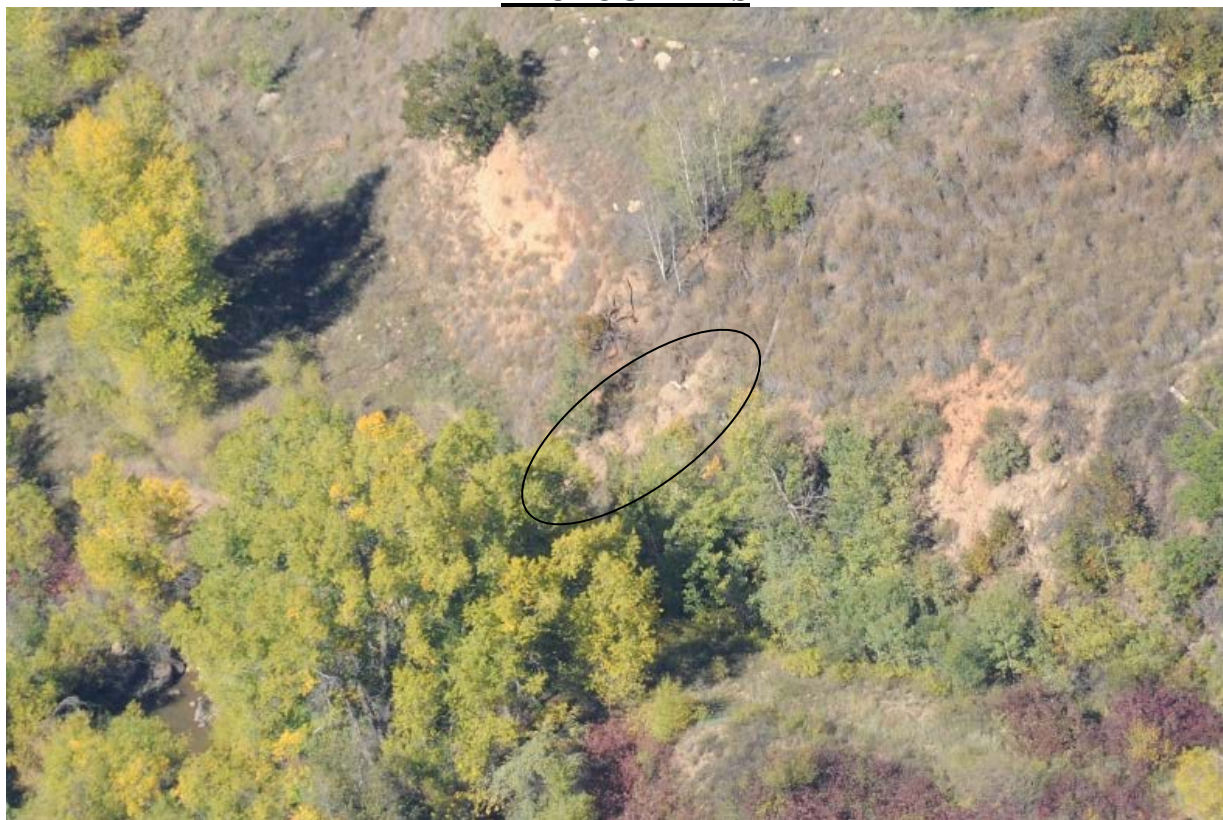
It appears that the lower portal area that was excavated and backfilled on September 9, 2013 is stable. The backfilled area was left rough with small hills and depressions for revegetation. These hills and depressions are visible in aerial photo 1.

Photo 1 – The Excavated Lower Portal Area

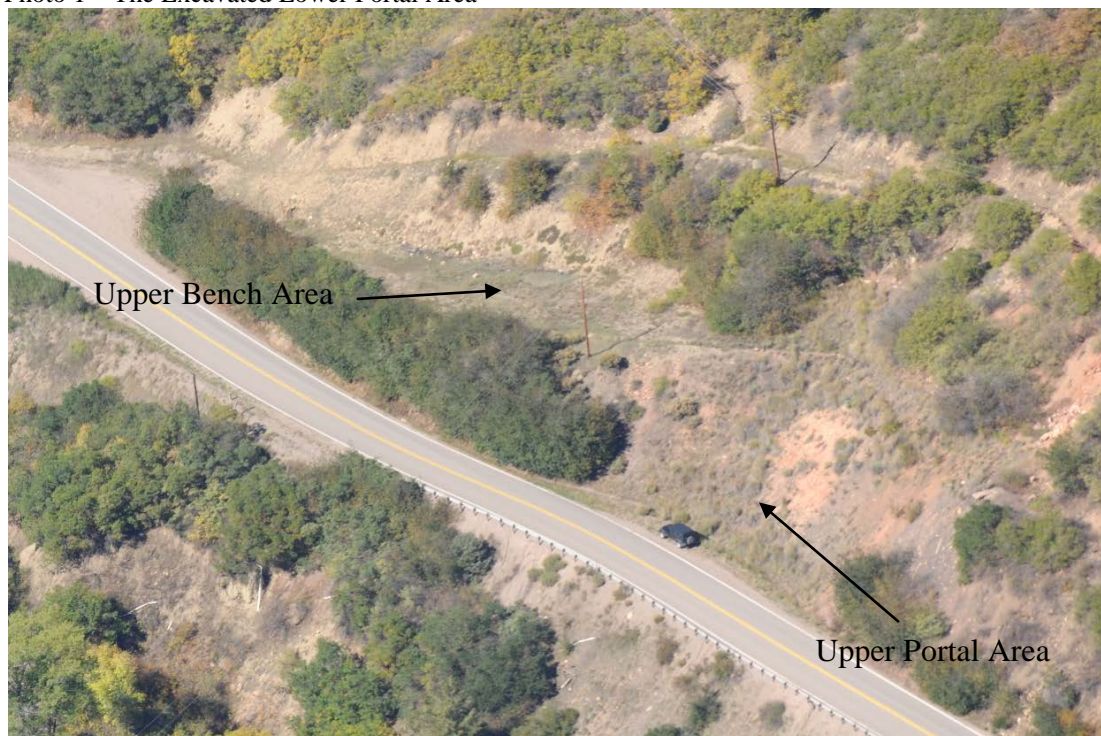
The upper portal area and bench area appear to be stable (photo 2).

Photo 2- The Upper Portal Area and Bench
