## COLORADO DIVISION OF RECLAMATION, MINING AND SAFETY COAL PROGRAM INSPECTION REPORT

<b>Permit Number:</b> C-1981-012 <b>Mine Name:</b> New Elk Mine <b>Operator:</b> New Elk Coal Company, LLC <b>Operator Address:</b> Mr Mark Haywood 12250 Highway 12 Weston, CO 81091	<b>County:</b> Las Animas <b>Operation Type:</b> Underground <b>Permit Status:</b> Temporary Cessation <b>Ownership:</b> Private
	<b>Operator Representative Present:</b>  Greg Smith
<b>Operator Representative Signature:</b> (Field Issuance Only)

<b>Inspection Start Date:</b> September 17, 2013 <b>Inspection Start Time:</b> 13:40 <b>Inspection End Date:</b> September 19, 2013 <b>Inspection End Time:</b> 13:00	<b>Inspection Type:</b> Coal Partial Inspection <b>Inspection Reason:</b> Normal I&E Program <b>Weather:</b> Clear
<b>Joint Inspection Agency:</b>  None	<b>Joint Inspection Contacts:</b>
<b>Post Inspection Agency:</b>  None	<b>Post Inspection Contacts:</b>
<b>Inspector(s):</b>  Leigh D. Simmons	<b>Inspector's Signature:</b>

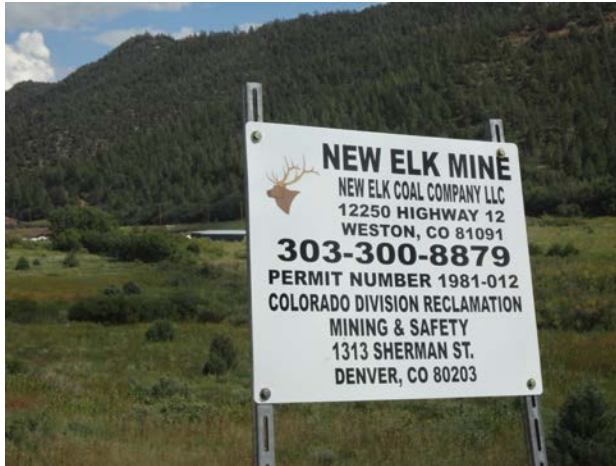
Photo 1: Mine ID sign

Most mine ID signs had been replaced with permanent signs. **The new signs need a phone number for the Division (303 866 3567) in order to be fully compliant with the regulations.**

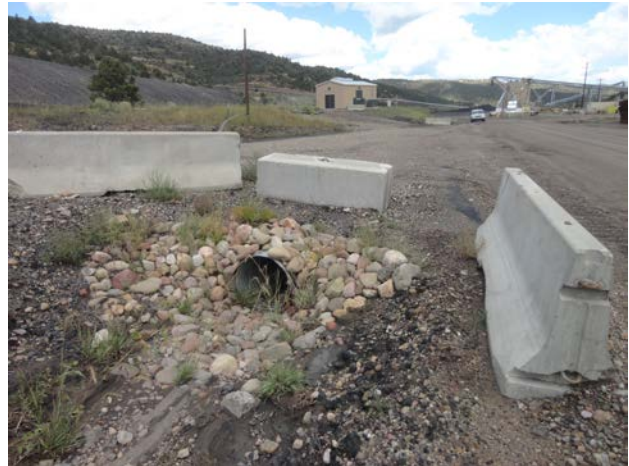
- No further work had taken place to re-grade ditch D14, because the ground was judged to have been too soft. The ditch had not breached again, although accumulated sediment had risen to within 6-8” of the top of the ditch.
- Culverts C73 and C19 had been cleared, (the final flushing of C19 was in progress).
- The channel where culvert C4 used to be had been graded to prevent the impoundment of water.
- The berm at the new water tank SAE had been restored.
- No further work had taken place in the area of culvert C41, although people and equipment were scheduled to begin work up there shortly.
- The upland diversion ditch above the RDA had been cleared of rocks and trees, and re-graded.
- The upland diversion ditch had not yet been surveyed, this should be completed by September 30, 2013, and the survey data submitted to the Division as soon as possible.

Photo 2: C73 cleaned

Abatement Description: Clear culverts C73 and C19 of accumulated sediment to restore them to the approved design

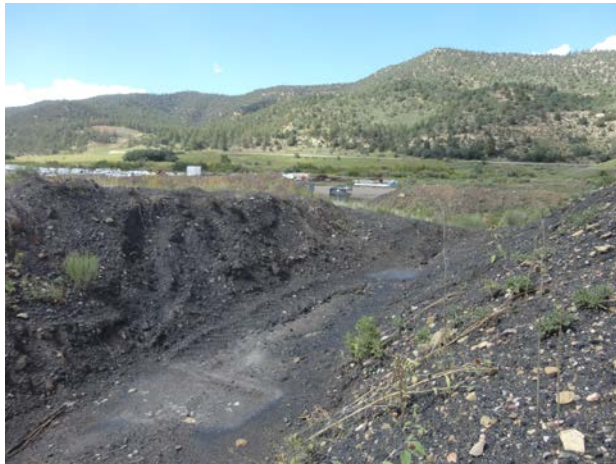
Photo 3: Graded channel where C4 used to be

Abatement Description: Grade the channel where culvert C4 was removed to prevent the impoundment of water

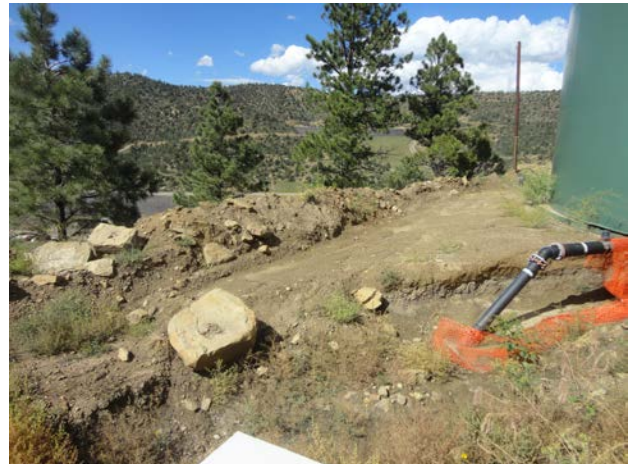
Photo 4: Berm at water tank SAE

Abatement Description: Restore the berm at the "new water tank" SAE to its approved design

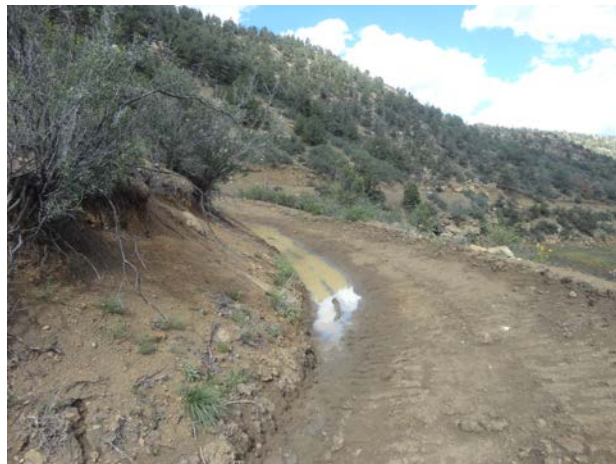
Photo 5: RDA upland diversion

Abatement Description: Clear the upland diversion ditch above the RDA of fallen rocks and trees

Abatement Description: Survey the entire length of the upland diversion ditch above the RDA to allow comparison of constructed ditch with the approved design

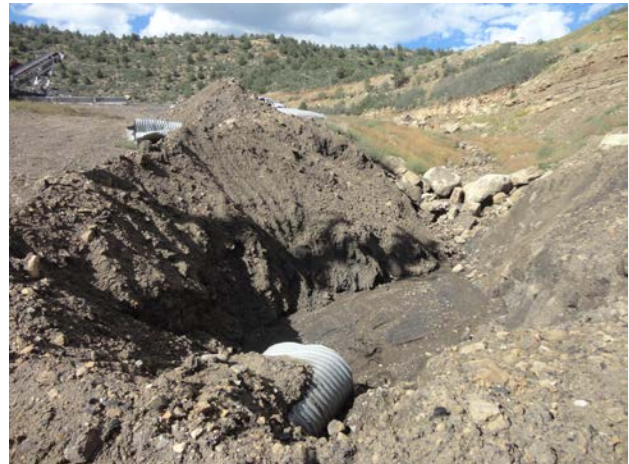
- Culvert C88 had been repaired.
- Erosive gullies between the RDA conveyor belt and pond 8 had been partially repaired. Heavy rain had washed out some of the repairs. **These repairs will be made more permanent as part of the “C41 project”.**
- Culverts C39 and C-A were inspected. No problems were observed.
- All culverts on the road to the RDA were clear.

Photo 6: C88 repaired

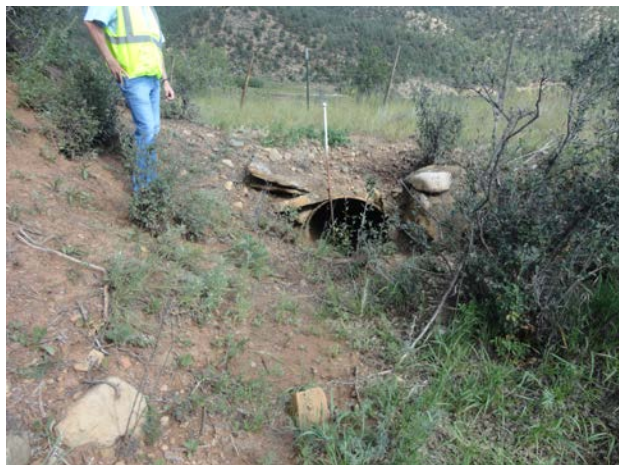
Photo 7: C21

- Culvert C49 was clear (but outlets into a much smaller culvert, owned by the Division of Parks and Wildlife); C21 had not yet been cleaned. **C21 should be cleaned at the inlet, at least, as soon as possible.**

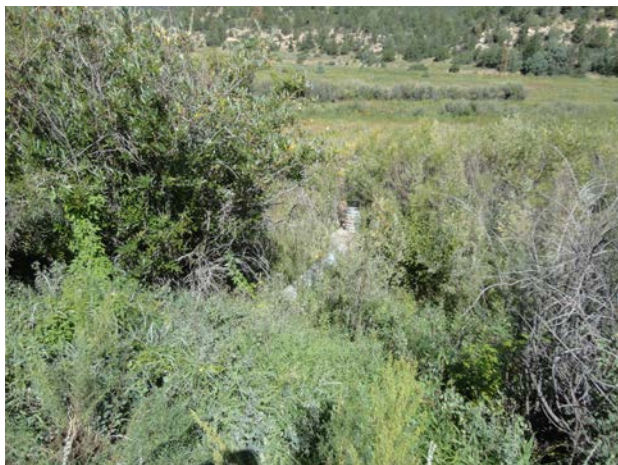
Photo 8: Pond 4 overgrown vegetation

- Pond 4 had a small amount of water, but was not discharging. Vegetation had grown up to the point that access to the spillway was difficult. **The vegetation should be cleared before the winter.**

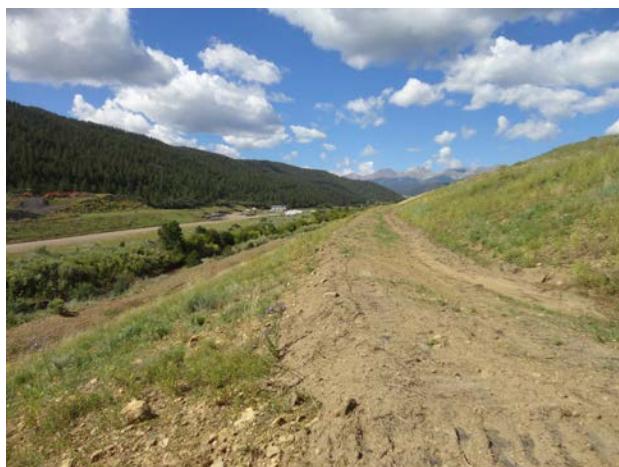
The channel of the contour ditch on the south side of DWDA 1 had been cleared. The erosion beneath the contour ditch had not been repaired, but given that the damage is fairly minor it was agreed that an attempt to repair it may cause more harm than good, therefore time will be allowed to for vegetation to fill in. **The erosion should be monitored.**

Photo 9: Repaired contour ditch on DWDA 1

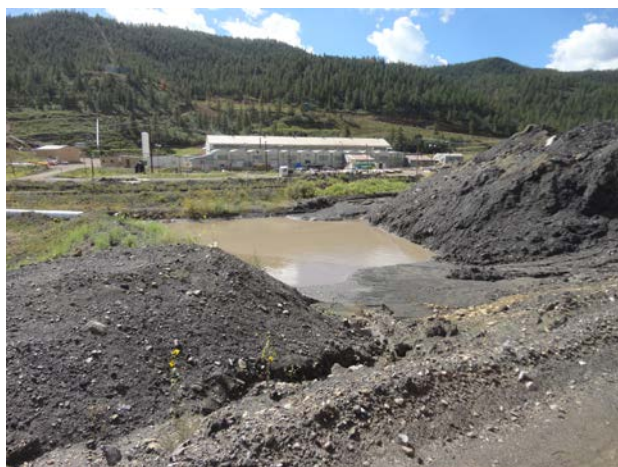
Photo 20: C13 inlet

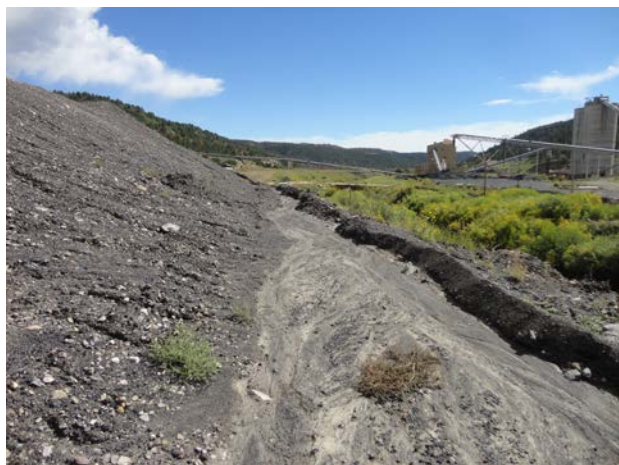
Photo 41: D14

Abatement Description: Ditch D14 should be restored to the approved design.

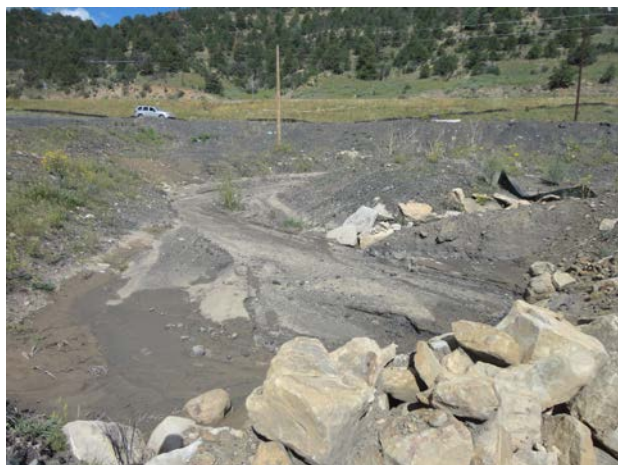
- The sump at the inlet to C13 was inspected and looked to be in good shape. South of the highway, the culvert across the gateway (C14?) was partially blocked. **C14 and the ditch below should be cleaned.**
- From the outlet of culvert C30 to the river, including the section where C26 was removed, sediment is currently being caught by what is effectively a large rock-check dam. It was agreed with Mr. Smith that a long term solution for this area would be to remove all the bales and flow control devices, and armor the entire length of that section of channel. **This should be tackled when people and equipment are available to do it.**

Photo 32: Ditch below C30

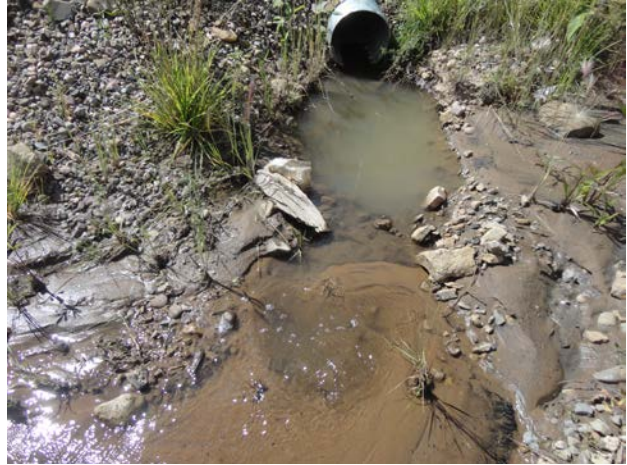
Photo 54: Upwelling from buried culvert bypassing C16c

- The PVC pipes in D32b had not been removed. **Their function should be assessed and they should be removed if appropriate.**
- **The “C16 system” of culverts and ditches should be redesigned** - as previously stated. This will need to be handled as part of TR68 which is already in progress. In the meantime, the system is just about functional. C16a was clear; C16b was half full; C16c was redundant since it is too high - instead flow is conducted through a section of black pipe (the outlet of which is buried), the head caused by the sump pump discharge was sufficient to cause water to up-well from the buried pipe; C16 was clear; D16 will need to be cleaned soon.
