COLORADO DIVISION OF RECLAMATION, MINING AND SAFETY COAL PROGRAM INSPECTION REPORT

Permit Number: C-1996-084 Mine Name: Lorencito Canyon Mine Operator: New Elk Coal Company, LLC Operator Address: Mr Mark Haywood 12250 Highway 12 Weston, CO 81091	County: Las Animas Operation Type: Surface Permit Status: Permanent Cessation Ownership: Private
Operator Representative Present: Greg Smith	
Operator Representative Signature: (Field Issuance Only)

Inspection Start Date: September 18, 2013 Inspection Start Time: 09:00 Inspection End Date: September 18, 2013 Inspection End Time: 15:00		Inspection Type: Coal Partial Inspection Inspection Reason: Normal I&E Program Weather: Clear	
Joint Inspection Agency: None		Joint Inspection Contacts:	
Post Inspection Agency: None		Post Inspection Contacts:	
Inspector(s): Leigh D. Simmons	Inspector's Signature:

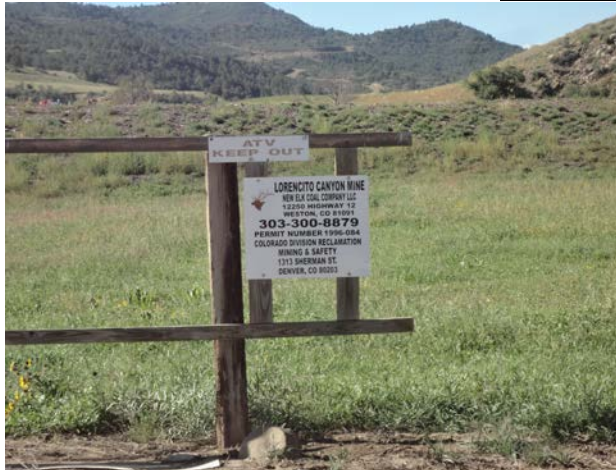
New signs had been produced and were being erected during the inspection. The signs contain all of the required information, except that the phone number for the Division should be added (303,866 3567).

Photo 1: New Mine ID sign

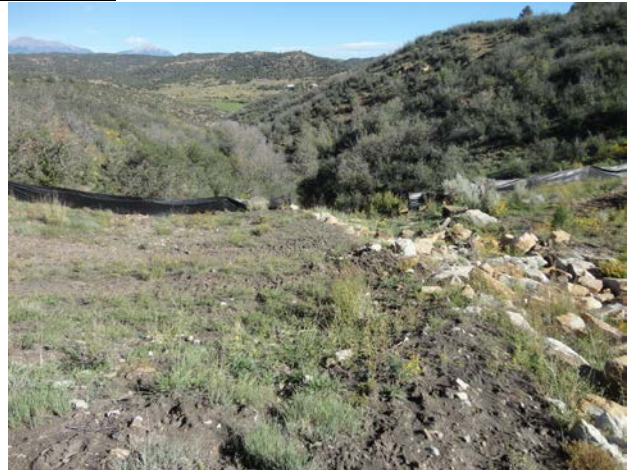
Pond 9 was discharging by drips. The very large gully south of the pond (below the outlet of culvert C19) had been repaired using large rocks. The smaller gullies around the pond had not been touched. The silt fence below the emergency spillway had been repaired.

Photo 2: Restored silt fence below pond 9 embankment

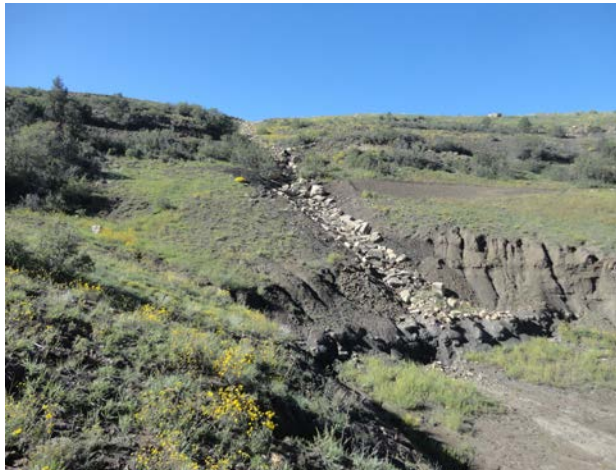
Photo 3: Pond 9, showing repaired gully (1)

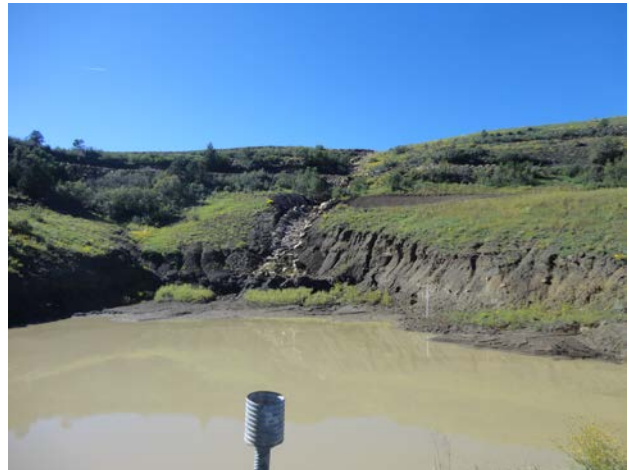
Photo 4: Pond 9, showing repaired gully (2)

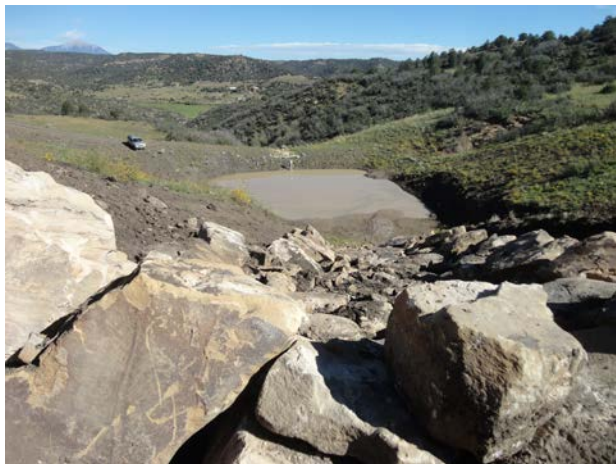
Photo 5: Pond 9, showing repaired gully (3)

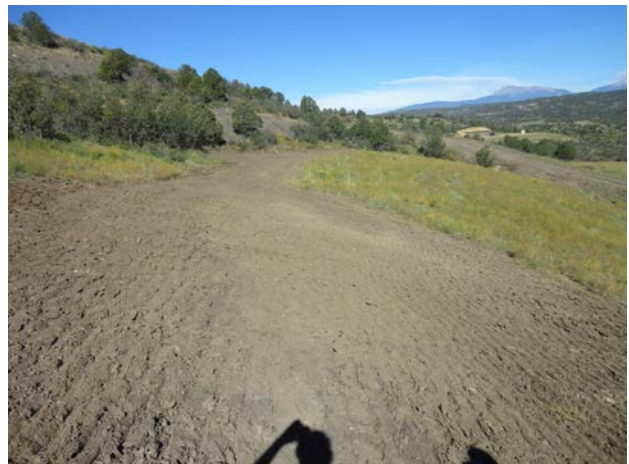
Photo 6: Gully access to be re-seeded

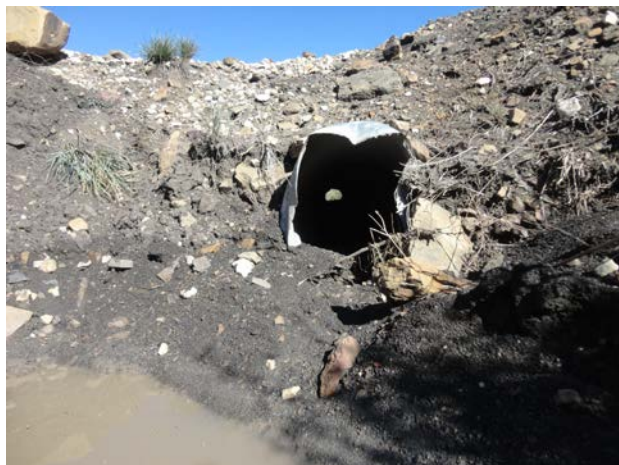
C1 had been cleared at the inlet. Recent rain had washed more sediment into it. **The culvert should be flushed and slight damage to the ends repaired when it is practical to do so.**

Photo 7: C1 to be flushed and repaired

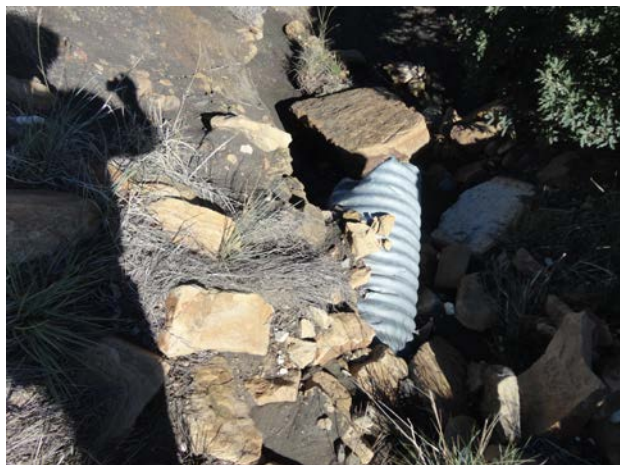
Photo 8: C1 outlet

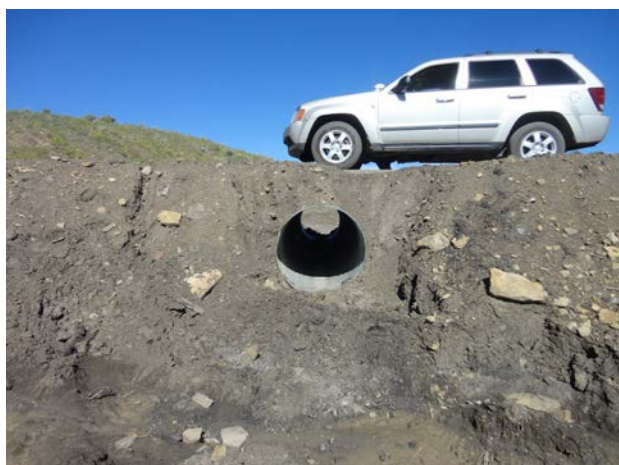
C2 had been cleaned (or replaced) and was in excellent shape.

Photo 9: C2 looking good

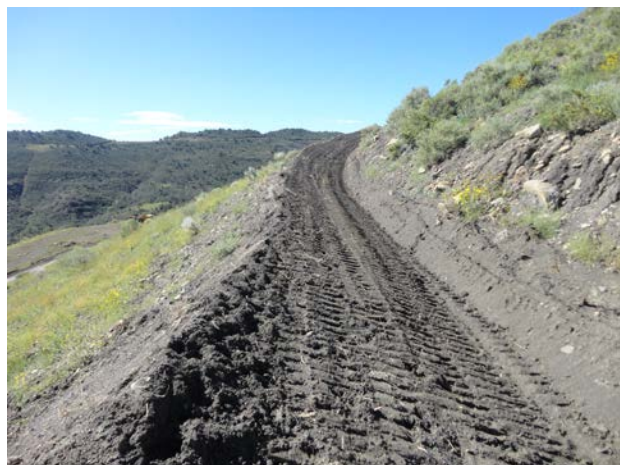
Ditches 2, 3 and 4 had all been cleaned and graded, and the damage to D4 above C3 had been repaired.

Photo 10: D4 repair above C3

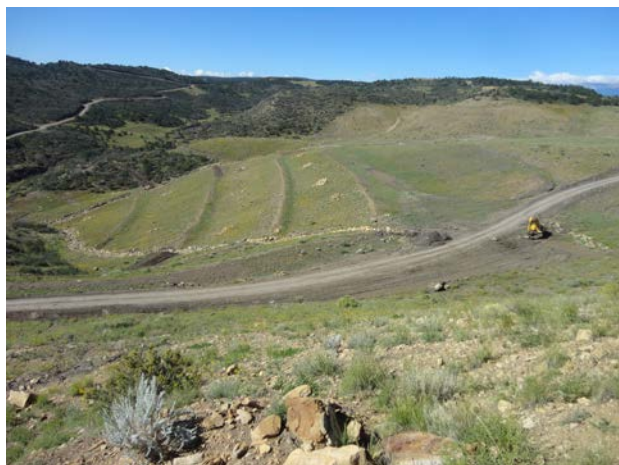
Photo 11: Fill 7

Fills 7, 8 and 9 were all well vegetated. There was no evidence of damage caused by drainage problems. Mr. Masarotti had cleaned some accumulated sediment from the highest bench of fill 8, and planned to work on the down-drain over the next few days.

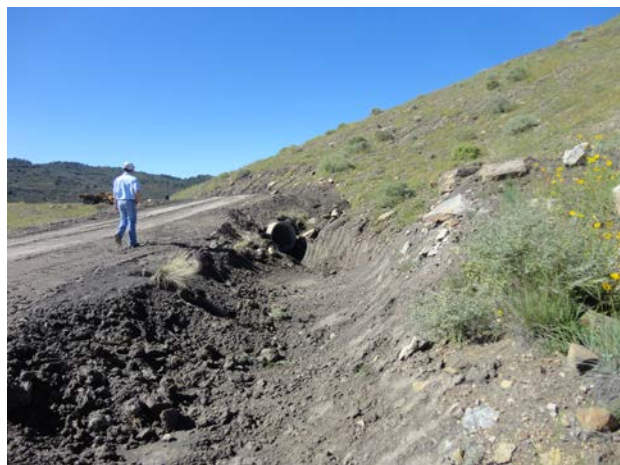
C3 had been cleared at both ends - the small amount of sediment left in the culvert was not significant.

Photo 12: C3 inlet – recent work

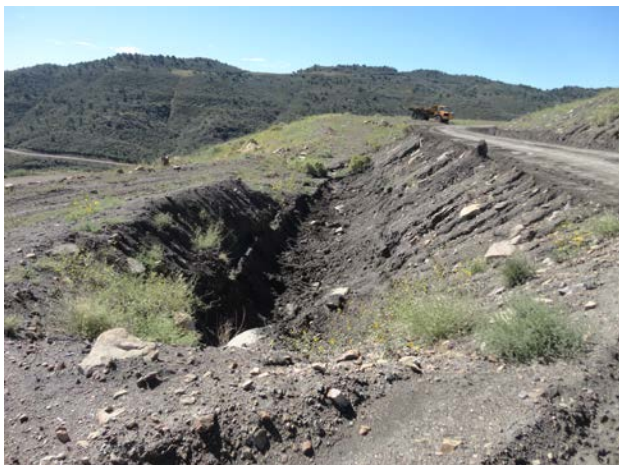
Photo 13: C3 outlet – recent work

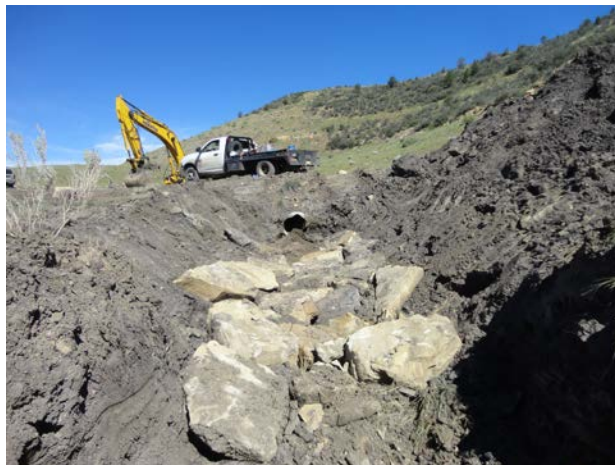
C4 had been cleaned at both ends, but **the culvert should be flushed before the accumulated sediment hardens up.**

Work was in progress on D10, near to C4. Mr. Steele plans to continue the armoring to the top of the down-drain on the east side of fill 7.

Photo 14: C4 – work in progress

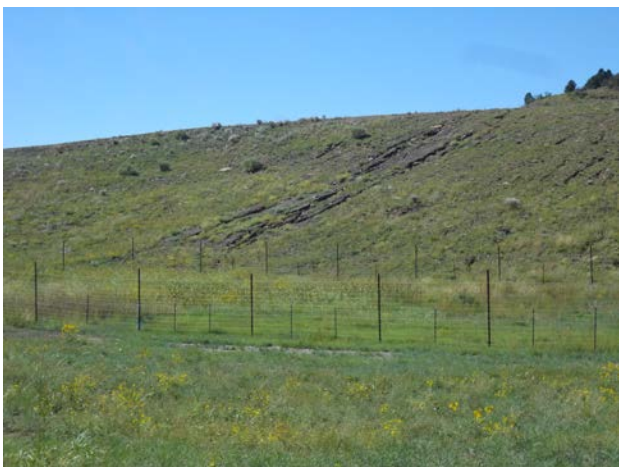
C5 appeared to be slightly mis-located on the draft map. The culvert was clear. Could the culvert be used somehow to help prevent the erosion plaguing the east facing slope above the shrub plot?

Photo 15: Shrub plot and nearby erosion

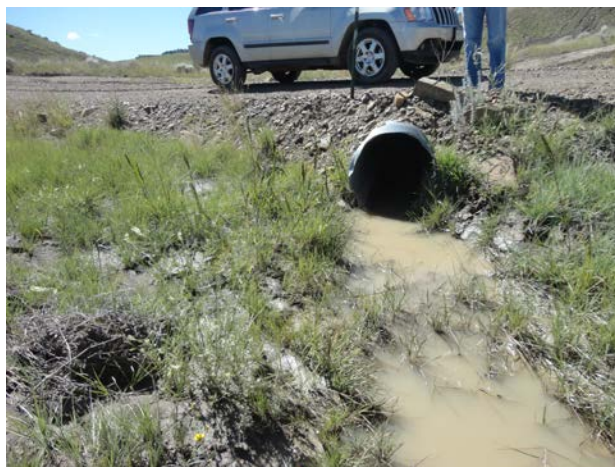
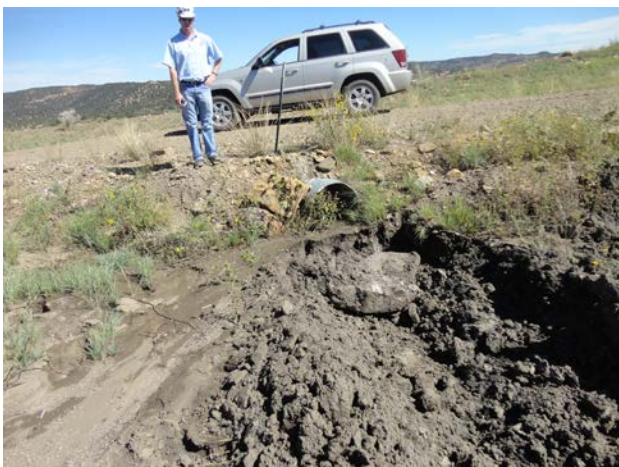
C8 had had a sump excavated at the inlet, but **the culvert itself will need to be flushed.**

Photo 16: C8 to be flushed (1)

Photo 17: C8 to be flushed (2)

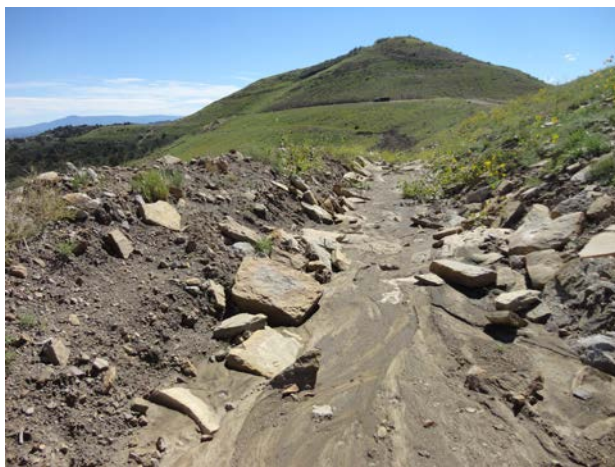
Photo 18: Repairs to highest terrace of fill 8

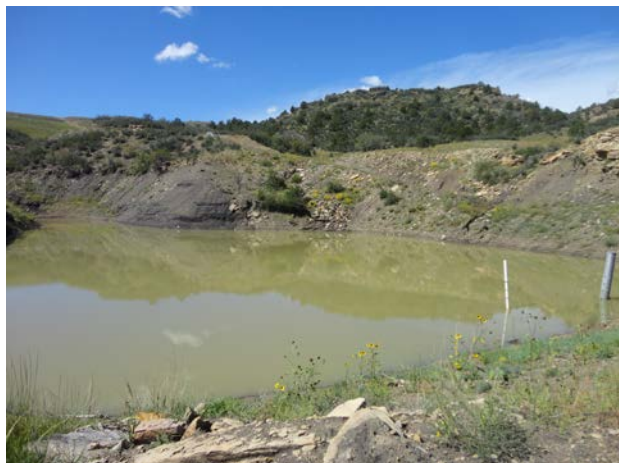
Pond 8 was discharging at a trickle.

Photo 19: Pond 8

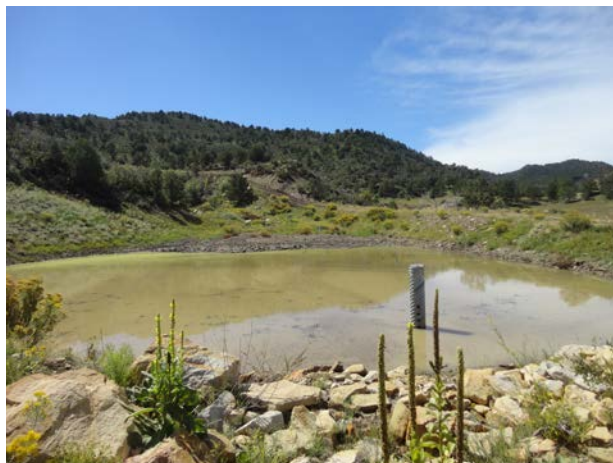
Pond 5 was discharging by drips. The pond was just accessible by road, since new water bars had been built. Above the drainage to pond 5, the flat area that had previously been armored will need to be monitored and

Photo 20: Pond 5

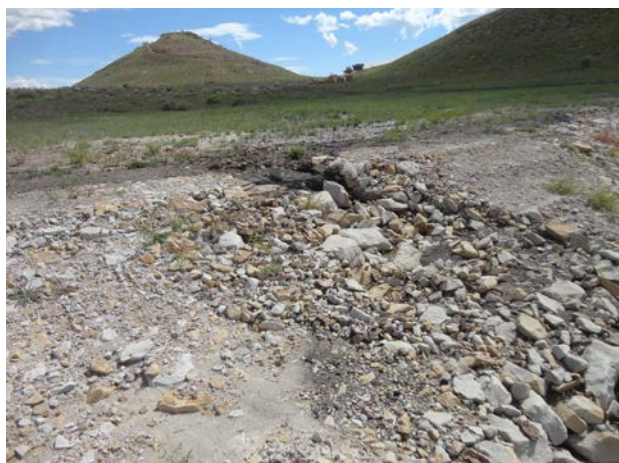
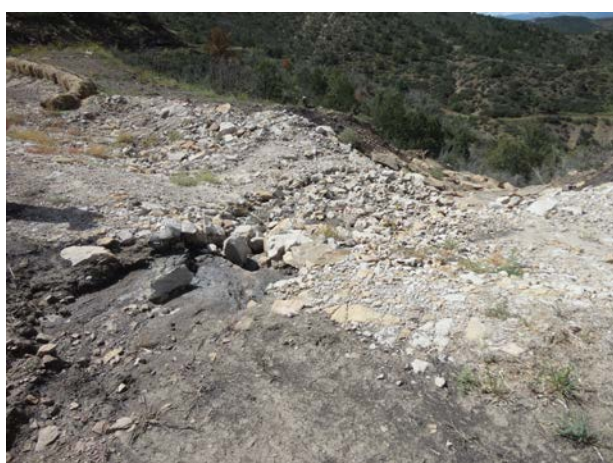
maintained to ensure that no disturbed area run-off gets into the drainage if the pond is to be a candidate for bond release.

Photo 21: Flat area above pond 5 drainage (1)

Photo 22: Flat area above pond 5 drainage (2)

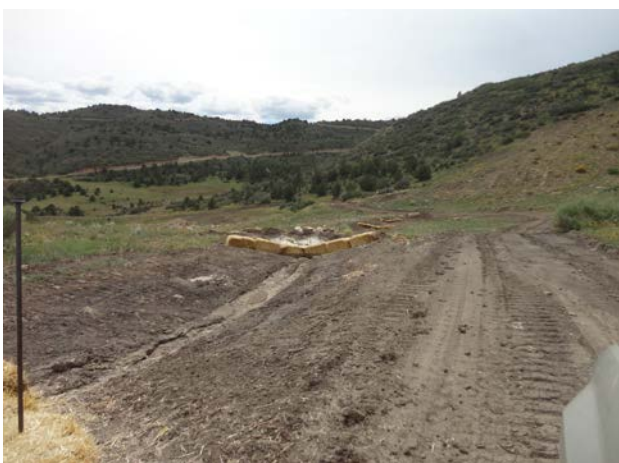
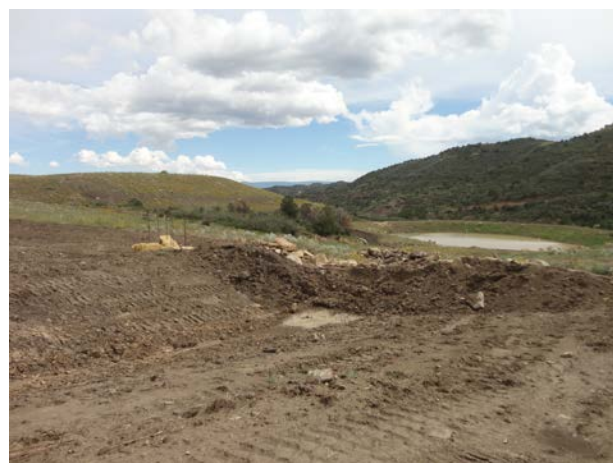
Ditches 19 and 20 above pond 6 had been repaired and the flow control structures had been restored.

The roads around the site were in good to adequate condition. In particular the roads to ponds 5 and 6 had received attention. Both were passable by car.

Photo 23: Road to pond 6 and D20 (1)

Photo 24: Road to pond 6 and D20 (2)

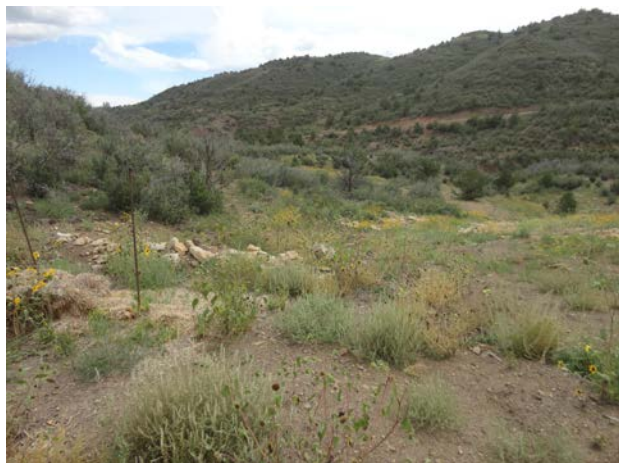
Pond 6 was discharging at a rate of approximately one drip every 5 seconds. **The flat area beside the emergency spillway must be carefully monitored to ensure that no off-site disturbance is allowed to occur.**

Photo 25: Erosion to monitor below pond 6

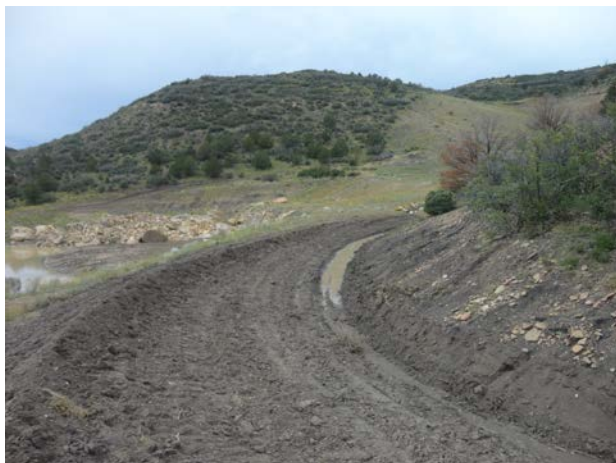
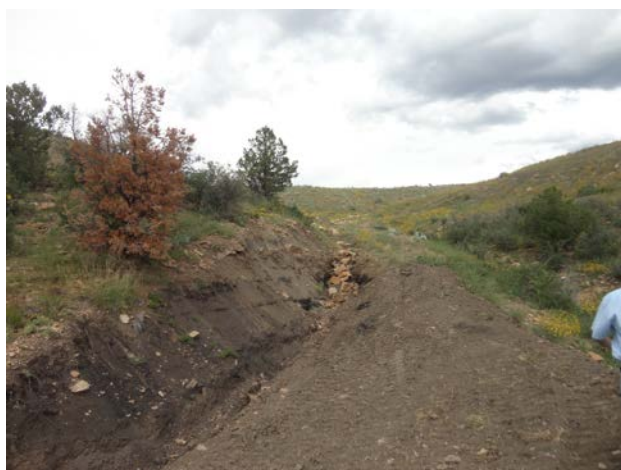
Ditch 18 and the adjacent contour ditch had been re-cut.

Photo 26: D18 improvements (1)

Photo 27: D18 improvements (2)

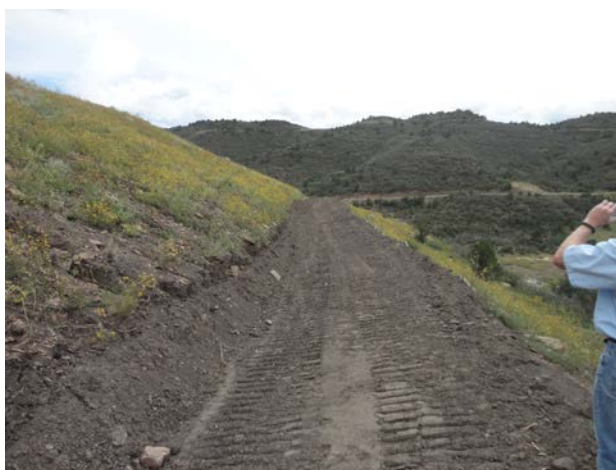
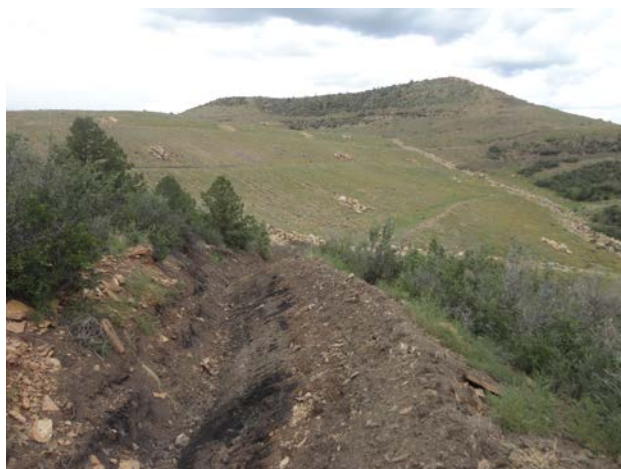
Photo 28: Contour ditch between ponds 6 and 7 (1)

Photo 29: Contour ditch between ponds 6 and 7 (2)

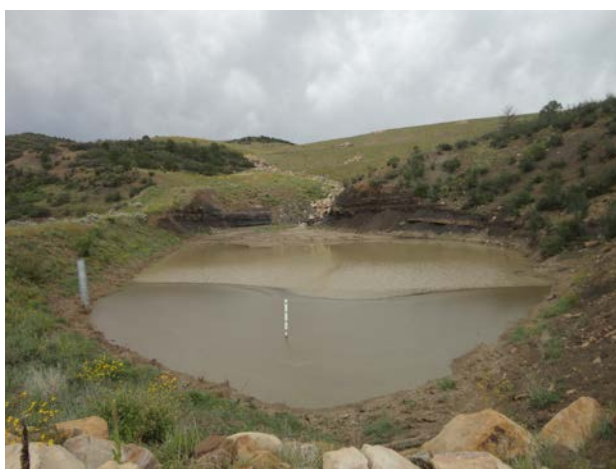
Pond 7 was not discharging.

Photo 30: Pond 7

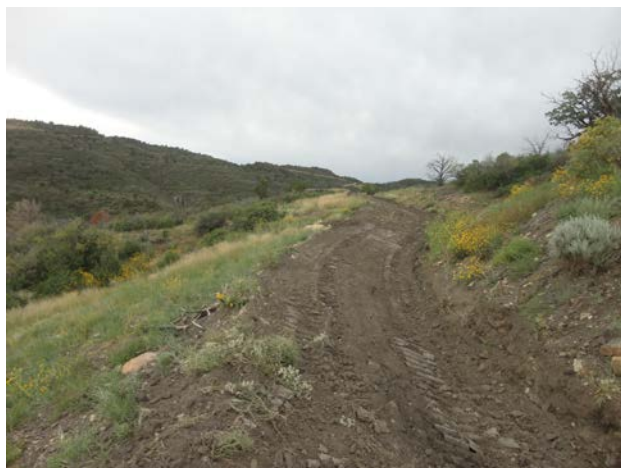
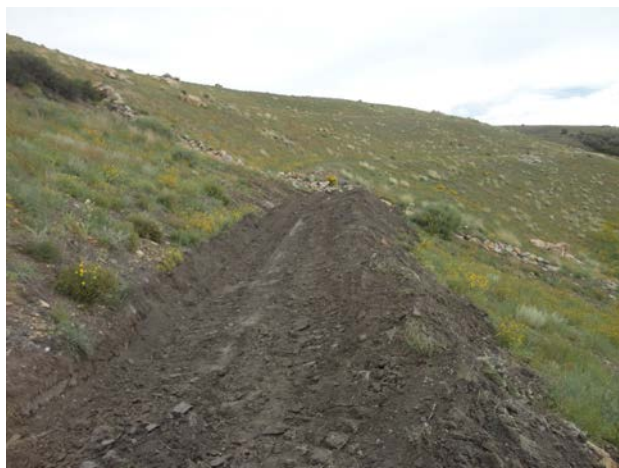
Photo 31: Contour ditch between ponds 7 and 9a (1)

Photo 32: Contour ditch between ponds 7 and 9a (2)

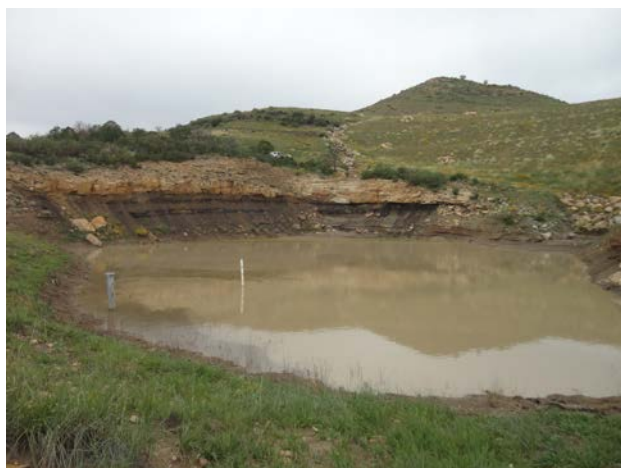
Pond 9a was discharging by drips.

Photo 33: Pond 9a
