**COLORADO DIVISION OF RECLAMATION, MINING AND SAFETY  
COAL PROGRAM INSPECTION REPORT**

<b>Permit Number:</b> C-1992-081 <b>Mine Name:</b> Hayden Gulch Loadout <b>Operator:</b> Hayden Gulch Terminal, LLC <b>Operator Address:</b> Mr. Roy Karo 37796 Routt County Road 53 P.O. Box 670 Hayden, CO 81639	<b>County:</b> Routt <b>Operation Type:</b> Loadout <b>Permit Status:</b> Permanent Cessation <b>Ownership:</b> Private
	<b>Operator Representative Present:</b>  None
<b>Operator Representative Signature: (Field Issuance Only)</b>

<b>Inspection Start Date:</b> September 25, 2013 <b>Inspection Start Time:</b> 10:03 <b>Inspection End Date:</b> September 25, 2013 <b>Inspection End Time:</b> 10:05	<b>Inspection Type:</b> Aerial Inspection <b>Inspection Reason:</b> Normal I&E Program <b>Weather:</b> Clear
<b>Joint Inspection Agency:</b>  None	<b>Joint Inspection Contacts:</b>  
<b>Post Inspection Agency:</b>  None	<b>Post Inspection Contacts:</b>  
<b>Inspector(s):</b>  Jared L. Ebert  Harry B. Ranney	<b>Inspector's Signature:</b>

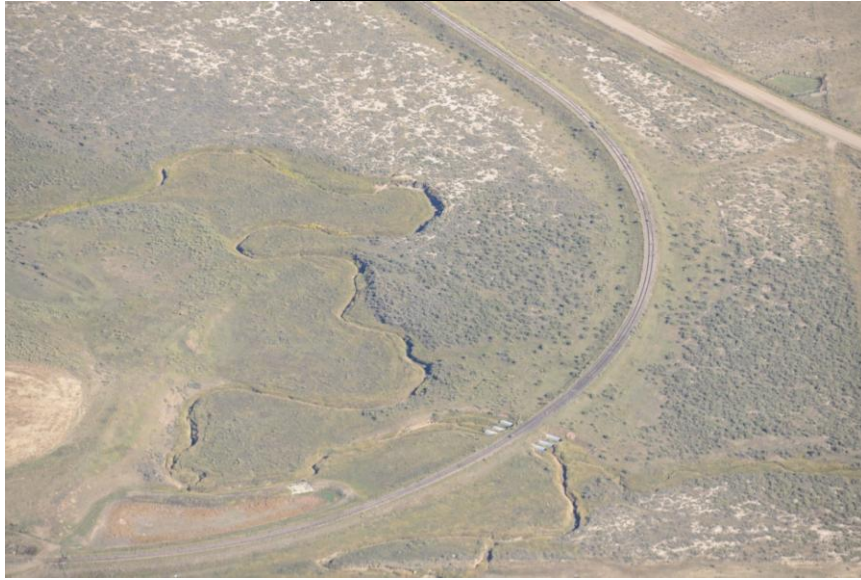
The truck loop and rail loop ponds are visible. These ponds appear functional. The truck loop pond was holding water and the rail loop pond appeared dry.

Rail Loop Pond and west end of rail loop

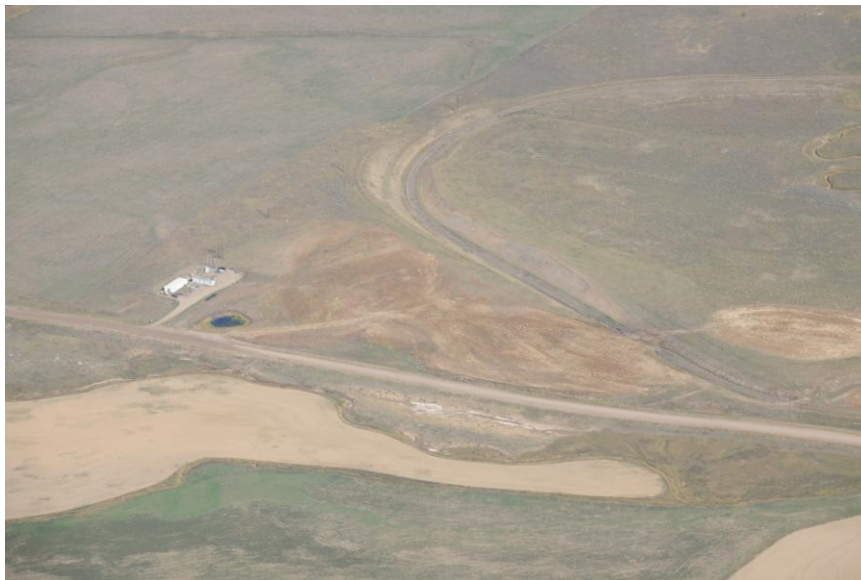
Vegetation appears to have established throughout the reclaimed facilities area and topsoil stockpile No. 2 area.

The topsoil stockpile no. 2 area and the former facilities area that was backfilled and graded in 2011 was visible. Overall, it appears these areas are stable. Large gullies were not observed.

Office trailers, Truck Loop Pond, former facilities area and topsoil stockpile #2
