**COLORADO DIVISION OF RECLAMATION, MINING AND SAFETY
COAL PROGRAM INSPECTION REPORT**

Permit Number: C-1992-081 Mine Name: Hayden Gulch Loadout Operator: Hayden Gulch Terminal, LLC Operator Address: Mr. Roy Karo 37796 Routt County Road 53 P.O. Box 670 Hayden, CO 81639	County: Routt Operation Type: Loadout Permit Status: Permanent Cessation Ownership: Private
	Operator Representative Present: Roy Karo
Operator Representative Signature: (Field Issuance Only)

Inspection Start Date: September 23, 2013 Inspection Start Time: 12:00 Inspection End Date: September 23, 2013 Inspection End Time: 13:30		Inspection Type: Coal Partial Inspection Inspection Reason: Normal I&E Program Weather: Clear	
Joint Inspection Agency: None		Joint Inspection Contacts:	
Post Inspection Agency: None		Post Inspection Contacts:	
Inspector(s): Jared L. Ebert	Inspector's Signature:

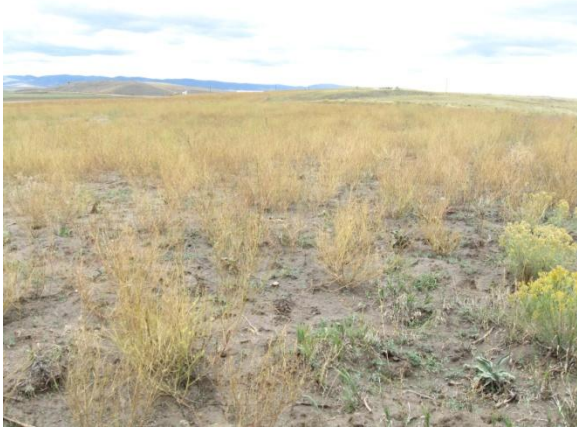
Topsoil stockpile No. 2.

Topsoil stockpile 2 was observed, this pile was stable. Some grass has begun to establish on the stockpile. The primary plant cover found on the pile was yellow sweet clover.

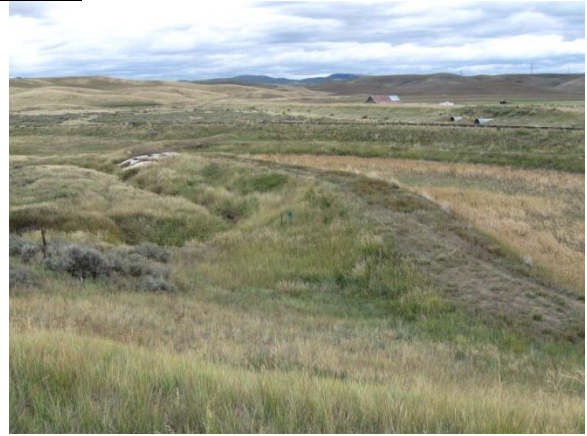
Rail Loop Pond

The rail loop pond was dry, the embankment was stable. The primary spillway was clear and functional. The earthen berm used to hold the discharge pipe had not been repaired at the time of the inspection. However, the Operator indicated they intended to repair this berm in the near future.

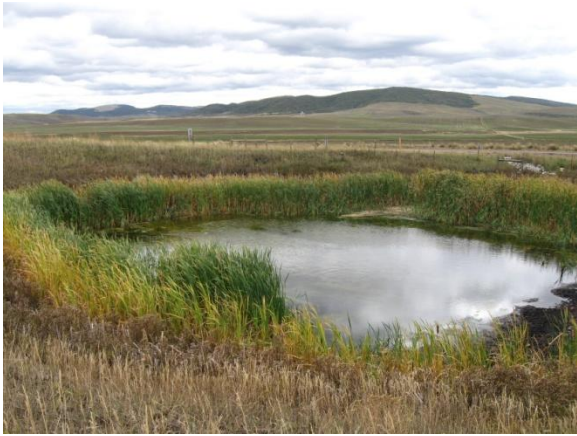
Truck Loop Pond

The truck loop pond was holding water but was not discharging. The embankment was stable and the primary and emergency spillways were clear and functional.
