**COLORADO DIVISION OF RECLAMATION, MINING AND SAFETY
COAL PROGRAM INSPECTION REPORT**

Permit Number: C-1981-010 Mine Name: Trapper Mine Operator: Trapper Mining, Inc. Operator Address: Mr. Forrest V Luke P.O. Box 187 Craig, CO 81626	County: Moffat Operation Type: Surface Permit Status: Active Ownership: Federal
Operator Representative Present: Graham Roberts and Billy Nicholson	
Operator Representative Signature: (Field Issuance Only)

Inspection Start Date: September 24, 2013 Inspection Start Time: 07:45 Inspection End Date: September 25, 2013 Inspection End Time: 11:00		Inspection Type: Coal Complete inspection (ground visit) with Aerial Inspection Reason: Normal I&E Program Weather: Clear	
Joint Inspection Agency: None		Joint Inspection Contacts:	
Post Inspection Agency: None		Post Inspection Contacts:	
Inspector(s): Jared L. Ebert Harry B. Ranney	Inspector's Signature:

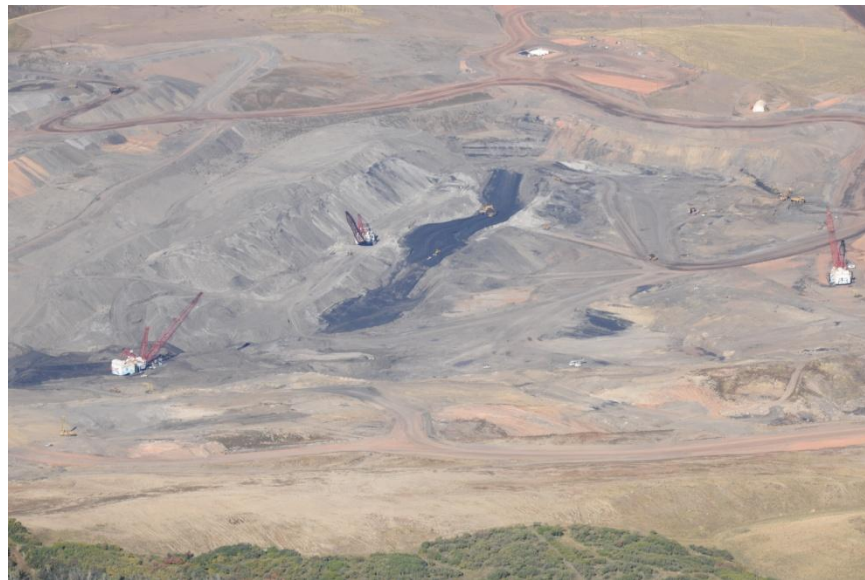
Two draglines were operating in the L and M pit area. One dragline was staged near the scoria pile. A shovel was excavating coal and loading it into haul trucks.

Active mine area, draglines on the left mining in L and M pit. Dragline on the right staged near scoria pile.

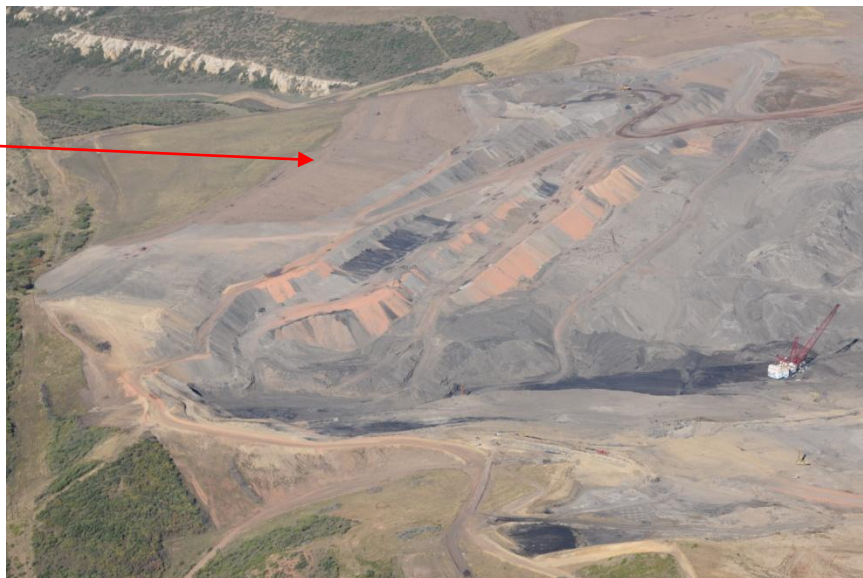
TMI was concurrently backfilling spoil behind the active mining operation.

Concurrent reclamation, backfilling west (behind) active mining, topsoil application.

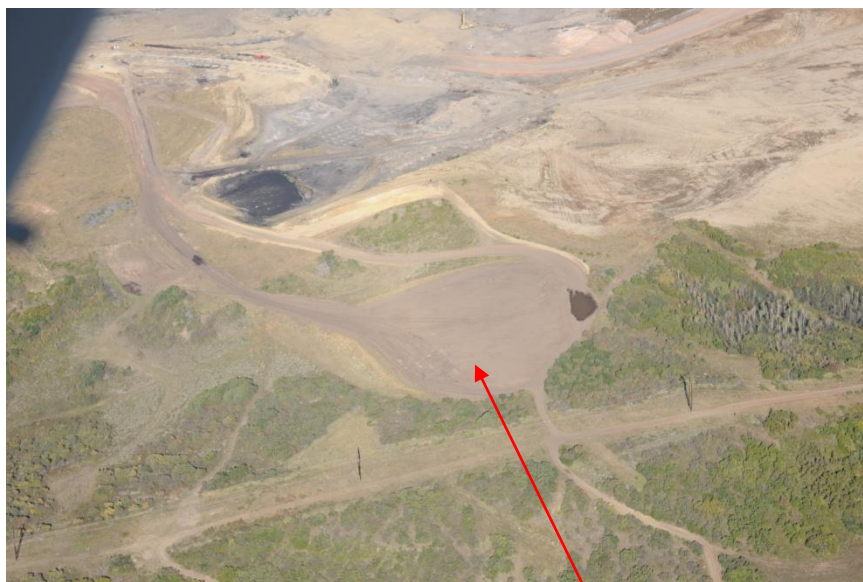
It appears topsoil was recently hauled from stockpile G2-06.

Topsoil hauled from pile G2-06

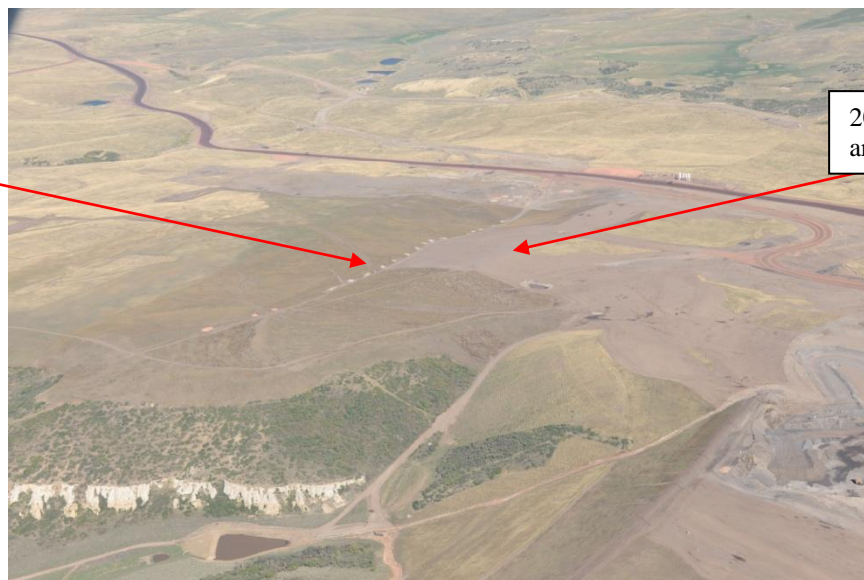
The horse gulch fill was observed. The final bench of the fill appears to have been completed. The rills observed on the upper face of the fill earlier this year have been repaired and they appear stable. According to Mr. Nicholson, a track hoe was used recently to break up some of the larger rock placed in the north and south rock drains of the fill.

Reconstructed East Pyeatt
Drainage

2013 topsoil application
area; F/Z Pit

F/Z Pit Reclamation, Horse Gulch fill

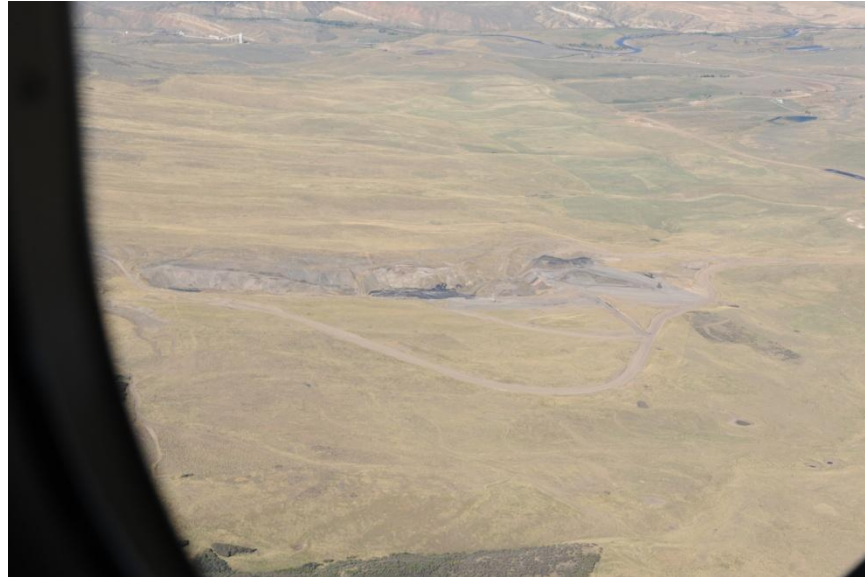
D/E Pit

At the time of the inspection the Operator was actively backfilling an excavation at the north end of the D/E Pit. According to Mr. Roberts this parcel was used as a training area for new loader operators.

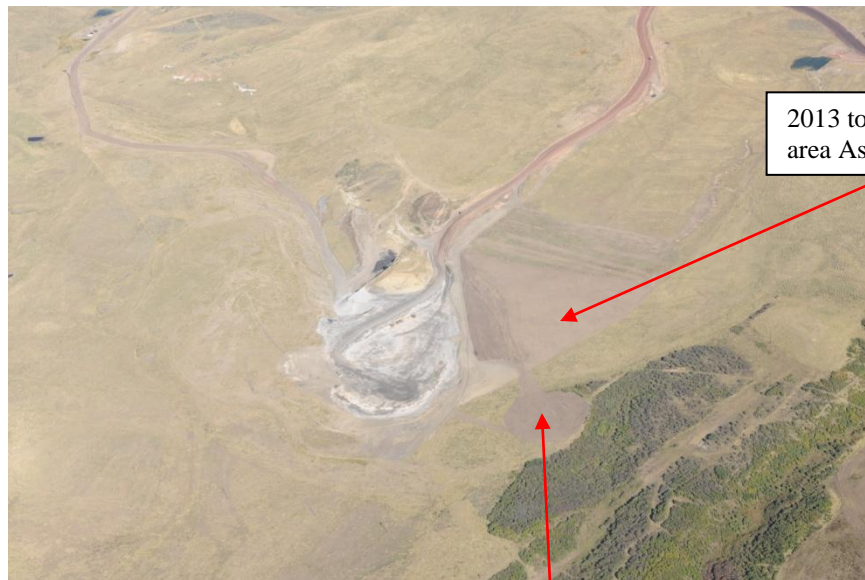
Ash continues to be backfilled at the south end of the ash pit . A large area on the southeast end of the pit was recently graded and topsoiled.

Topsoil appears to have been hauled from stockpile A88-4 to the 2013 Ash pit topsoil lay down area. It appears a small portion of Phase III bond release area has been re-disturbed. TMI will need to account for this re-disturbance in the 2013 Annual Reclamation Report.

Ash Pit, Topsoil Pile A88-4

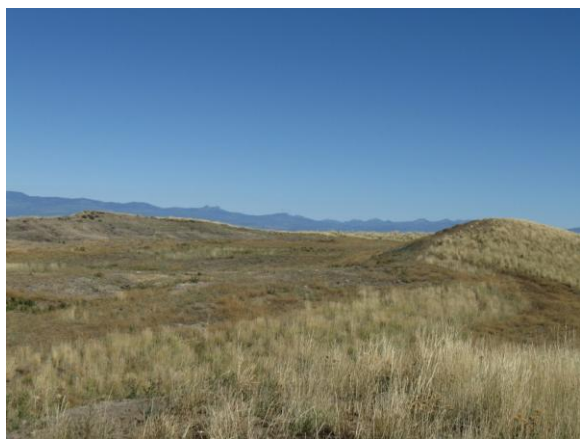
The scarp above the D/E pit on the south side appeared to be stable and does not appear to have changed much since the last inspection of the area. Vegetation has begun to establish in the affected area.

Scarp above D/E Pit.

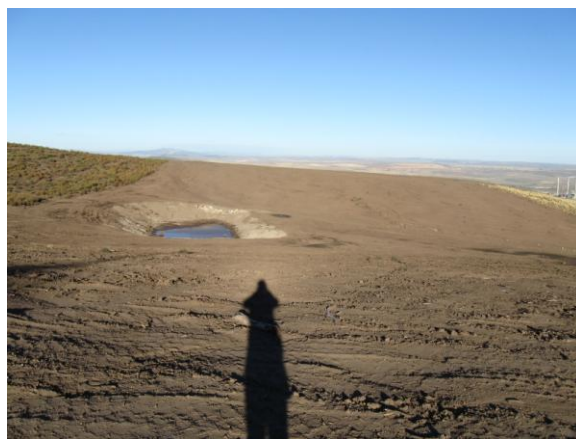
Topsoil from stockpile Z1-09 had been spread over the 2013 topsoil area in the Z Pit parcel.

2013 topsoil application area, Z-Pit, new dozer basin.

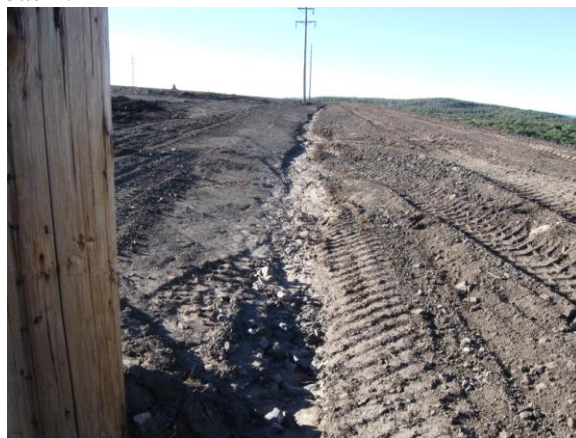
Drainage ditch on the top bench of Horse Gulch fill.
